SAFETY DIGEST

Lessons from Marine Accident Reports

1/2025

MARINE ACCIDENT INVESTIGATION BRANCH

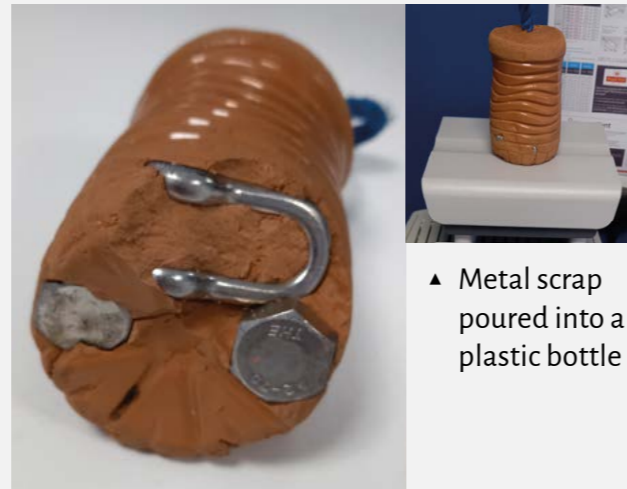
▲ Metal scrap poured into a plastic bottle

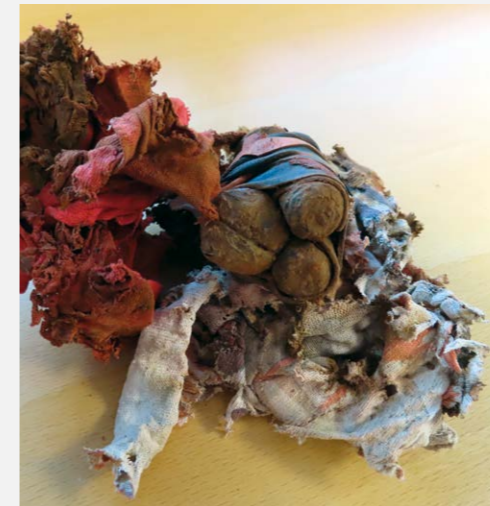
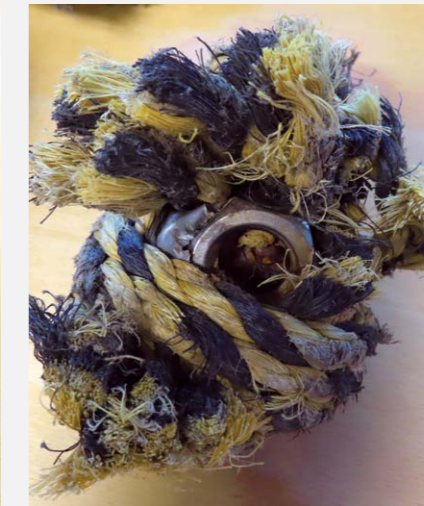
▲ ▼ Dangerous monkey's fists filled with metal scrap

Many ports in the UK are willing to provide safe alternatives such as sandbags to replace dangerously weighted heaving lines.

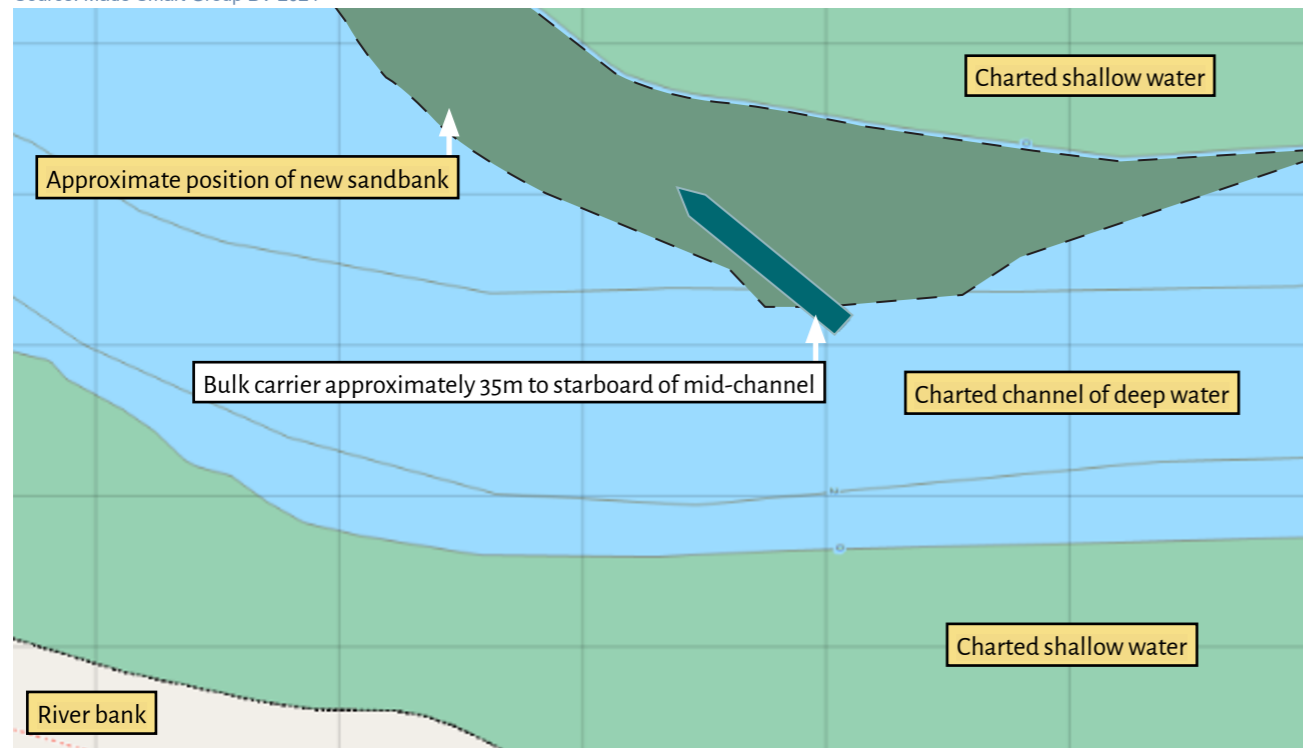
Figure 1: The bulk carrier's position near mid-channel shortly after going aground

The pilot tried to extricate the ship from the apparent grounding by using maximum power astern but, aside from making the ship's stern pivot around more to port, this had little impact other than to point the bows further towards the new sandbank (Figure 1). The ship's team sounded their tanks and found no water ingress. With the tide now ebbing, it became clear that the bulk carrier was firmly aground. Having informed all the relevant local authorities and examined towing options it was inevitable that the pilot and ship's crew would have to wait until the next high tide to free themselves. The pilot stayed on board as a contingency measure during the long wait. At low water it was seen that the sandbank on the inside of the river bend had extended almost 200m further out into the river than it had

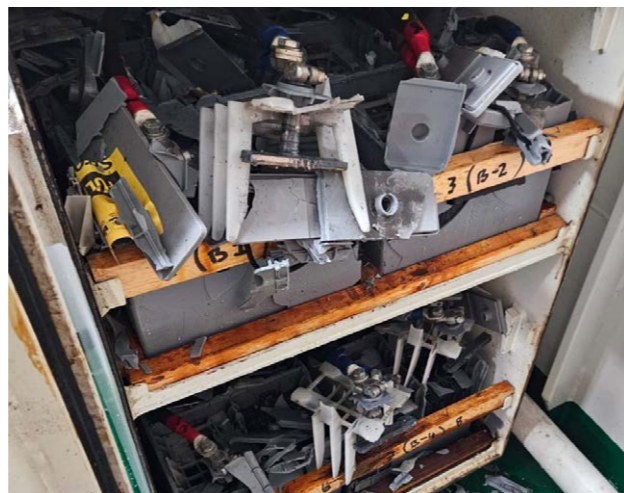
A barge crew member escaped injury when a bank of four lead acid batteries exploded on starting a generator engine after completing the start-up checks. The four batteries simultaneously exploded as the start solenoid closed to power up the starter motor. Fortunately, the bank of batteries was housed in a secure steel battery locker that contained the explosion and limited the damage (Figure 1).

Figure 1: Battery locker after the explosion

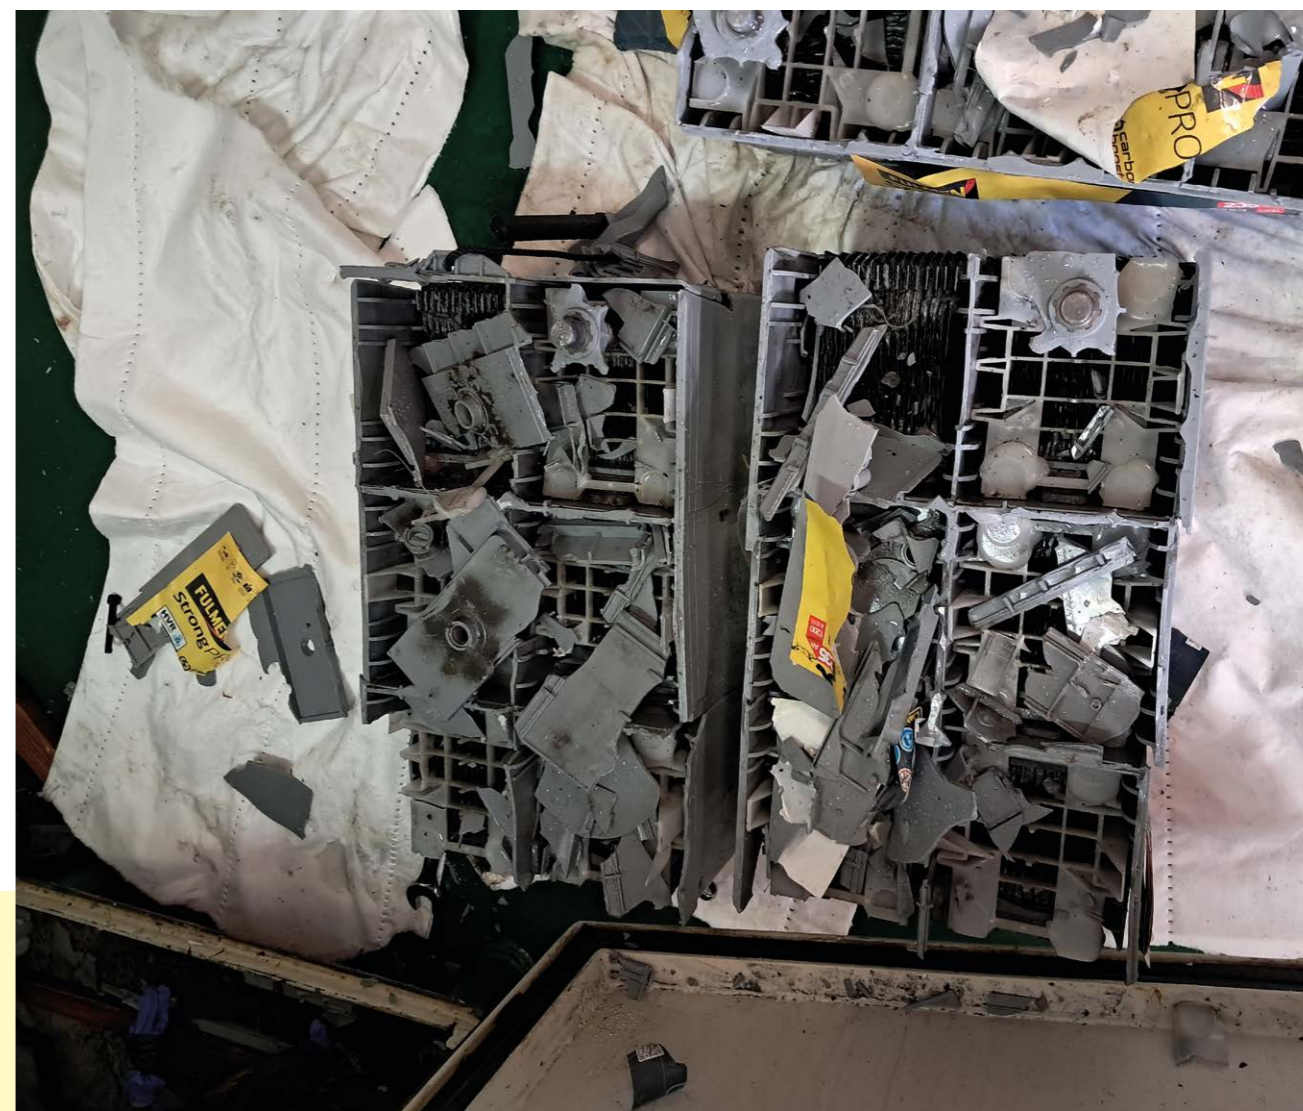
An investigation found that the batteries, which had been in service on the vessel for more than 5 years, were of a low maintenance, valve-regulated lead acid (VRLA) type that was incorrect for their intended purpose due to the battery circuit being maintained by a continuous float charge. The battery charging system was found to be working correctly, maintaining the required rate of trickle charge.

Given the wet cell nature of the batteries and the length of time they had been in service, it is most likely that the electrolyte level had gradually dropped because of continuous float charging. This exposed the top of the cell plates, which probably started to corrode. The cells shorted out when the batteries were subjected to a high discharge load, causing the explosion (Figure 2).

Figure 2: Destroyed batteries

2. **Maintain** → Batteries are a piece of machinery and require a documented service and maintenance log. The record should individually list the type of battery; where it is located on board; when it entered service; dates and details of any inspections or maintenance and, if applicable, what corrective action was taken; and when it is due for replacement.
3. **Hazard** → Safe stowage of battery installations is crucial to contain and minimise impact in the event of a fire or explosion. To prevent a build-up of gases from the charging process batteries should be kept in a purpose-built, well-ventilated locker in a cool, dry location away from the elements. Light fittings in a battery compartment should be corrosion-resistant and flame/explosion-proof.

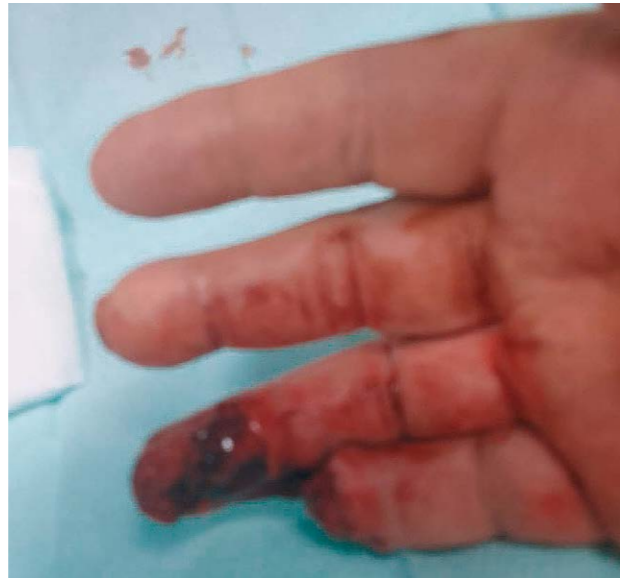
The river's current moved the tender against the barge and the mooring rope slipped off the cleat. As the crew member went to resecure it, the wash from a passing boat caused the tender to rise and fall. The crew member placed the eye of the mooring rope onto the cleat just as the tender descended, causing their fingers to be caught in the bight and crushed against the cleat.

Figure: The crew member's injured fingers

- Hazard** → Relative movement between a vessel and its mooring point creates a dynamic environment that requires crew members to be alert to entrapment risks when handling mooring ropes. Unexpected boat movements due to strengthening or receding waves, wind and currents can cause ropes to switch from slack to taut without warning: keep your fingers clear.
- Equipment** → Manage the risk. The difference in height between the two boats in this case increased the likelihood that the mooring rope would slip off the cleat and need to be resecured. Where this is a routine operation, and ropes cannot be run horizontally, conduct a risk assessment of the design and fitting of the cleats to prevent slippage.

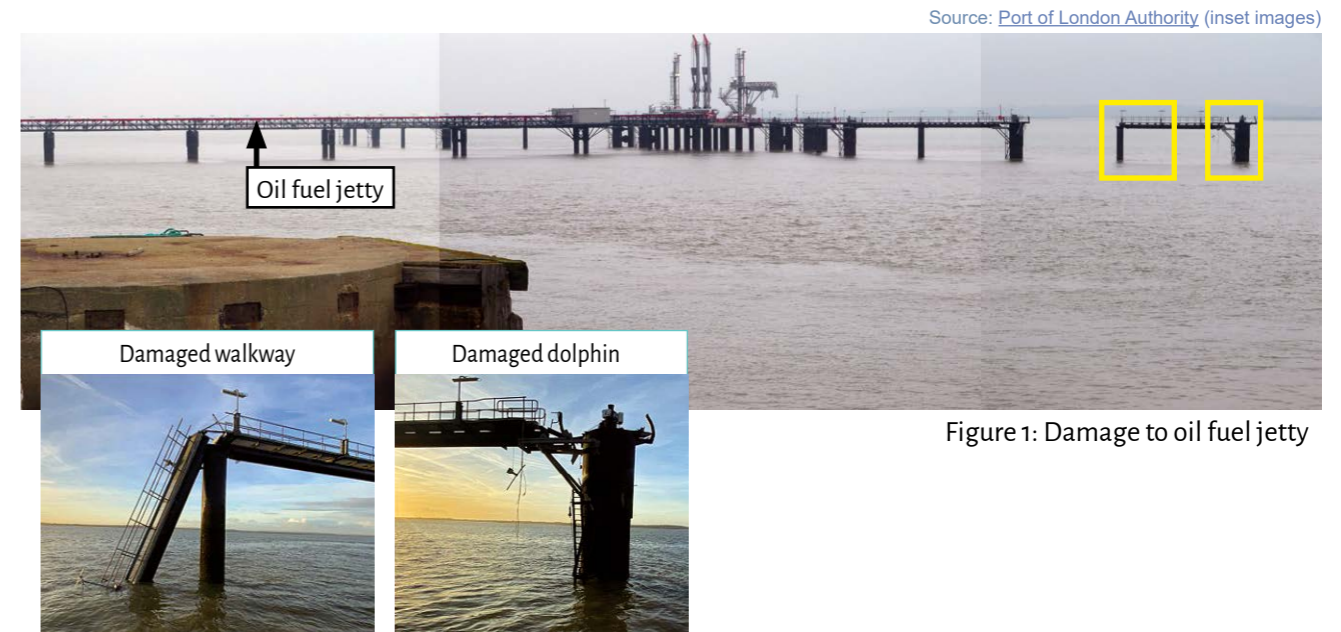
and swept down towards an adjacent jetty. In the darkness, and with no one supporting the pilot, the hazardous nature of the situation went unnoticed until it was too late. Despite the master and the pilot shouting a series of engine, helm and anchor orders, the starboard aft quarter of the oil tanker struck the nearest mooring platform (or dolphin) on the adjacent jetty with a great deal of force, dislodging a walkway and cutting all but emergency electrical supplies to the jetty (Figure 1). The oil tanker came to rest on the landward side of the jetty with its bows held by the vessel's anchor and the mud of the riverbank.

Figure 1: Damage to oil fuel jetty

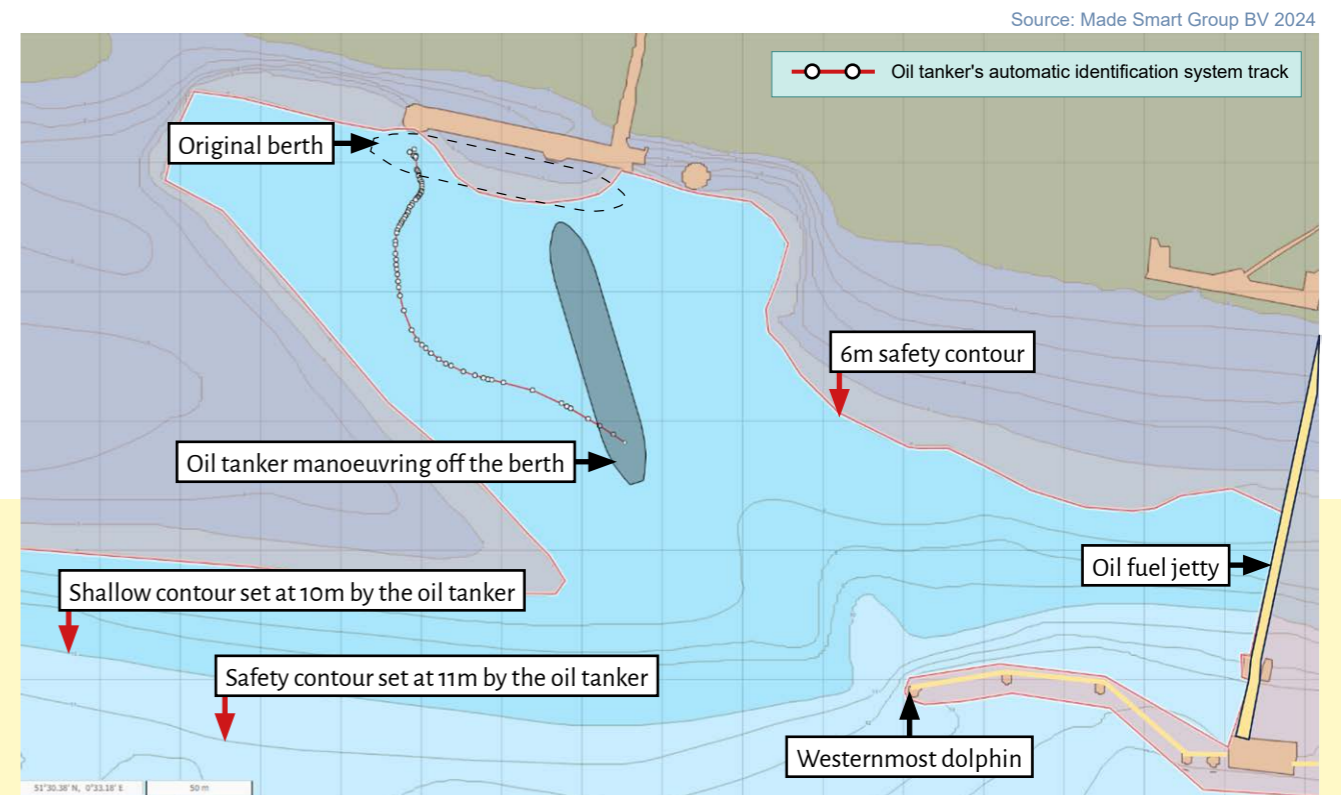
A high-density electronic navigational chart was available for the area, but safety contours in the ECDIS had not been selected with care. The contours used marked the entire area off the berth as being within the safety contour and nominally unsafe.

Figure 2: Safety contour used for the move

2. **Margin of safety** → The oil tanker's ECDIS safety contour was set to 11m but the vessel's proximity to shallow water and other hazards was not effectively monitored. A safety contour is used to mark the division between safe and unsafe waters and should, at a minimum, account for height of tide, vessel draught, squat, charting accuracies and the impact of weather. A safety contour setting of 6m would have complied with the company safety management system and allowed the dangerous waters to be readily identified and avoided (Figure 2). High-density ENC's are becoming increasingly available, allowing the selection of intermediate contours to give the best possible picture of safe water. The benefits afforded by these products can make all the difference when used to their full advantage.

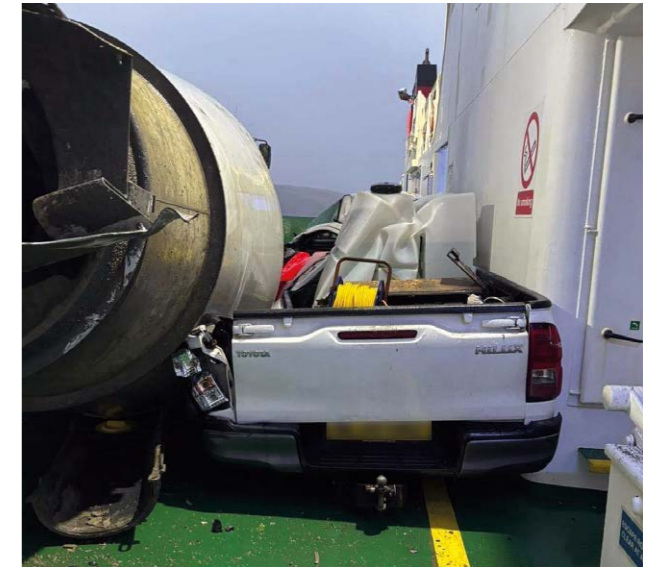
The ferry rolled heavily and the ready-mix cement lorry toppled over onto the adjacent pickup truck, crushing it (see figure). The two occupants of the pickup truck escaped unharmed but were understandably shaken by their experience.

Figure: The cement lorry and crushed pickup truck

1. **Hazard** → It is probable that the ferry's movement combined with the cement load's shift in centre of gravity caused the lorry to tip over. Drivers of these lorries often undertake awareness and prevention training that focuses on rollover hazards on sites and when on the road but does not include situations where the lorry is being transported on a ship's vehicle deck. In this case the rollover risk appeared to be minimal as the lorry was stationary on a level deck and the driver of the lorry might not have expected the ferry's motion in the seemingly benign sea conditions. The crew of the ferry understood that the ready-mix lorry had a high centre of gravity that would alter as the cement moved around in the rotating drum. The driver was asked to stop the drum to mitigate the risk, but this was not done; however, while the crew had considered the effect of sudden tidal turbulence on the lorry, they did not take further prevention measures such as lashing the lorry to the ferry's deck.

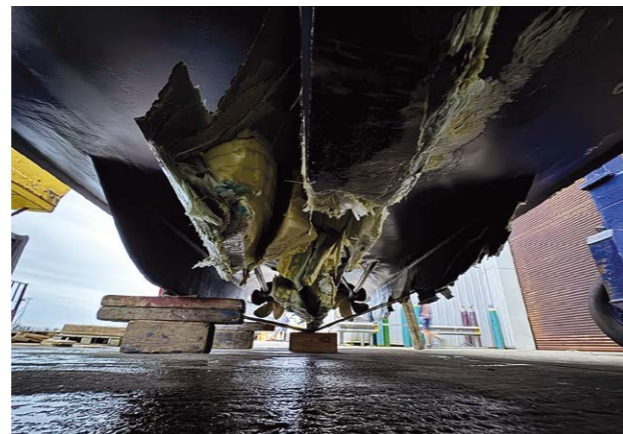
Figure: Hull damage to the rescue craft

On arrival back at base the rescue craft was lifted clear of the water and examined. Approximately 75% of the keel had suffered impact damage, the hull was cracked in several places, and there was significant surface delamination (see figure). After much deliberation, the rescue craft was eventually scheduled for repair.

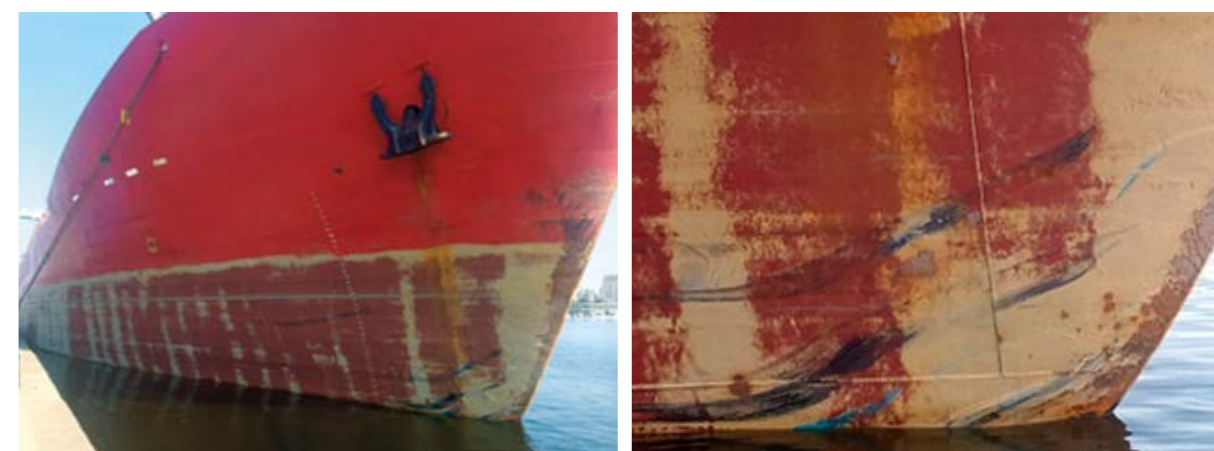
The pilot was checking the intentions of the pilot vessel at the master's request when it made a sudden turn to starboard across the bows of the cargo ship. The pilot shot into action, shouting into their radio and ordering the master to slow in speed. Nothing could stop the inevitable collision, and the bows of the cargo ship crunched into the starboard quarter of the pilot vessel (Figure 2). The pilot vessel quickly succumbed to flooding and sank to the bottom of the channel. Fortunately, all four crew were uninjured and managed to swim clear to be rescued by two local tugs.

Figure 2: Damage to the bows of the cargo ship

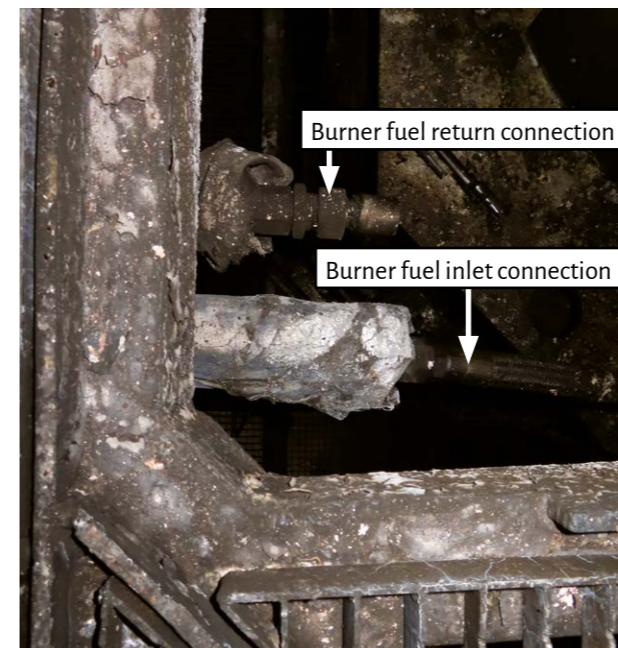
The fire had started when a connection on the flexible fuel return hose failed where it was joined to the burner unit on the boiler (Figure 1). Fuel from the detached connection had sprayed onto adjacent hot surfaces, causing a fire of such intensity that it caused serious damage to the equipment in that area (Figure 2).

Figure 1: Return line connection

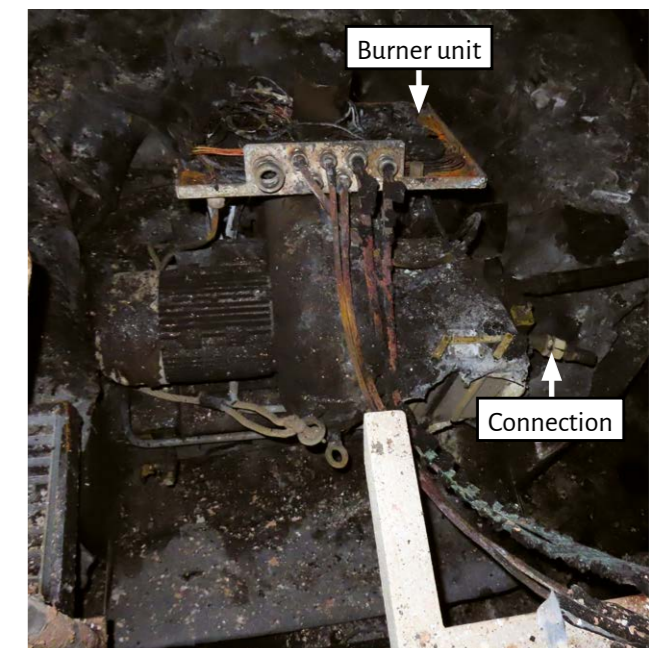
Figure 2: Damage to the boiler

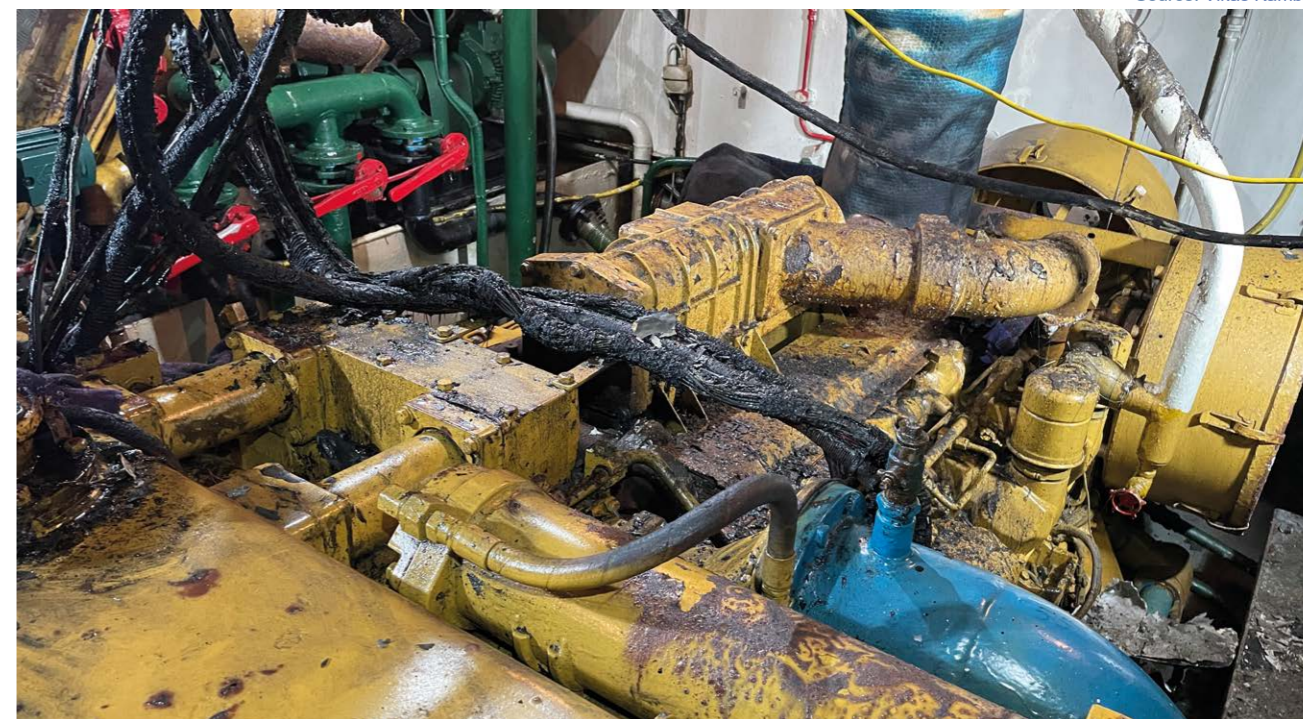
Figure 1: View from port forward toward the starboard aft corner of the engine room after the fire

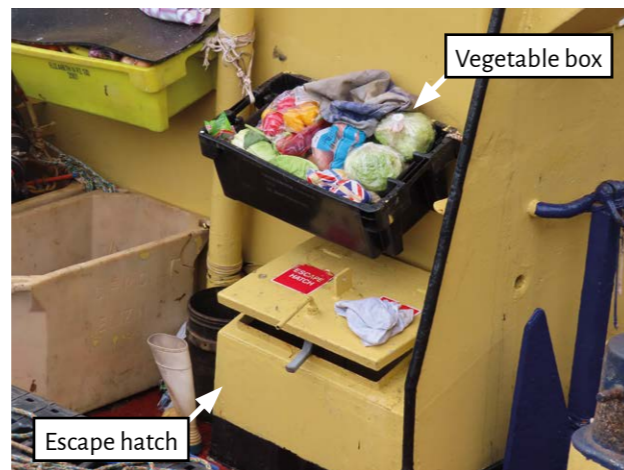
Figure 1: The blocked escape hatch

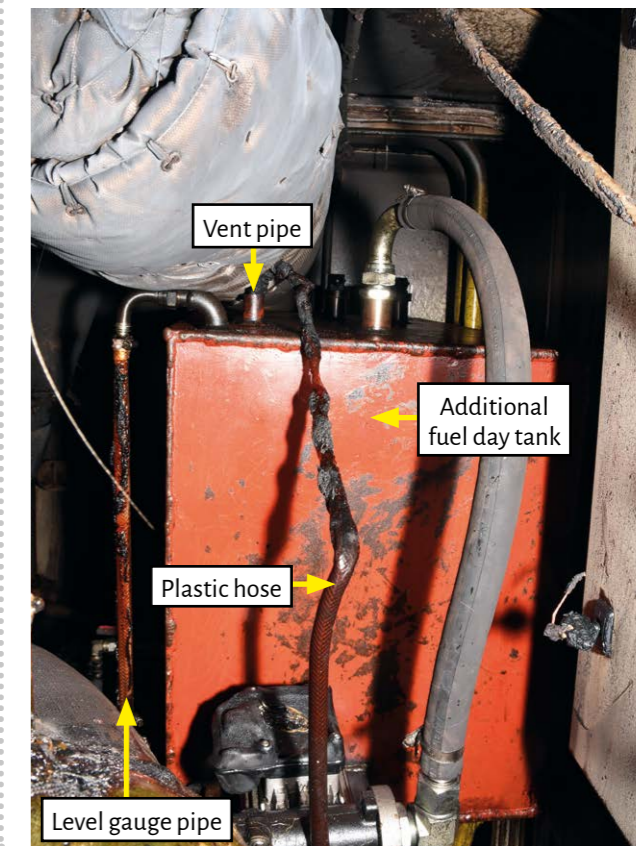
it overflowed through the vent and the spilled fuel ignited on the starboard generator's hot exhaust, engulfing the engine room in smoke and flames.

Figure 3: The installed fuel oil day tank
