Rail Accident Investigation Branch

Rail Accident Report

**Passenger train collision with a road vehicle at
Redcar level crossing, Redcar and Cleveland
1 May 2024**

Report 05/2025
April 2025

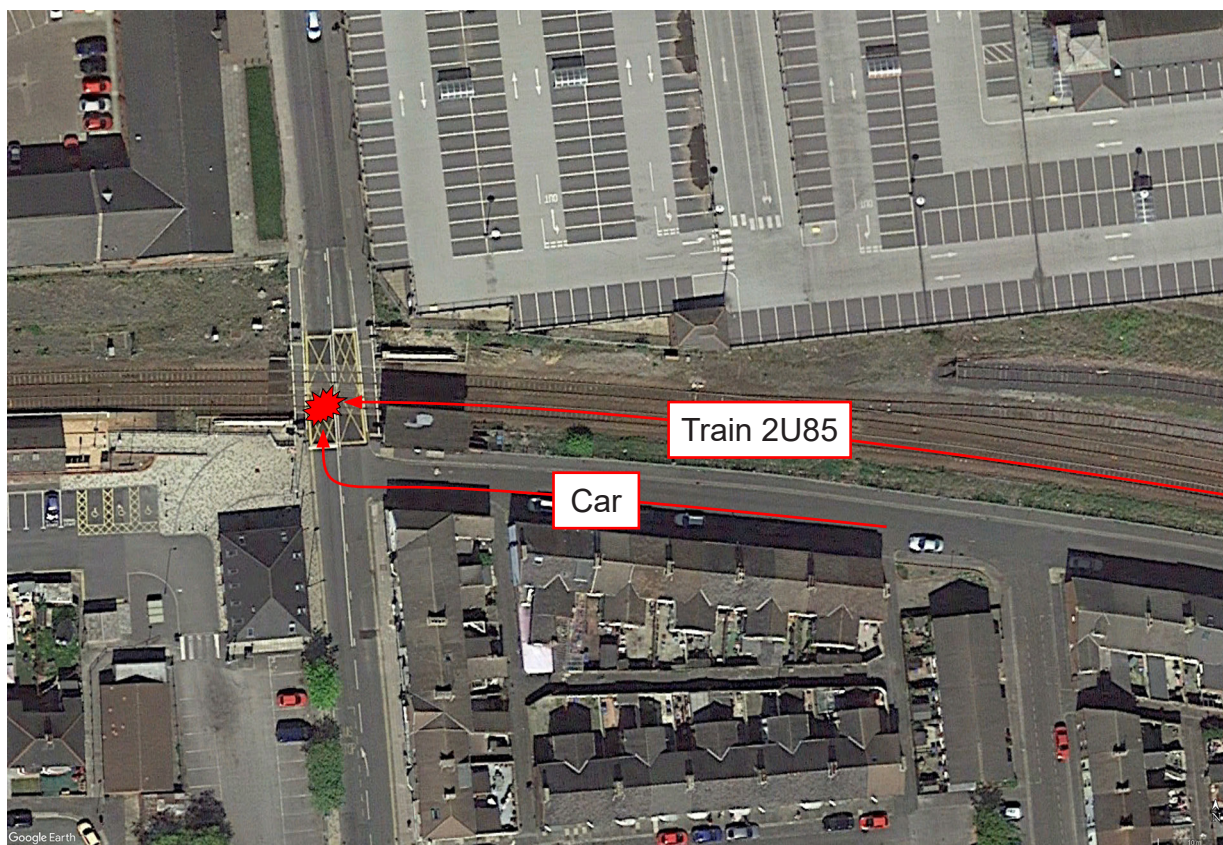
Figure 10: Direction of approach for the car and the train (courtesy of Google with RAIB annotations).

- 44 The train entered the level crossing, at the same time as the car, while the crossing was open to road traffic.
- 45 At the time of the accident, Redcar level crossing was not closed to road traffic. The wig-wag lights and audible alarm had therefore not operated, and the gates had not closed the road. The car approached and entered the crossing while it was in this open state.
- 46 Before entering the crossing, the car driver, who was very familiar with it (paragraph 32), noted that there was no queueing traffic, which they found to be very unusual. The driver saw that the wig-wag lights were not flashing, and that the level crossing gate was open to the road.

- 47 As soon as the car started to cross the track, it was struck by the train approaching from the right-hand side. Road users are not required to look for approaching trains at this type of level crossing, as they should be prevented from entering the crossing by the flashing wig-wags and gates. However, even if the car driver had looked to their right, they would have had no sight of the train before entering the level crossing because their view would have been blocked by the signal box, which is located on the right-hand southern corner of the crossing (from the perspective of the car driver).

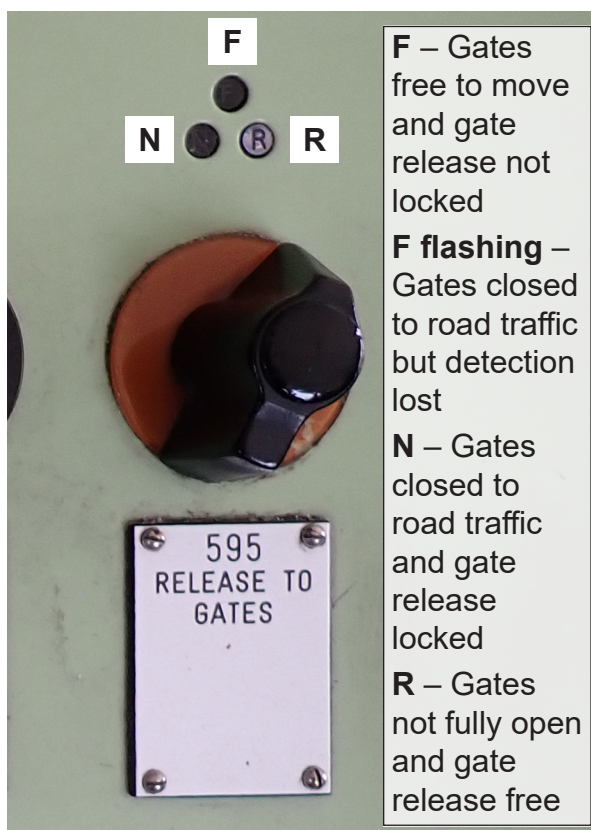
Figure 11: Crossing release indications.

- 68 There are small indicator lamps associated with the crossing release switch (paragraph 43 and figure 11). Of these, the 'N' indicator lamp (which tells the signaller that the gates are not locked after being closed to road traffic) could have alerted the signaller that the crossing was open. Witness evidence shows that the signaller did not observe the status of these lamps. This is because these indications are small and are intended to indicate the status of the interlocking rather than whether the crossing is closed. As a result, they are not routinely checked during signalling operations to determine the status of Redcar level crossing and are not included on the route cards (see paragraph 72).

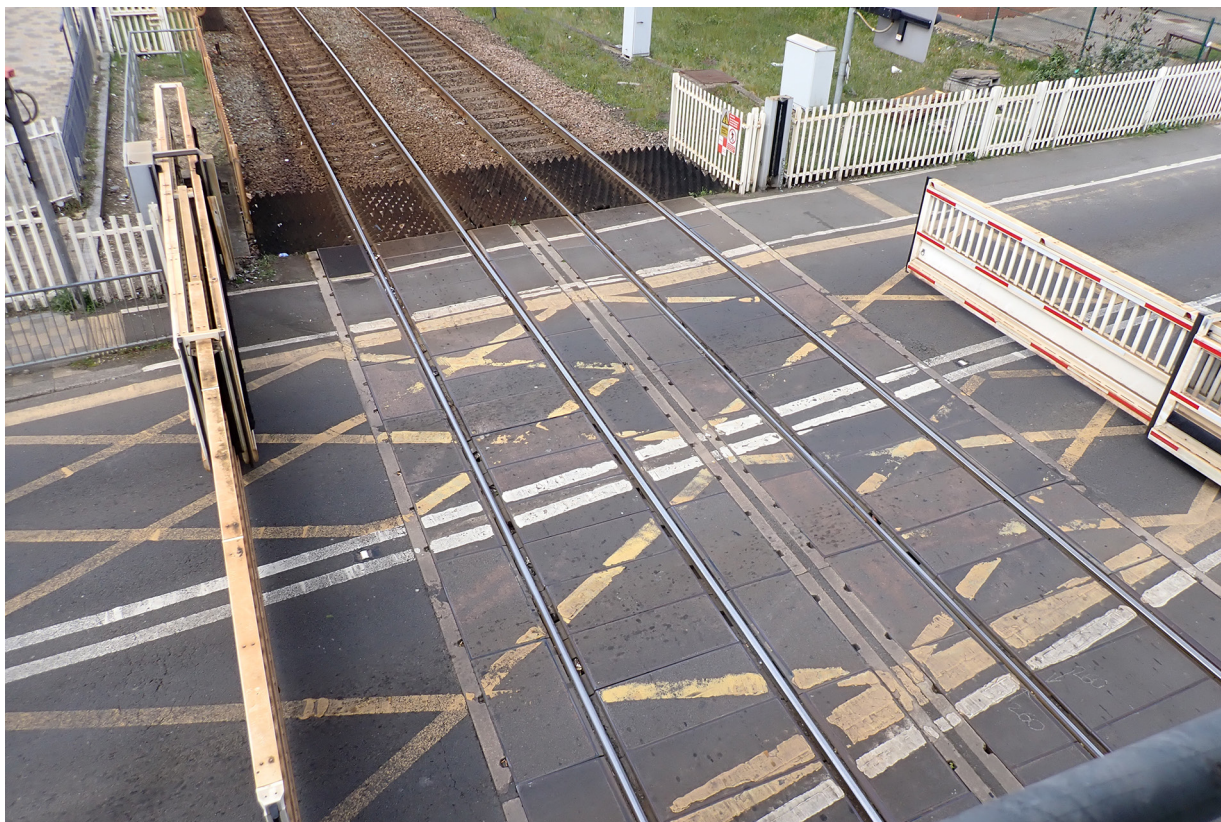
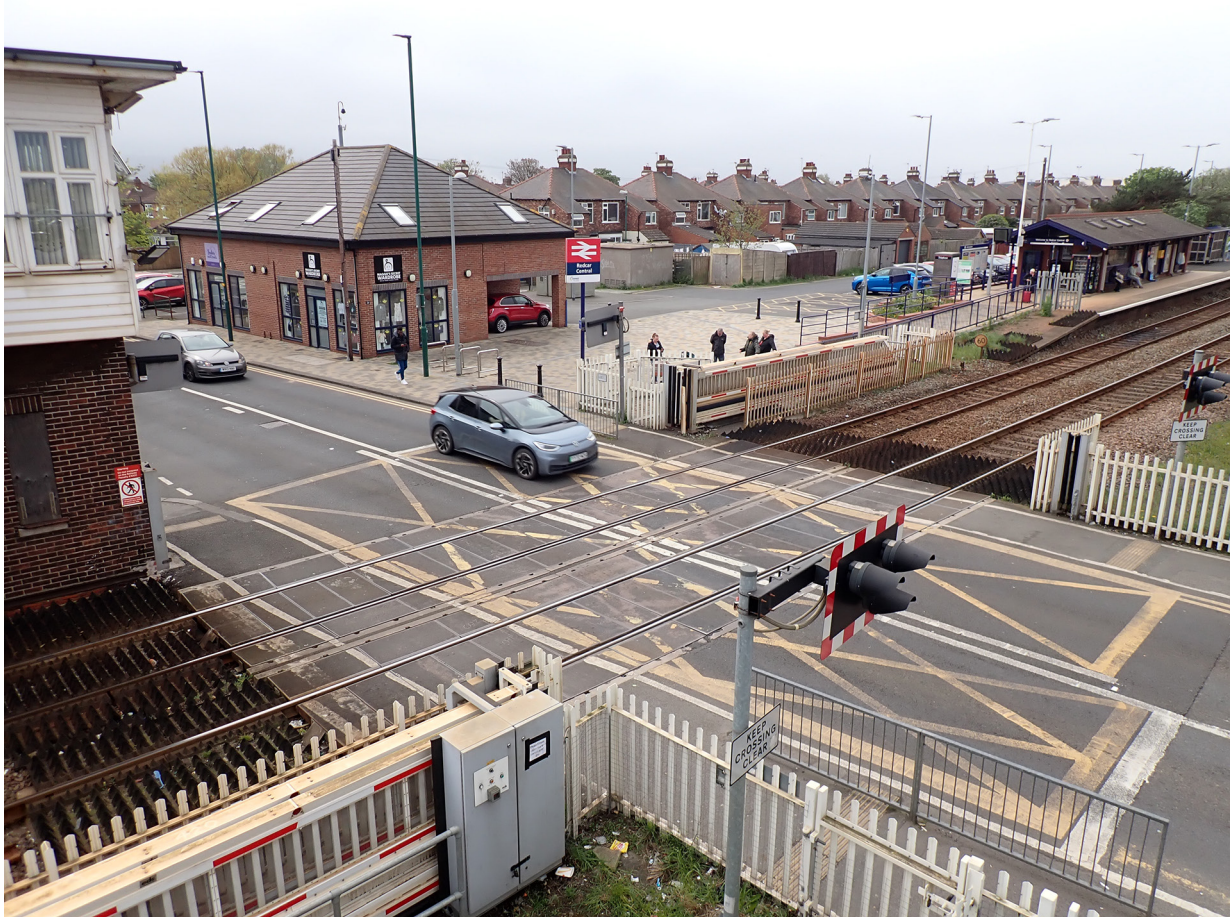
94 The level crossing gates at Redcar are of a unique design on Network Rail's infrastructure. They each consist of a horizontally extending, cantilevered gate (figure 12) that is motor-driven and operated from the pedestal in Redcar signal box (figures 6 and 9). These gates were installed in 2016 and replaced a set of wooden, motor-driven, swung gates. These swung gates had suffered from a history of unreliable operation, partly down to the wind that tends to blow in from the sea at Redcar. Network Rail was unable to replace them with conventional lifting boom barriers because the position of the signal box did not allow sufficient space for the necessary equipment. Unlike Church Lane level crossing barriers, those at Redcar do not rise into the air and so are not visible from a distance when they are open to road traffic (figure 13).

95 On the day of the accident, after the signaller had reopened the barriers to allow traffic to ease, there was no road traffic passing across the crossing while train 2U85 approached. This meant that the train driver was provided with no visual clue from crossing road traffic that the gates, and therefore the road, were still open, which would have prompted the driver to brake. This was also the reason that the car driver was able to immediately exit the side road and enter the crossing (paragraph 32).

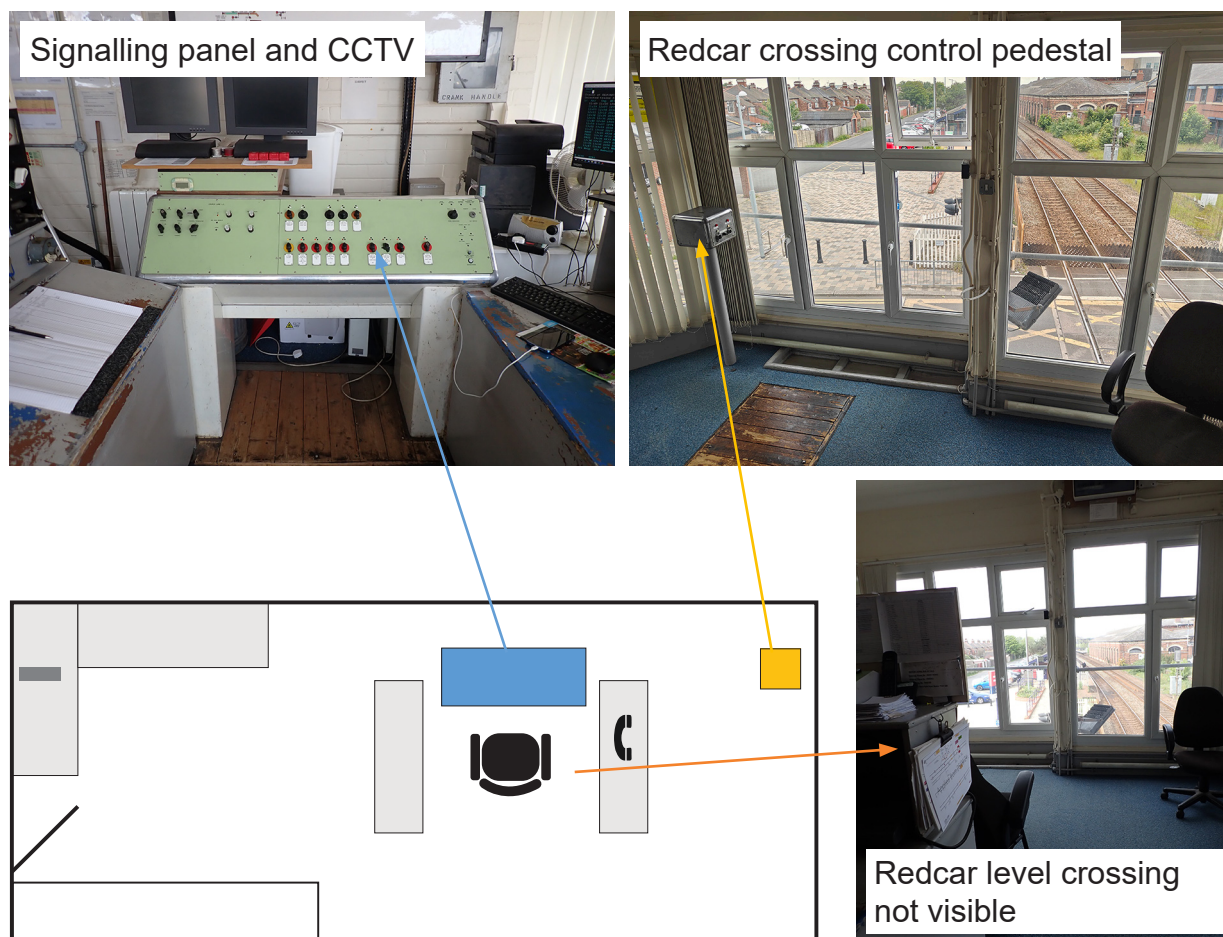
Figure 14: Layout of the signal box.

- 122 The Redcar signaller was therefore in a situation where information about the level crossings that they were operating came from two different locations in the signal box. The signaller has to walk between these locations routinely to complete the sequence necessary for the passage of each train. The design of the crossing gates also means that their position cannot be seen from the seat at the signalling panel. Although there are small indications associated with the level crossing release switch, these are not routinely checked when signalling trains (paragraph 68). In the case of this accident, the lack of visibility of both crossings when setting the route meant that the signaller did not have an effective reminder that the Redcar level crossing was still open, after they were interrupted while setting the route for train 2U85.

- 124 No ergonomic assessment of the signal box at Redcar was found in Network Rail's records. This is because there had been no operational or design changes made to the signal box, or to the level crossing, that were significant enough to require such an assessment since the introduction of the ergonomic standard. For example, the upgrade of the Redcar level crossing gates in 2016 was assessed to have had no ergonomic effect on the operation of the signal box. This was because the level crossing controls remained the same and the signal supervision of the gates remained unchanged.

- 1 *The intent of this recommendation is to reduce the risk of signallers at Redcar, and other signal boxes with similar ergonomic issues, making errors.*
