Report on the investigation of  
the double fatality and subsequent loss  
of the small commercial vessel

## ***Calypso 2***

near West End, Anguilla

REPORT NO 6/2025

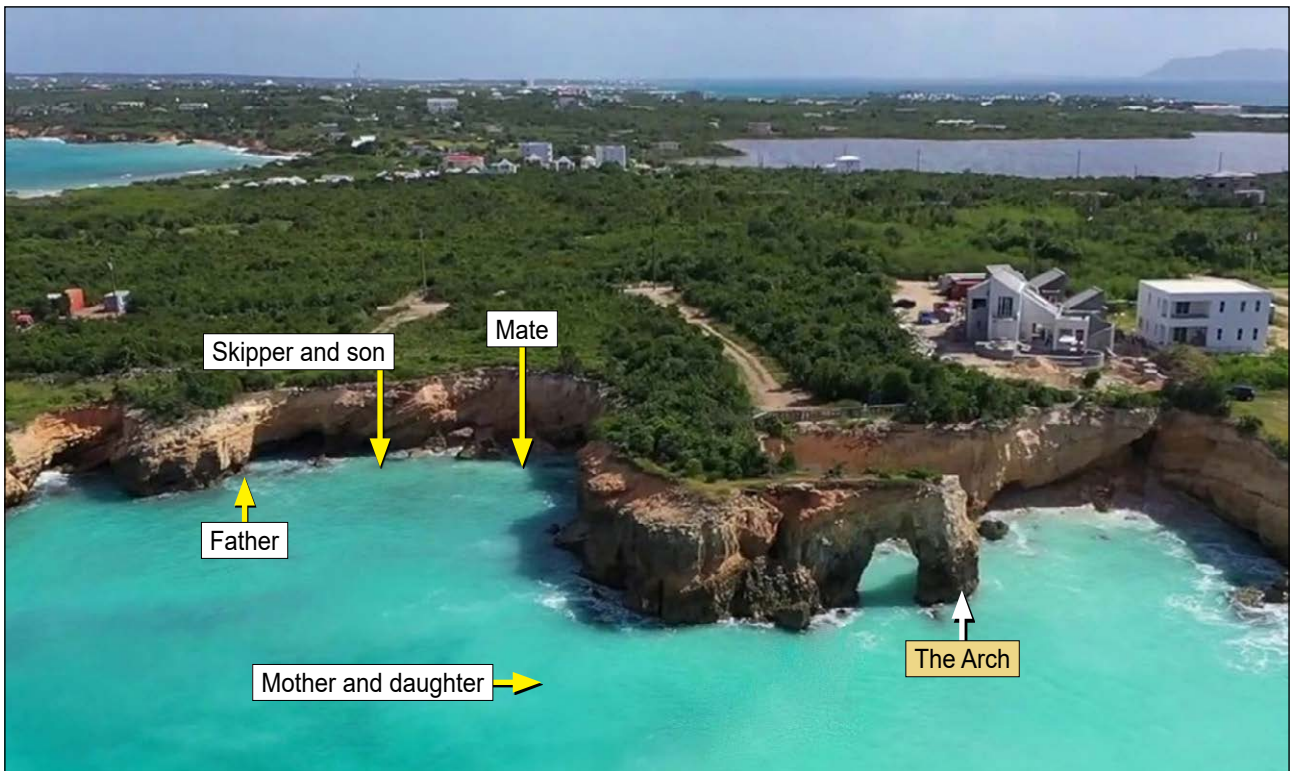
**Figure 4:** Accident location, showing positions of the casualties

*Calypso 2*'s passengers and crew became separated once in the water (**Figure 4**). The father, his son, and the skipper accessed the base of the cliff but the mother, her daughter, and the mate remained in the turbulent surf and ground seas. The daughter, who was a strong swimmer, managed to pull her motionless mother out past the breaking surf to calmer water. The mate was floating face down in the water. Those at the base of the cliff shouted for help.

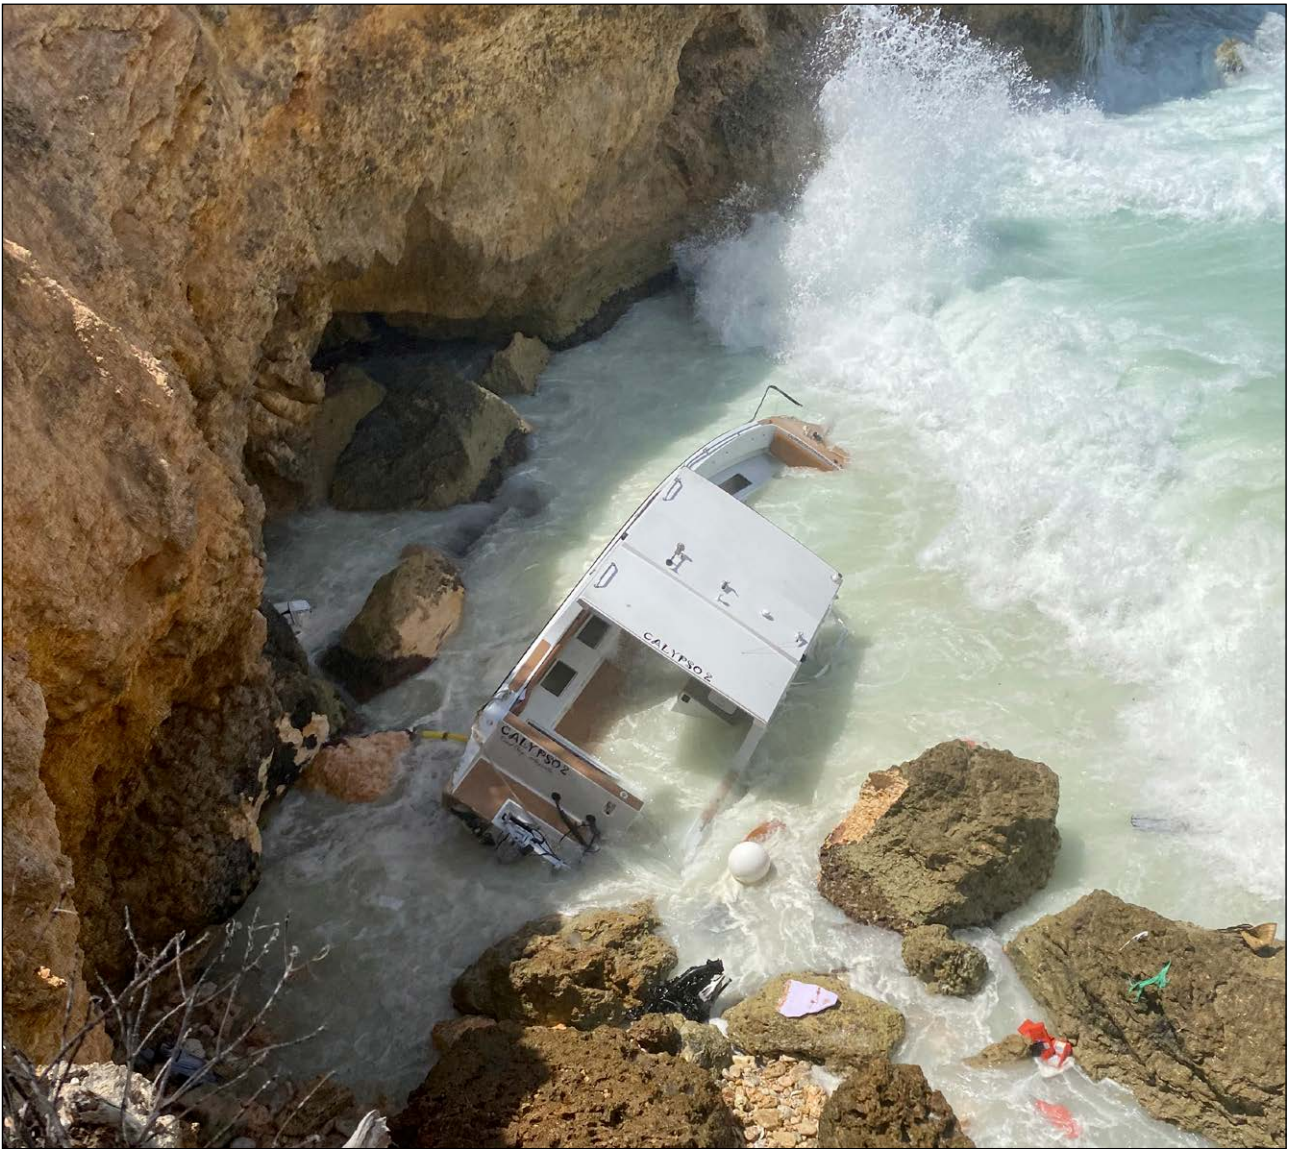
**Figure 9:** *Calypso 2* aground in the cove

The accident happened because *Calypso 2* was too close to shore, and was swamped and propelled into the rocks and cliffs by a large wave before it could be manoeuvred away. Robin Rosenberg and Shanika Thomas were not wearing PFDs and drowned after they were ejected into the water.

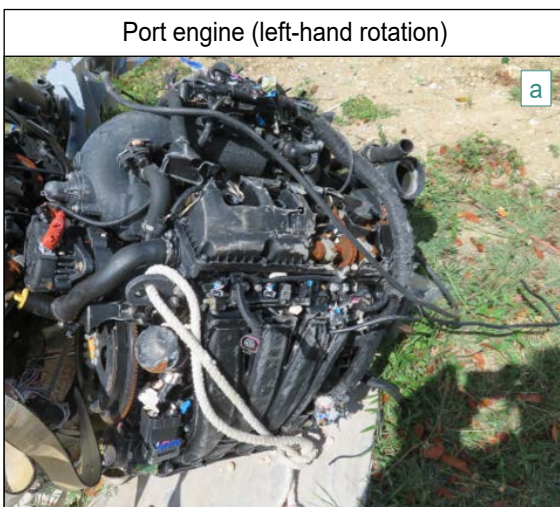
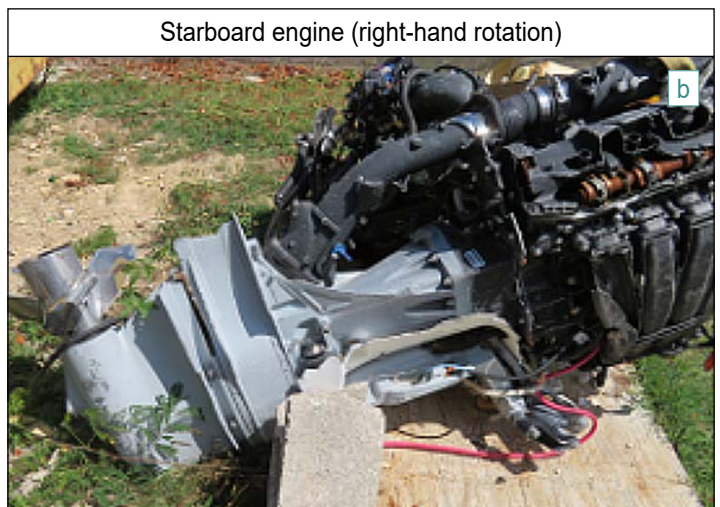
**Figure 10:** *Calypso 2*'s engines after the accident

- Both engines showed damage from immersion in seawater.
- The port engine had lost its lower leg unit, including the gearbox and propeller.
- The starboard engine was almost complete and the propeller was still in place, though the blades were bent.

- The port engine (left-hand rotation) had no useable electronic data that could be obtained from the unit (**Figure 10a**).
- The starboard engine (right-hand rotation) showed evidence that the engine was in neutral or stopped when it came into contact with the ground.
- There was no brush damage on the propeller blades and no evidence of torque stress damage to the propeller drive splines. The drive pin was intact and the propeller hub was still theoretically useable (**Figure 10b**).
- There was no evidence to indicate that either engine had hydraulically locked<sup>9</sup>.

The post-accident examination of the engines indicated that they were not operated at high power just before they became damaged. This also suggests that the helm was either unmanned or, if someone was at the helm, they did not take effective action in sufficient time to avoid being swamped.
