Serious Incident

Aircraft Type and Registration:	Airbus A320-214, G-EJCI	
No & Type of Engines:	2 CFM56-5B4/3 turbofan engines	
Year of Manufacture:	2011 (Serial no: 4581)	
Date & Time (UTC):	30 July 2023 at 1653 hrs	
Location:	After departure from Toulouse-Blagnac Airport, France	
Type of Flight:	Commercial Air Transport (Passenger)	
Persons on Board:	Crew - 6	Passengers - 176
Injuries:	Crew - None	Passengers - None
Nature of Damage:	None reported	
Commander's Licence:	Airline Transport Pilot's Licence	
Commander's Age:	62 years	
Commander's Flying Experience:	16,488 hours (of which 12,992 were on type) Last 90 days - 132 hours Last 28 days - 32 hours	
Information Source:	Aircraft Accident Report Form submitted by the pilot, interviews and investigation reports

Synopsis

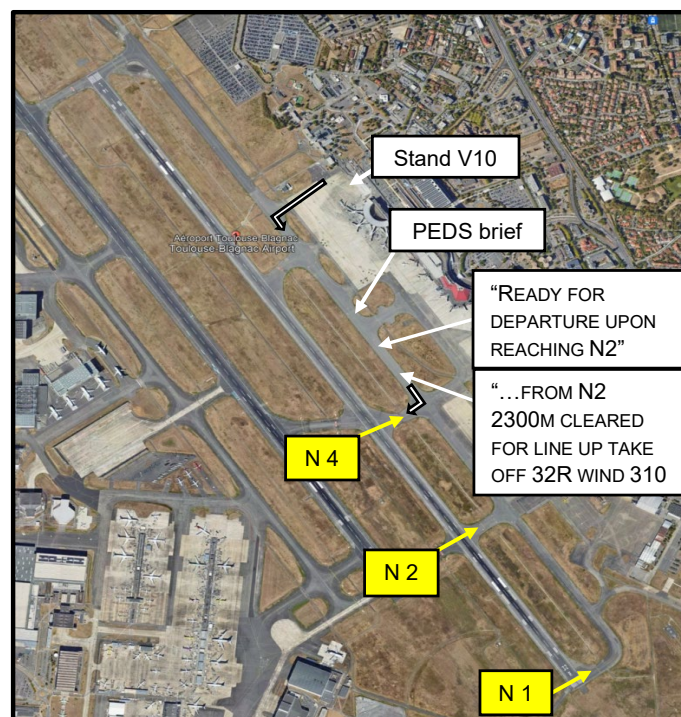
Figure 2

Following the PEDS brief the co-pilot informed Tower that they would be "READY FOR DEPARTURE UPON REACHING N2" (Figure 2). Tower replied, "BONJOUR FROM N2 2,300 M CLEARED FOR LINE UP TAKE OFF 32R WIND 310 DEGREES 12 KT". As the co-pilot read back the takeoff clearance the aircraft was approaching the N4 intersection where the commander turned the aircraft right, towards the holding point N4 for Runway 32R.

Toulouse-Blagnac Airport showing relevant intersections and actions taken by the crew and ATC

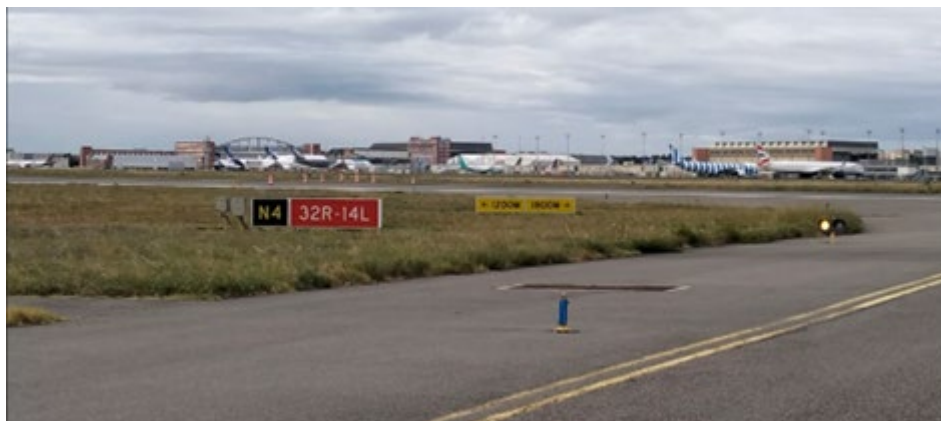
Figure 3

The crew completed the line-up flow, part of which requires that *'each pilot silently verifies takeoff intersection'*. This was followed by the line-up checklist as the aircraft entered Runway 32R via N4. Runway signage and guard lights ('wig-wags') were installed on both sides of the taxiway at the N4 holding point for runway 32R, as shown in Figure 3.

Holding point N4 for Runway 32R at Toulouse-Blagnac Airport

Additionally, the DSNB requested that the airfield operator consider installing controllable stop bars at N4.

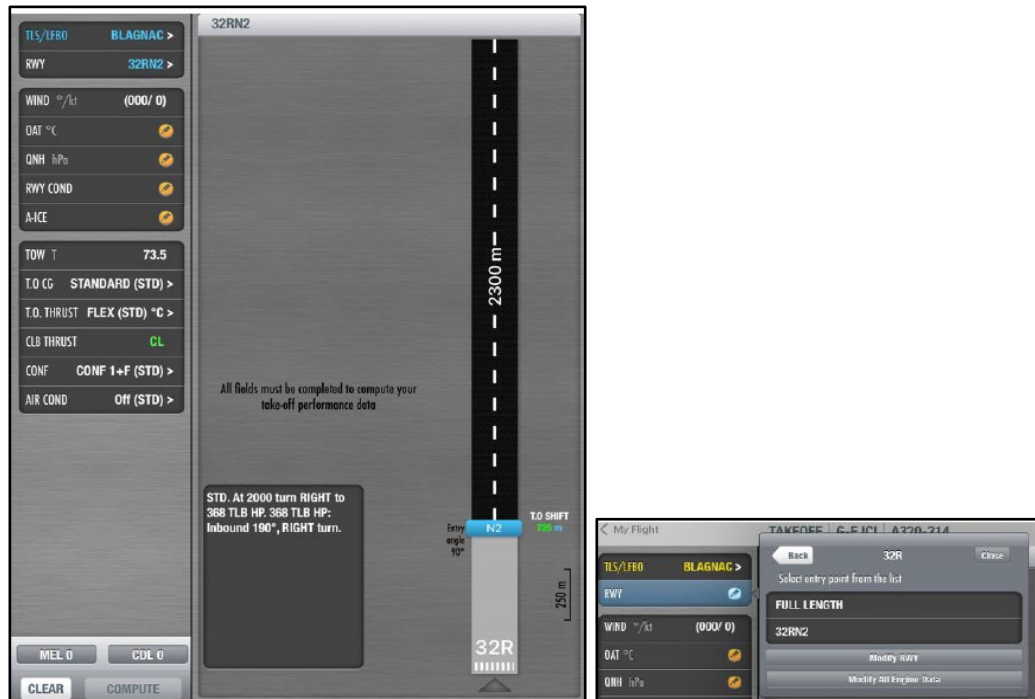
Figure 4

The FlySmart+ application uses data drawn exclusively from the operator's fleet. When an intersection is selected it is displayed on a graphic (Figure 3) which will only display takeoff options available to the operator's aircraft: for Runway 32R at Toulouse, full length (N1) and intersection N2. The position of intersection N2 in relation to intersection N4 is not displayed as N4 is not available for use by the operator's aircraft. Departures from intersection N4 on Runway 32 R are prohibited for turbojets over 7 tonnes.

FlySmart+ takeoff application (used with permission)

with the depiction of the runway layout on the FlySmart + application showing only one intersection for Runway 32R, may have contributed to the inaccurate mental model that there was only one runway intersection.

- Undertook to include within the scope of future EFB project developments a review of the design of the FlySmart+ takeoff module to include representation of all runway intersections.
