Serious Incident

Aircraft Type and Registration:	Airbus A320-214, G-EZGY	
No & Type of Engines:	2 CFM56-5B4/3 turbofan engines	
Year of Manufacture:	2018 (Serial no: 8,385)	
Date & Time (UTC):	19 June 2024 at 1955 hrs	
Location:	Kerkira Airport, Corfu	
Type of Flight:	Commercial Air Transport (Passenger)	
Persons on Board:	Crew - 6	Passengers - 174
Injuries:	Crew - None	Passengers - None
Nature of Damage:	None	
Commander's Licence:	Airline Transport Pilot's Licence	
Commander's Age:	40 years	
Commander's Flying Experience:	5,303 hours (of which 5,047 were on type) Last 90 days - 213 hours Last 28 days - 77 hours	
Information Source:	Aircraft Accident Report Form submitted by the pilot and further enquiries by the AAIB

Synopsis

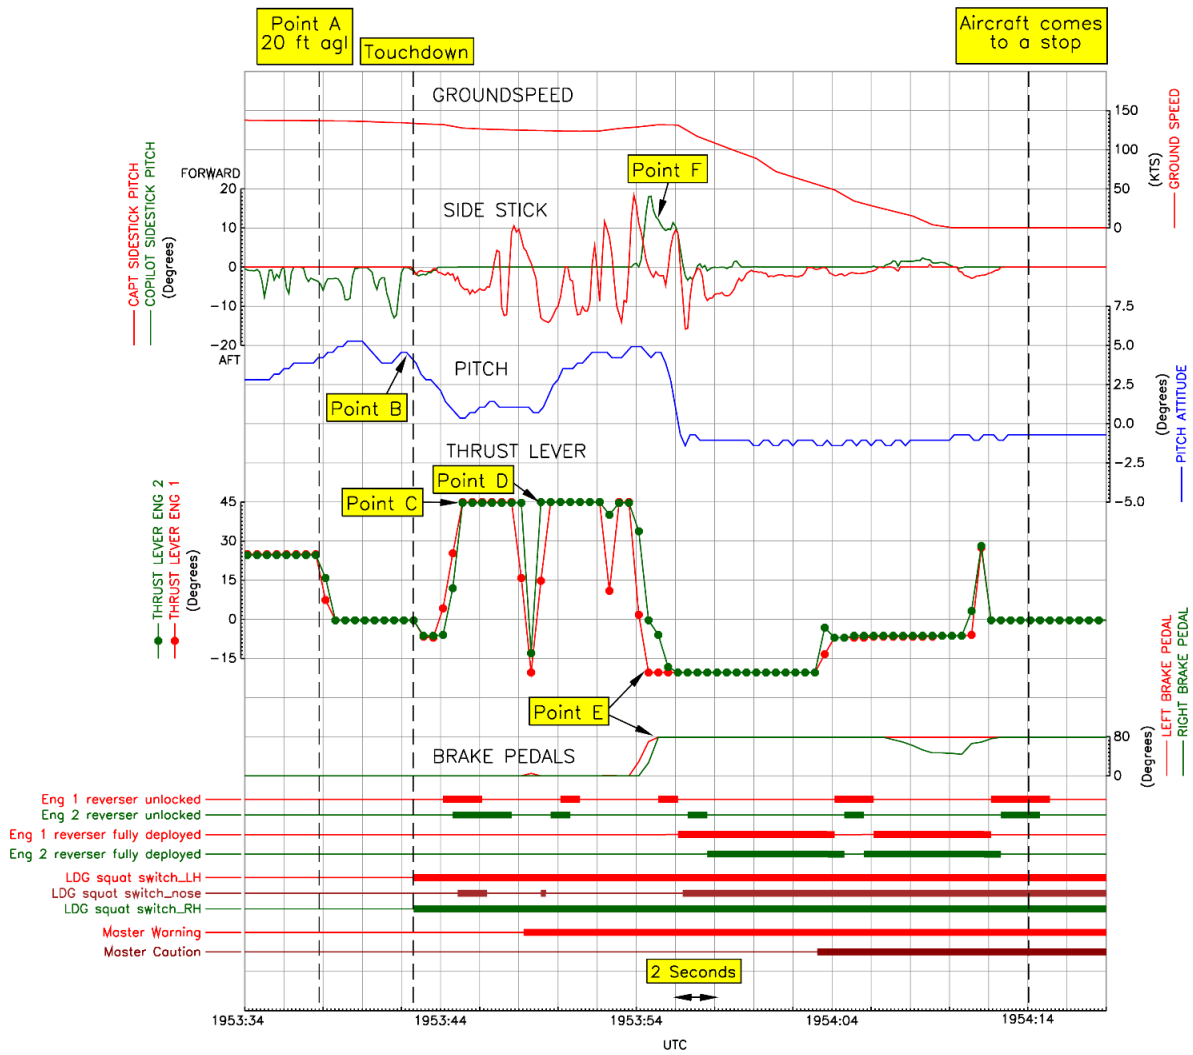
Figure 1

The aircraft flew over the runway threshold at a height of about 55 ft agl which coincided with the flare initiation. The pitch attitude of the aircraft gradually increased from 3° nose-up and when the aircraft was at about 20 ft agl (Figure 1 Point A) the pitch attitude was 4°, which coincided with the thrust levers being retarded to the idle position, which disengaged the auto thrust system. Further aft sidestick inputs were applied by the co-pilot and at about 10 ft agl the pitch attitude was just over 5°. The pitch attitude then started to reduce slightly but a further aft sidestick input was applied, causing the nose to pitch back up slightly (Figure 1 Point B). The pitch up commands caused the descent rate to decrease and remain stable at about 250 fpm for three seconds. The aircraft subsequently touched down at 130 KCAS and at about 660 m from the Runway 34 threshold, which was on, or just after⁷, the final TDZ marker (Figure 2). The thrust levers were then quickly retarded to the REV IDLE position and the thrust reverser doors opened.

As the thrust levers had been retarded to the REV IDLE position by the co-pilot, the commander had almost simultaneously selected his sidestick priority pushbutton. This was followed by the thrust levers being quickly advanced to the TOGA position (Figure 1 Point C and Figure 2). The thrust reverser doors then closed (they had been in transit between their closed and open positions for about two seconds). The aircraft at this point had de-rotated with the weight settling on the nose gear. The thrust levers remained in the TOGA position for three seconds while the commander applied aft sidestick, stabilising the nose-up pitch at 1°.

The thrust levers were then briefly retarded to REV MAX before being quickly moved back to TOGA (Figure 1 Point D and Figure 2). This caused the thrust reverser doors to open briefly and then close. A master warning (red warning) was also activated because the aircraft was not in the takeoff configuration, with full flap still deployed.

As the aircraft started to de-rotate from 5° nose-up pitch, the commander had briefly moved his sidestick from a forward position to slightly aft of neutral, which coincided with the co-pilot applying forward sidestick for about two seconds (Figure 1 Point F). The commander had continued to select his sidestick priority pushbutton and therefore the simultaneous control inputs were not summed.

Touchdown and rejected takeoff

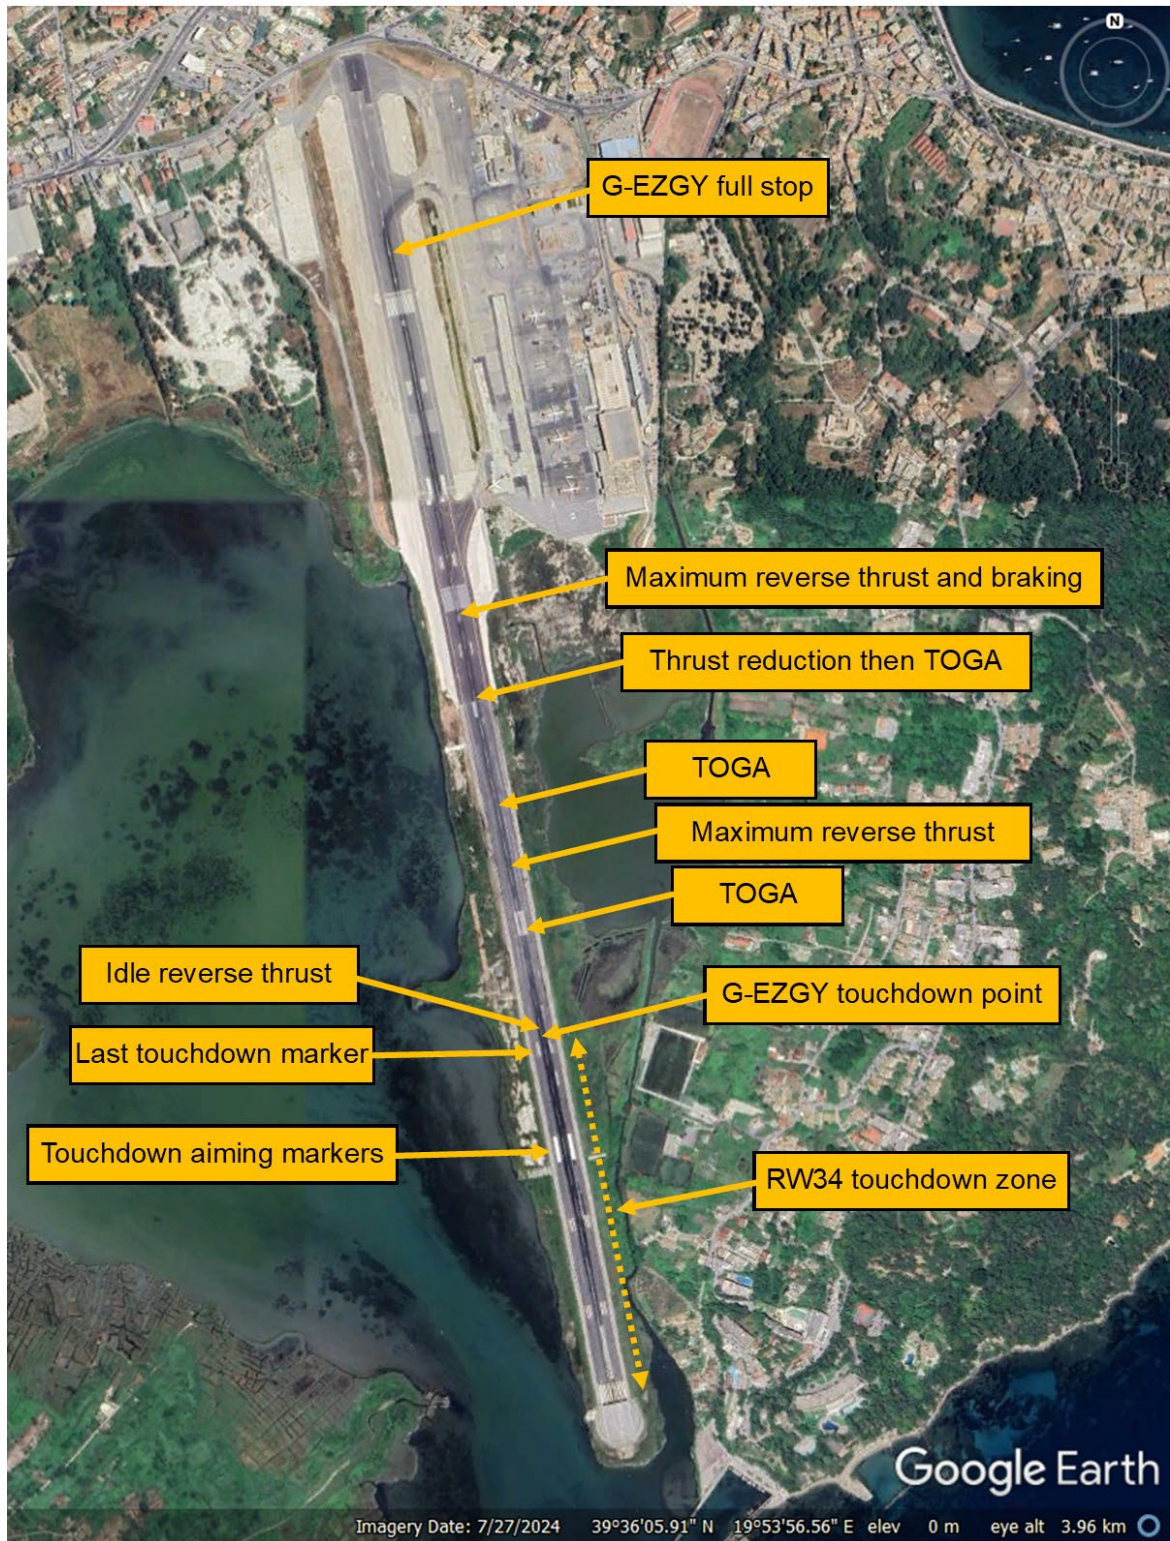
Figure 2

Overview of CFU showing key points during the landing
(Image ©2024 Airbus)

CFU is a coastal airfield with limited approach lighting on Runway 34 due to the final approach being largely over water (Figure 2). On Runway 34 there is only one set of TDZ markings beyond the target touchdown point whereas on Runway 16 there are two sets. The threshold on Runway 34 is inset by 59 m resulting in a total landing distance available of 2,314 m. The Runway 34 PAPIs are positioned to the left of the TDZ aiming markers, 415 m from the runway threshold. The end of the Runway 34 TDZ is 620 m from the threshold and is marked at night by '*Simple Touchdown zone lights*' (Figure 3).

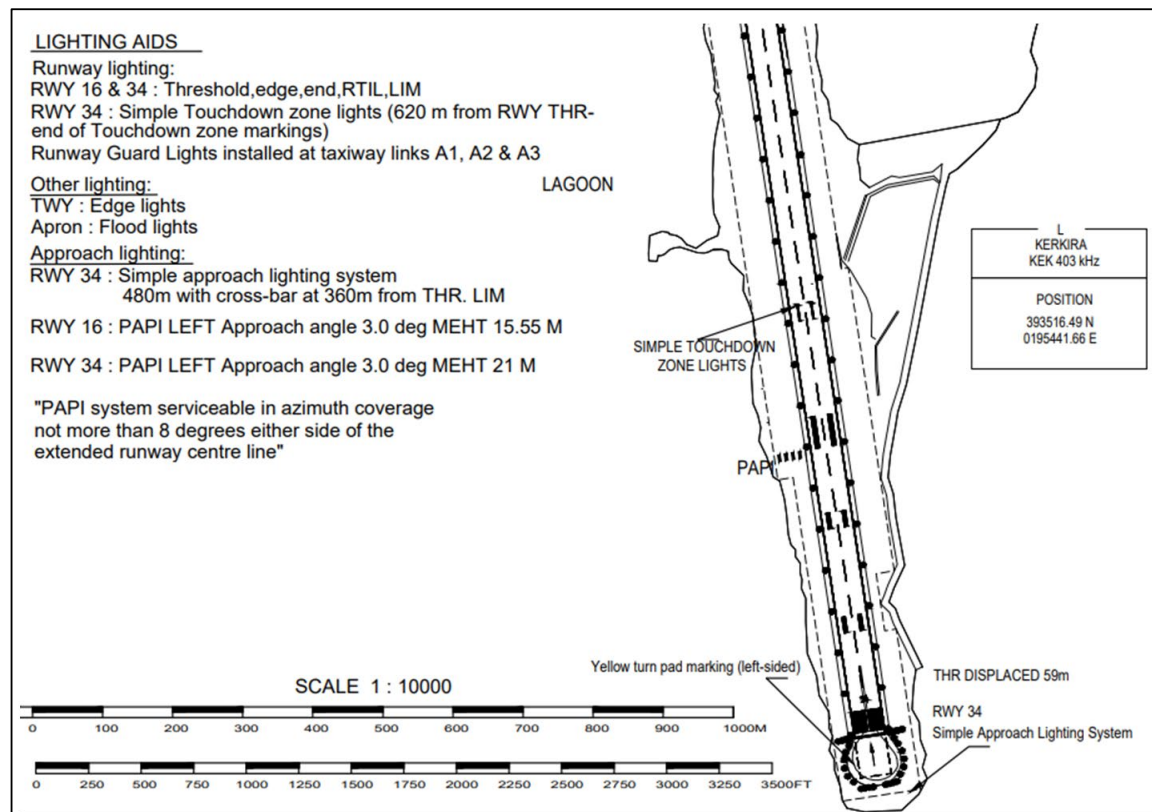
Figure 3

Extract from the LGKR airfield chart (reproduced from AIP Greece)

- To liaise with CFU on the siting of the Runway 34 PAPI lights and TDZ aiming point markings and to enquire whether these could be repositioned 300 m from the threshold, *'as per EASA regulation.'*
- To review the CFU airport risk assessment and re-assess whether sufficient mitigations are in place to manage the runway excursion risk associated with the non-standard position of the aiming point markers on Runway 34.
- To review the company's balked landing procedure.
- To share details of the event with its pilot community through the medium of safety publications.

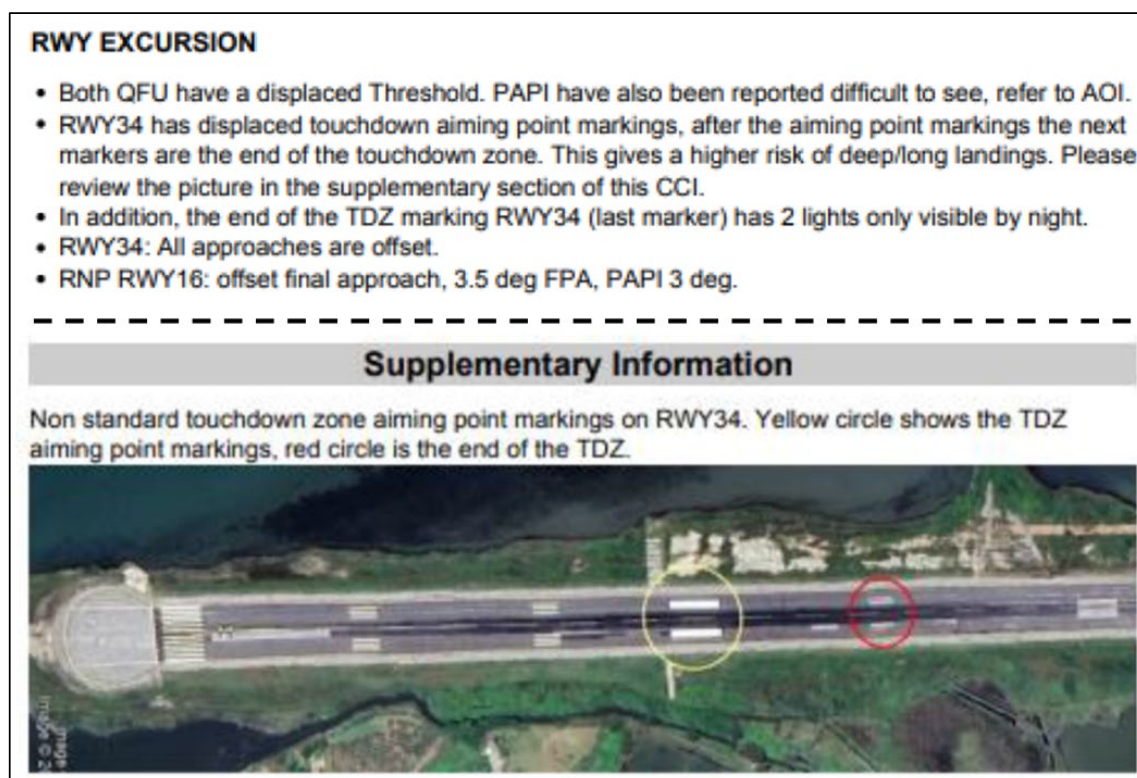
Figure 4

CFU is categorized by the operator as 'a Category B restricted airport, which is further defined as an airport with complexity and threat levels that require specified restrictions but do not require an aerodrome visit or specific training.' Due to 'circling approaches, unusual local weather conditions [and] terrain' considerations, pilots classified as 'inexperienced' in accordance with the operator's Operations Manual are not permitted to operate into CFU. Both pilots exceeded the operator's minimum experience level requirements to operate into CFU. The Threat and Error Management (TEM) section of the operator's guidance to pilots (CCI⁹) operating into CFU described a higher risk of deep landings on Runway 34 due to displaced touchdown aiming point markers and only one set of markings beyond the TDZ aiming point (Figure 4).

Extract from the operator's CCI TEM guidance for pilots operating into CFU
(Reproduced from the operator's internal safety report)
