Accident

Aircraft Type and Registration:	Just SuperStol, G-SSTL
No & Type of Engines:	1 Rotax 912ULS piston engine
Year of Manufacture:	2016 (Serial no: LAA 397-15377)
Date & Time (UTC):	4 July 2024 at 1900 hrs
Location:	Near Romsey, Hampshire
Type of Flight:	Private
Persons on Board:	Crew - 1 Passengers - None
Injuries:	Crew - 1 (Serious) Passengers - N/A
Nature of Damage:	Landing gear detached and airframe distortion
Commander's Licence:	PPL(A)
Commander's Age:	67 years
Commander's Flying Experience:	315 hours (of which 4 were on type) Last 90 days - 4 hours Last 28 days - 1 hour
Information Source:	Enquiries by the AAIB

Synopsis

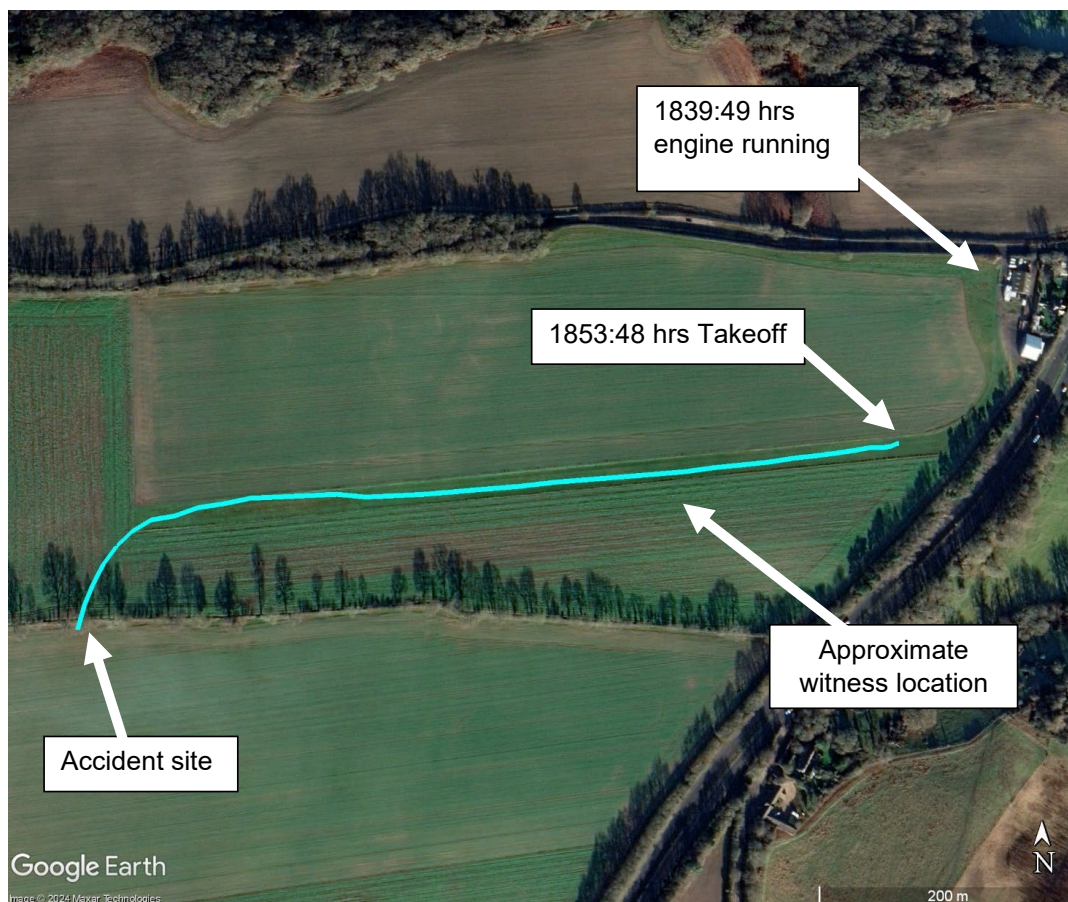
Figure 1
G-SSTL GNSS Position data

His friend (the only witness present) moved further along the runway and stood to the side to observe and video the takeoff. He heard the aircraft power increase and watched as the aircraft accelerated along the runway and the tail lift as normal. The aircraft became airborne and started to climb away. He then noticed that the aircraft appeared to level, the engine note changed, and the aircraft sank a small amount before appearing to climb again. The witness immediately thought that the climb was not normal. The pilot's recollection was the same, the engine power appeared to stagnate before picking up again then lose power a second time. The pilot decided to carry out a forced landing in a field to his left (Figure 1).

The witness observed the aircraft change heading before "gently floating down, wings level". It touched down at the edge of the field about two metres from a drainage ditch. It rolled down into the ditch at which point the landing gear collapsed and detached. The aircraft carried on through a hedgerow which brought it rapidly to a stop. The pilot sustained serious injuries during the accident and had to be extracted from the wreckage by the emergency services who had been called by the witness.

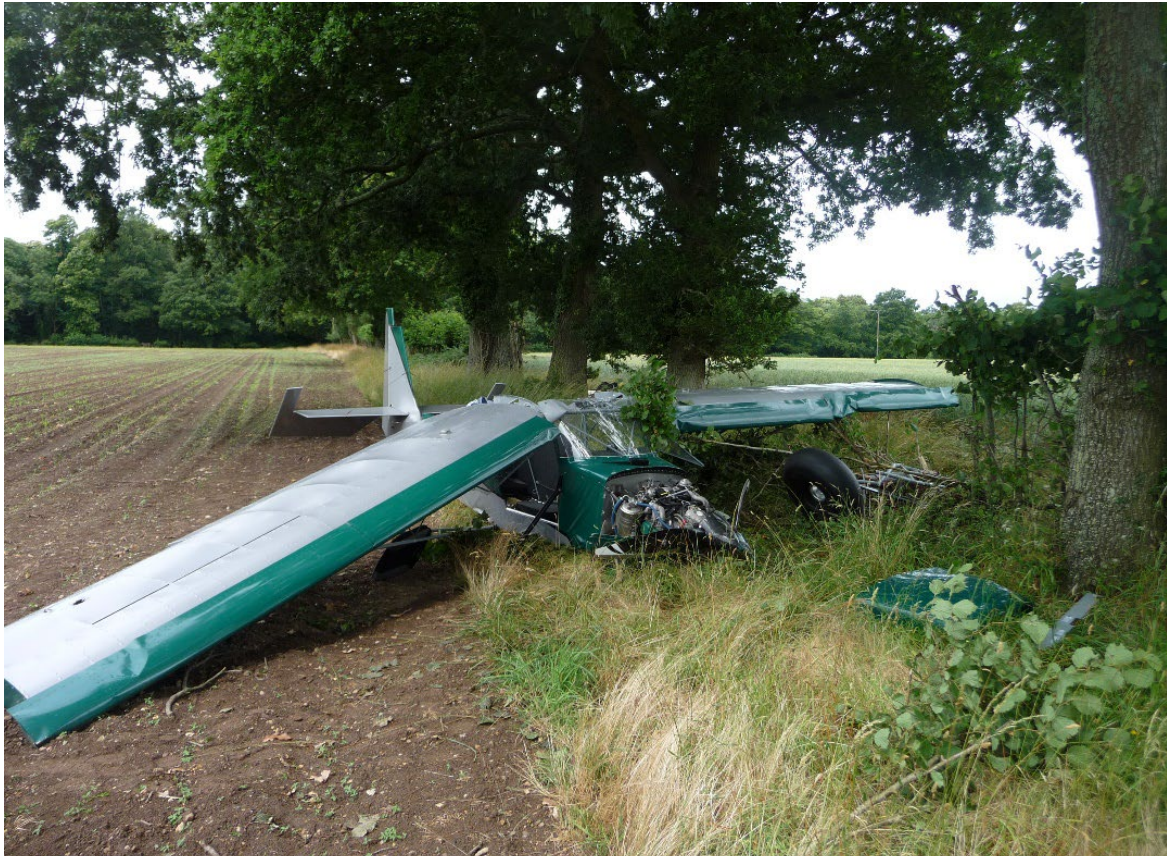
Figure 2

The aircraft had landed approximately 100 m from the end of the runway diagonally left of the runway centre line. A pair of wheel marks were present in a wheat crop at the edge of the field. The landing gear was partially detached and caught in the drainage ditch. During the impact the engine had been bent slightly downward in its mounts and one of the propeller blades had broken at its root and bent rearwards. The aircraft had broken through a substantial hazel bush in the hedge row denting the leading edge of the left wing and causing the aircraft to rotate through approximately 90° (Figure 2). The right wing had pivoted slightly forwards about its main spar mounting bolt. The rear spar attachment bolt had been pulled sideways out its hole.

Accident site and aircraft damage

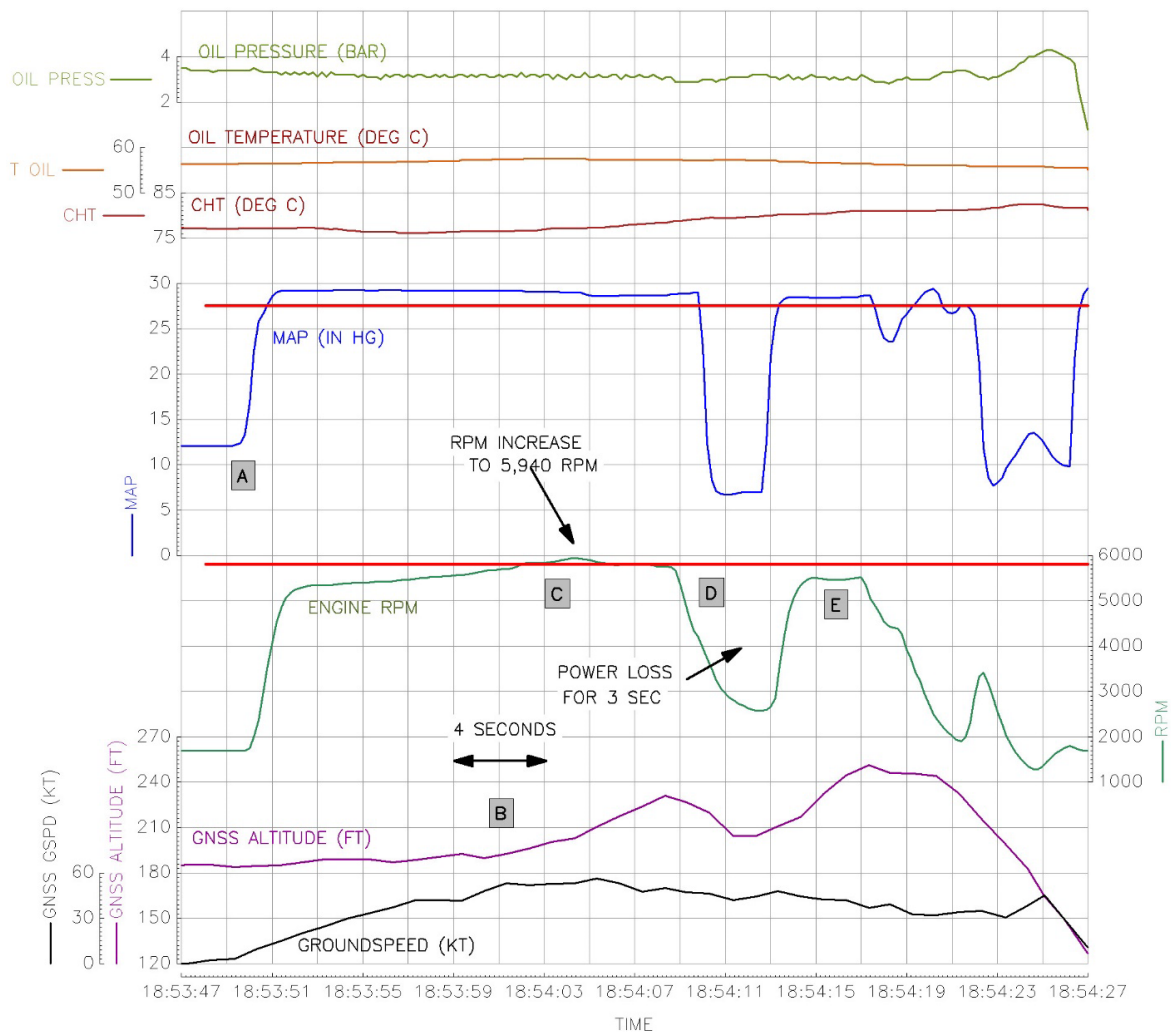
Figure 3
G-SSTL flight and engine data

At 1853:48 hrs, the takeoff commenced with a recorded increase in engine rpm and MAP with oil temperature, pressure and CHT all within normal operating limits (Point A, Figure 3).

The MAP rose to approximately 29 InHg, above the alarm threshold of 27.5 InHg for the engine display. The aircraft accelerated to a groundspeed of approximately 53 kt and started to climb (Point B). At the same time, the engine rpm increased and then exceeded the upper warning limit of 5,800 rpm (Point C). Maximum recorded rpm was 5,940 rpm after which a rapid decrease in engine rpm and MAP was recorded (Point D). This lasted for three seconds before power was restored for a further four seconds (Point E). After this point, there was a reduction in engine power with reducing / fluctuating rpm and MAP. The aircraft descended and hit the ground at approximately 1854:27 hrs.

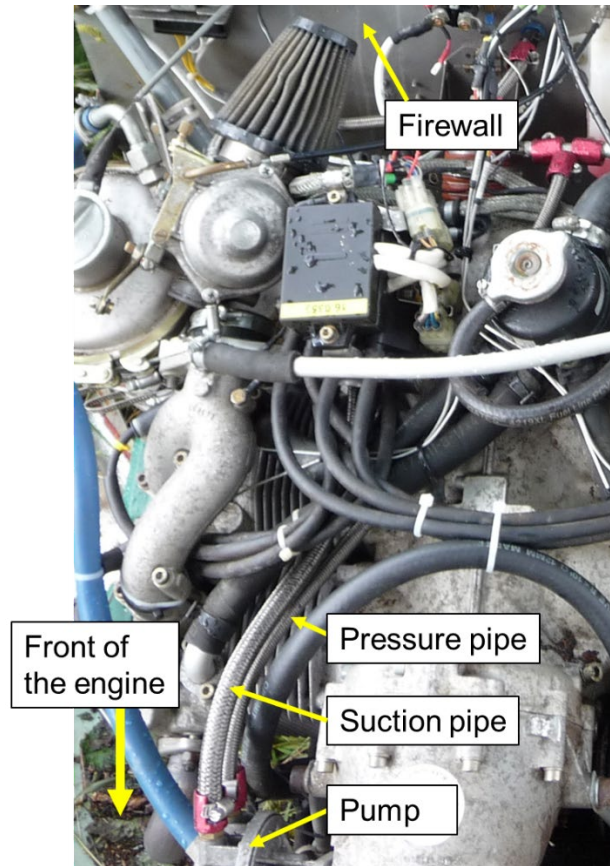
Figure 4
Fuel suction and pressure pipe location

The fuel suction pipe was routed from the Gascolator upwards along the top of the engine block to the pump. Figure 4 shows the fuel pipe location looking from above. There was no thermal insulation on the fuel pipes.

- The SB states that fuel pipe routing within the engine bay should be away from heat sources and thermally insulated. In this aircraft, the suction line from the Gascolator to the diaphragm fuel pump is routed within 30 mm of the right rear cylinder exhaust down pipe. From there it lies under the right inlet manifold across the block lying on top of the pump outlet pressure line to the carburetors. There is no thermal insulation around the engine bay fuel lines.

- All the fuel hoses must also be sufficiently supported in order to avoid excessive vibration. The pressure and suction lines in G-SSTL lay across and were in contact the engine block which may have made them susceptible to vibration.

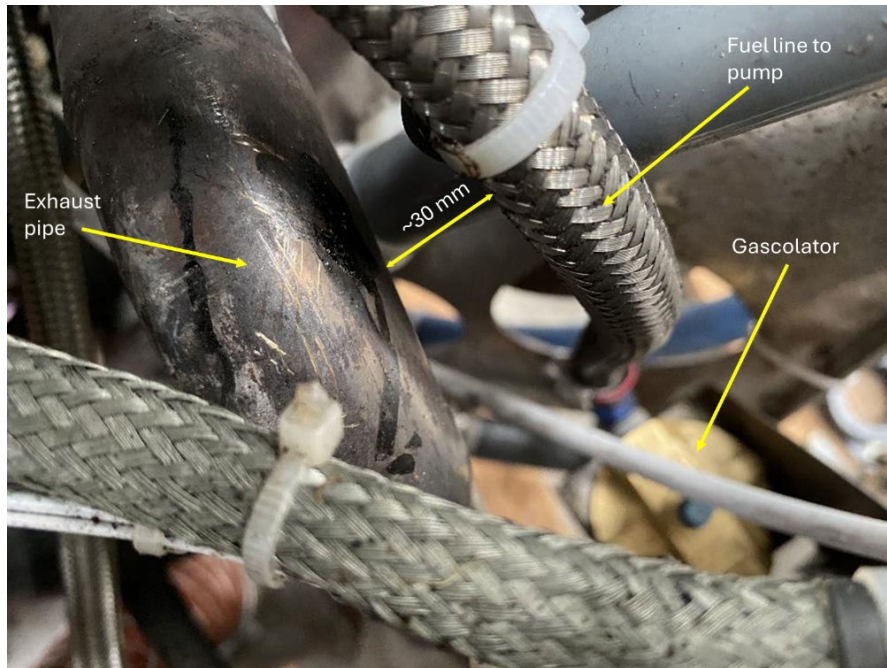
Figure 5
Suction pipe position in relation to exhaust downpipe

The lower part of the suction pipe near the fire wall was found to be in proximity to the right rear cylinder exhaust down pipe and was attached to part of the engine bearer frame by a cable tie and rubber collar. There was also evidence that the cable tie contacted the down pipe whilst it was hot. However, this may have occurred during the impact sequence as the engine mounting frame distorted. Measurements taken between the fuel pipe and the exhaust downpipe accounting for the distortion, suggest an original clearance of approximately 30 mm (Figure 5).

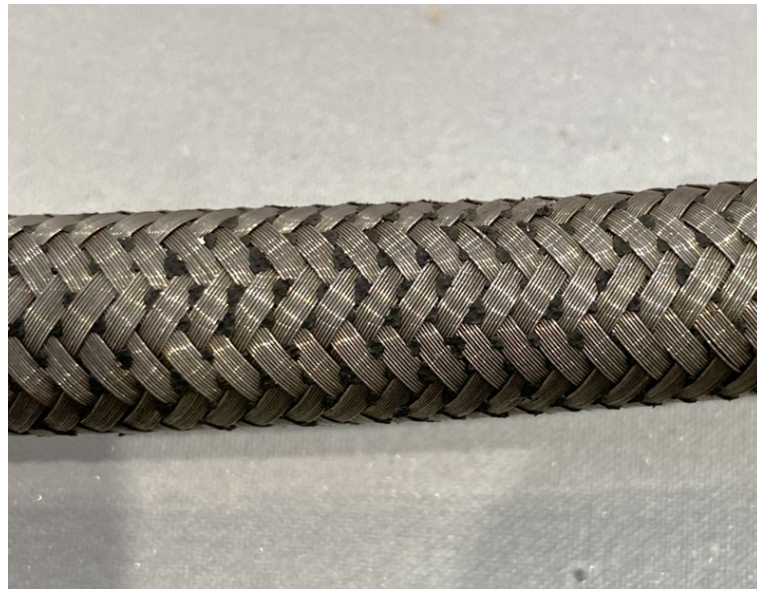
Figure 6
Suction pipe condition

The recently replaced fuel lines were examined. The pipes, filter and non-return valve within the airframe were in an as new condition as was the braided fuel pipe assembly between the pump and carburettors. However, the suction pipe from the Gascolator to the gearbox driven pump was discoloured grey rather than bright silver braiding. The tube within the braiding showed signs of degradation and appeared to be leaching through and between the braiding weave. Figure 6 shows the apparent pipe degradation.

The degradation of the rubber compound within the braided pipe between the Gascolator and the pumps appears to be evidence that this pipe was externally heated. However, experiments were carried out to establish the effect of heat on the pipes. Blown air heating raised the surface temperature on the sample pipes to between 150°C to 160°C and this was found to have no lasting effect.
