# ***AAIB Bulletin***

# ***4/2025***

Rockwell Commander 112 TCA	N4698W	23-Dec-24	3
----------------------------	--------	-----------	---

ATR 72-500 (72-212A)	LY-JUP	12-Aug-24	13
----------------------	--------	-----------	----

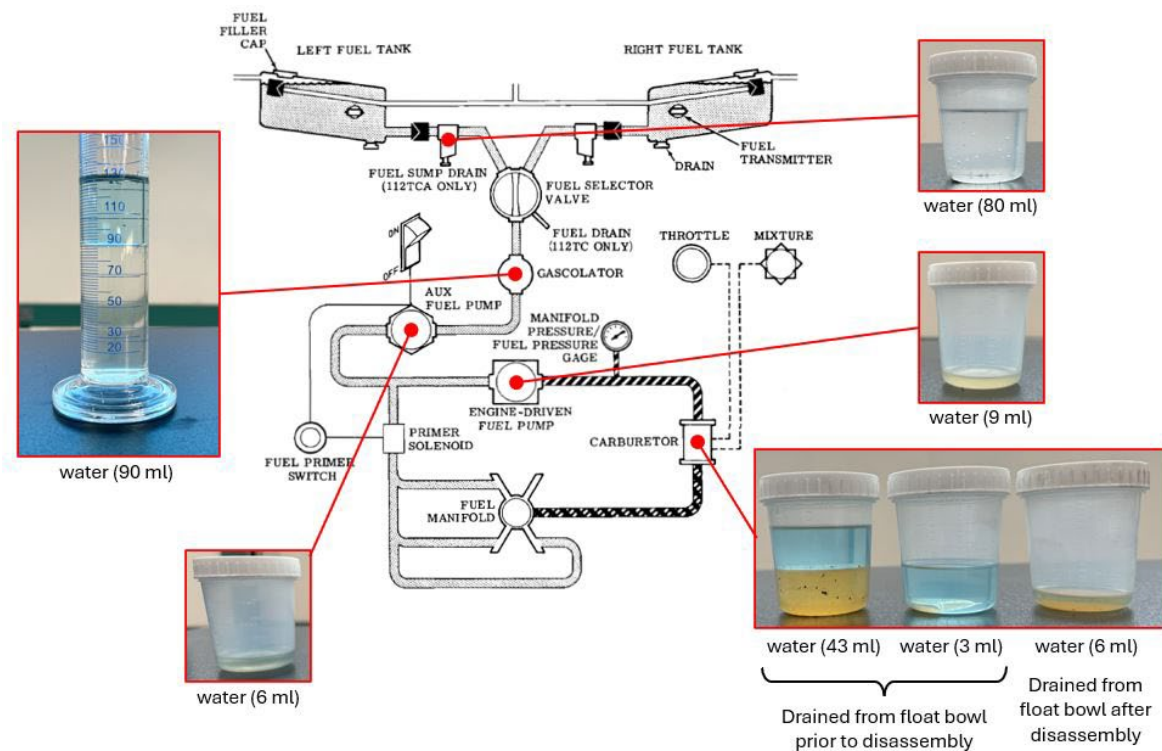
**Figure 1**

Testing of fuel recovered from the right wing confirmed it met the specification for AVGAS 100LL. Examination of the aircraft and engine fuel system revealed significant water contamination throughout the system downstream of the fuel selector valve and also in the left wheel well sump drain (Figure 1). The volume of water recovered from the carburettor float bowl was sufficient to cover the power jet inlet port in the bottom of the bowl, proving that it was possible for water, rather than fuel, to be drawn into the main nozzle and carburettor venturi.

Water recovered from the aircraft's fuel system  
(fuel system diagram courtesy of Commander Aircraft Corp)

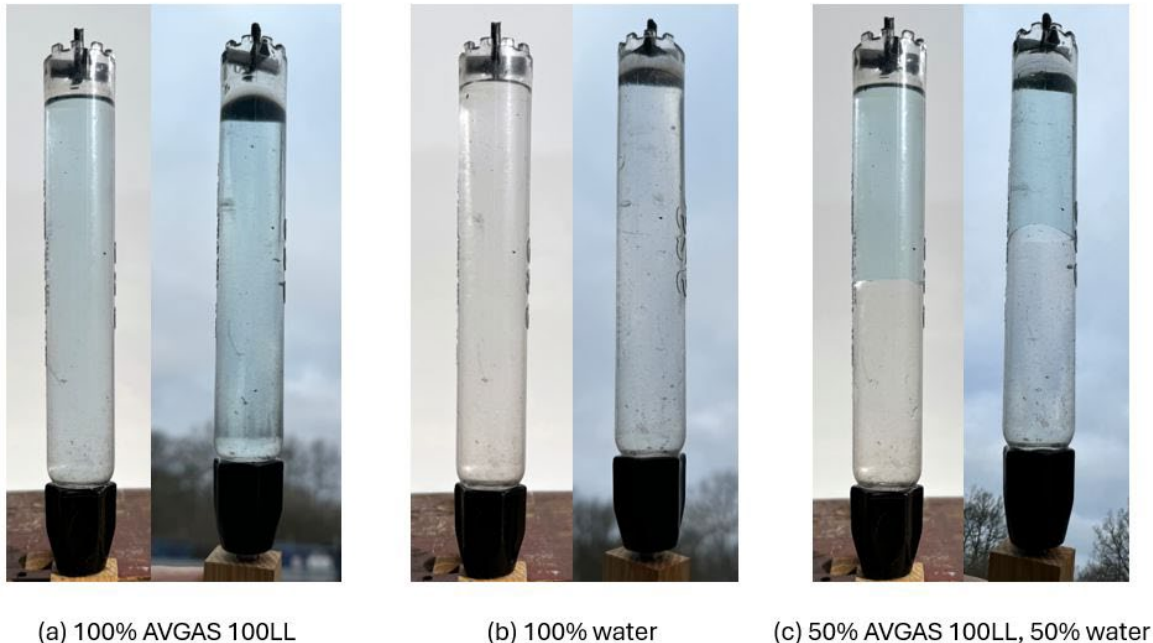
**Figure 3**

A fuel sample tube found in the aircraft was used in photographs recording differing fuel and water samples held against two different backgrounds (Figure 3). The fuel sample tube has a capacity of 34 ml. It was noted that the 100% water sample, using the sample tube straight after it had been filled with AVGAS 100LL, retained an odour of AVGAS, although it was not as strong as when the tube was filled with AVGAS.

Fuel and water samples photographed against two different backgrounds. Fuel sample tube from N4698W used

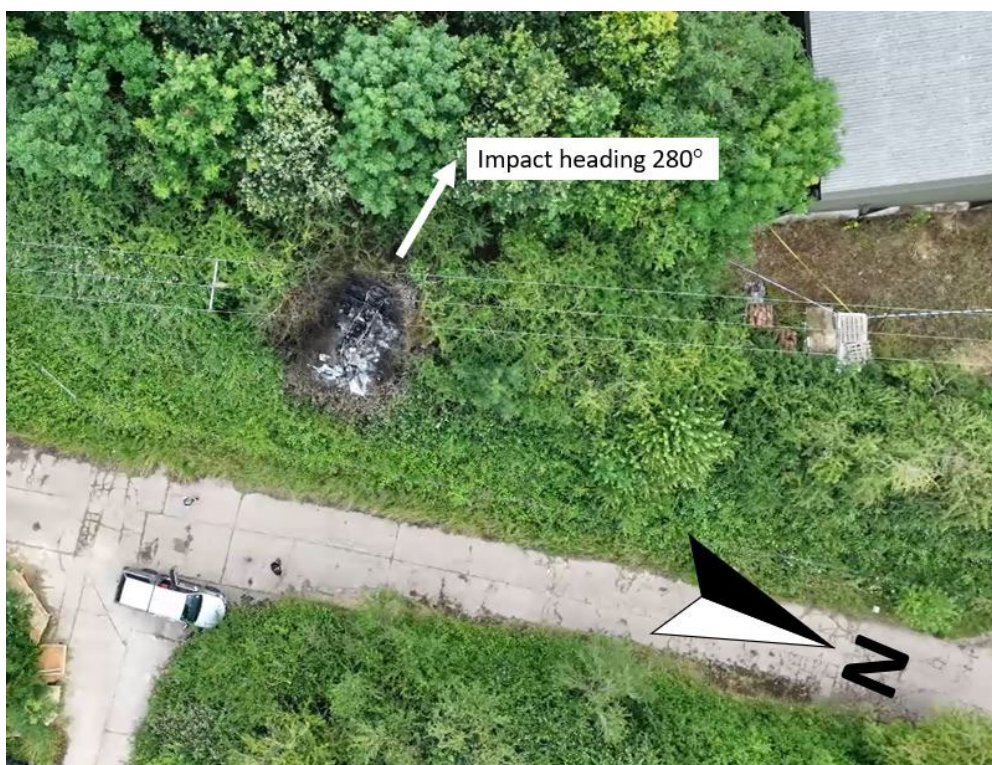
**Figure 1**  
G-EEEEK accident site

The aircraft struck the ground in a wooded area approximately 170 m to the south of Runway 09-27, adjacent to the airfield access road. The compact nature of the accident site, lack of ground impact marks away from the aircraft wreckage and relative lack of distortion to the fuselage's welded steel frame showed that the aircraft had struck the ground at low speed in an approximately level pitch and roll attitude (Figure 1). Three-phase electrical cables directly above the aircraft wreckage were intact, apart from minor fire damage, indicating that the flight path prior to impact was not vertical to the ground and that the aircraft had a low degree of forward speed at impact. The low forward speed was further confirmed by the lack of significant forward displacement of debris from the main aircraft wreckage.

An intense post-impact fire had occurred, consuming the majority of the flammable material of the aircraft's structure, and it was not possible to determine if the aircraft had been rotating in yaw at impact.

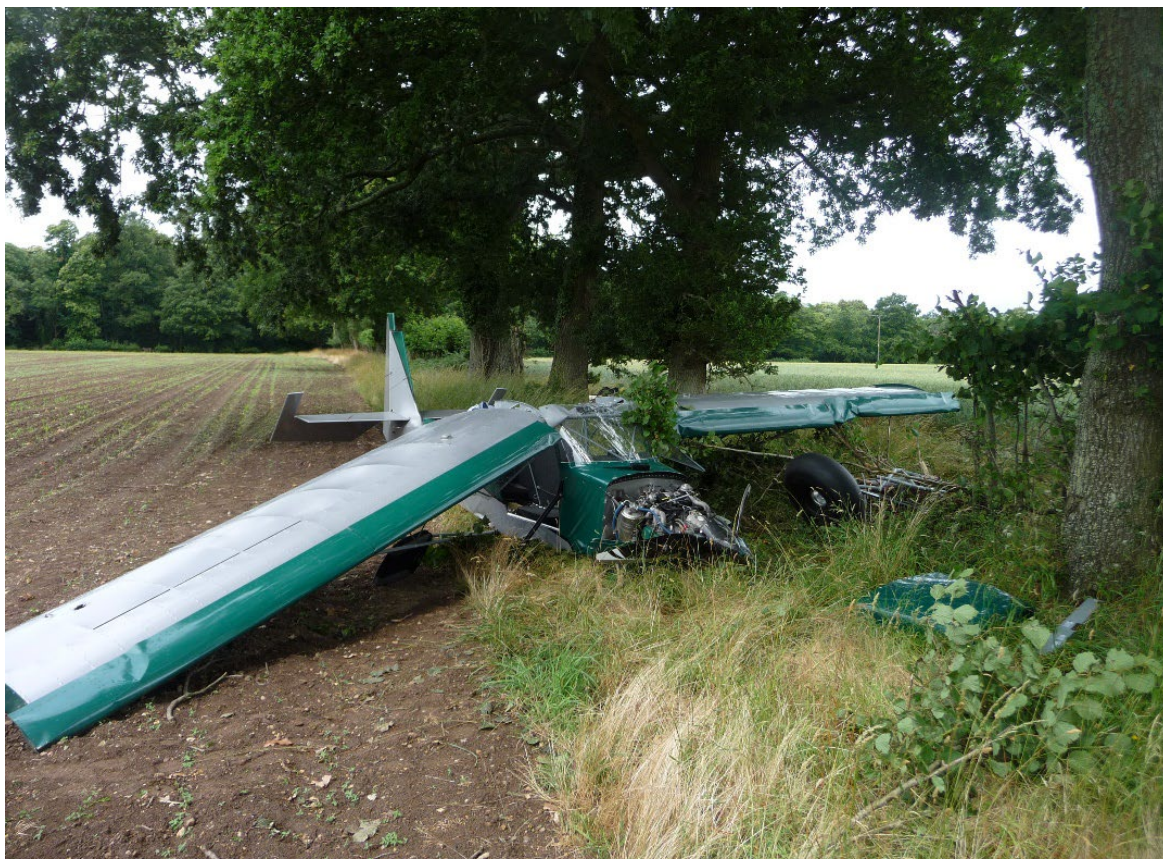
**Figure 2**

Accident site and aircraft damage

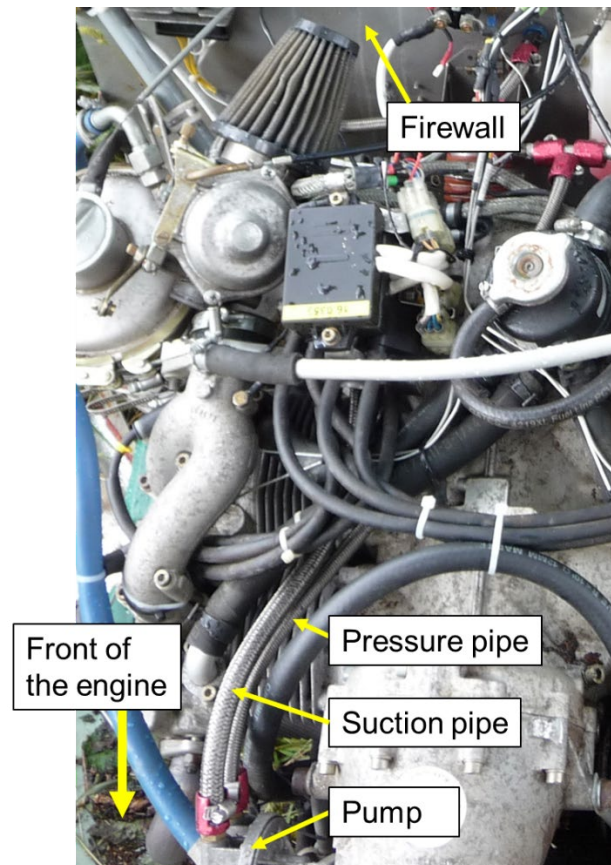
**Figure 4**

The fuel suction pipe was routed from the Gascolator upwards along the top of the engine block to the pump. Figure 4 shows the fuel pipe location looking from above. There was no thermal insulation on the fuel pipes.

Fuel suction and pressure pipe location

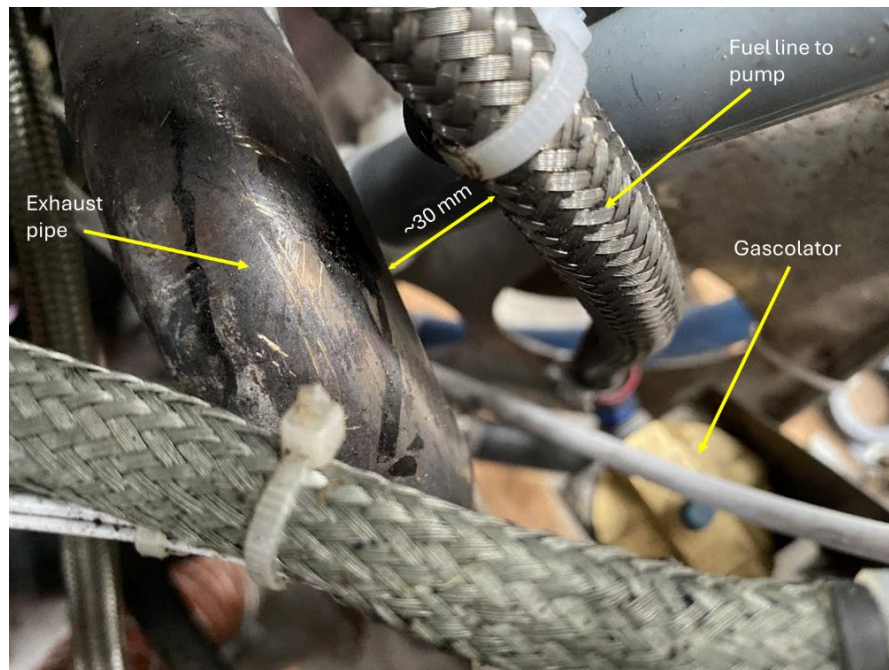
**Figure 5**

The lower part of the suction pipe near the fire wall was found to be in proximity to the right rear cylinder exhaust down pipe and was attached to part of the engine bearer frame by a cable tie and rubber collar. There was also evidence that the cable tie contacted the down pipe whilst it was hot. However, this may have occurred during the impact sequence as the engine mounting frame distorted. Measurements taken between the fuel pipe and the exhaust downpipe accounting for the distortion, suggest an original clearance of approximately 30 mm (Figure 5).

Suction pipe position in relation to exhaust downpipe

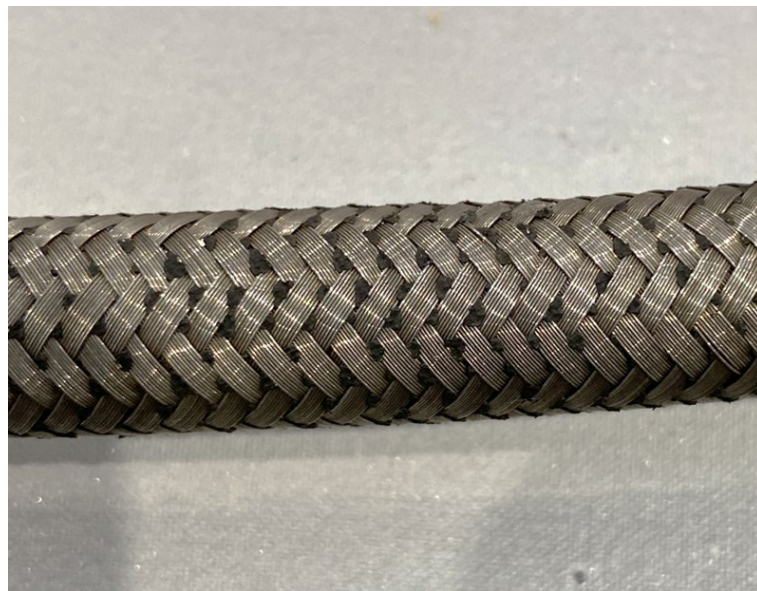
**Figure 6**  
Suction pipe condition

The recently replaced fuel lines were examined. The pipes, filter and non-return valve within the airframe were in an as new condition as was the braided fuel pipe assembly between the pump and carburettors. However, the suction pipe from the Gascolator to the gearbox driven pump was discoloured grey rather than bright silver braiding. The tube within the braiding showed signs of degradation and appeared to be leaching through and between the braiding weave. Figure 6 shows the apparent pipe degradation.

The degradation of the rubber compound within the braided pipe between the Gascolator and the pumps appears to be evidence that this pipe was externally heated. However, experiments were carried out to establish the effect of heat on the pipes. Blown air heating raised the surface temperature on the sample pipes to between 150°C to 160°C and this was found to have no lasting effect.
