Rail Accident Report

Runaway of a trolley and subsequent collision at North Rode, Cheshire 26 May 2024

Report 07/2025
May 2025

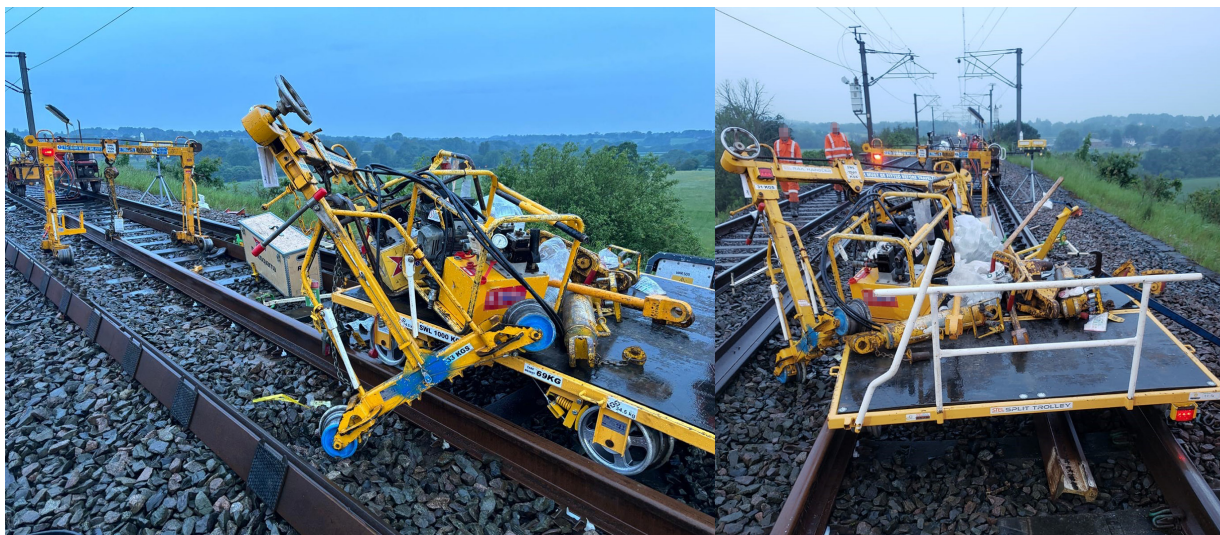
- 4 The site supervisor and the controller of site safety (COSS) saw the runaway trolley approaching at around 20 mph (32 km/h) and shouted a warning which provided enough time for their colleagues to get clear. No one was hurt in the accident, but the ironman, the trolley and the equipment it was carrying were damaged (figure 2).
- 5 The trolley had previously been pushed uphill from the site of work to the access point to collect a piece of equipment. The runaway began while the trolley was returning to the site of work. Evidence suggests that the trolley ran uncontrolled, downhill, for approximately 1100 metres before colliding with the ironman.

Figure 2: Final position of the runaway trolley having collided with the ironman (courtesy of Rhomberg Sersa Rail Group Ltd).

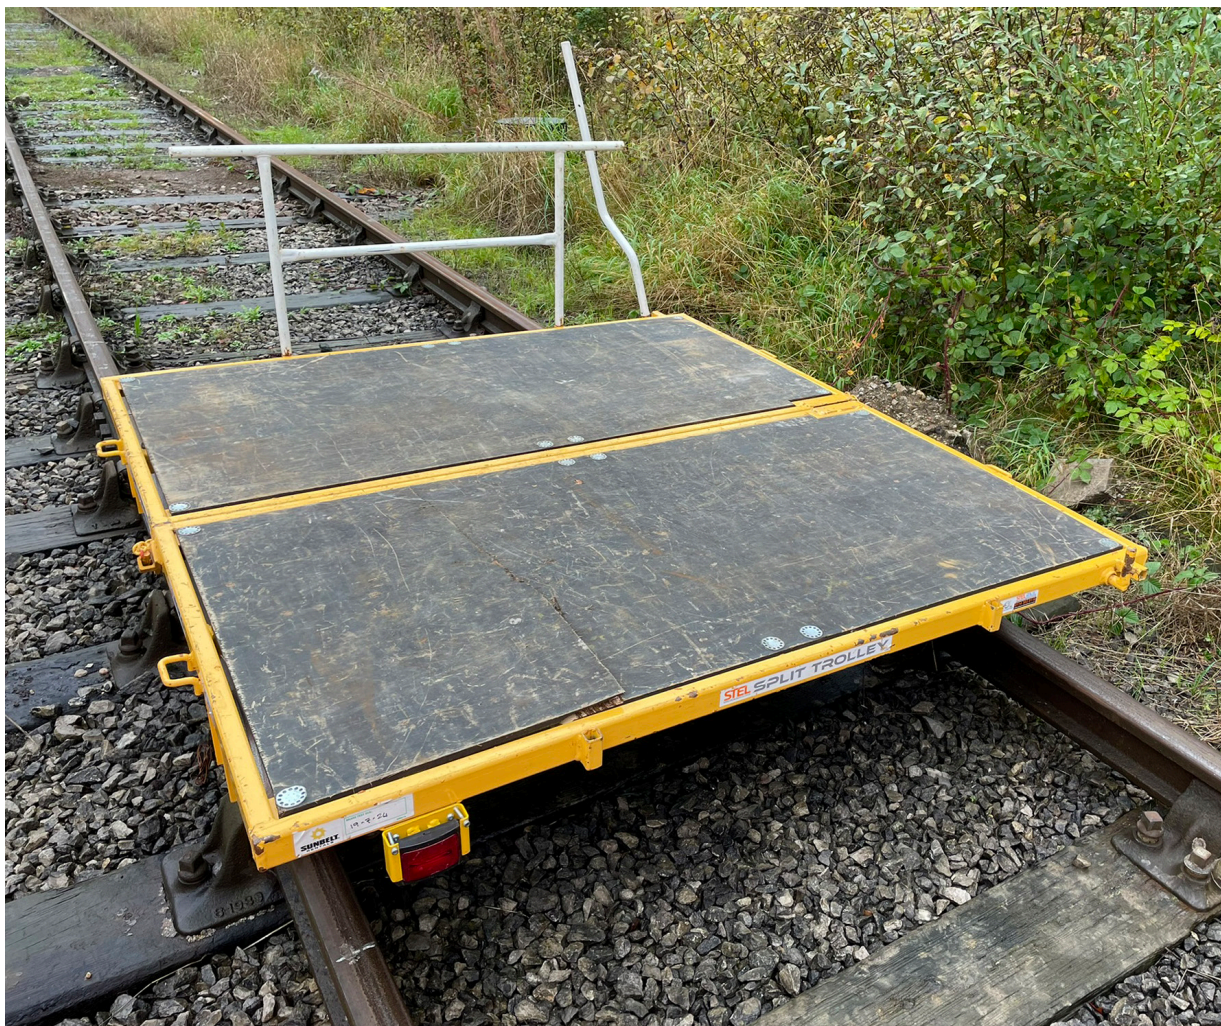
- 15 The manual hand trolley which ran away (figure 4) was manufactured by STEL. RSRG bought the trolley new in October 2023. It is described in more detail in paragraph 58.

Figure 4: The trolley involved in the accident.

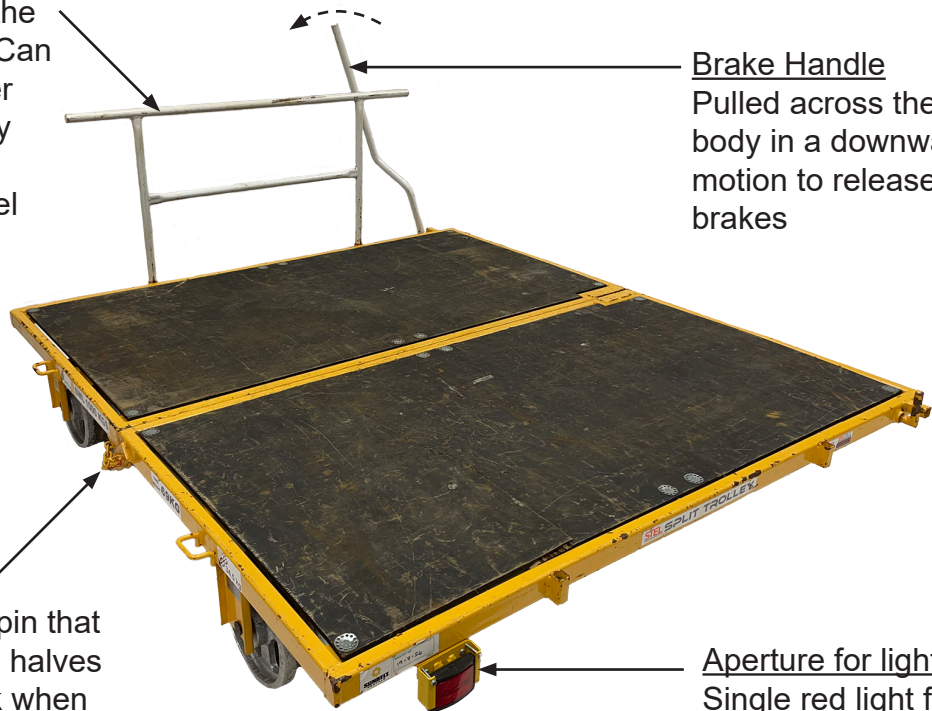
Figure 9: Schematic of the trolley and how it is operated.

- 59 The push barrier is used by an operator to push the trolley forward. It can be attached to either end of the trolley within fixings (the base of the push barrier inserts into hollow brackets) depending on the direction the trolley is required to travel.

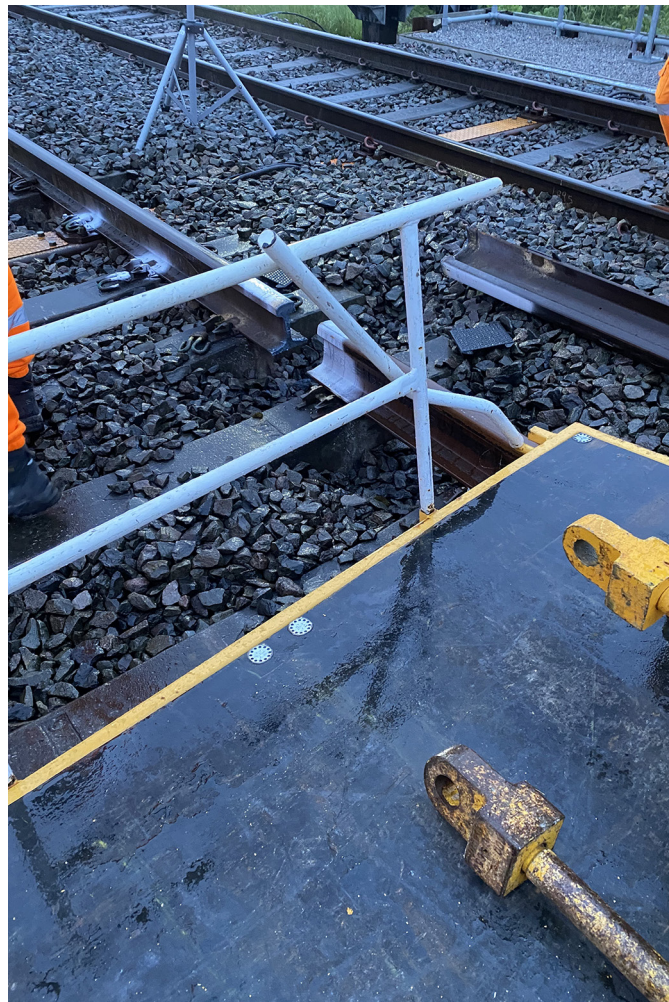
62 The trolley ran away on a downhill gradient because the operator had rendered its brake ineffective.

63 The brakes of the trolley are released by the trolley operator depressing the brake handle (see paragraph 67). Immediately before the accident, the trolley operator had forced the brake handle under the push barrier (figure 10) to keep the brake handle in a depressed state without them having to apply pressure to it. The trolley was found in that state immediately after impact and the trolley operator stated that is what had happened. This meant that the trolley had no effective brakes when operating on a downhill gradient of 1 in 176, allowing the trolley to run away from the operator.

Figure 10: The brake handle, shown wedged under the push barrier, immediately after the collision (courtesy of RSRG).

- 77 The trolley operator had rendered the brake ineffective before the runaway by forcing the brake handle under the push barrier. This caused the brake handle to be fixed in a depressed state, defeating the failsafe trolley brake. Although the base of the trolley handle used at the time of the accident had some deformation, RAIB identified that a brake handle could also be positioned under the push barrier even on a new trolley of the same model, which did not have a brake handle with this deformation. This was achieved without undue difficulty.

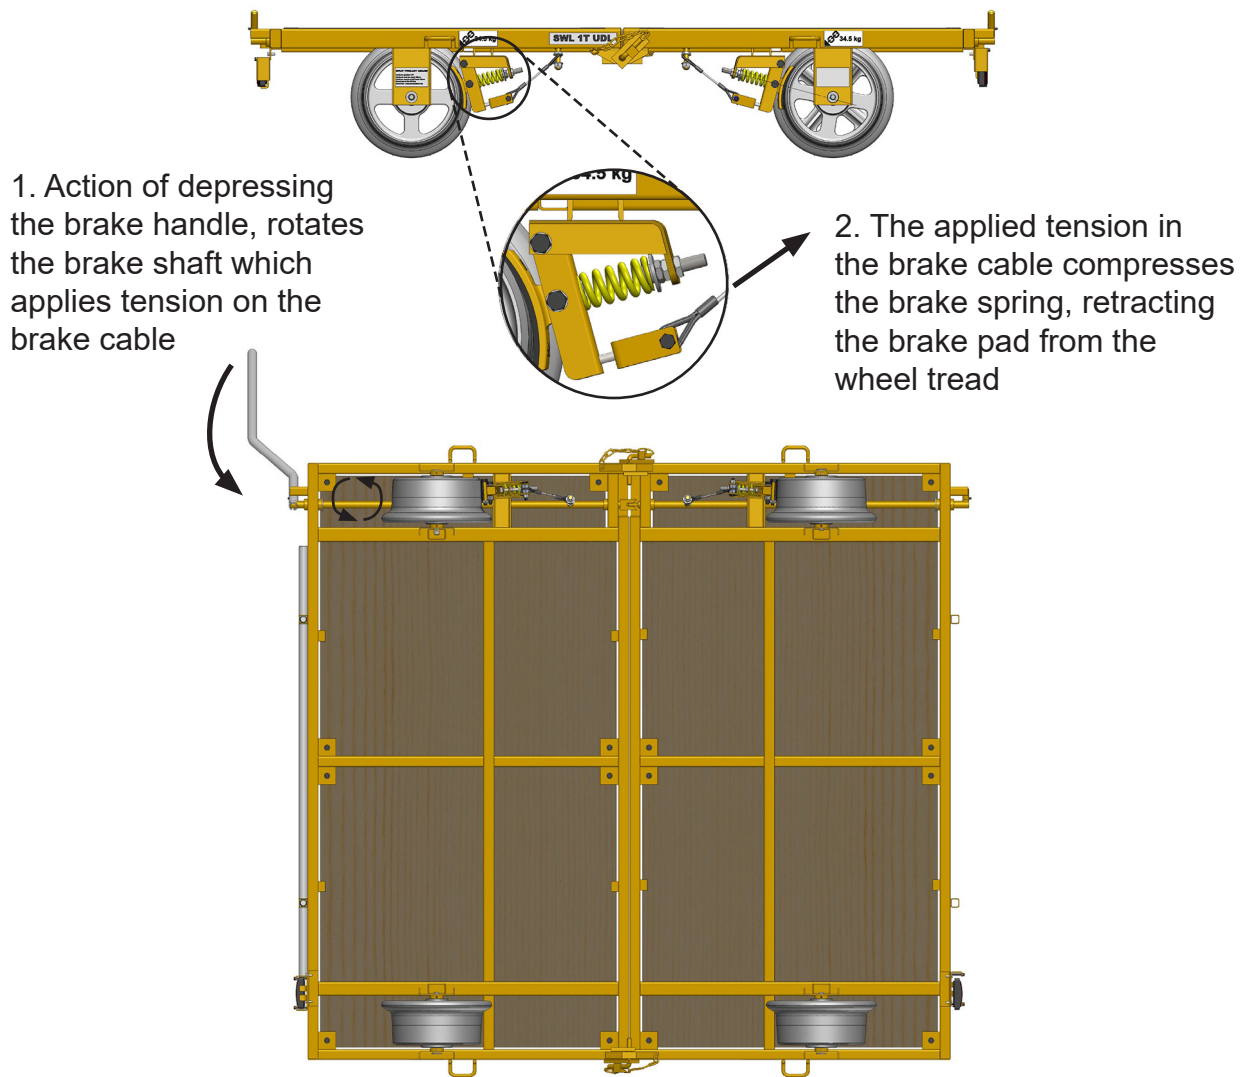
- 69 In its normal state, the trolley brake is always engaged, with the friction shoes applied to the rail wheels by means of the springs. As such, the brakes are considered to be failsafe, as a positive action (depressing the brake handle) is required to release the brakes.

Figure 11: Schematic of the trolley braking system (courtesy of STEL with RAIB annotations).
