**Serious Incident**

<b>Aircraft Type and Registration:</b>	Boeing 777-236, G-VIIT	
<b>No &amp; Type of Engines:</b>	2 General Electric Co GE90-85B turbofan engines	
<b>Year of Manufacture:</b>	1999 (Serial no: 29962)	
<b>Date &amp; Time (UTC):</b>	28 June 2024 at 1120 hrs	
<b>Location:</b>	London Gatwick Airport	
<b>Type of Flight:</b>	Commercial Air Transport (Passenger)	
<b>Persons on Board:</b>	Crew - 13	Passengers - 334
<b>Injuries:</b>	Crew - None	Passengers - None
<b>Nature of Damage:</b>	Fire on the right-side main wheel brakes which was extinguished by fire crew	
<b>Commander's Licence:</b>	Airline Transport Pilot's Licence	
<b>Commander's Age:</b>	56 years	
<b>Commander's Flying Experience:</b>	22,374 hours (of which 18,616 were on type) Last 90 days - 210 hours Last 28 days - 54 hours	
<b>Information Source:</b>	Aircraft Accident Report Form submitted by the pilot and other enquiries by the AAIB

**Synopsis**

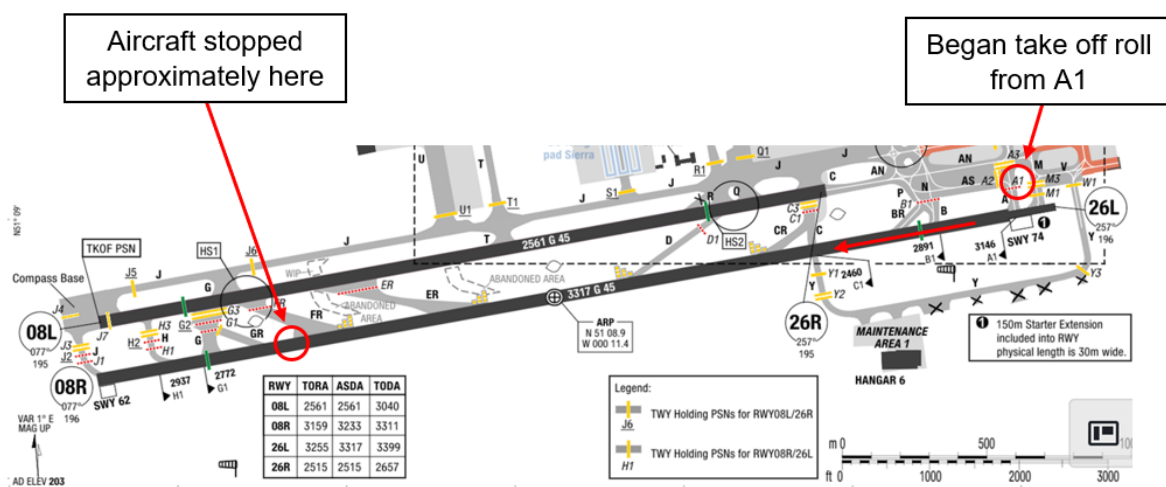
Figure 1

The aircraft stopped before intersection GR (Figure 1). The airport rescue and firefighting service attended the aircraft and extinguished a fire from hot brakes on the right main landing gear.

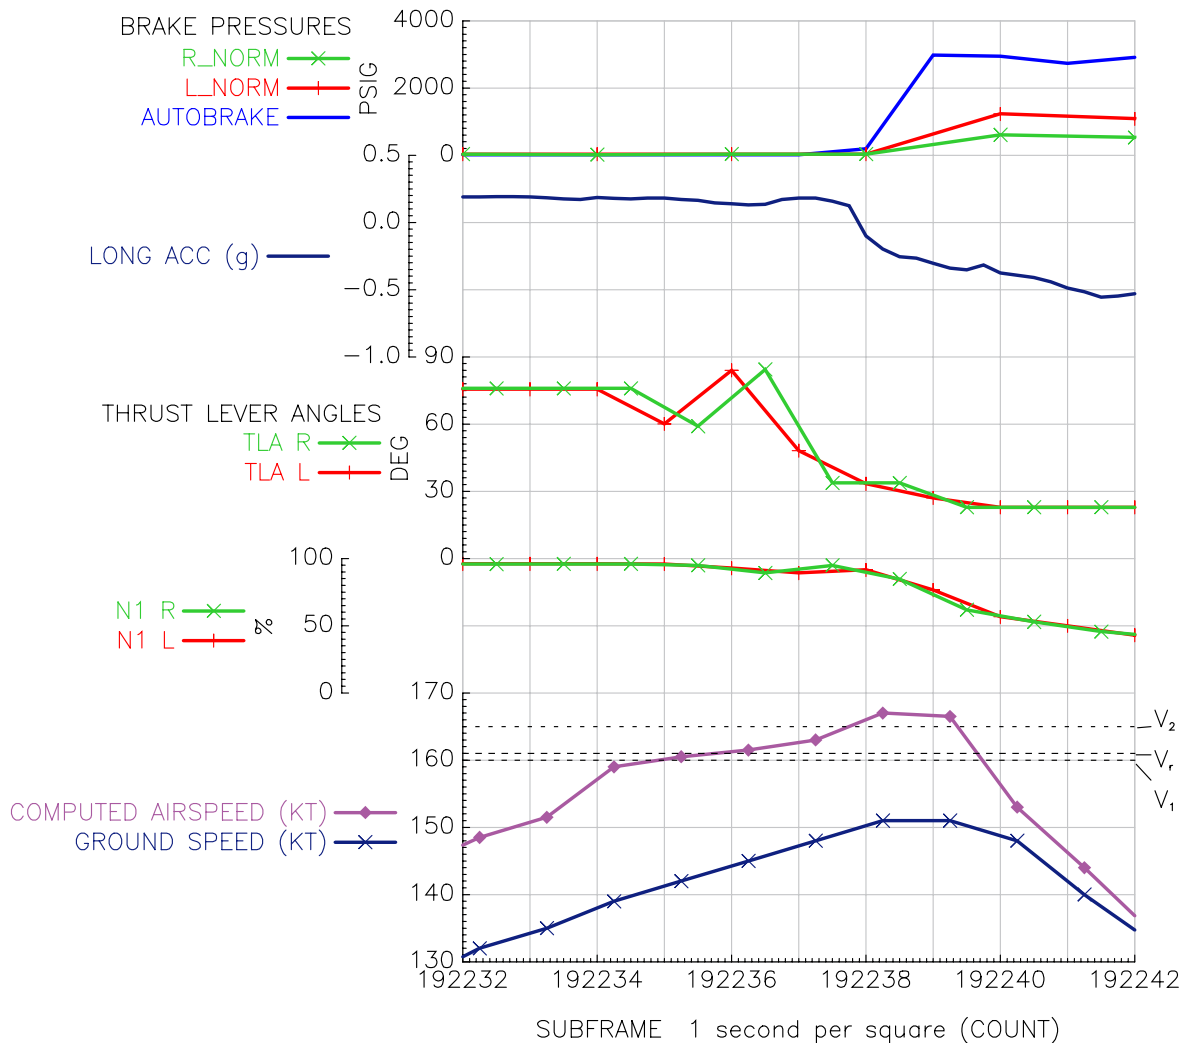
**Figure 2**  
Recorded flight data

The thrust levers were retarded first at around 160 KIAS<sup>6</sup>, then again at around 162 KIAS. G-VIIT reached approximately 167 KIAS before stopping (Figure 2).
