Serious Incident

Aircraft Type and Registration:	Airbus Helicopters EC175 B, G-MCSH	
No & Type of Engines:	2 Pratt & Whitney Canada PT6C-67E turboshaft engines	
Year of Manufacture:	2018 (Serial no: 5034)	
Date & Time (UTC):	17 February 2023 at 0900 hrs	
Location:	Elgin Oil Platform, North Sea	
Type of Flight:	Commercial	
Persons on Board¹:	Crew - None	Passengers - None
Injuries:	Crew - N/A	Passengers - N/A
Nature of Damage:	Four rotor blades detached. Damage to helicopter fuselage	
Commander's Licence:	Airline Transport Pilot's Licence	
Commander's Age:	38 years	
Commander's Flying Experience:	4,703 hours (of which 2,159 hours were on type) Last 90 days - 91 hours Last 28 days - 30 hours	
Information Source:	AAIB Field Investigation

Synopsis

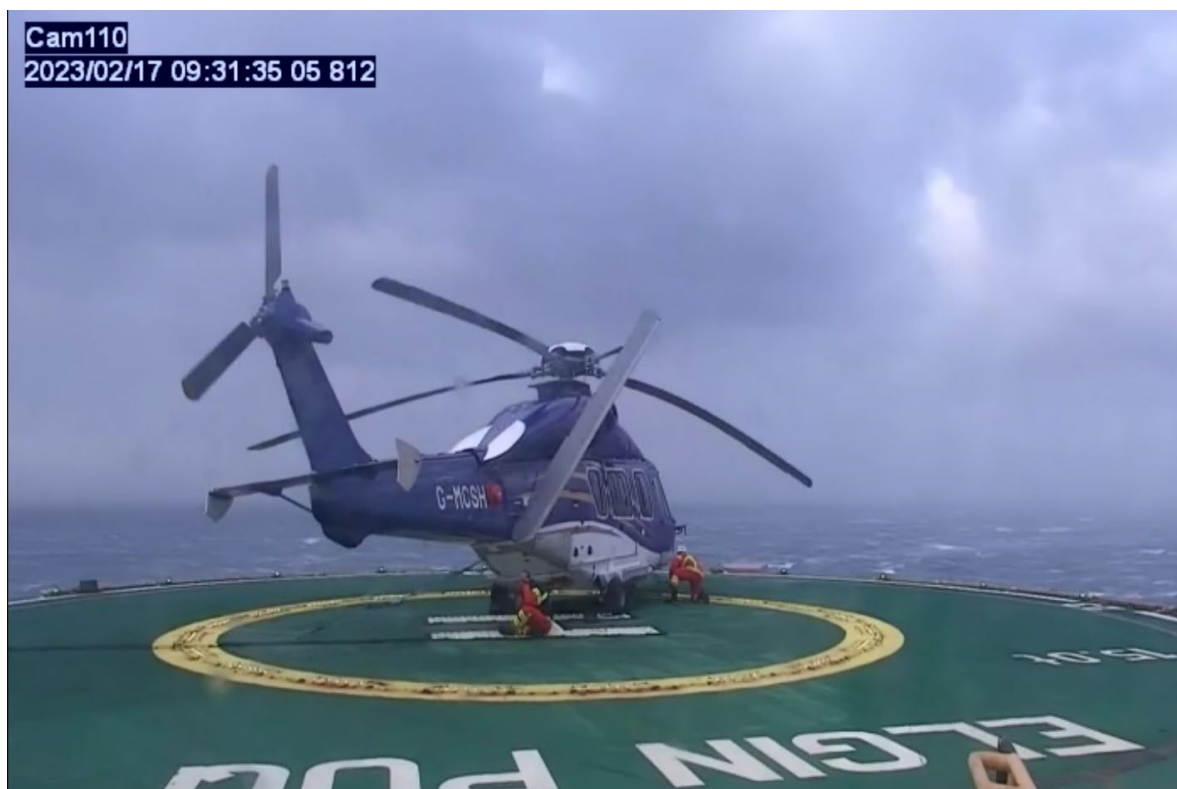
Figure 1

CCTV image of G-MCSH blade fracturing and striking fuselage close to helideck crew member trying to secure the rear of the helicopter
(courtesy Total Energies E&P UK Limited)

The four remaining blades continued to rotate, with increasingly strong wind conditions causing them to sail. Over the next 1 hour 40 minutes three of the remaining blades lifted at different times to the point where they also failed. The broken blades remained on the helideck and were later recovered.

The four broken main rotor blades had all fractured in the aerofoil section just outboard of where the root transitions to the aerofoil. Each of the fractured blades had failed in bending associated with being forced upward.

The left side of the helicopter fuselage showed multiple impact marks indicating where the failed blades had struck it, including cracks and holes to the left pilot's seat door window and the loss of the external emergency door handle.

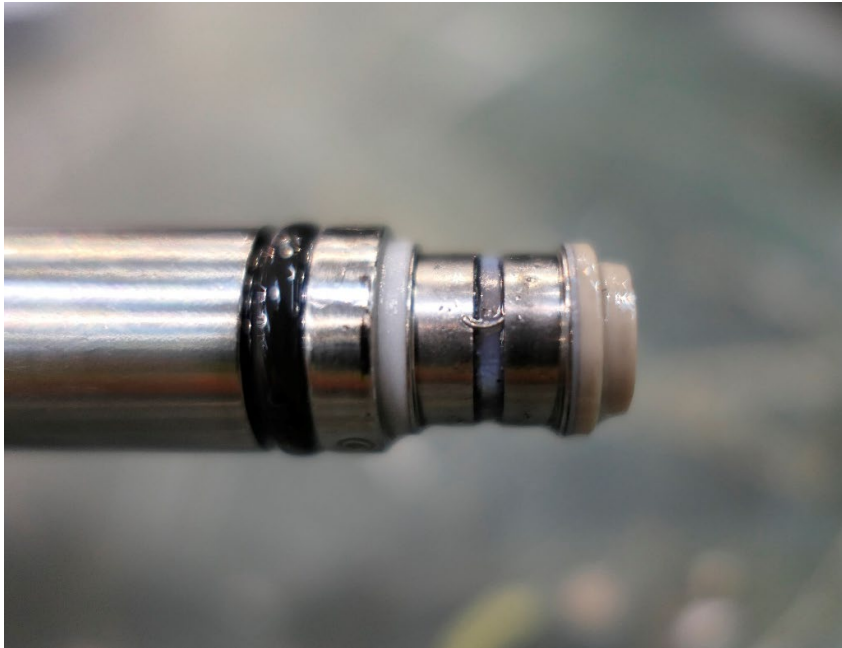
Figure 8

On removal of the TGB chip detector, it was found that a fragment of a spring reinforced seal was the cause of the TGB XMSN CHIP caution (Figure 8). The sliding collar assembly fitted to the TGB on G-MCSH had previously been replaced due to a similar seal fragment causing a chip caution. This was associated with the failure of a seal, damaged when the sliding collar assembly was fitted.

Fragment on tail rotor gearbox chip detector

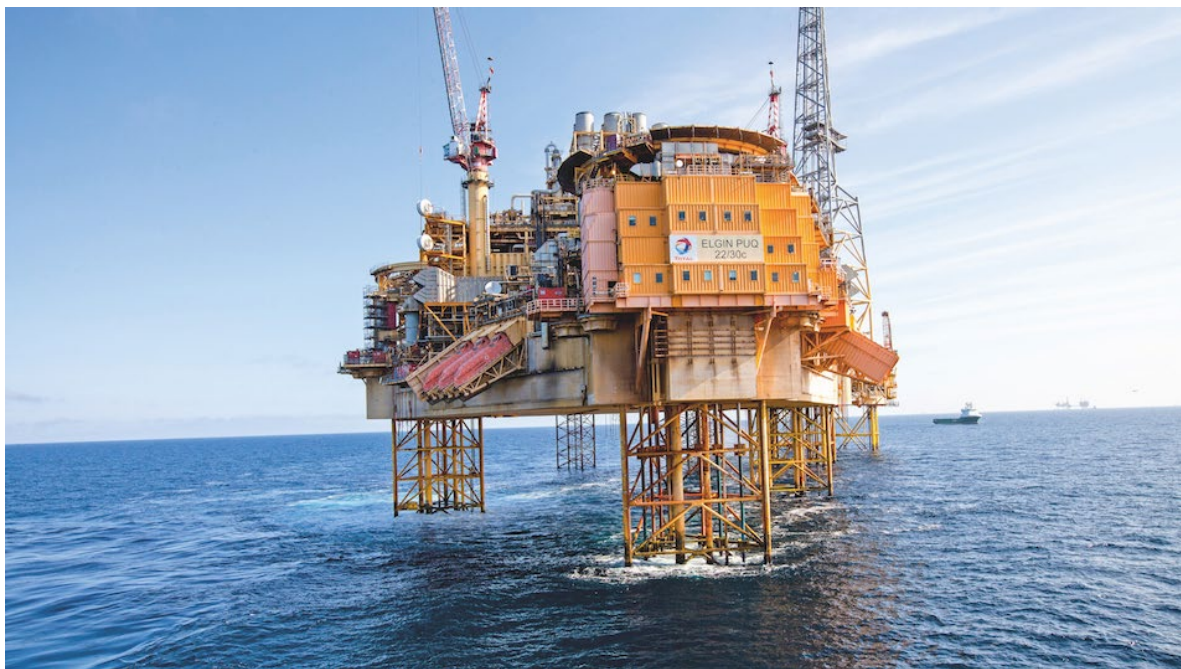
Figure 15

In 2008 a CFD study was conducted to check the effect of adding an accommodation block under the helideck. This concluded that the resulting vertical wind component would exceed the still current CAA recommended limit of 0.9 m/s for a significant portion of the bounding box. The test results showed vertical wind components of 5 m/s, both with and without the accommodation block, at the windward edge of the helideck, but with the area affected increasing when the accommodation block was present. Similarly, when considering standard deviation of the vertical airflow velocity, both with and without the accommodation block present, areas of the helideck were above the 2.4 m/s limit. With the block present, the extent of the affected area increased so that the majority of the helideck was either at or above the CAA limit.

The CFD study considered only a limited number of wind directions, thought to be those most relevant to the new accommodation block. It calculated that the Elgin PUQ would experience winds of 25 m/s, as used in the study, 9% of the time. The study was performed without including the 3 m extension to the helideck. The extension had been created by adding turbulence panels around the edge of the helideck, but the report stated there was not enough information provided on them for their inclusion in the modelling. It stated that their presence would be expected to reduce the turbulence and velocity gradients at the leading edge of the helideck. Much of the report's analysis relied on averaging vertical wind speeds and standard deviations throughout the bounding box as well as looking specifically at those at rotor height. For the study the rotor height used was for the EH101, 4.7 m above the helideck (rotor height for the EC175 is 3.48 m). The accommodation block was later added (Figure 15).

Elgin PUQ platform helideck showing accommodation block
(courtesy Total Energies E&P UK Limited)

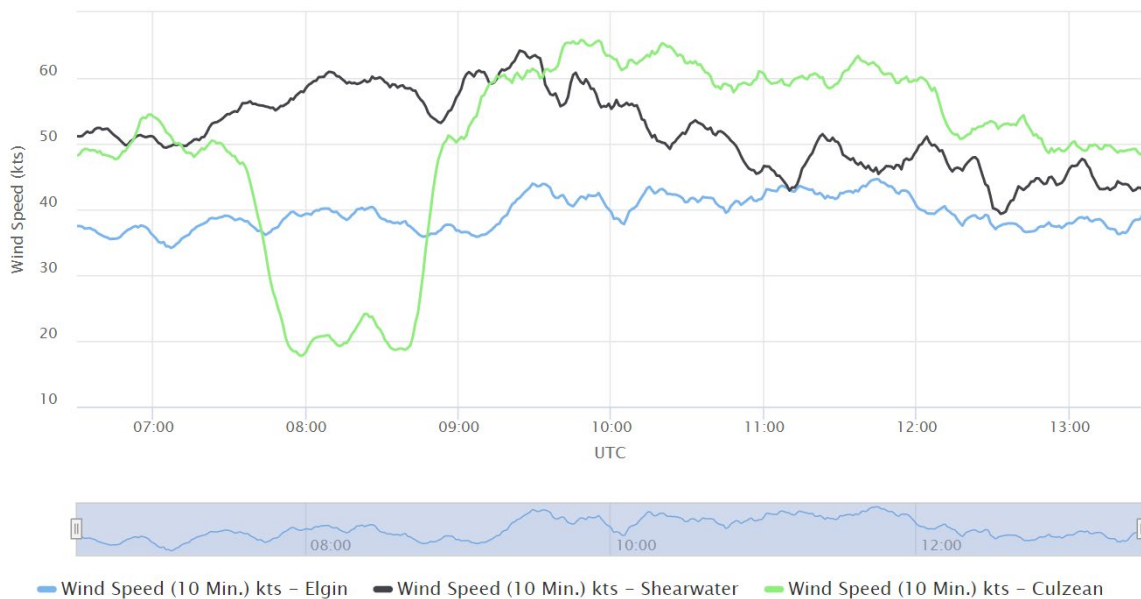
Figure 16

Ten-minute Averaged Wind Speeds for Elgin, Shearwater and Culzean Offshore Platforms

It has not been possible to explain the discrepancies between the three platforms through any technical issues, but they may be due to localised weather effects. Similarly, it has not been possible to explain the drop in windspeed recorded on the Culzean platform between about 0730-0900 hrs. Further comparisons since the event have not identified significant general differences in reported wind speeds between the three platforms. However, on 22 January 2024, the area was affected by Storm Isha and similar differences in wind were once again noted by the operator. They reported that at 0555 hrs the Elgin PUQ was reporting a wind of 43 kt with no gusts whilst the Shearwater, 4 nm away, was reporting winds of 62 kt, gusting 75 kt.

Irrespective of the cause, it is considered the windspeed recorded on the Elgin PUQ at the time of the storm passage was likely to have been lower than actually experienced. Evidence indicates this situation is a wider issue affecting other platforms at various times and under various conditions. In order to ensure such differences can be identified and affected helicopter operations alerted, the following Safety Recommendation is made:

It is recommended that Leading Offshore Energy Industry Competitiveness Limited incorporates comparative wind speed analysis as part of the Helimet quality control and notification system.

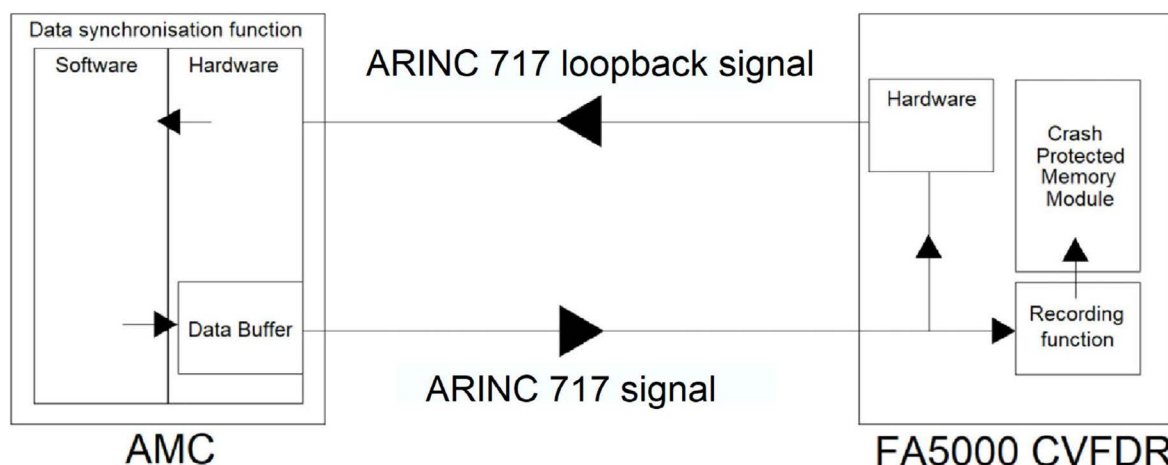
**Figure 20**

- A loss of flight data recording for 5 seconds at 10-minute intervals occurred after about three hours and fifteen minutes of helicopter operation. This was a result of the FA5000 CVFDR ARINC⁵ 717 loopback signal being out of specification. This affects EC175, UH-72, and EC145 helicopters that are installed with Helionix Version 8 software.
- Neither the loss of chronological recording nor data for periods of 5 seconds will result in a CVFDR Built In Test (BIT) fault message. It is necessary to readout all recorded flight data to confirm the presence of the anomalies.
- The cause of the anomalous operation of the Vision 1000 was not identified. Other State accident investigation authorities have experienced similar recording issues with Vision 1000s.

AMC - FA5000 ARINC 717 loopback signal
