Maritime &
Coastguard
Agency

SS Richard Montgomery: Survey report 2024

December 2nd 2024

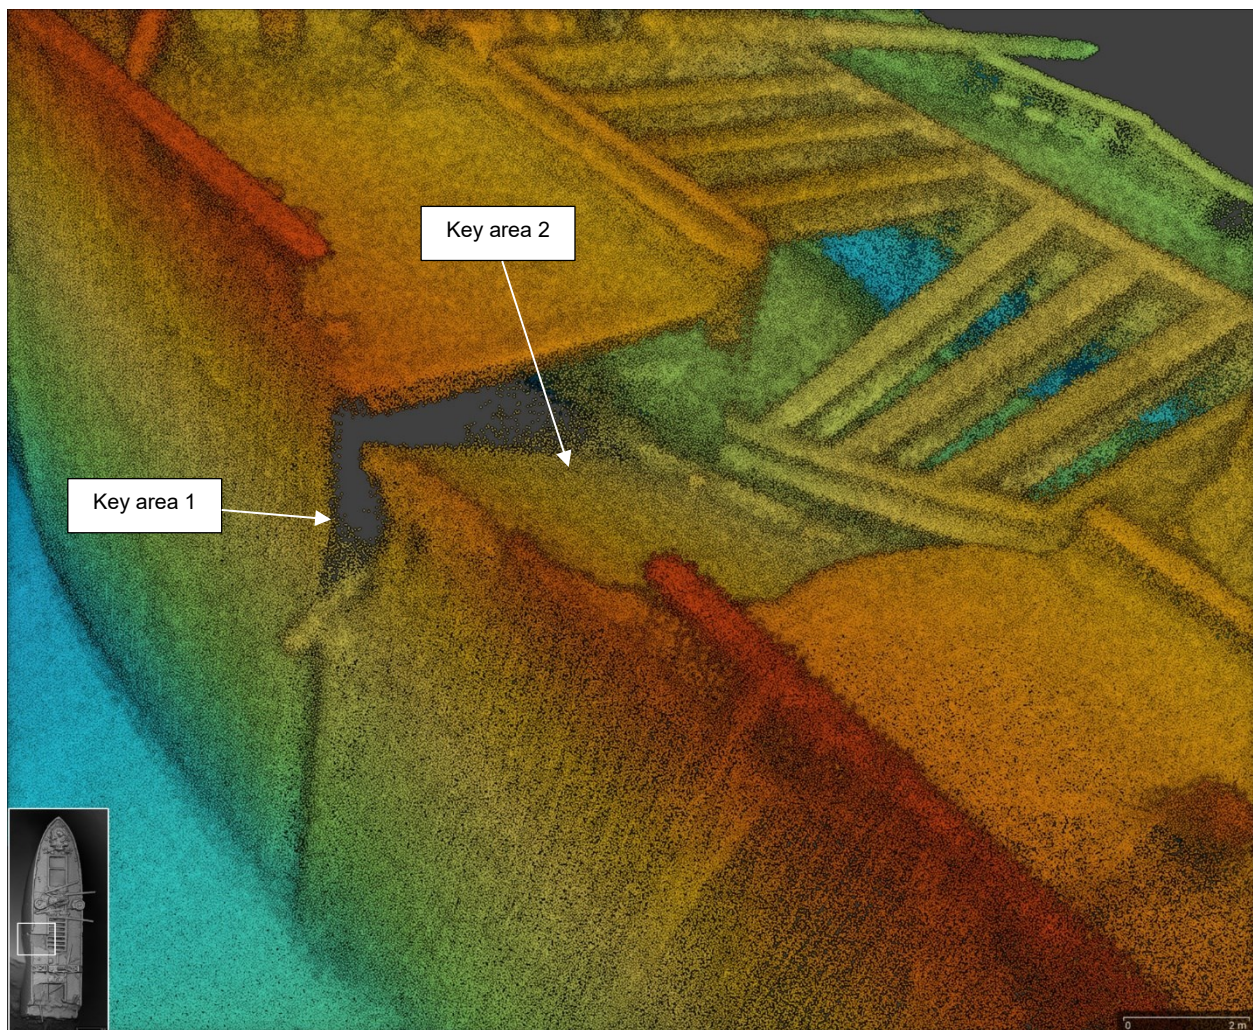
4.1.2 Key area 1 – Crack in the hull (port side, forward section) (Figure 7).

4.1.3 Key area 2 – Collapse of cargo hold 2 deck (port side, forward section) (Figure 7).

The forward section of the Richard Montgomery is seriously hogging almost exactly halfway along the no. 2 hold hatch. This hogging has resulted in a crack appearing on the upper part of the port side while the lower part of the starboard side is significantly buckled giving the appearance that the forward part of the wreck is splitting in two and pivoting about the starboard rim of hold 2. The flexing of the upper deck has caused a portion of the upper deck and half of the hold 2 hatch cover supports to collapse through into the 'tween deck space.

Figure 7. Point cloud image of key areas 1 and 2.

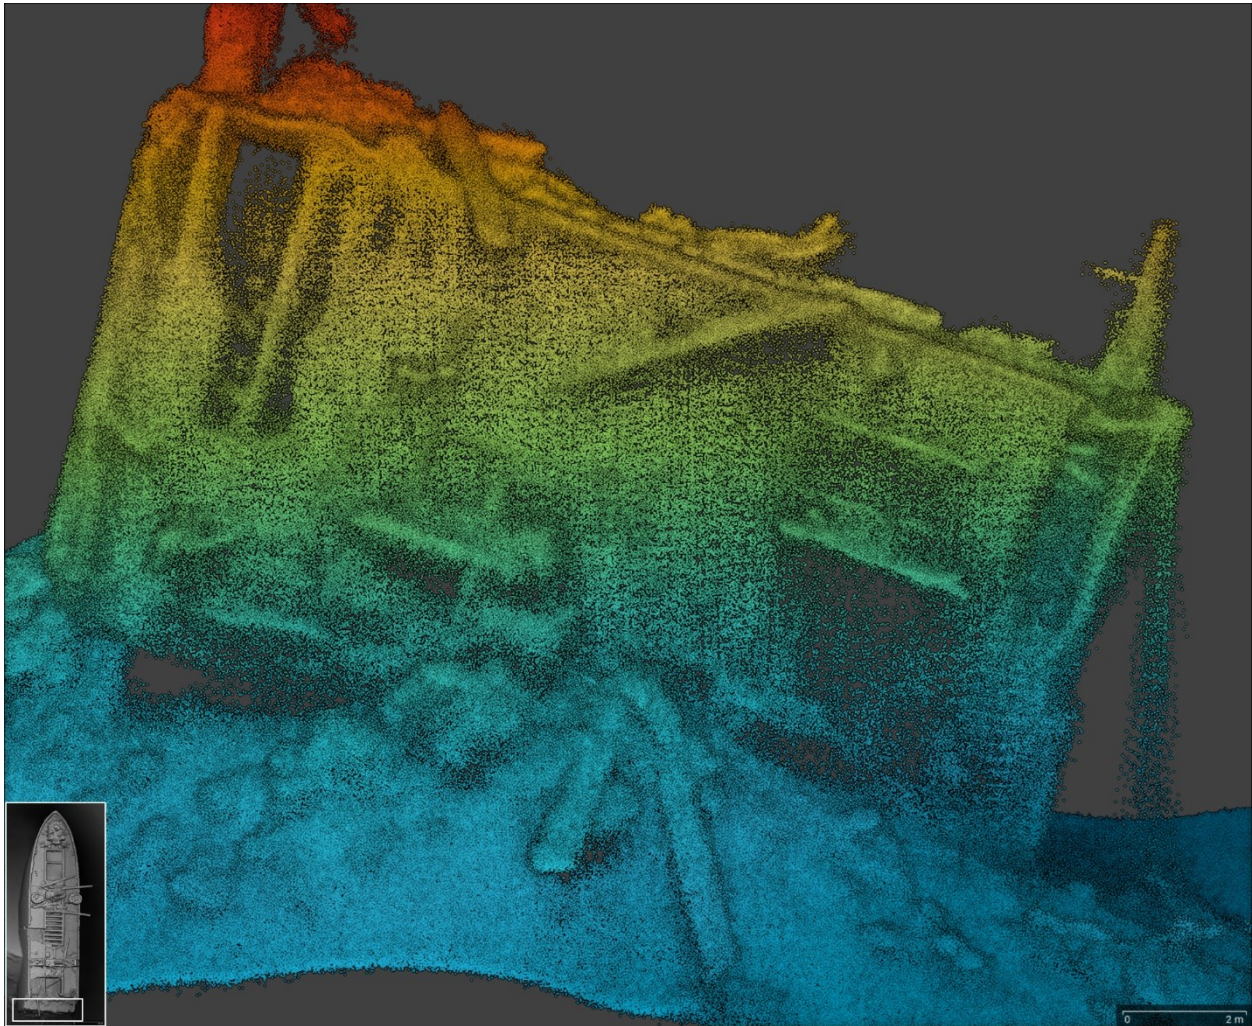
4.1.4 Key area 3 – Aperture (aft end, forward section) (Figure 8).

Figure 8. Point cloud image of the aperture, key area 3.

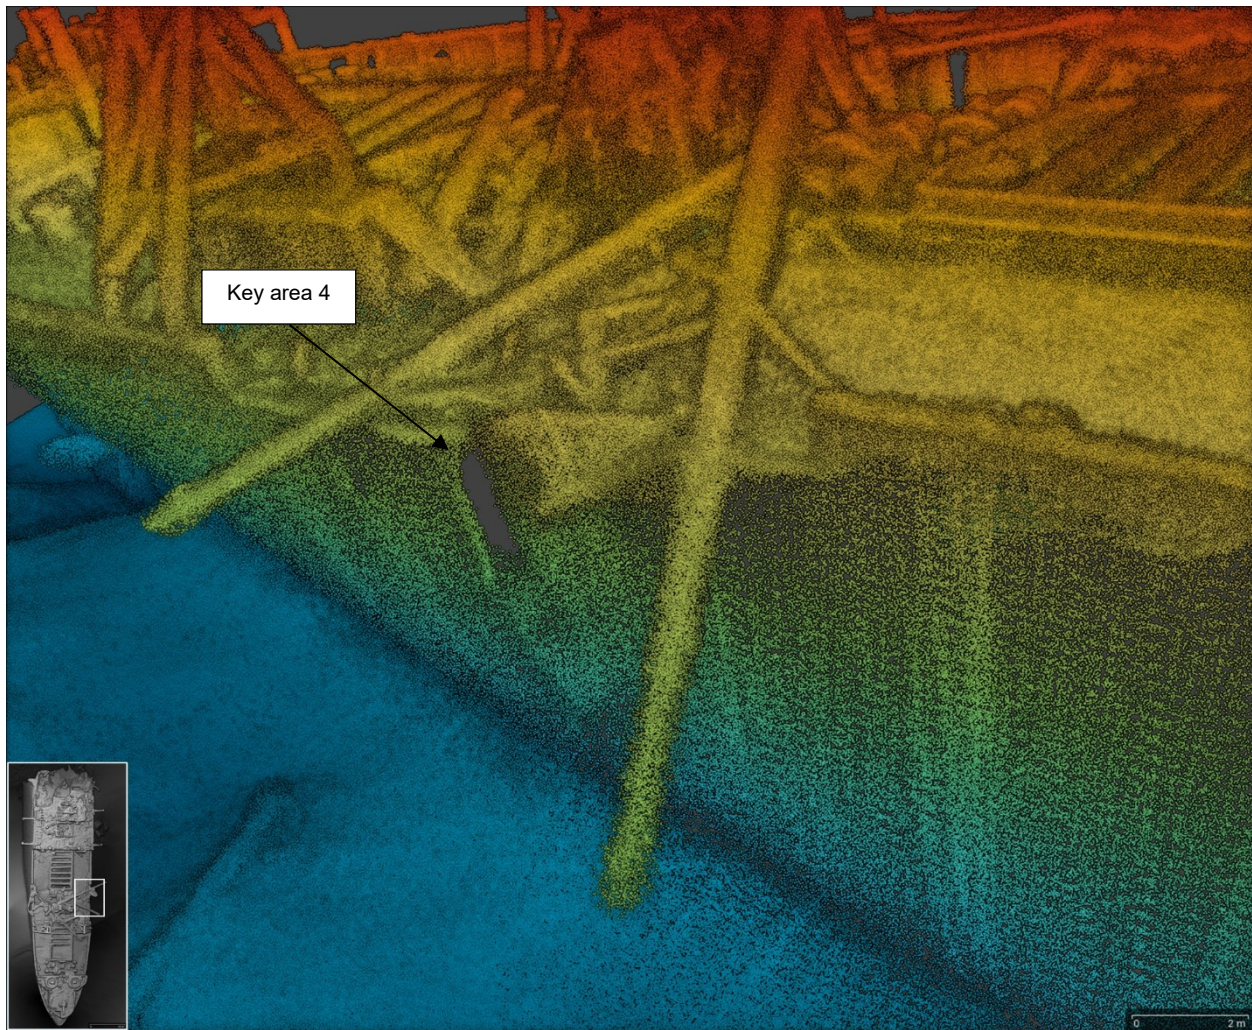
4.1.5 Key area 4 – Split in the hull (starboard side, aft section near the aft mast house) (Figure 9).

Key areas 4 and 5 represent the two ends of the same feature, namely a transverse crack across the rear hull section. Like the forward section, the rear section is hogging and potentially breaking in two about halfway along its length. The split appears to be occurring just forward of the mast with the mast remaining upright with respect to the stern part as it drops away from the forward part.

Figure 9. Point cloud image of the split in the hull, key area 4.

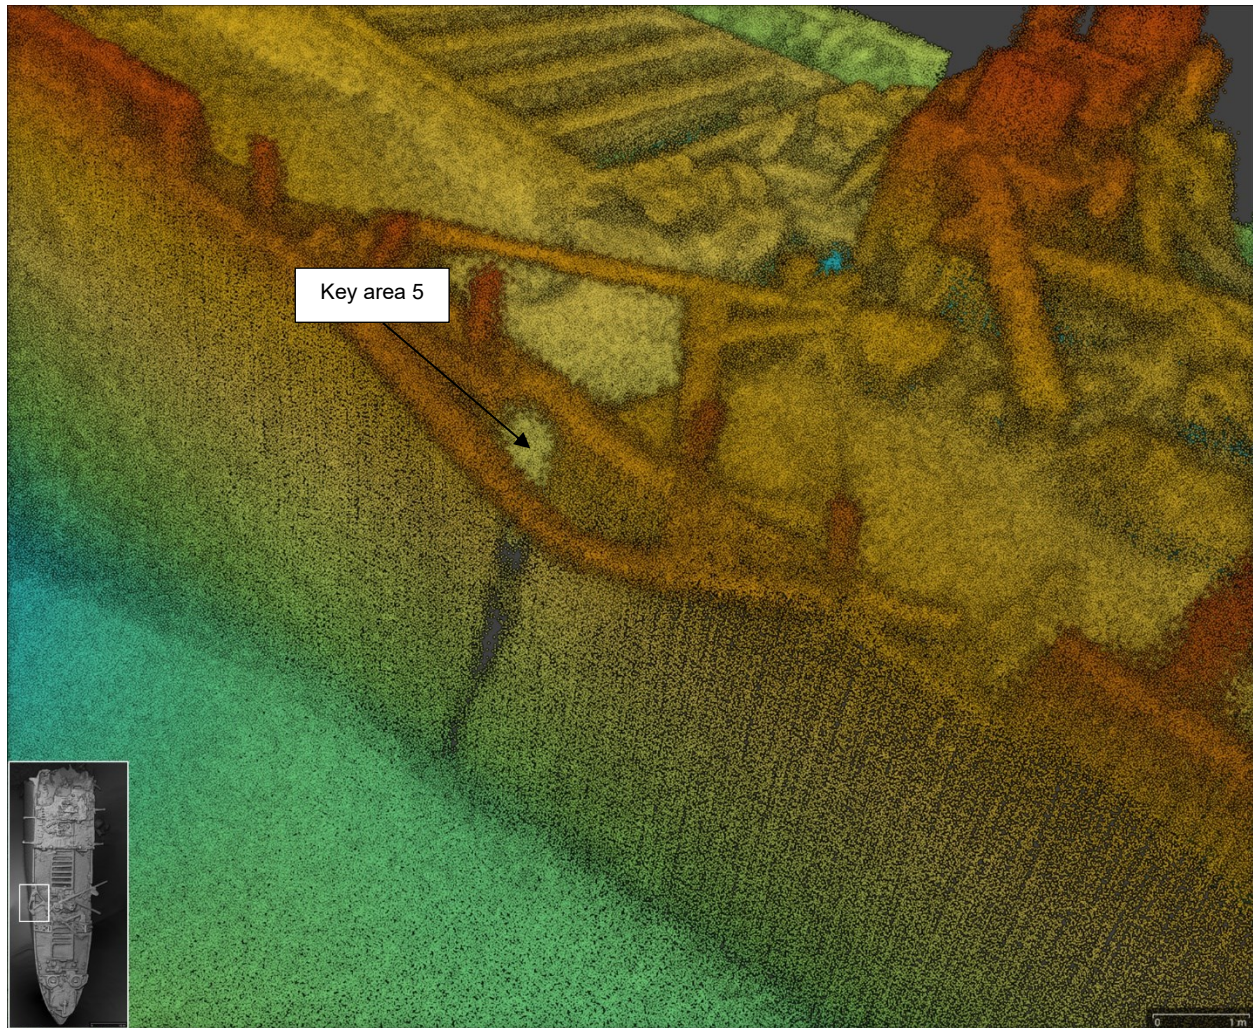
4.1.6 Key area 5 – Split in the deck and split in the hull (aft section, port side)
(Figure 10).

Figure 10. Point cloud image of the split in deck, key area 5.

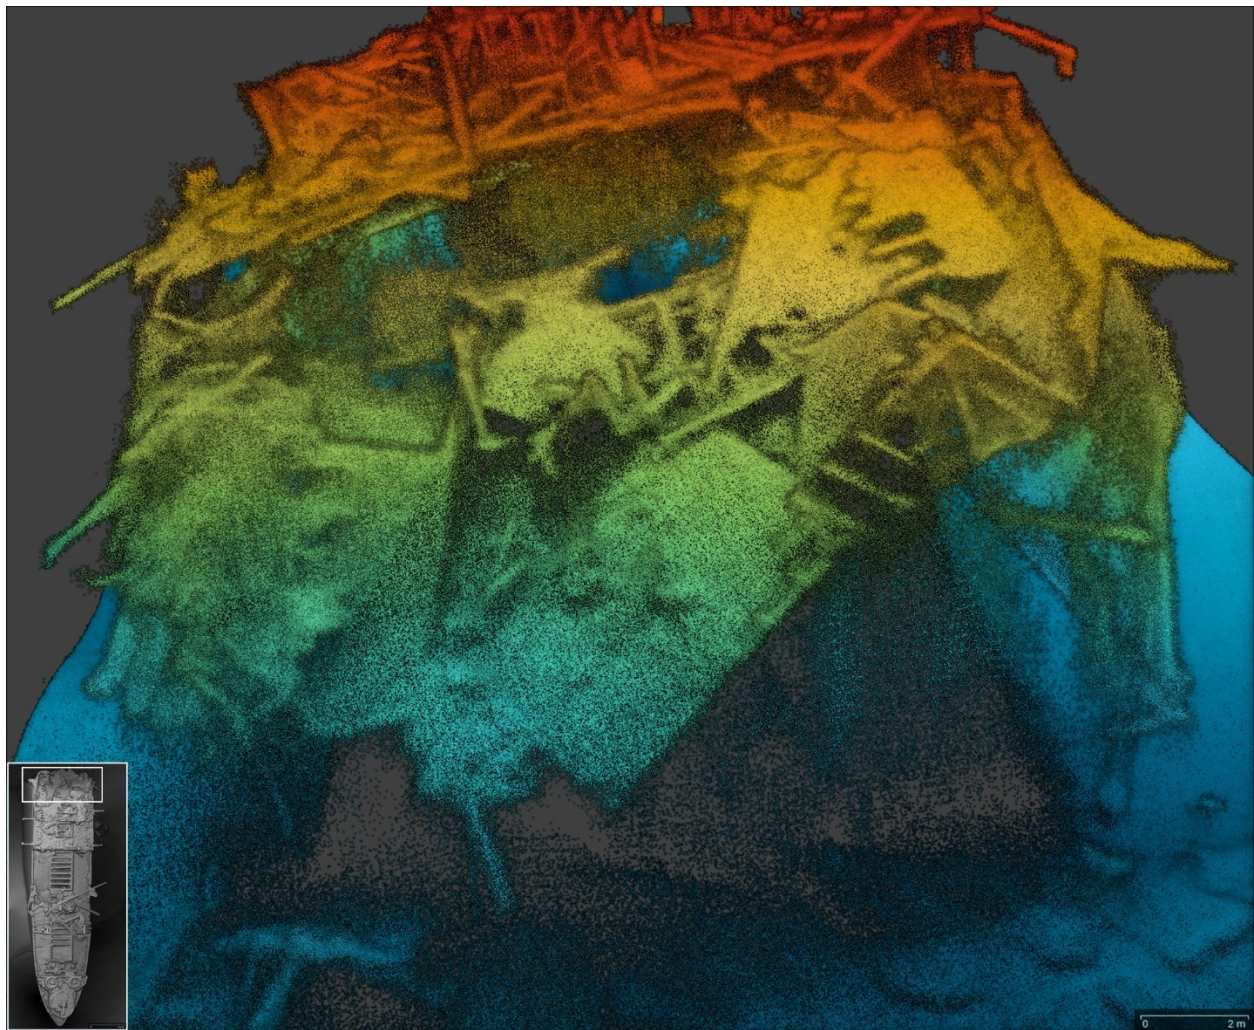
4.1.7 Key area 6 – Boiler room casing, collapsing bridge deck and the collapsing boat deck (forward end, aft section) (Figure 11).

This area was left unsupported when the ship broke in two back in 1944. Consequently, it has been badly affected by wave and current action and is steadily collapsing and falling into the gap between the two halves of the vessel. This area has showed significant degradation in earlier surveys.

Figure 11. Point cloud image of the collapsing bridge area, key area 6.

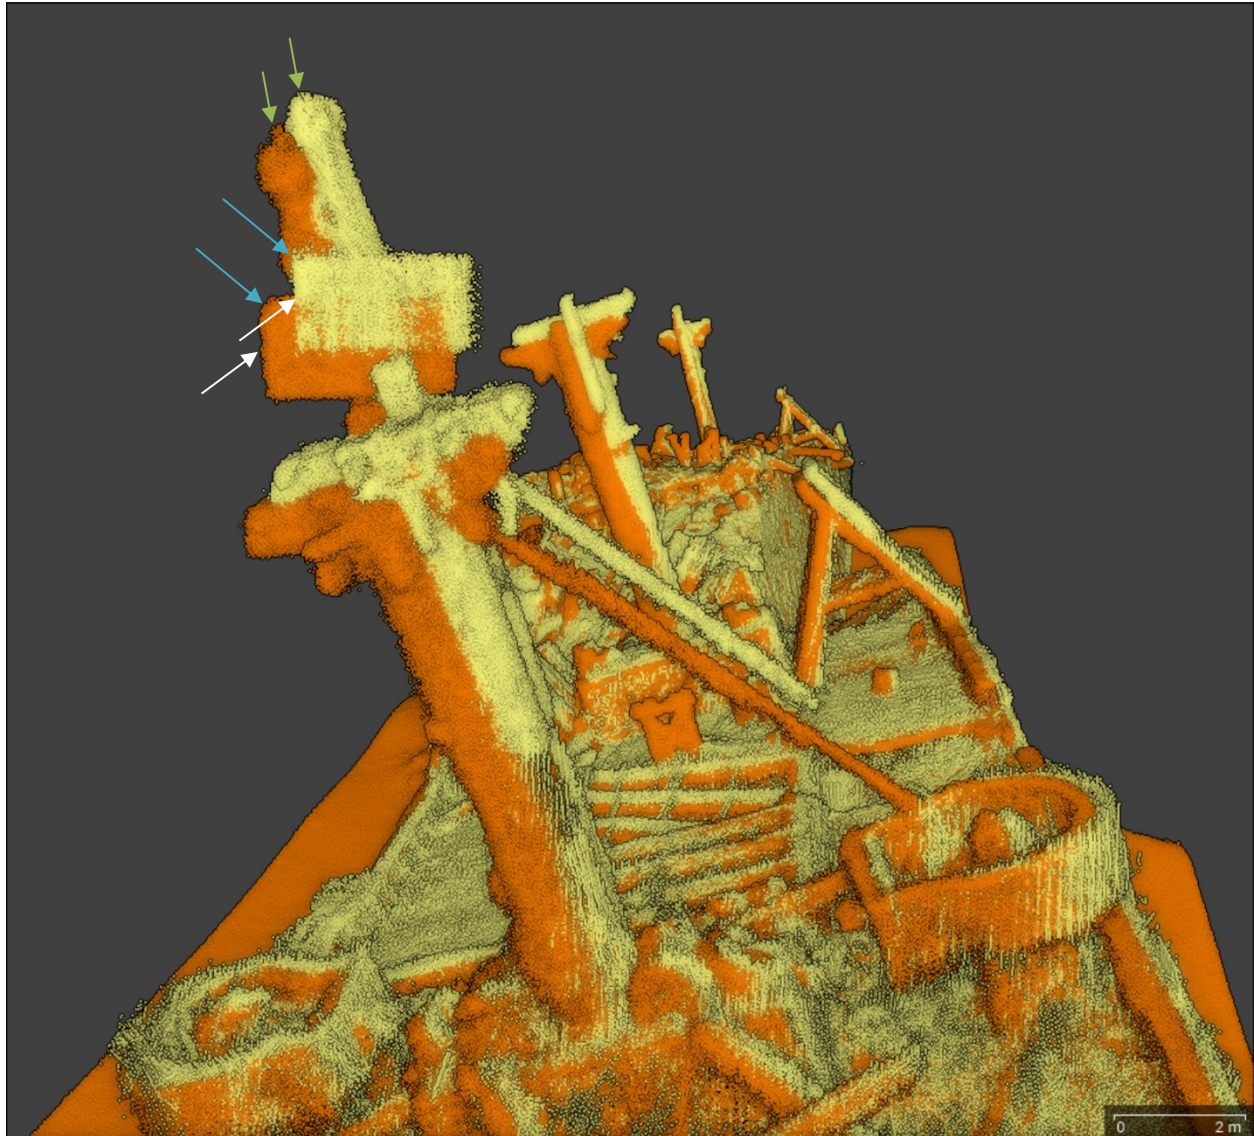
4.3.3 Increase in tilt of the bow section

By comparing this year's survey data with that from 2022 and 2023 it is apparent that the tilt of the bow section is increasing. This increase of tilt is most visible when comparing the laser scans of the top of the masts since they are furthest from the centre of the wreck. Measurements were made at three different locations on the foremast, and they show a horizontal shift of 43 to 55 centimetres towards the east between the 2022 and 2024 survey data (Figure 14). Although the reason for the increase in tilt is a subject of debate there is no question that this is an ongoing event.

Figure 14. Point cloud data comparing the 2022 full survey (yellow) with the 2024 full survey (orange). Note the positional changes of objects on the closest section (the bow). Arrows pointing towards areas of the mast which were used to determine the horizontal shift.

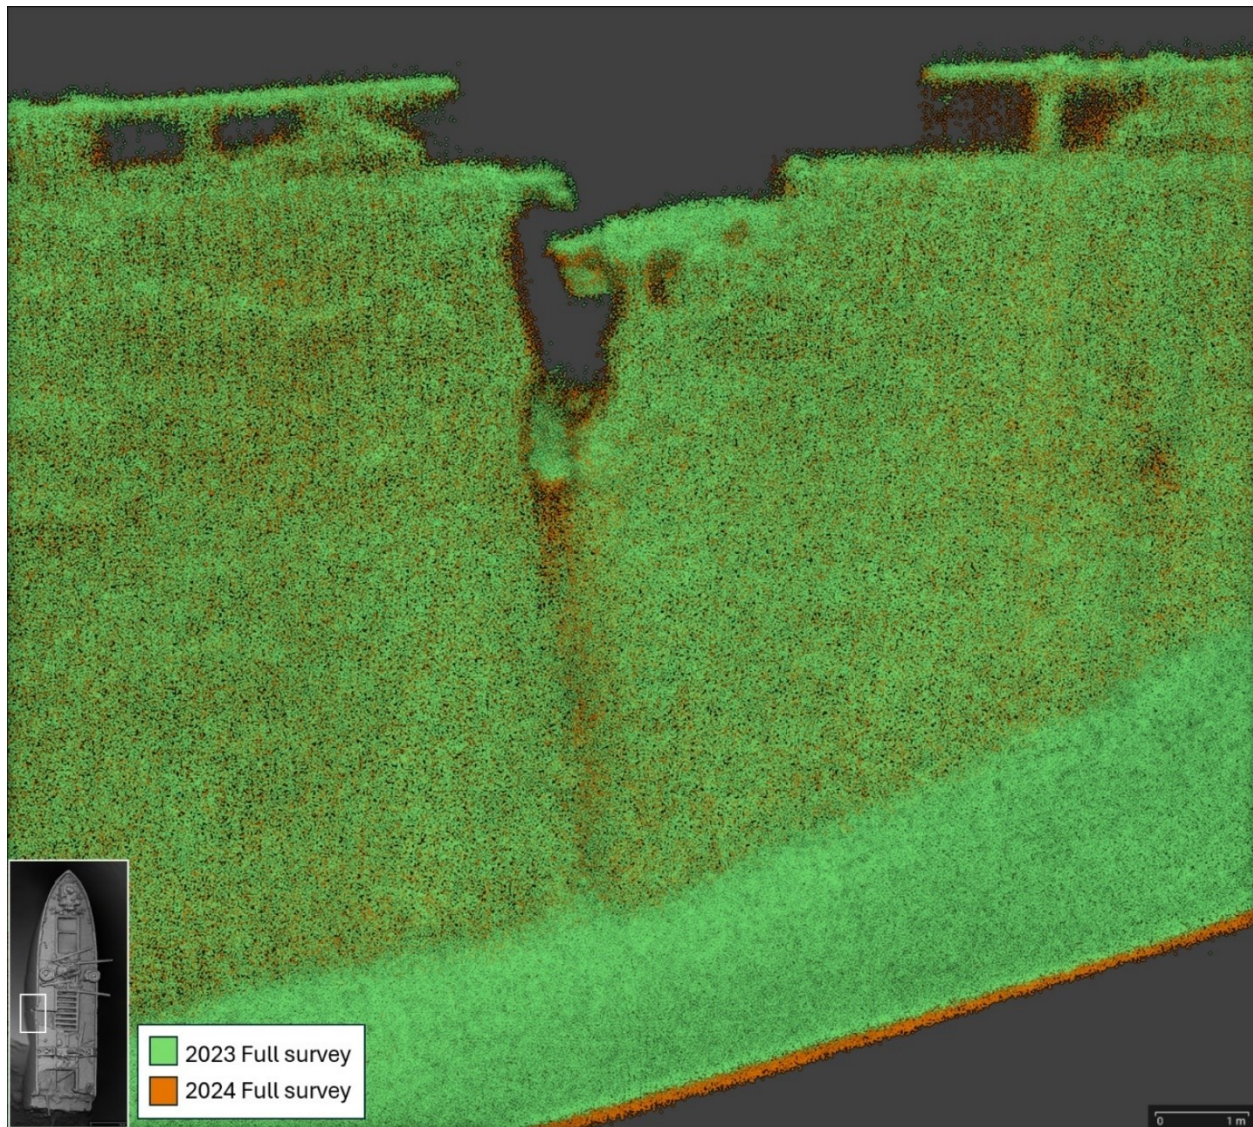
The crack in the hull is well defined in the 2023 full survey, 2024 snapshot survey and 2024 full survey (Figure 15). However, it is not possible to say whether the crack has become wider or not due to the error margin of the data points in the point cloud. If it has become wider as earlier comparisons shows it is by at most a few cm.

Figure 15. Point cloud cross section comparison of the wreck showing key area 1, the crack in the hull.

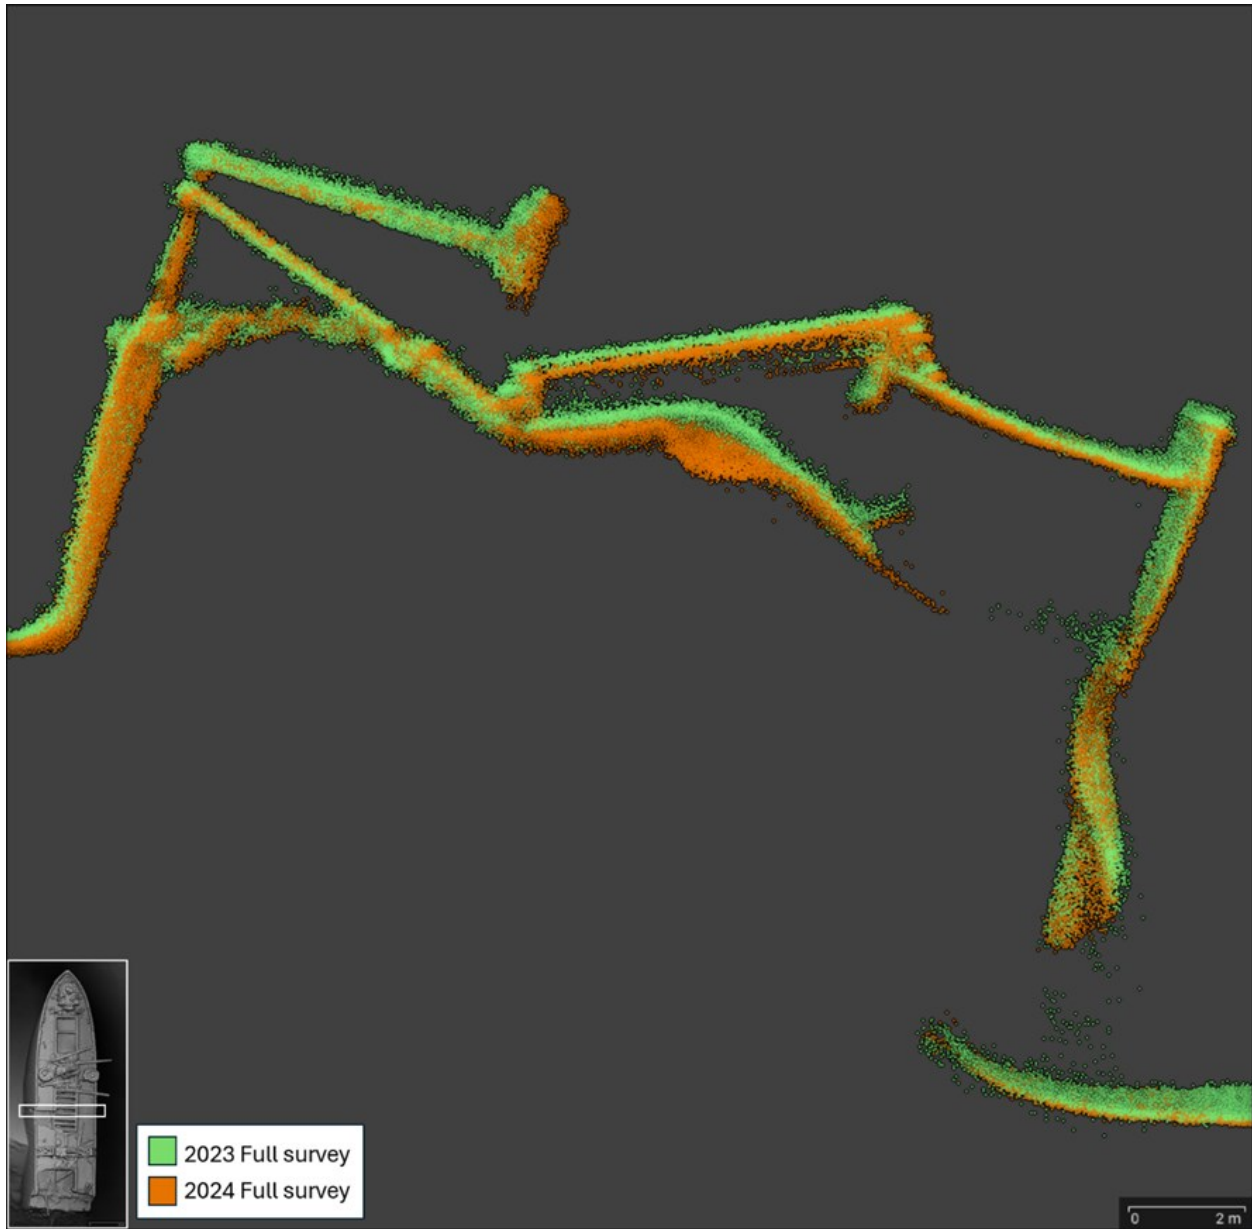
Overlaying the 2024 and 2023 full survey data on a cross section shows the extent of the upper deck collapse (Figure 16). The upper deck does not seem to have collapsed further, but the hatch supports over the collapsed part of hold 2 have dropped, see section 4.5.2.

Figure 16. Point cloud cross section of the wreck showing key area 2, the collapsed cargo hold 2 deck. The collapsed deck shows no difference between the 2023 and 2024 full survey. The cross section is 1 meter thick.

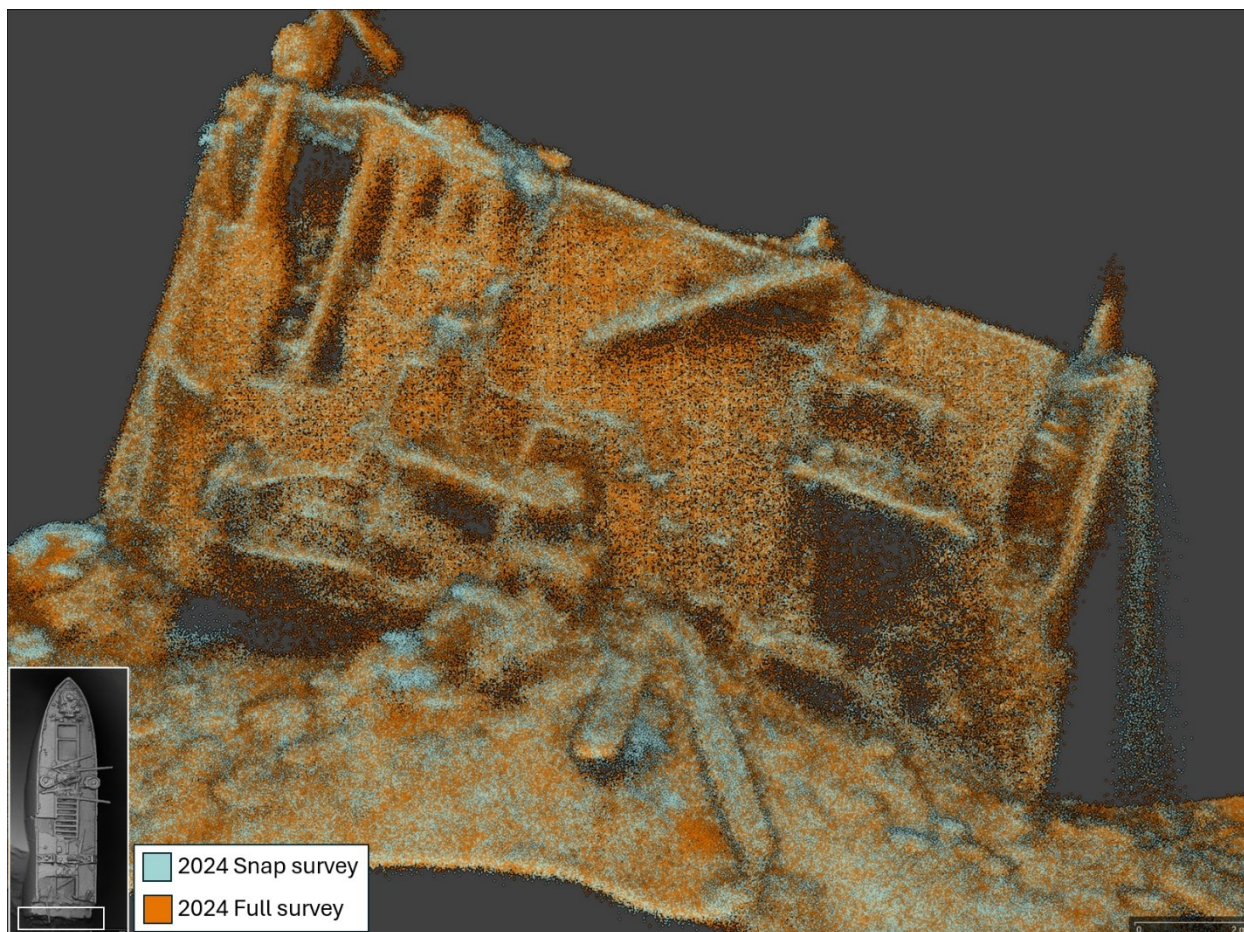
Figure 17 shows the apertures on the bulkhead at the aft end of the forward section. No structural differences were found between the 2024 snapshot and 2024 full survey.

Figure 17. Aperture in the bulkhead to rear of hold 3. The cross section is 10 meters thick.

Due to the nature of the aperture's location, the density of good quality soundings required for identifying any objects inside them is not enough.

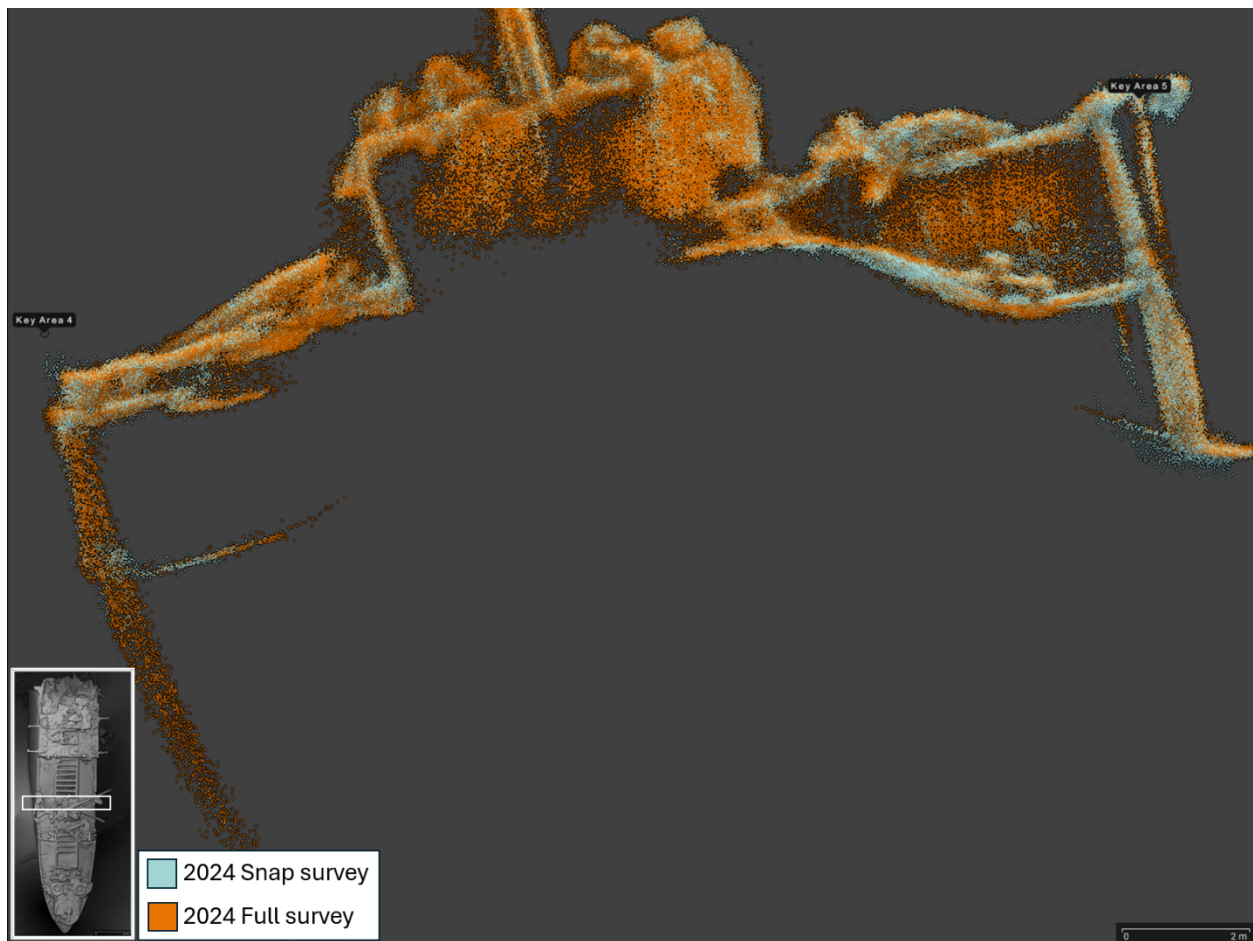
No notable differences can be seen between the 2023 full survey and 2024 full and snapshot surveys (Figure 18, Figure 19 and Figure 20).

Figure 18. Southward facing cross section showing the split in the hull and collapse of the deck at key area 5. No difference can be seen between the two surveys.

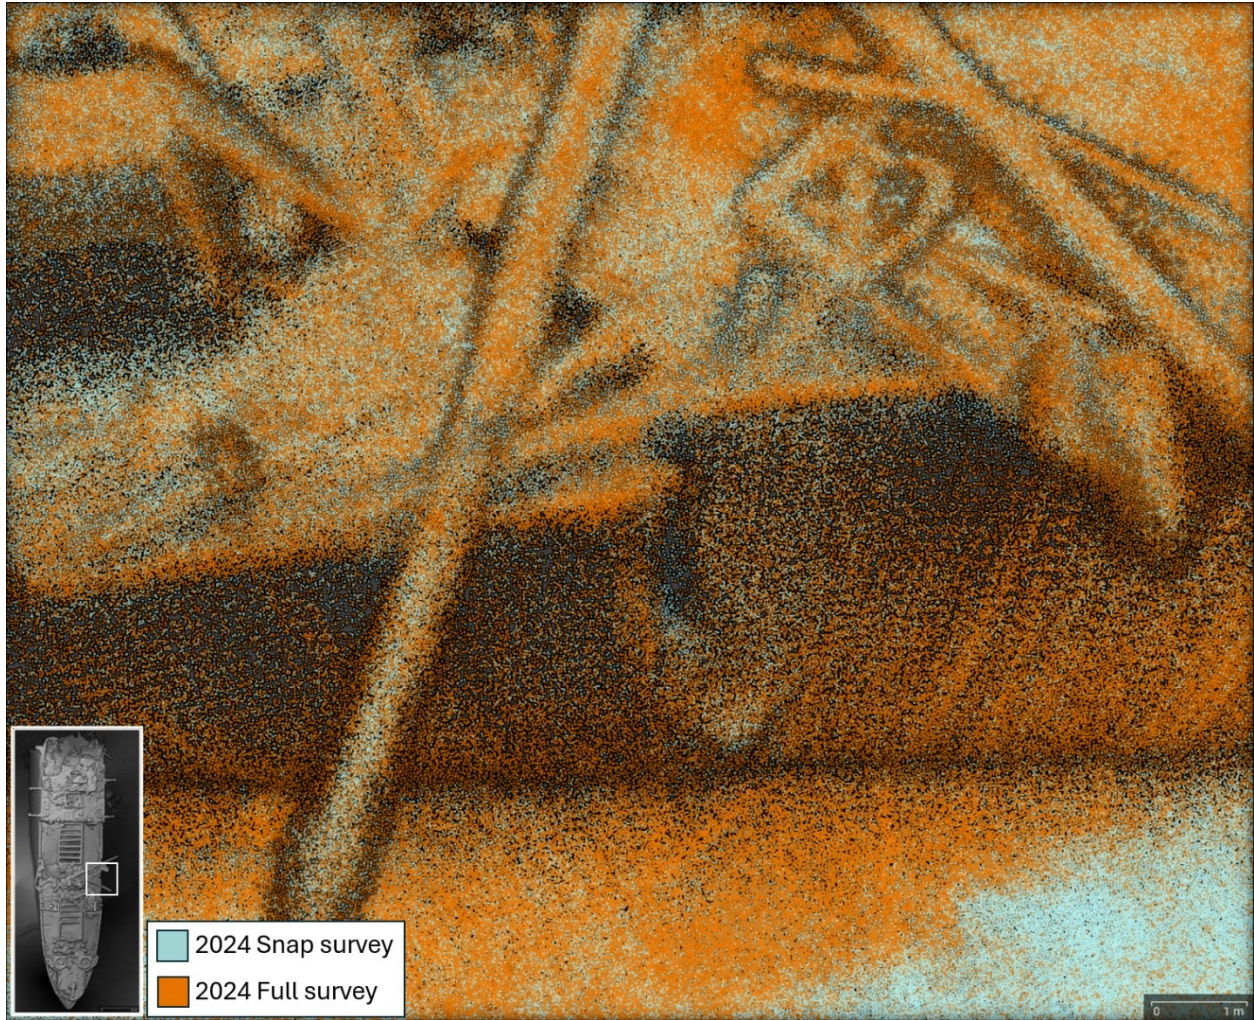
Figure 19. Point cloud view of key area 4 – the split in the hull. No difference can be seen between the 2024 snapshot and full survey.

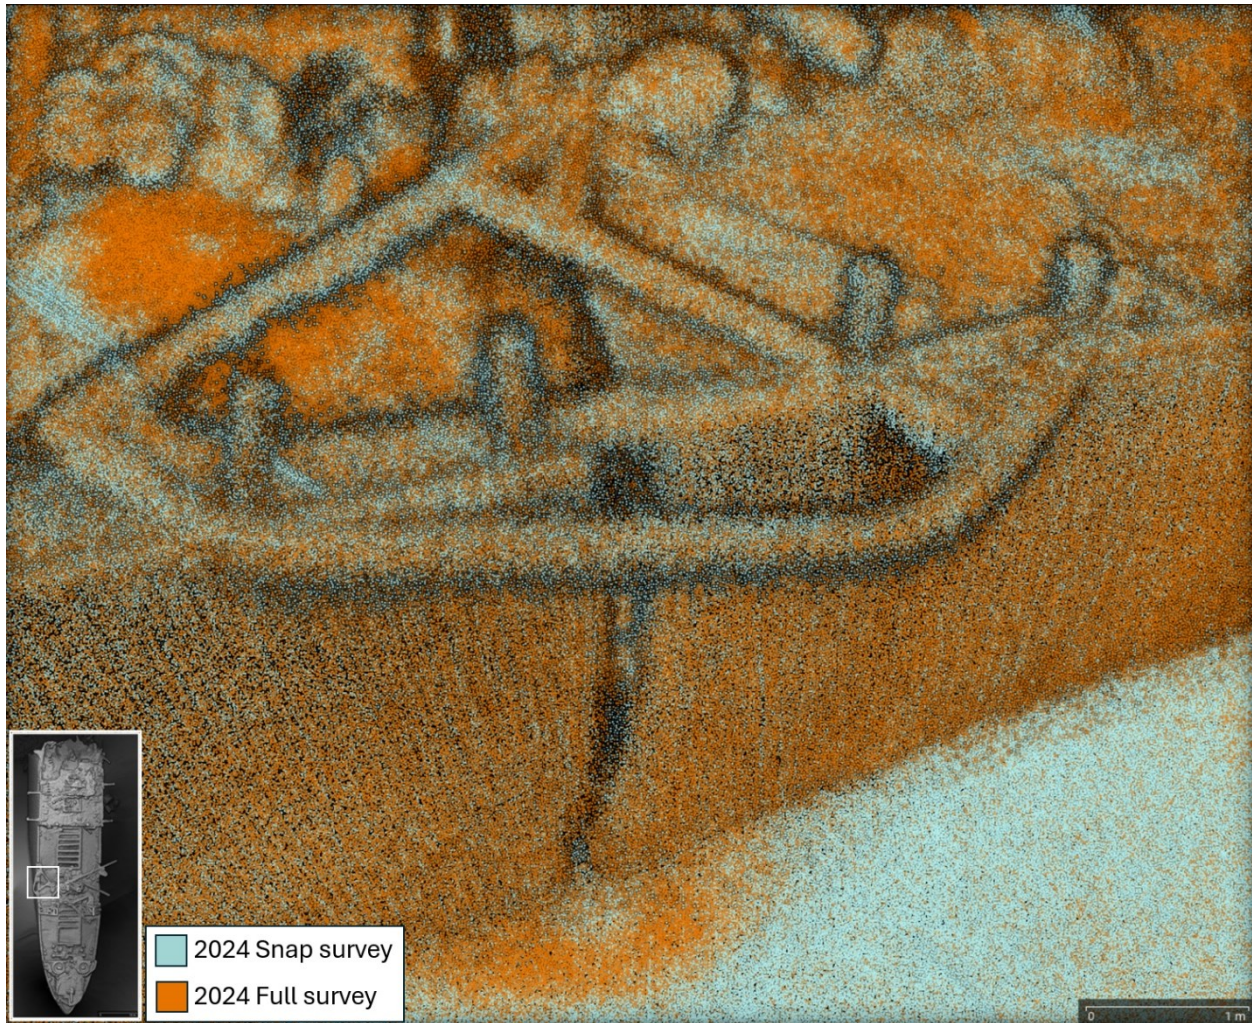
Figure 20. Point cloud view of key area 5 – the split in the hull and split in the deck. No difference can be seen between the 2024 snapshot and full survey.

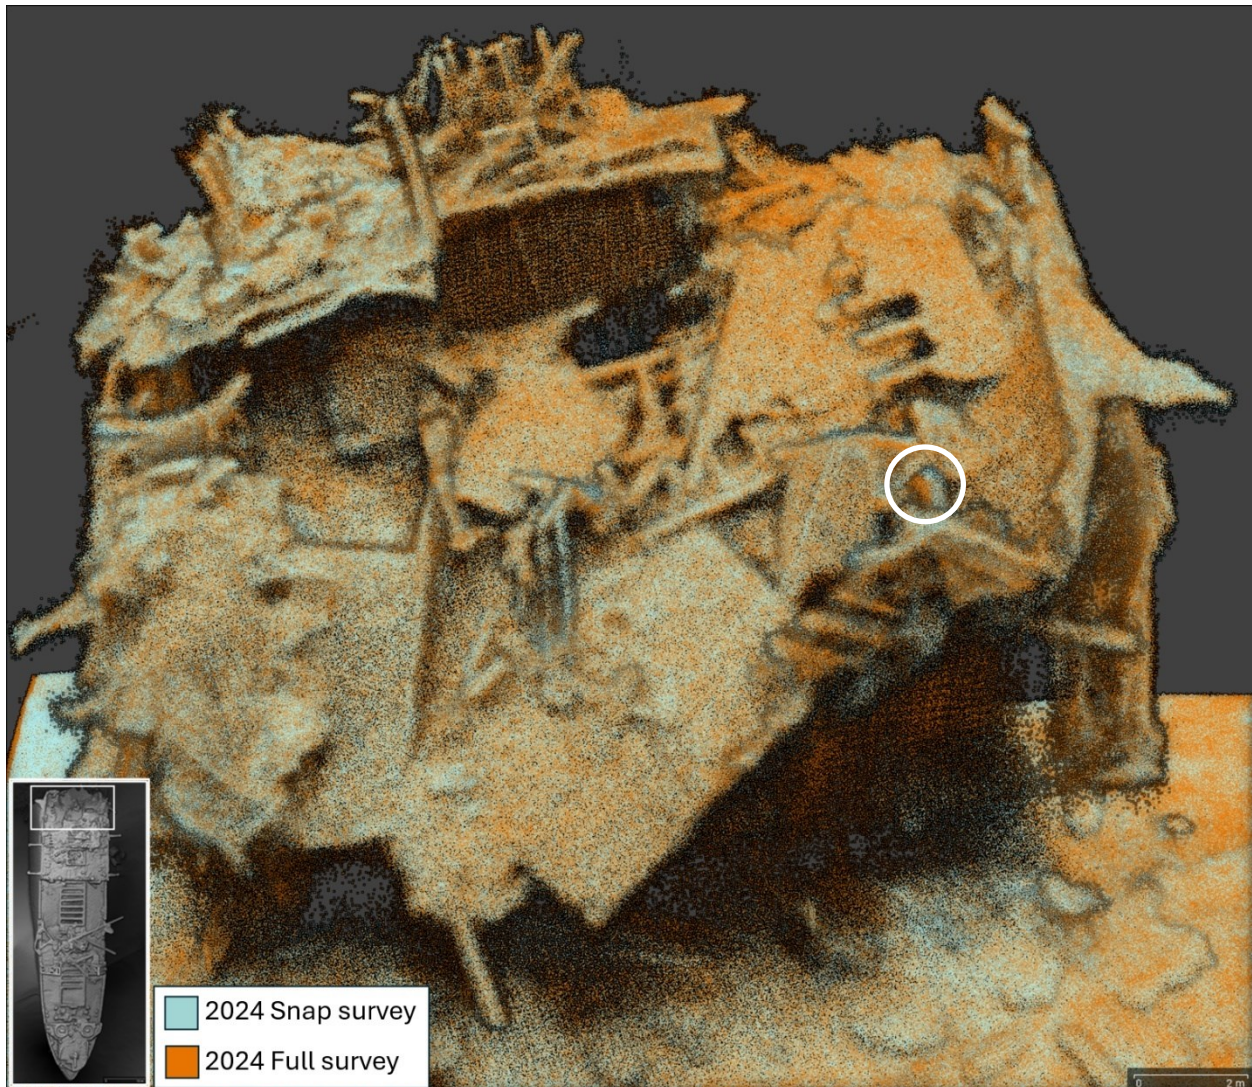
The boiler room casing, collapsing bridge deck and the collapsing boat deck usually shows rather big changes. Between the 2024 snapshot survey and full survey however, there is only one notable change (Figure 21). An object has tilted by approximately 15 cm.

Figure 21. Point cloud view of key area 6. The only difference between the 2024 snapshot and full survey is shown by the white circle where an object has tilted by 15 cm.

- 6.1.3** Almost no changes were found in the six key areas of the wreck when comparing the results from the 2024 full and snapshot survey. The only noticeable difference is in key area 6, the collapsing deck in the forward end of the aft section where an object has had a slight increase in tilt.

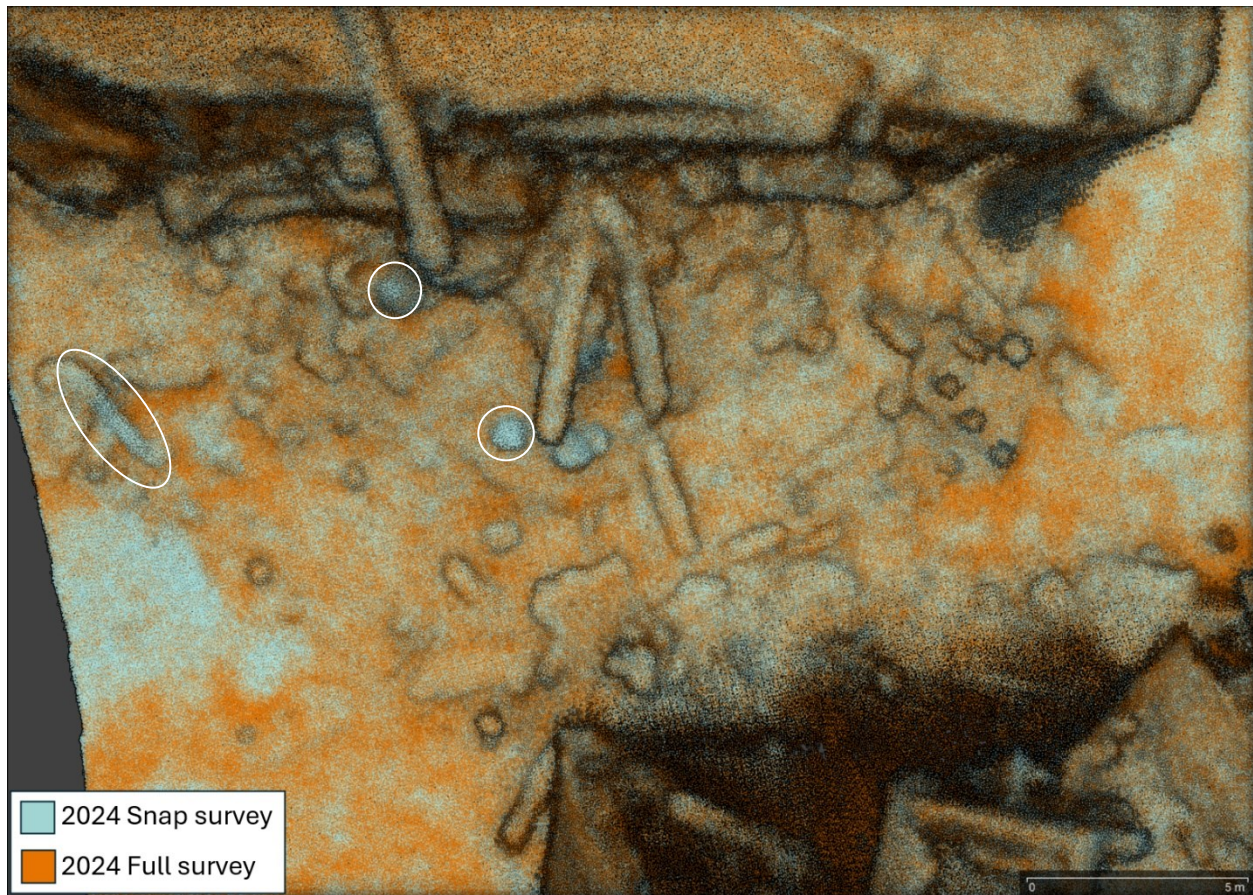
- 4.4.1** Between the 2024 snapshot and full survey three objects have seemingly disappeared from the area between the two sections of the SSRM (Figure 22). Two objects are round with a diameter of 40 and 65 centimetres and one object is reminiscent of a pole with a length of 2 meters and a diameter of 30 centimetres.

Figure 22. Point cloud image of the area between the two bow and stern sections of SSRM. Between the 2024 snapshot and full survey three objects (marked by white circles) have disappeared.

- 6.1.4** Three objects have disappeared in the area between the hull sections sometime between the 2024 snapshot and full survey.
- 6.1.5** There has been a drastic change of the sediment levels in hold 2 between the 2024 snapshot and full survey. The height of the sediment has been decreased by up to 2.3 meters and this sediment appears to have flowed into the interior of the wreck through two funnels.

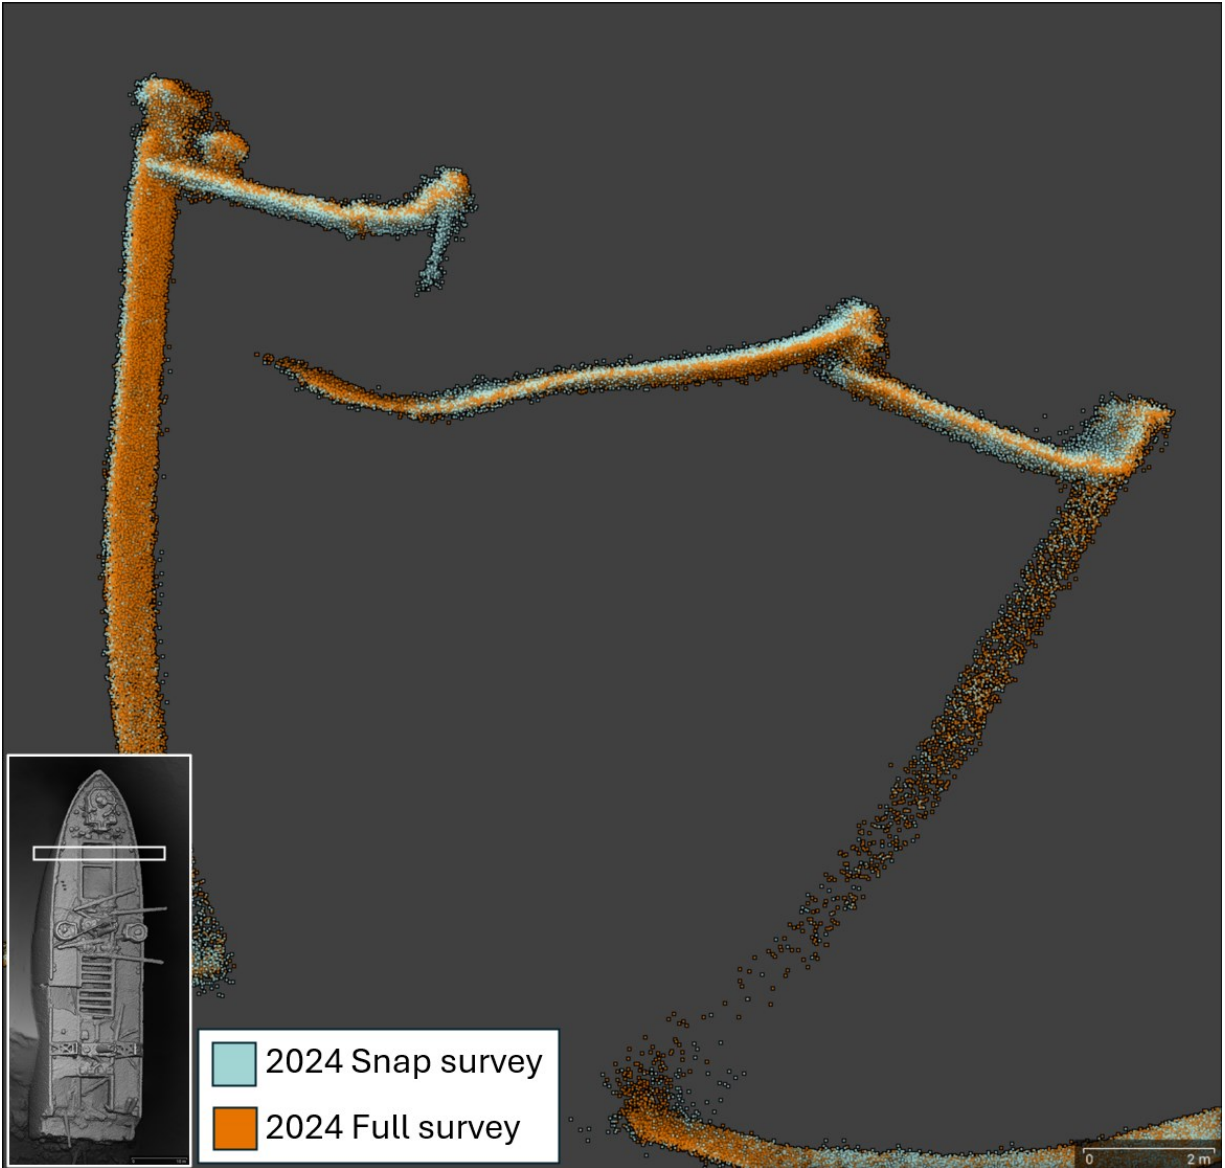
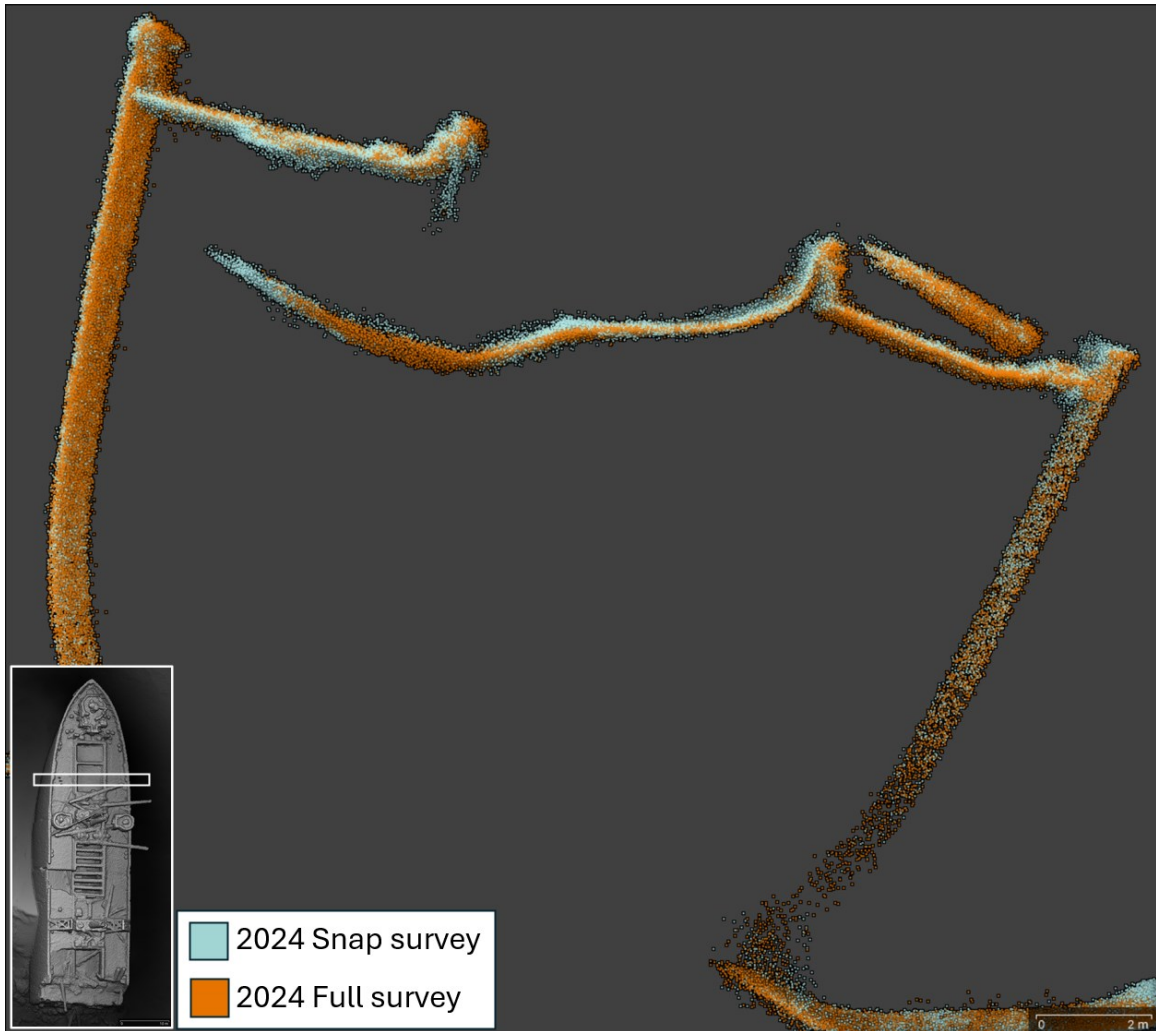
The hatch cover is missing as are all but one of the hatch cover supports. Sediment has settled in the 'tween deck space to a considerable depth, filling the starboard side to the top of the starboard side hatch coaming. The port side remains clear above the horizontal from the starboard hatch coaming. Apart from some undulations in the sediment surface there is no difference between the level identified by the 2024 snapshot and full survey (Figure 23 and Figure 24).

There is no indication that the second deck nor the second deck hatch covers have collapsed. However, it is possible, but is very unlikely, that the sediment has filled both the 'tween deck area and the lower hold.
