Maritime &
Coastguard
Agency

SS Richard Montgomery: Survey report 2024

December 2nd 2024

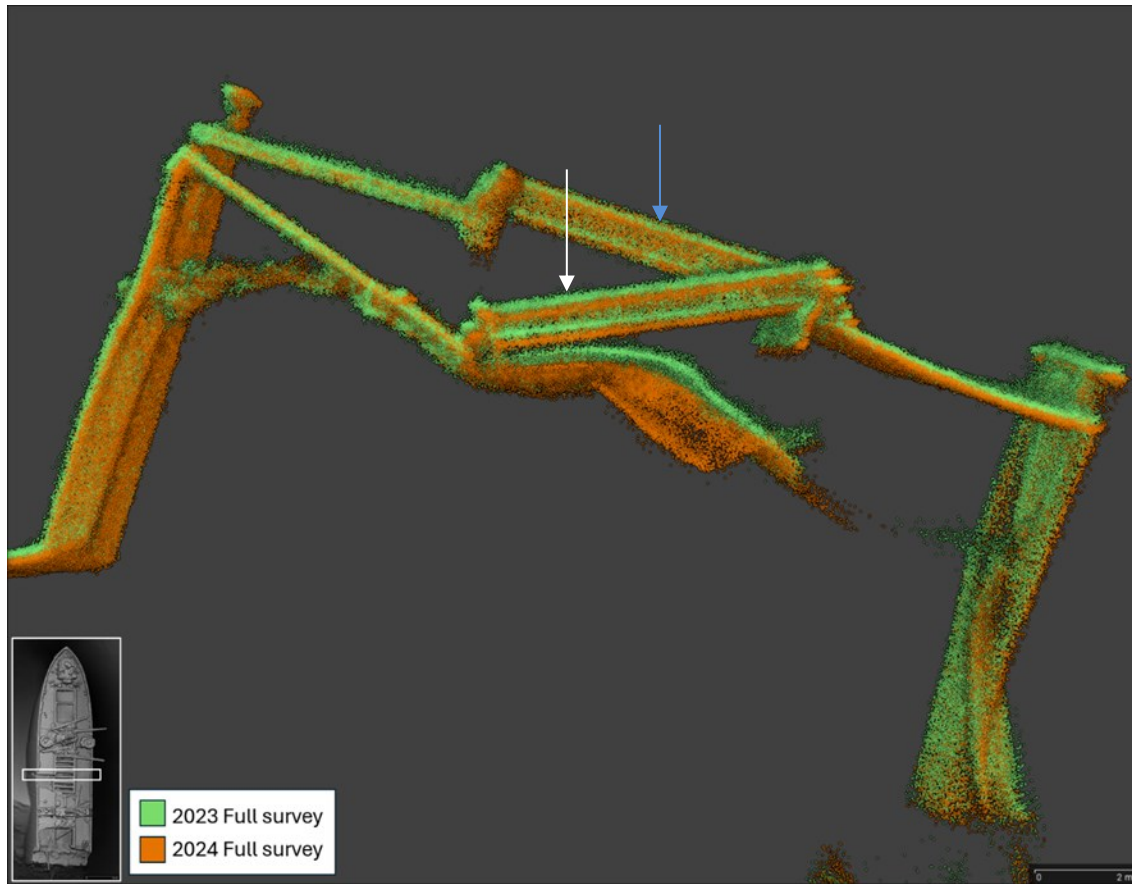
Between the two most recent full surveys (2023 and 2024), it appears that the hatch supports connected to the collapsed part of the hold 2 deck have dropped by approximately 13-17 cm (Figure 25). The hatch supports attached to the forward, non-collapsed section of the hold 2 deck has not dropped.

Figure 25. Point cloud cross section of the wreck showing the collapsed cargo hold 2 deck and hatch supports (white arrow), which have dropped by 13-17 cm between the 2023 and 2024 full survey. The hatch supports attached to the non-collapsed part of the hold 2 deck has not dropped (blue arrow). The cross section is 3 meters thick.

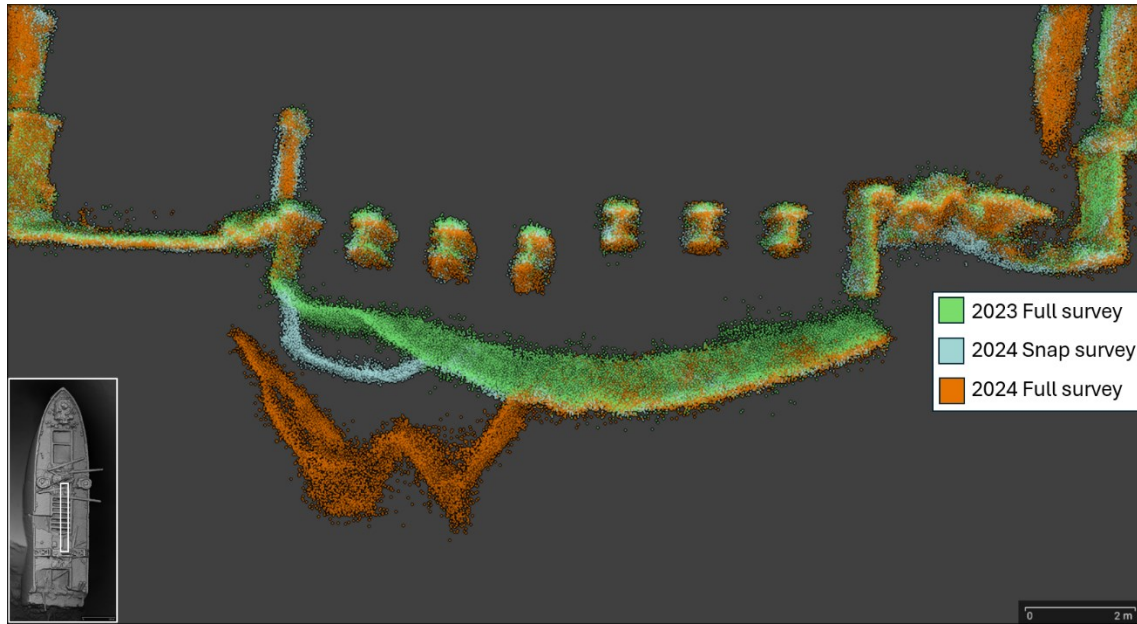
The sediment in hold 2 has decreased, this is visible in Figure 16 and Figure 25 but is much more prominent when shown as an along-wreck cross section (Figure 26). The sediment appears to have flowed into the wreck through two funnels and the vast majority of this decrease happened between the 2024 snapshot and full survey, although the reduction of sediment may have started as early as 2022. During the four and a half months that passed between the 2024 May (snapshot) and September (full) survey the sediment was reduced by 2.3 meters at one location in hold 2.

Figure 26. Point cloud along-wreck cross section of hold 2. There has been a 2.3m (height) reduction of sediment between the May (snapshot) and September (full) 2024 surveys. The cross section is 1 meter thick.

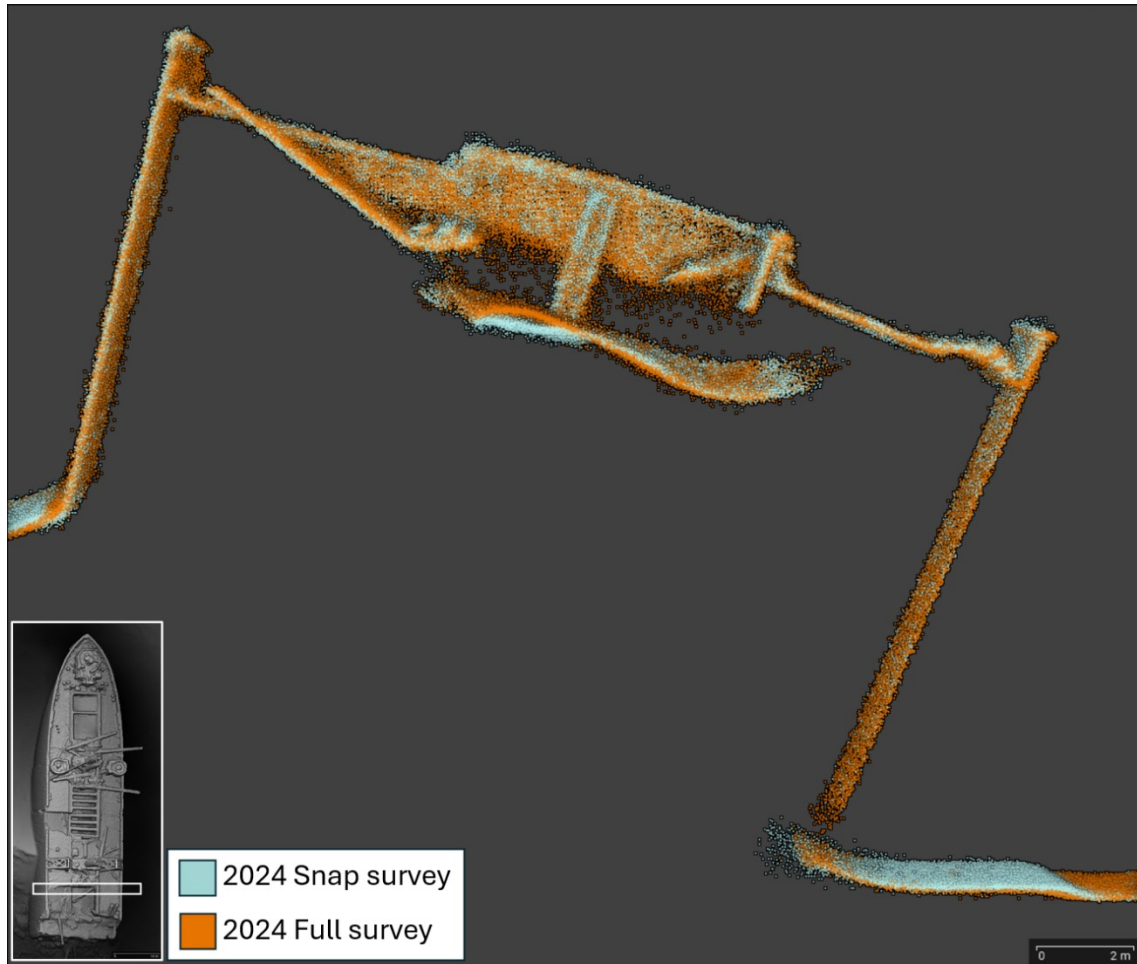
Sediment accumulation is largely limited to the forward part that still retains the protection of the upper deck (Figure 27). Similar to hold 1 and 2, there is no clear indication that the hatch leading to the second deck has collapsed.

Figure 27. Cross section through the hull at the forward edge of hold 3.

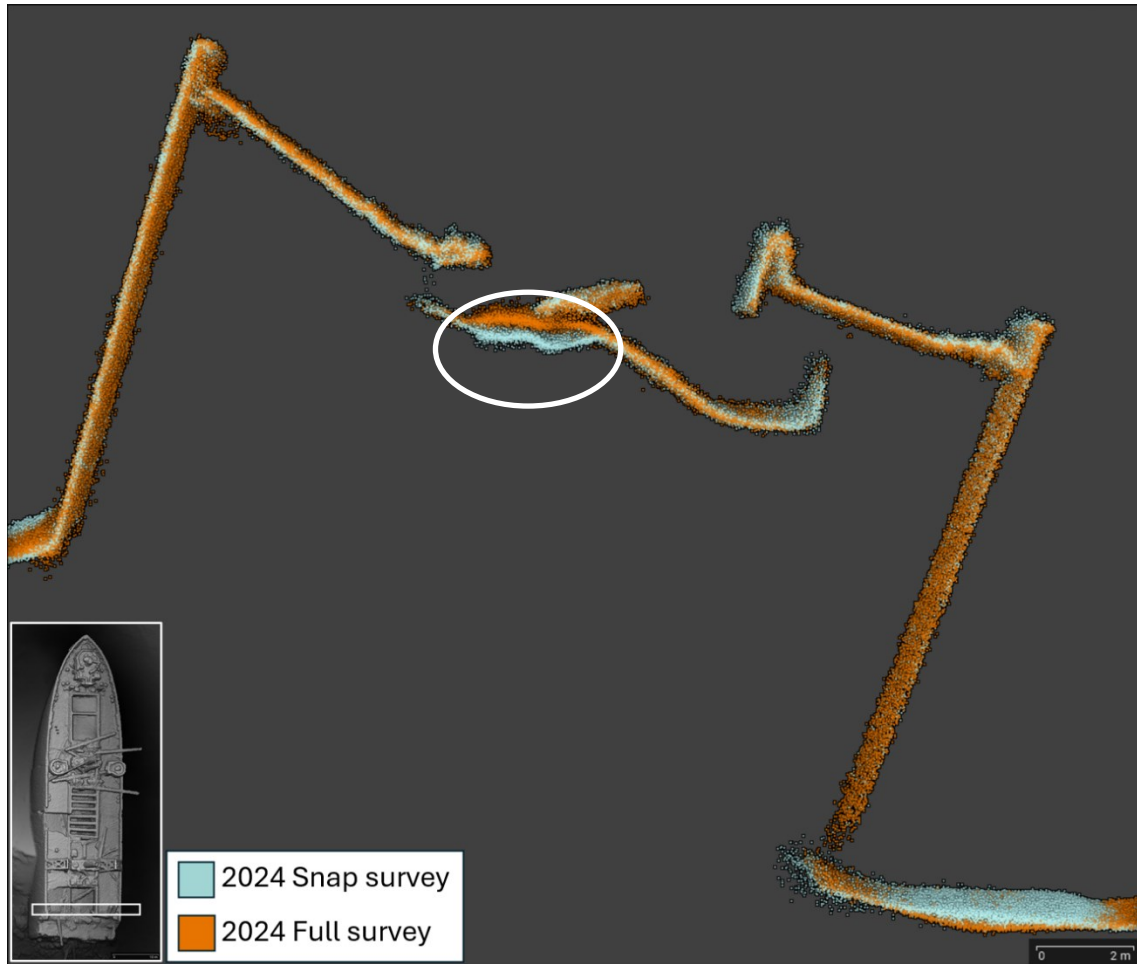
The amount of sedimentation in hold 3 is fluctuating. Between the 2023 full survey and 2024 snapshot survey the sediment level had decreased by approximately 45 cm. When comparing the 2024 snapshot and full survey the opposite can be seen, the sediment level increased by 40 cm (Figure 28).

Figure 28. Cross section through the hull at the middle of hold 3. Difference in sediment level circled.

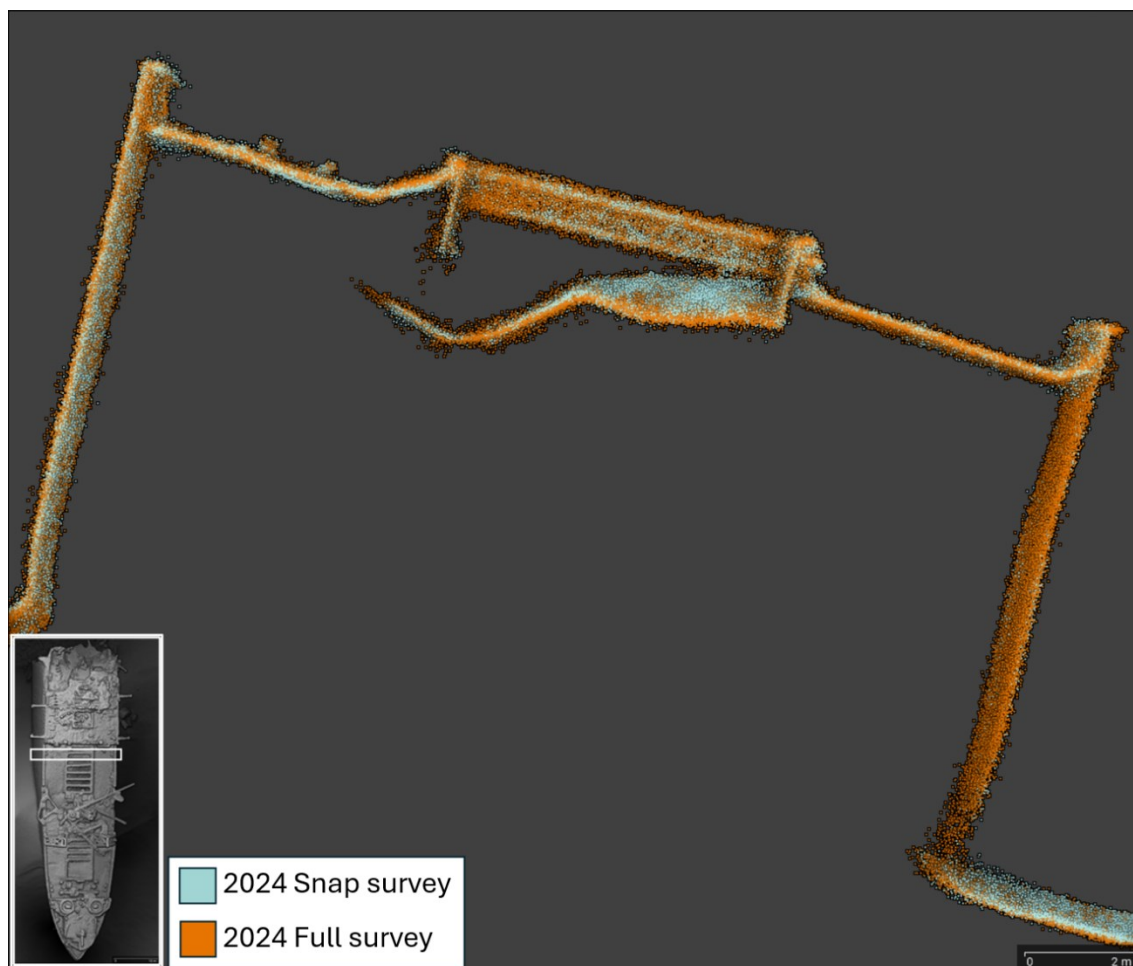
The sediment level in the forward part of hold 4 is largely unchanged between the 2024 snapshot and full surveys (Figure 29).

Figure 29. Cross section through the hull at the forward end of hold 4.

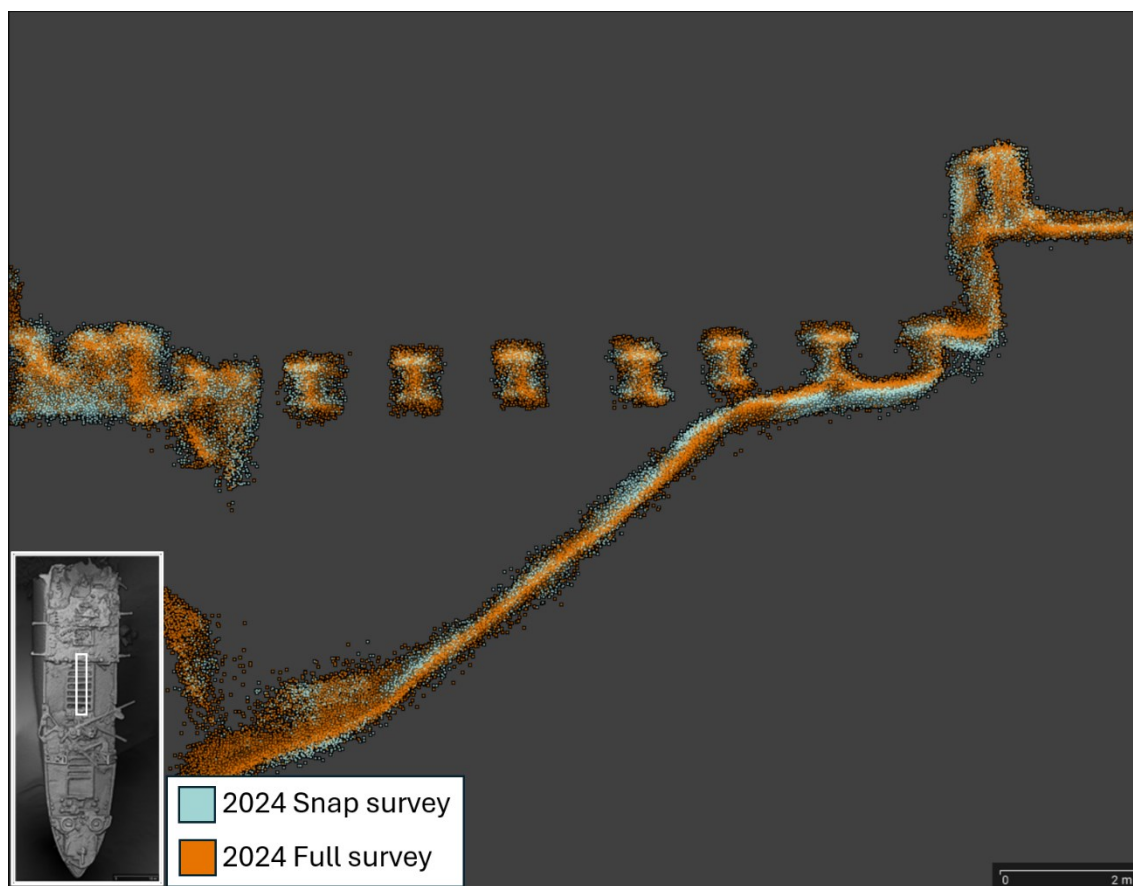
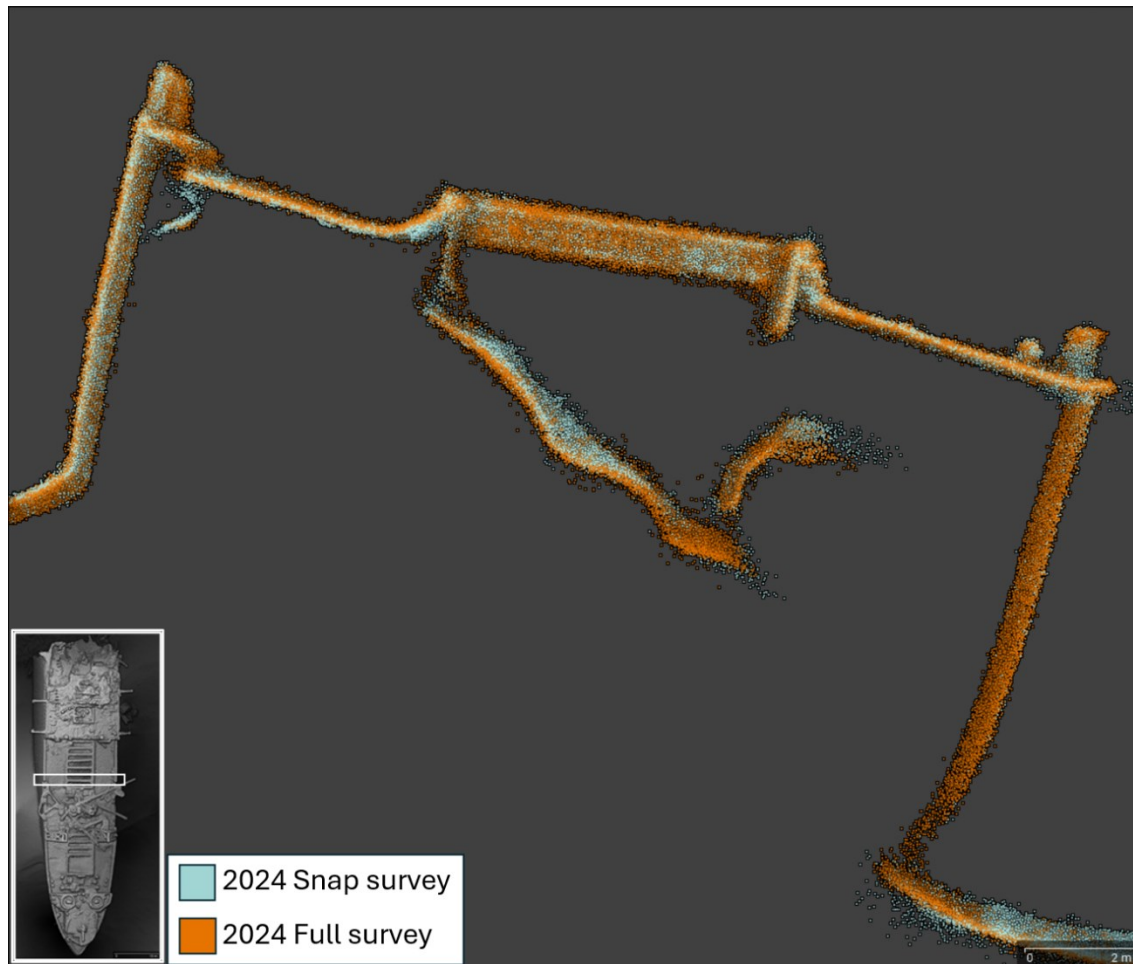
The rear of the hold 4 area shows the sediment layer descending below the level of the second deck due to some form of collapse, probably a partial collapse of the lower hatch cover which occurred between 2010 (where the survey showed the sediment above the second deck) and the 2017 survey where the sediment was just below the second deck (Figure 30). The sediment level at the full survey 2024 does not differ by a noteworthy amount from that of the 2024 snapshot survey (Figure 31).

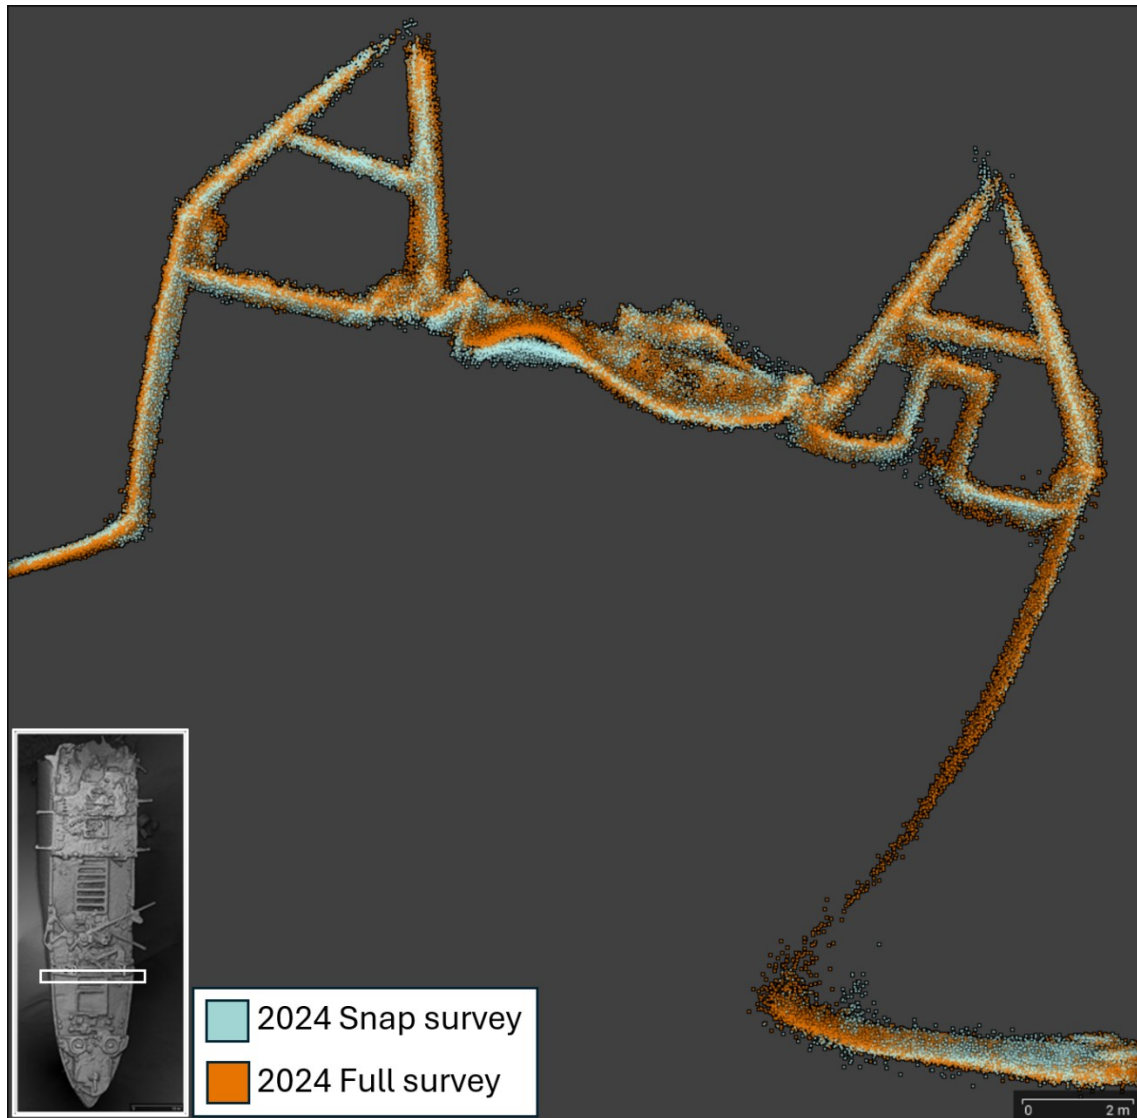
Hold 5 is the rear most hold. The forward four of the six hatch cover supports remain in place. Sediment levels in the forward section, port side of the hold have increased by 60 cm between the 2024 snapshot and full survey (Figure 32). There is no indication that the second deck or the lower hatch cover have collapsed. In the middle of the hold, by the fourth hatch cover support the sediment levels have increased by 90 cm (Figure 33). In the rear end of hold 5 there is little to no difference in sedimentation levels.

Figure 32. Cross section through the hull at the forward end of hold 5 where the sediment level has increased by 60 cm on the port side.

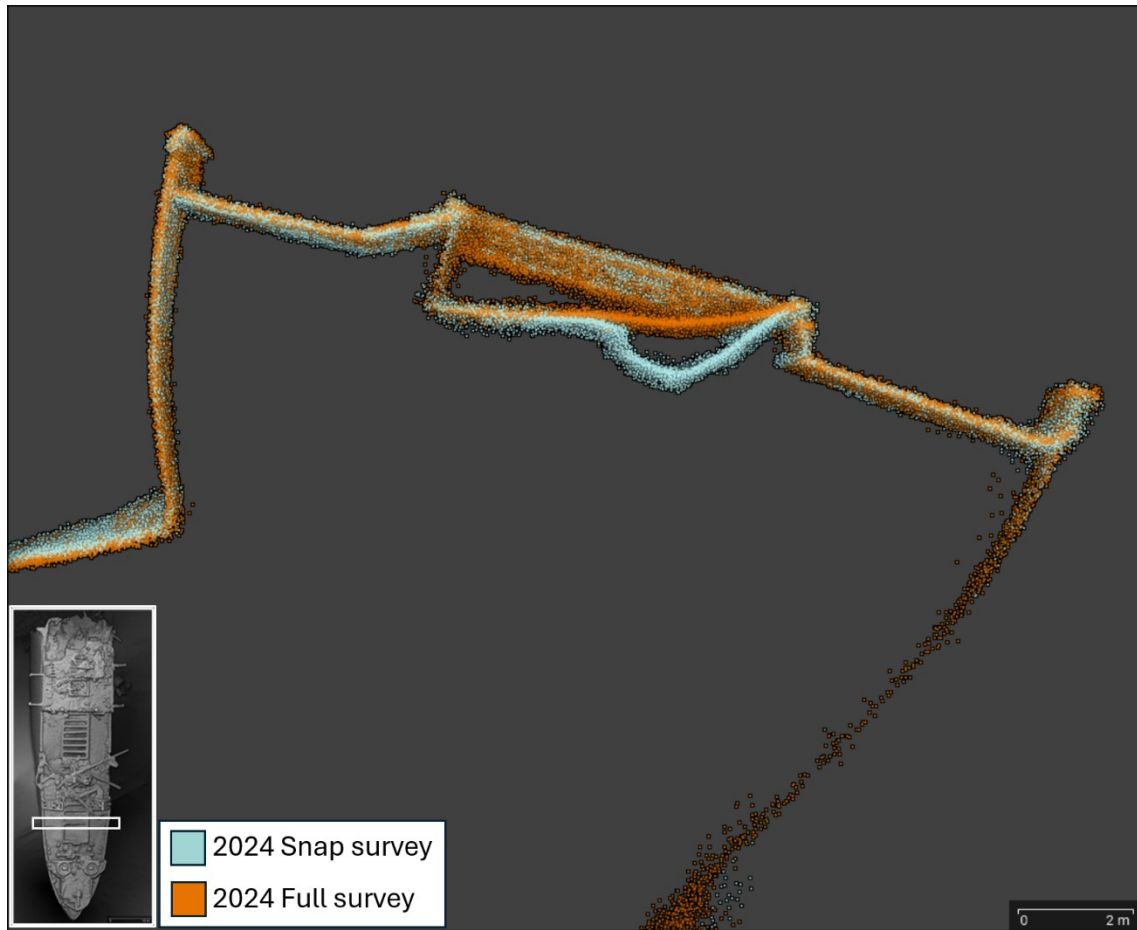
Figure 33. Cross section through the hull at the middle of hold 5 where the sediment level has increased by 90 cm on the starboard side.

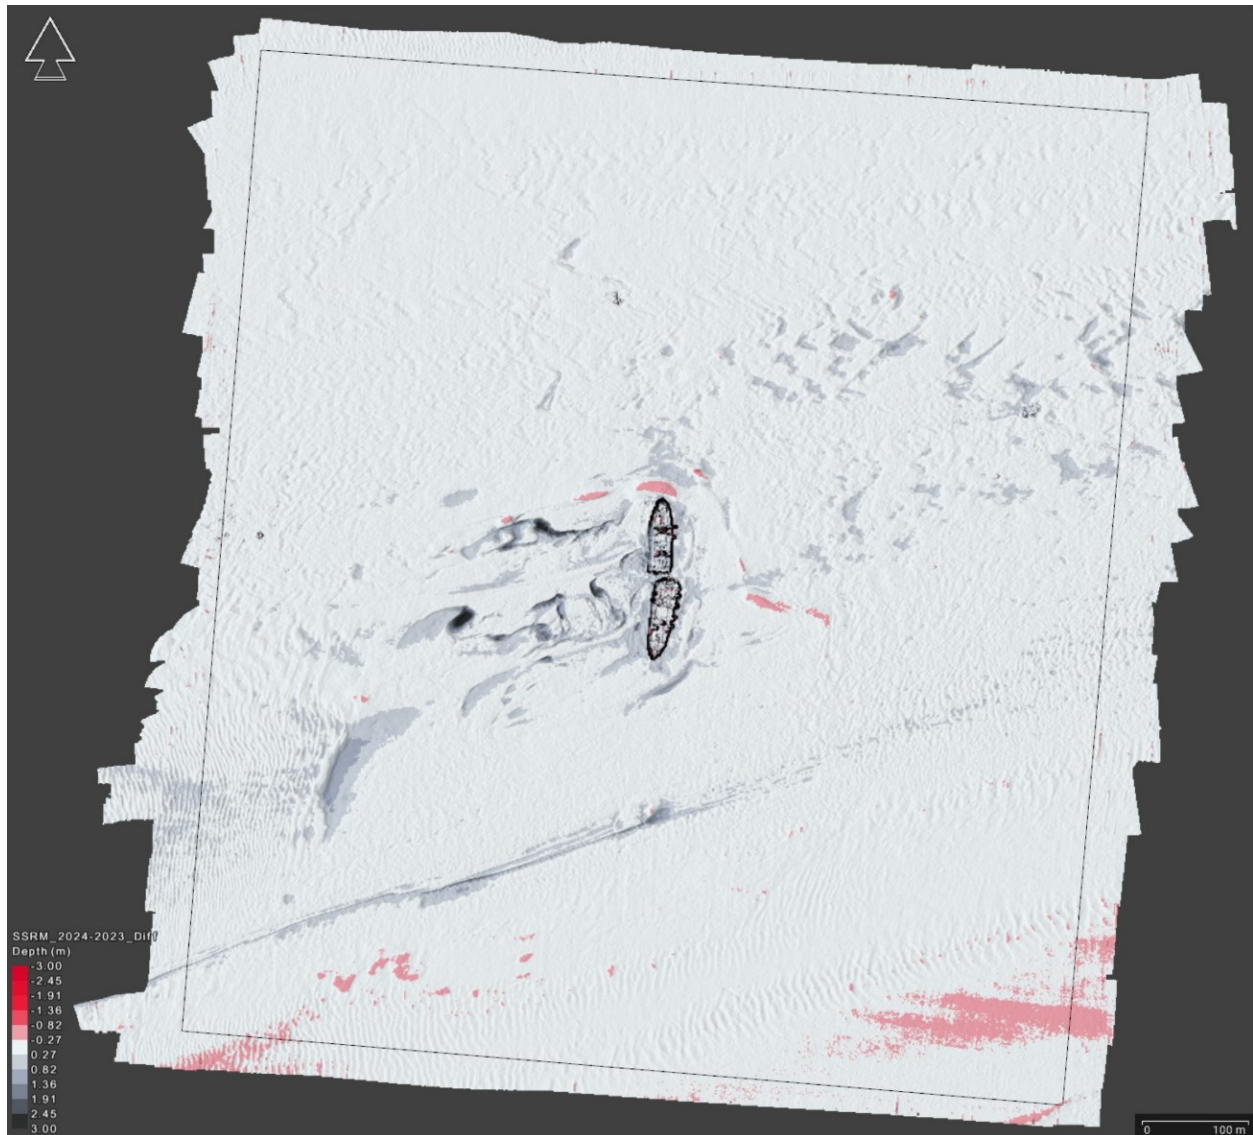
Figure 35. Difference model showing sediment changes that occurred between the 2023 and 2024 full surveys. Areas in red have had the depth reduced and dark grey areas have had an increase in depth.

In the immediate area surrounding SSRM there is a general increase in the depth. Most changes are small and within a range of 0-0.6 meters. One area to the west of the forward section shows larger increases in depth, the most prominent change can be found by the hull close to the main mast where there has been an increase in depth by 1.6 meters between the 2023 and 2024 full surveys (Figure 36). Just north of the wreck one of the few areas where a decrease in depth has occurred can be seen, the decrease is less than 0.82 meters.

Changes to the wider seafloor around SSRM has occurred mainly directly west of the wreck where some of the deeper parts of the scour has deepened further by 2-3.5 meters some 45-175 meters from the wreck (Figure 35).

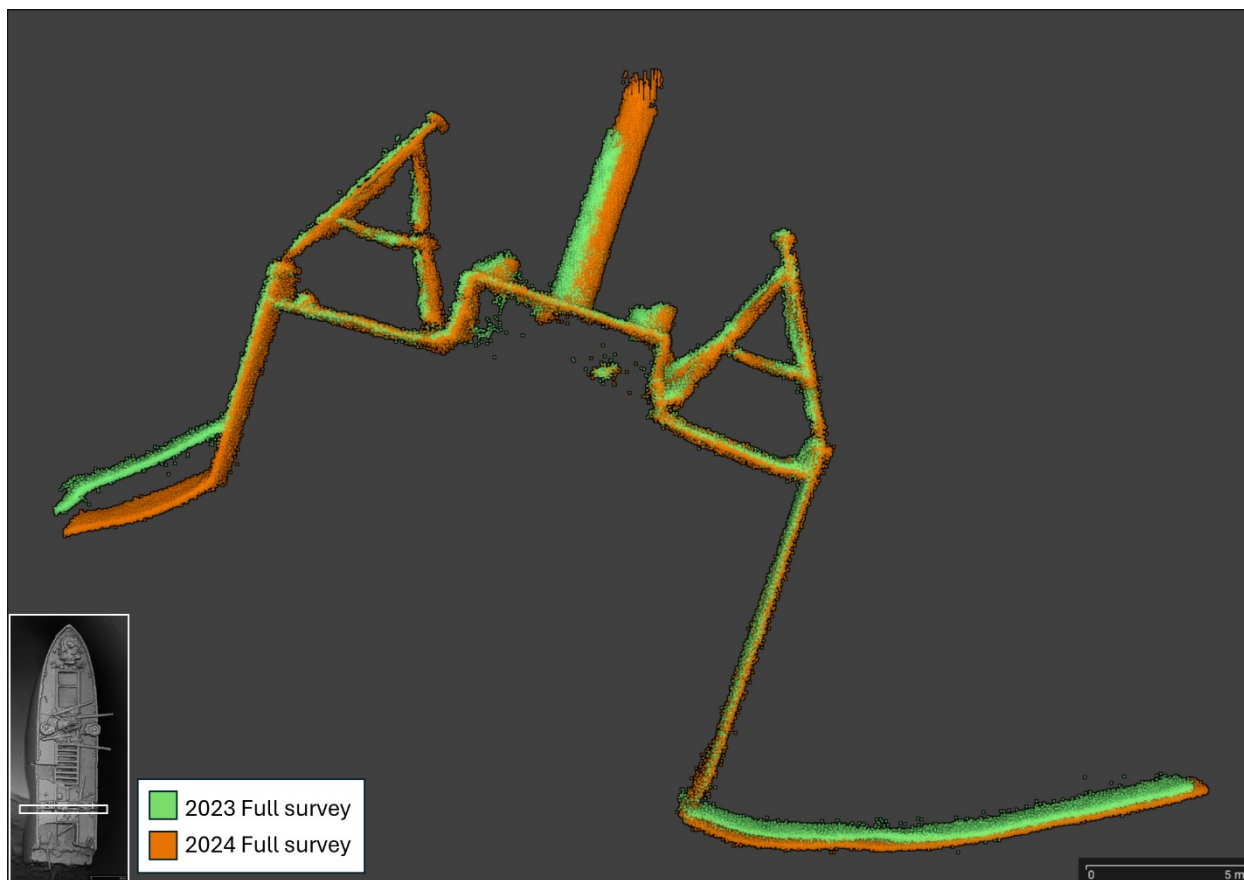
Figure 36. Cross section by the main mast of SSRM, forward section of the wreck. On the west (port) side of the wreck an increase in depth of 1.6 meters can be seen. This change in sediment levels occurred between the 2023 and 2024 full surveys.

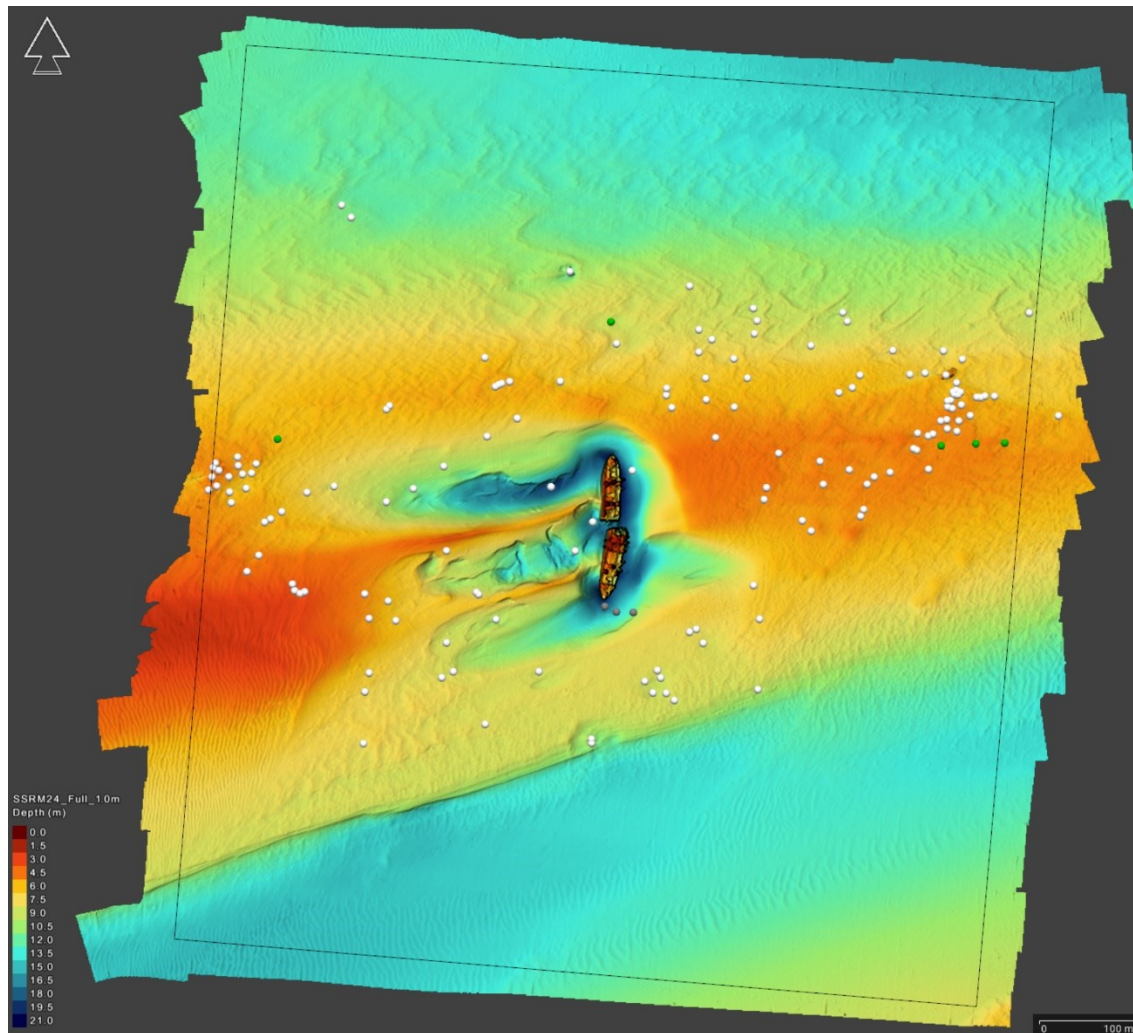
Five new targets were added to Appendix B – Gazetteer of Observations which contains the seabed contacts list (Figure 37). Of the 159 targets in the list 123 targets were found to be present. Six objects were deemed to be ‘plausible’, and one object was found at a slightly different location. 29 objects weren’t visible, probably due to the objects being covered by sediment. The seabed contacts, especially the smaller or lower lying ones, are subject to a pattern of being buried and uncovered by moving sediments. Consequently, their presence or not in any year’s data set is largely a function of the movement of sediment around and over them. Images of all seabed contacts can be found in Appendix C – Seabed Contacts Report Images 2024.

Figure 37. The SSRM survey area with seabed contacts, 2023 contacts in white, 2024 snapshot survey new contacts (3) in grey and 2024 full survey new contacts (5) in green.
