Yorkshire Water Services Ltd
Neiley Sludge Treatment Facility
Surrender of Permit (No. KP3536LL)
Surrender Site Condition Report

09/01/2025

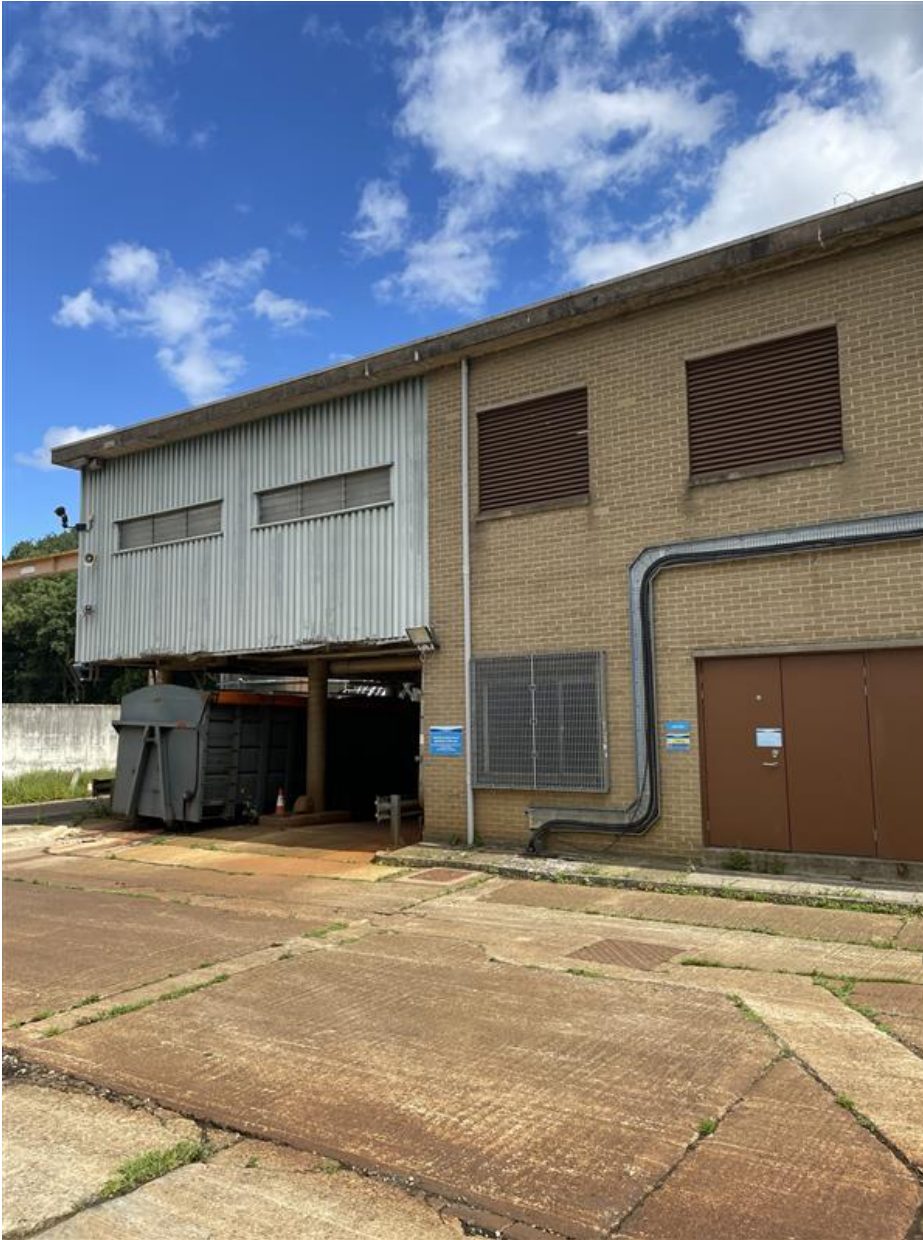
Photo 1. Sludge Thickening Building

The Sludge Thickening Building is well maintained. During the site visit, it was tidy and orderly (see Appendix A, Photo 1). The Sludge Thickening Building is approximately 39 years old. The building is split over two floors with the Thickened Sludge Storage under the building (Appendix A, Photo 6) and polymer dosing above the storage (Appendix A, Photo 2). There are some materials on the floor but it is reasonably tidy with no appearance of stain.

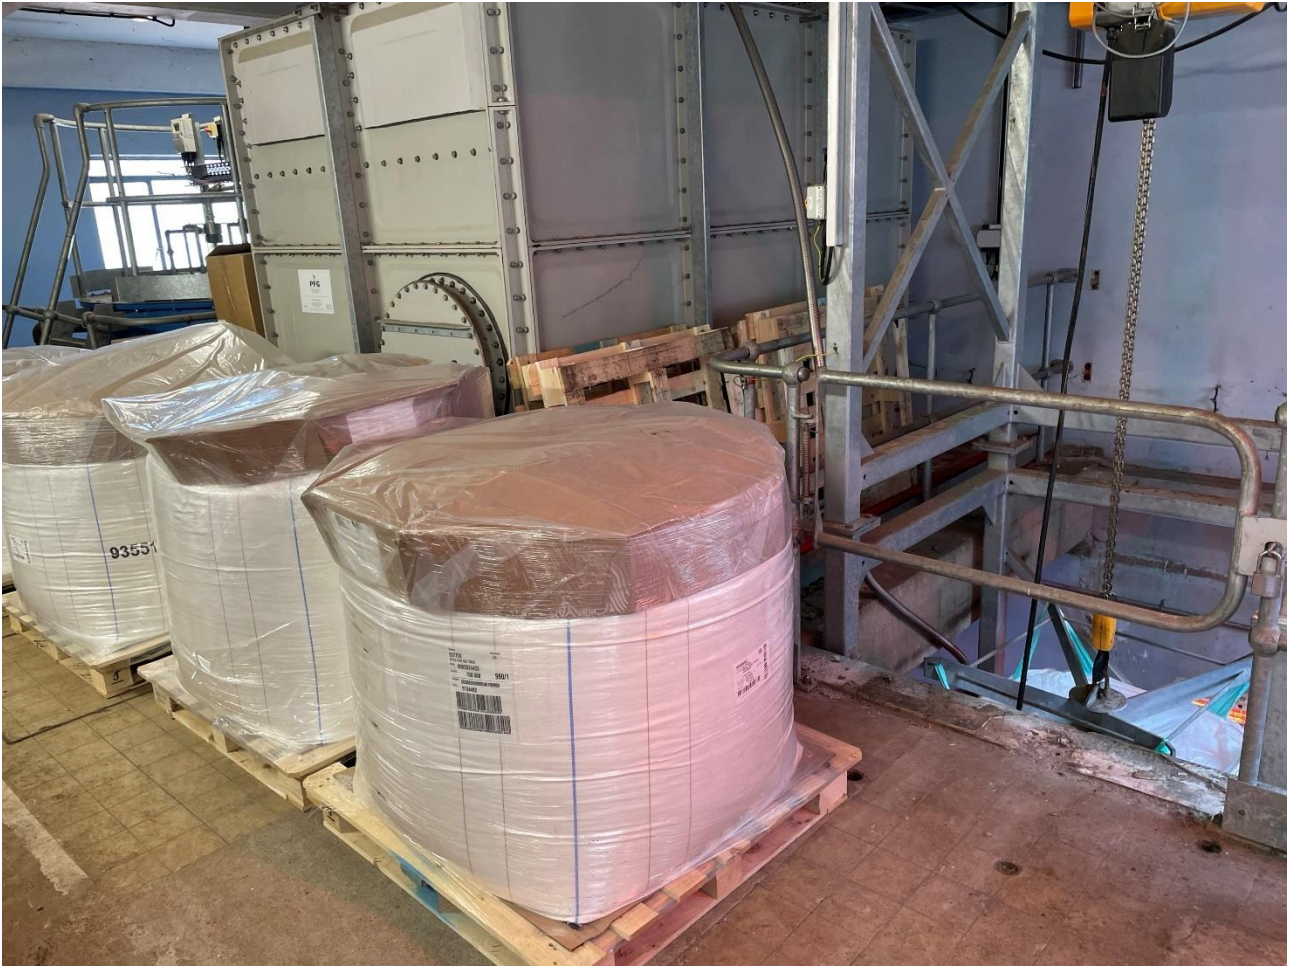
Photo 3. Polymer Storage Area

The Polymer Storage Area sits within the Sludge Thickening Building (Appendix A, Photo 3). It is in a satisfactory condition.

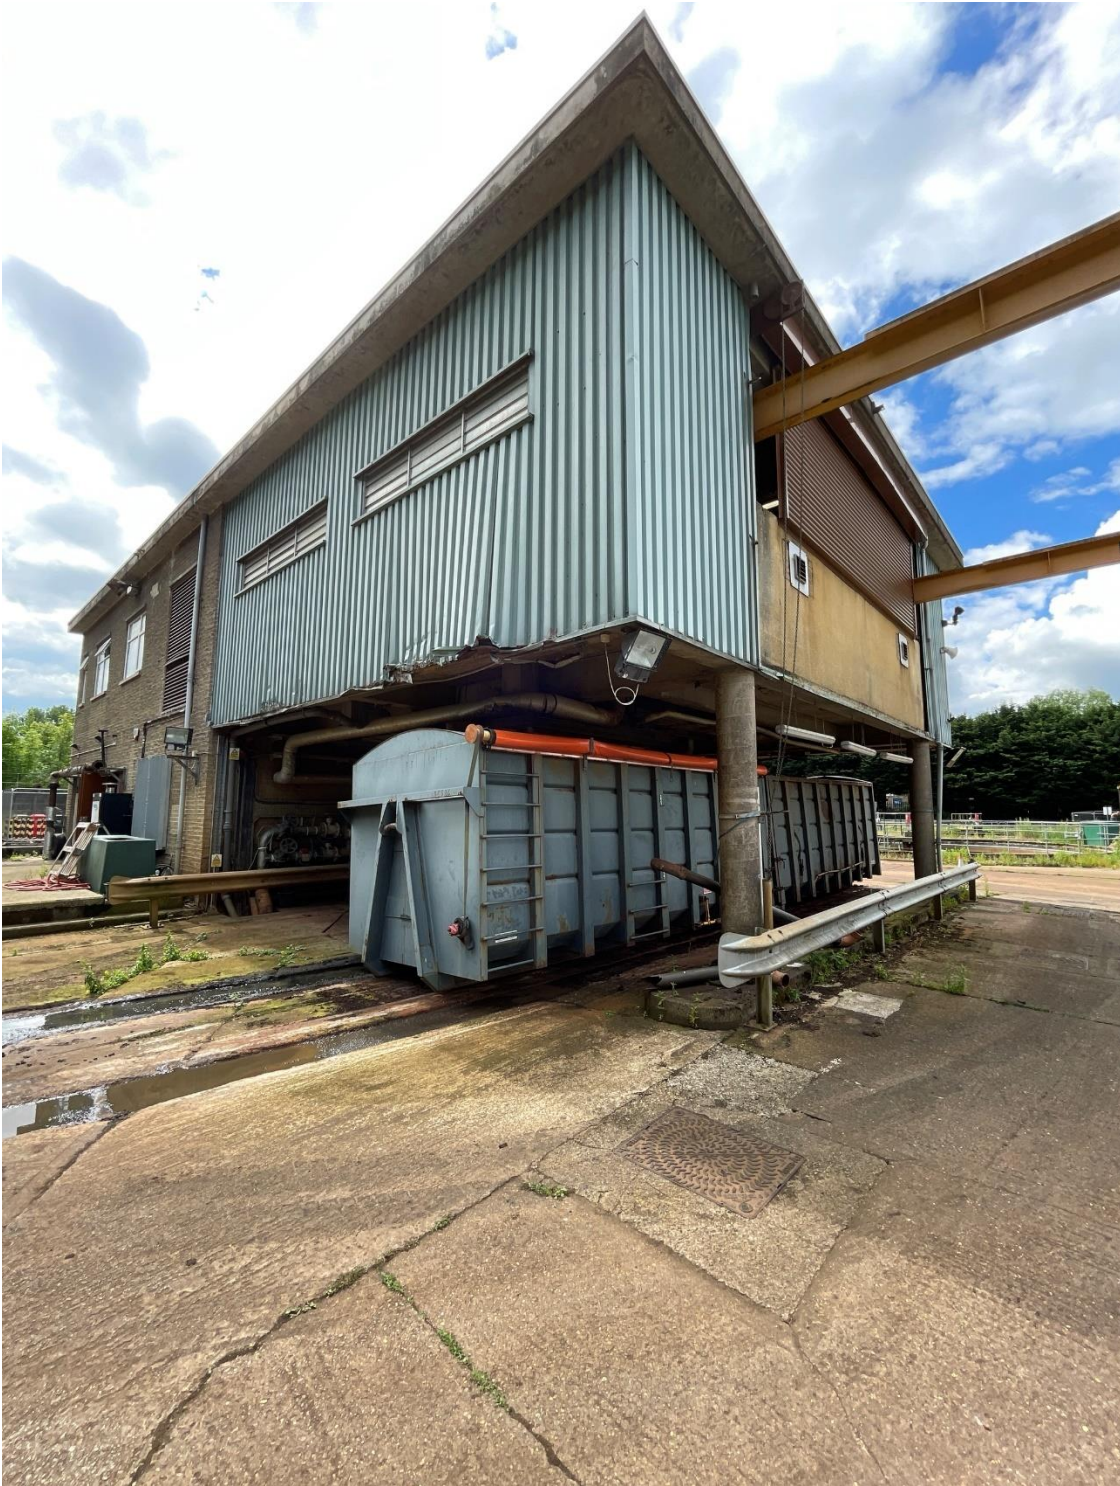
Photo 6. Thickened Sludge Storage

The thickened sludge storage tank appears to be in satisfactory condition (Appendix A, Photo 6).

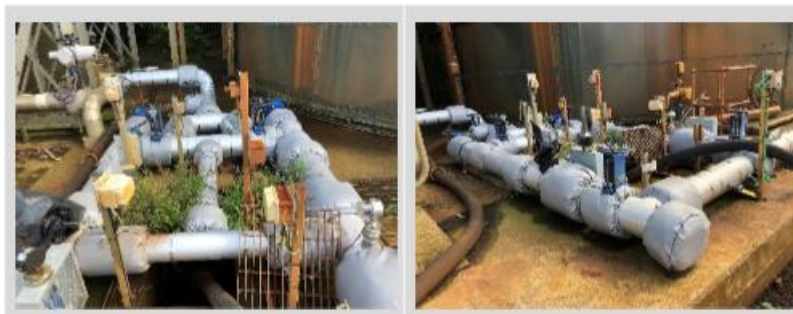
Item No. 1 and 2 on drawing no. SK-N001. The pipework from the unthickened sludge tanks to the sludge dewatering feed pumps has not been tested as it is located before the start of the IPPC boundary.

Photos of newly refurbished pipework configuration at unthickened sludge tanks

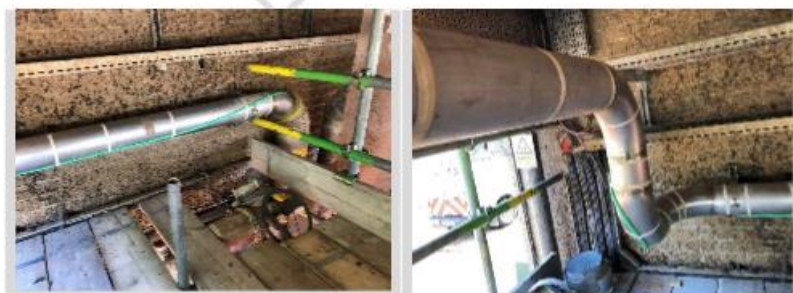
Item No 4 on drawing no. SK-N001. This item is a continuation of item 3 from the point the pipe emerges above ground. The pipework is above ground and a visual inspection was carried out in accordance with the generic testing methodology whilst the equipment was operational. The pipe appears in good condition and no evidence of leakage was observed therefore the pipe passed inspection.

Photos of above ground unthickened sludge pipework to centrifuges with lagging removed

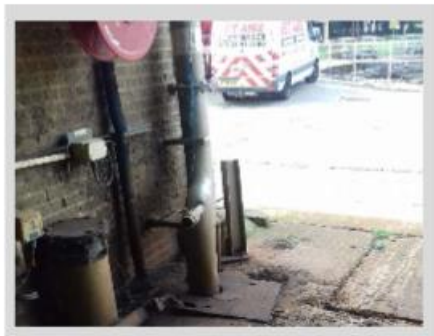
Item no. 11 on drawing no. SK-N001. The pipework drains the liquors from the centrifuge to the external drainage system. The pipe is above ground and has therefore been tested by means of a visual inspection in accordance with the generic testing methodology during operation of the dewatering equipment. There was no evidence of leakage therefore the pipe passed the inspection.

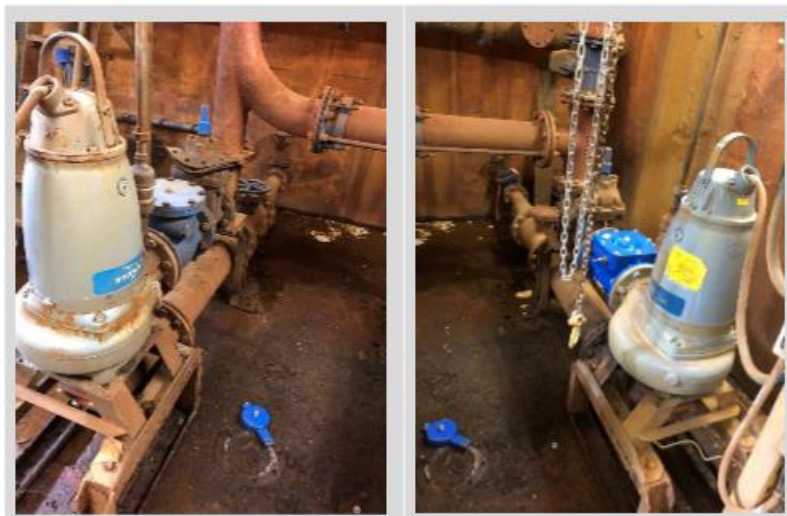
Item no. 15 on drawing no. SK-N001. The short section of pipe from the return liquors wet well to the return liquor pumps was visually inspected whilst the system was operational.

There was no evidence of any leakage therefore the pipe passed the test.

Photos of pipework from liquor return wet-well to liquor return pumps

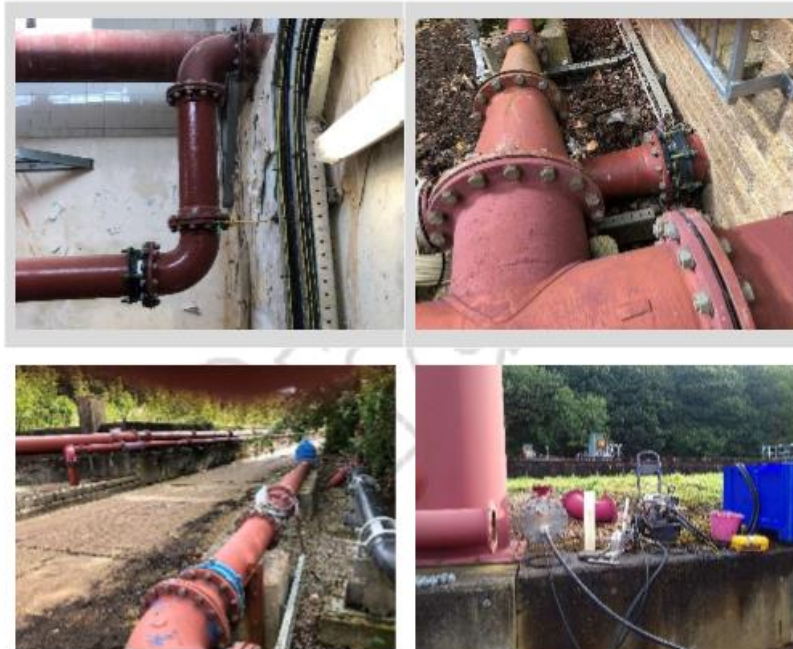
There was no evidence of any leakage on any of the above ground sections, therefore those sections of the pipe passed the test.

Section 1 comprises the length close to the pumping station where the pipe crosses the site access road. The pipe was pressurised to 3 bar, but it proved impossible to maintain the pressure for any length of time, indicating that the integrity of the pipe is compromised by one or more leaks. The pipe is deemed to have failed the testing procedure. The pipe should be further investigated to confirm the location of the leak(s). Suitable repairs should then be undertaken before the pressure test is repeated to confirm the restored integrity of the pipe.

Section 2 comprises the length from the end of the rectangular filters to the primary tank distribution chamber. This section of the pipe passed the pressure test.

Photos of above ground sections of liquor return pipe including pressure test equipment for below ground sections (bottom right)

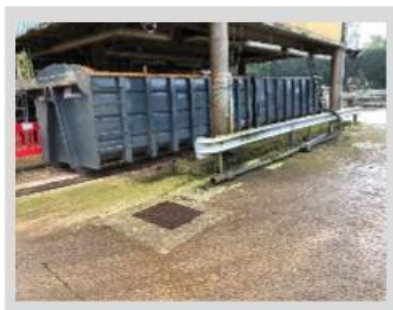
Item no. 17 on drawing no. SK-N001. The sludge cake skips receive the dewatered sludge and are changed on a regular basis. The skips on site at the time of inspection were fit for purpose.

Photos of sludge cake skips on site at the time of inspections

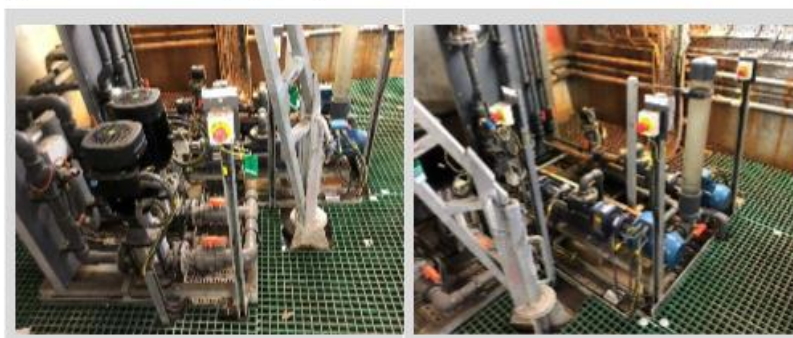
Item no. 19 on drawing no. SK-N001The polymer dosing equipment is located inside the centrifuge building and is sited in a bunded area for the containment of any leakage. The installation was tested as above ground pipework as described in the generic testing methodology. There was no sign of any leakage on the dosing system, therefore the equipment passed the test.

Photos of polymer dosing equipment in bunded area

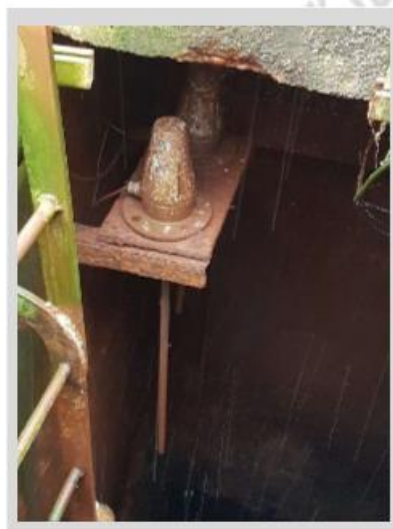
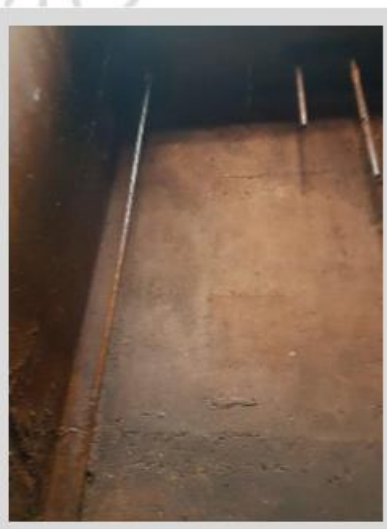
Item no. 20 on drawing no. SK-N001. The wet well was isolated and cleaned out in preparation for testing. The wet well was visually inspected with no obvious signs of leakage identified. The wet well was filled to the test level and left overnight to allow absorption to occur. A drop test was conducted the following day during which the water level within the wet well remained unchanged. The wet well passed the drop test.

Photos of liquor return wet-well

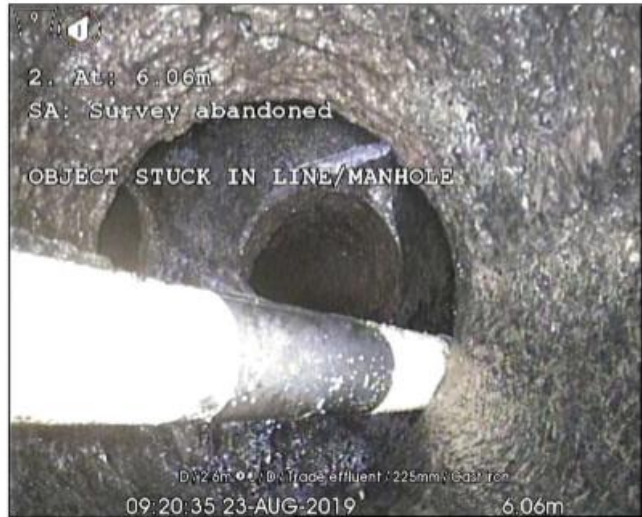
Photo: 9_1_7_30082019_091900_A.jpg

6.06m, Other obstacles, other object in invert, from 8 to 4 o'clock, 10% cross-sectional area loss

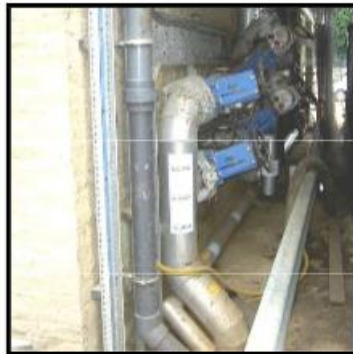
Item No 4 on drawing WC0703. This item is a continuation of item 3 from the point the pipe emerges above ground. The pipework is above ground and a visual inspection was carried out in accordance with the generic testing methodology whilst the equipment was operational. No evidence of leakage was observed therefore the pipe passed inspection.

Photo showing unthickened sludge pipe item 4

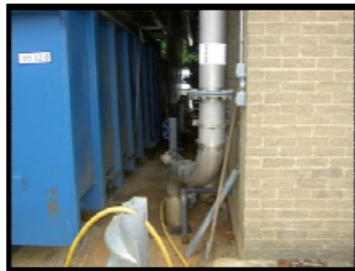
Item No. 11 on drawing No. WC0703. The pipework drains the liquors from the centrifuge to the external drainage system. The pipe is above ground and has therefore been tested by means of a visual inspection in accordance with the generic testing methodology during operation of the dewatering equipment. There was no evidence of leakage therefore the pipe passed the inspection.

Photo showing liquor pipework leaving the building entering the drainage system

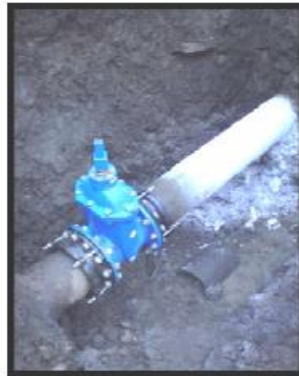
Item No. 16 on drawing no. WC0701 and WC0702. The rising main could not be isolated at the upstream end where it enters the PST distribution chamber so a valve was fitted to the pipe to enable a pressure test to be undertaken. To do this a live installation had to take place by freezing the pipe and fitting the new valve.

Photo showing new valve installation at the upstream end of the rising main

As the pipe is a rising main a pressure test was undertaken on this pipe as described in the generic testing methodology. The pipe failed the pressure test. The results of the test are presented on sheet B2 in appendix B.

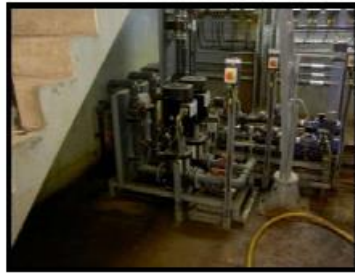
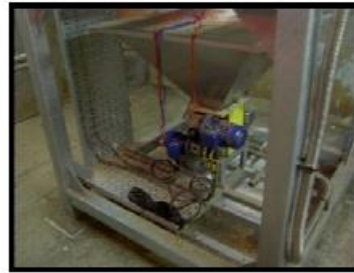
Item No. 19 on drawing No. WC0703. The polymer dosing equipment is located inside the centrifuge building and is contained in a bunded area. The installation was tested as above ground pipework as described in the generic testing methodology. There was no sign of any leakage on the dosing system. The equipment passed the test.

Photos showing new polymer dosing equipment

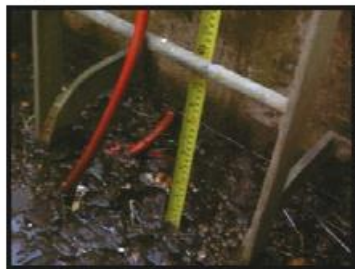
Item No. 20 on drawing No. WC0701. The wet well was isolated and cleaned out in preparation for testing. The wet well was filled to the test level and left overnight to allow absorption to occur. A drop test was conducted during which only 1mm of water depth was lost, the results of the test are recorded on sheet B1 in appendix B. The wet well passed the drop test.

Photo showing drop test measurements being taken at the wet well

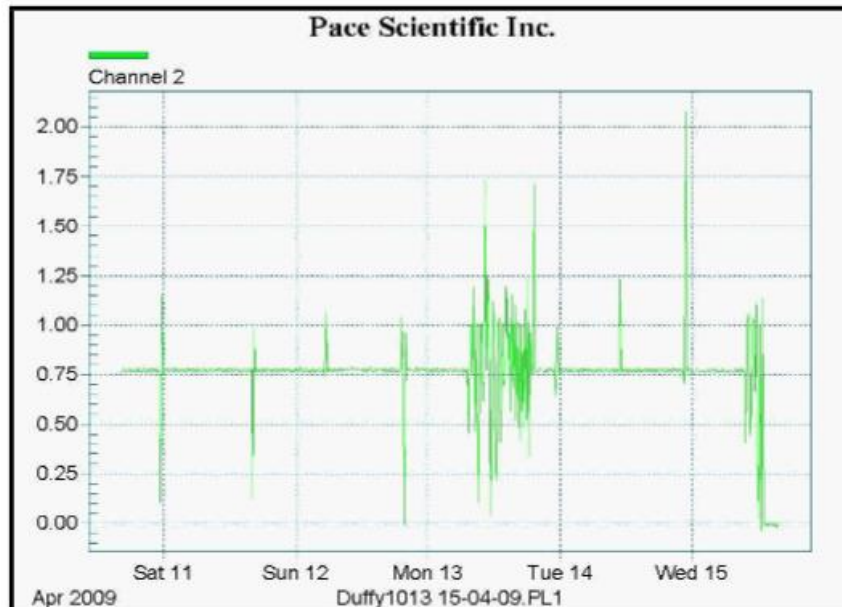
Item No 16 the return liquors rising main failed the first water pressure test at 3 bar. Following this failure the test pressure requirements were questioned as it was believed that the test pressure was too high compared with the working pressure of the pipe. In order to confirm the working pressure of the pipe a pressure recorder was installed for five days, the pressure recorded can be seen in the graph below.

Graph showing liquor return rising main pressures during the April 2009 operating period

The constant pressure reading of 0.75 bar is the residual pressure of the water in the pipe due to the hydrostatic head above the pumps. The troughs that appear on the graph show a vacuum effect when the pumps turn over for the first cycle. This trough is followed by a peak which is the surge of liquor travelling through the pipe. From this graph it has been determined that the working pressure is approximately 1.0 bar.

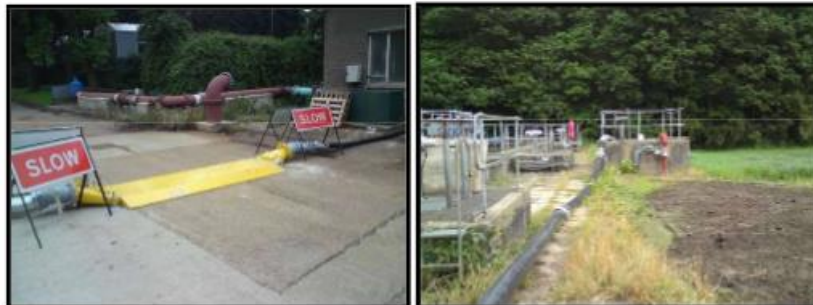
The temporary solution comprises an above ground pipe and as such can be visually inspected. This pipe has been inspected after installation and no leakage was evident therefore the pipe passed the inspection.

Photos showing replacement above ground pipework for the liquor rising main

It is recommended that this item be placed in the improvement programme as described in table 7 of section 3.3 of the generic testing methodology document, with a test return period of 1 year.
