Rail Accident Report

Runaway of a trolley and subsequent collision at North Rode, Cheshire 26 May 2024

Report 07/2025
May 2025

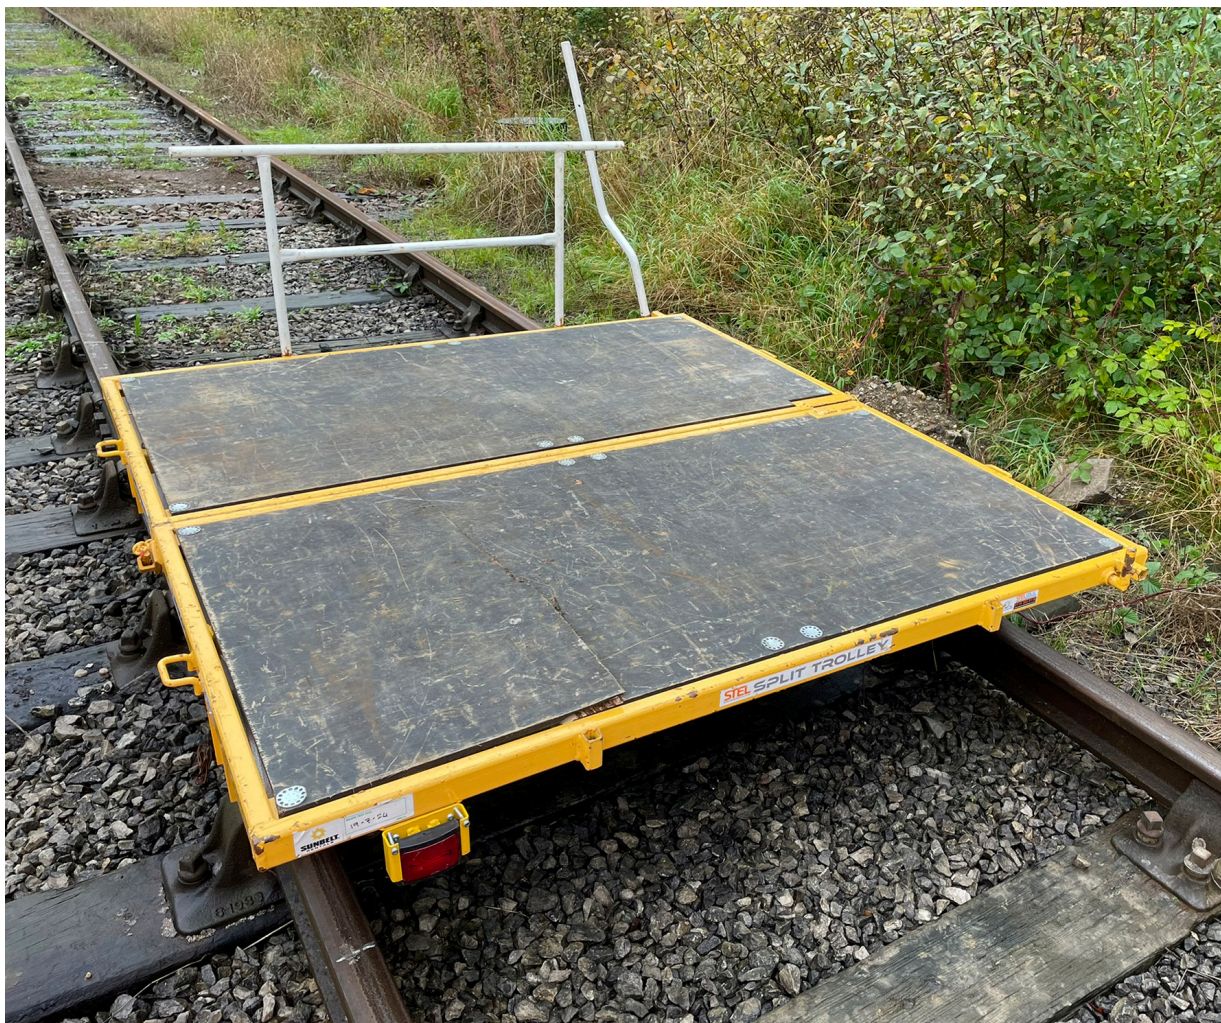
- 15 The manual hand trolley which ran away (figure 4) was manufactured by STEL. RSRG bought the trolley new in October 2023. It is described in more detail in paragraph 58.

Figure 4: The trolley involved in the accident.

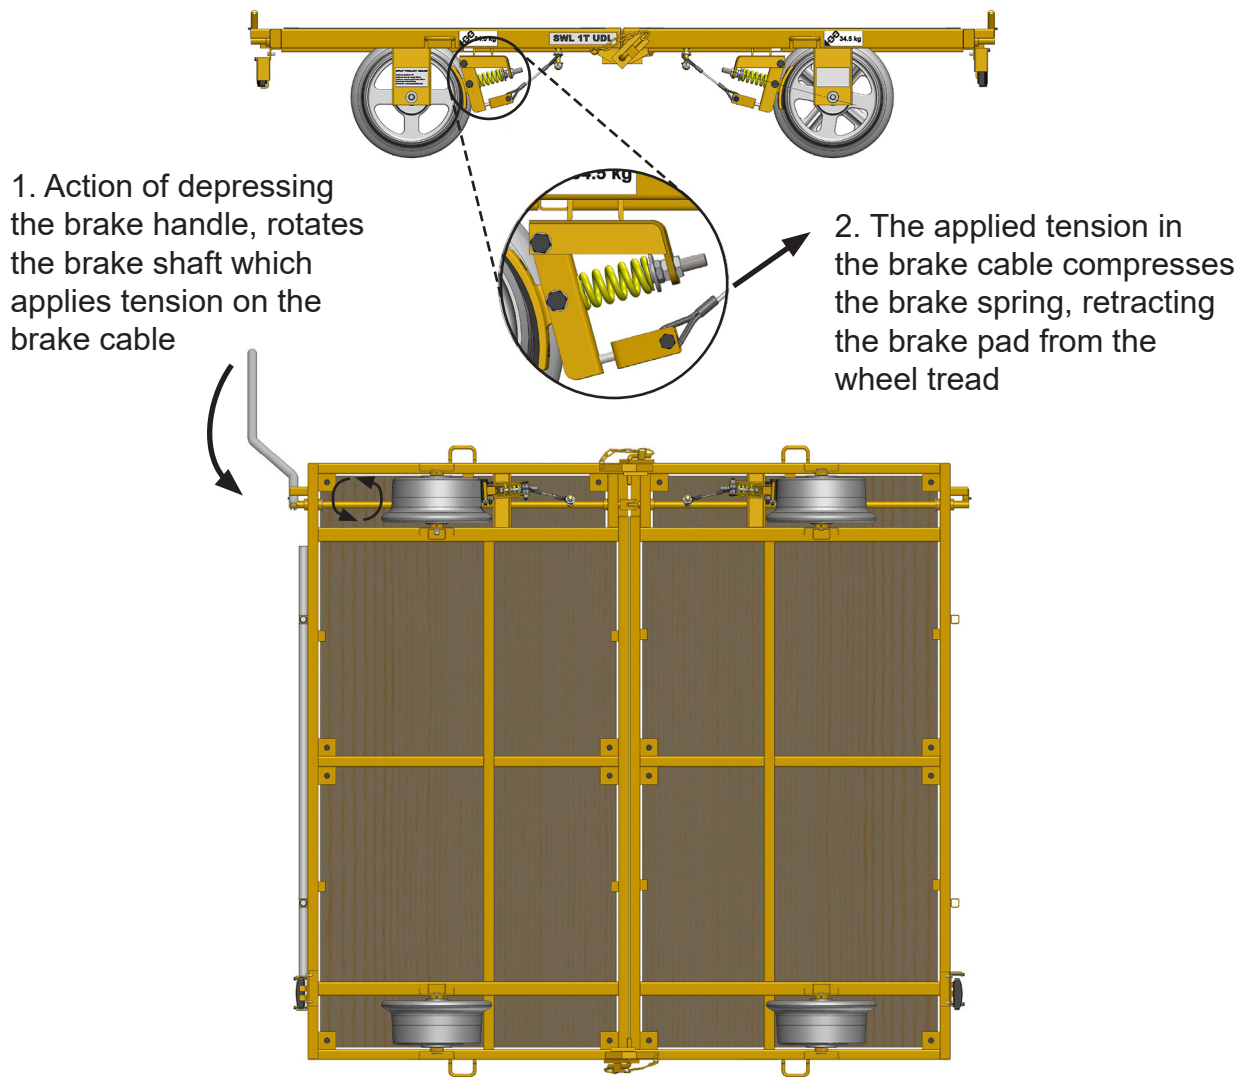
Figure 11: Schematic of the trolley braking system (courtesy of STEL with RAIB annotations).

- 71 Although the trolley was introduced before the current standards (see paragraph 106), RAIB post-accident testing results show that the braking system of the trolley could meet current requirements when the brake handle was positioned as designed.

- 76 RAIB also tested the functionality of the trolley brakes following the accident. To replicate the site conditions during the accident, the trolley was loaded with around 275 kg of mass and was used on a gradient averaging 1 in 135. This is steeper than the gradient at the accident site (paragraph 7). While the trolley was in motion, the brake handle sprang back towards the vertical if released by the operator. This automatically applied the brakes and stopped the trolley. The trolley remained static on the incline when under test. This shows that the brakes would have applied and stopped the trolley on 26 May 2024 had the operator not rendered them ineffective.
