Rail Accident Report

**Fatal collision between a tram and a pedestrian,
near Saughton tram stop, Edinburgh
11 September 2018**

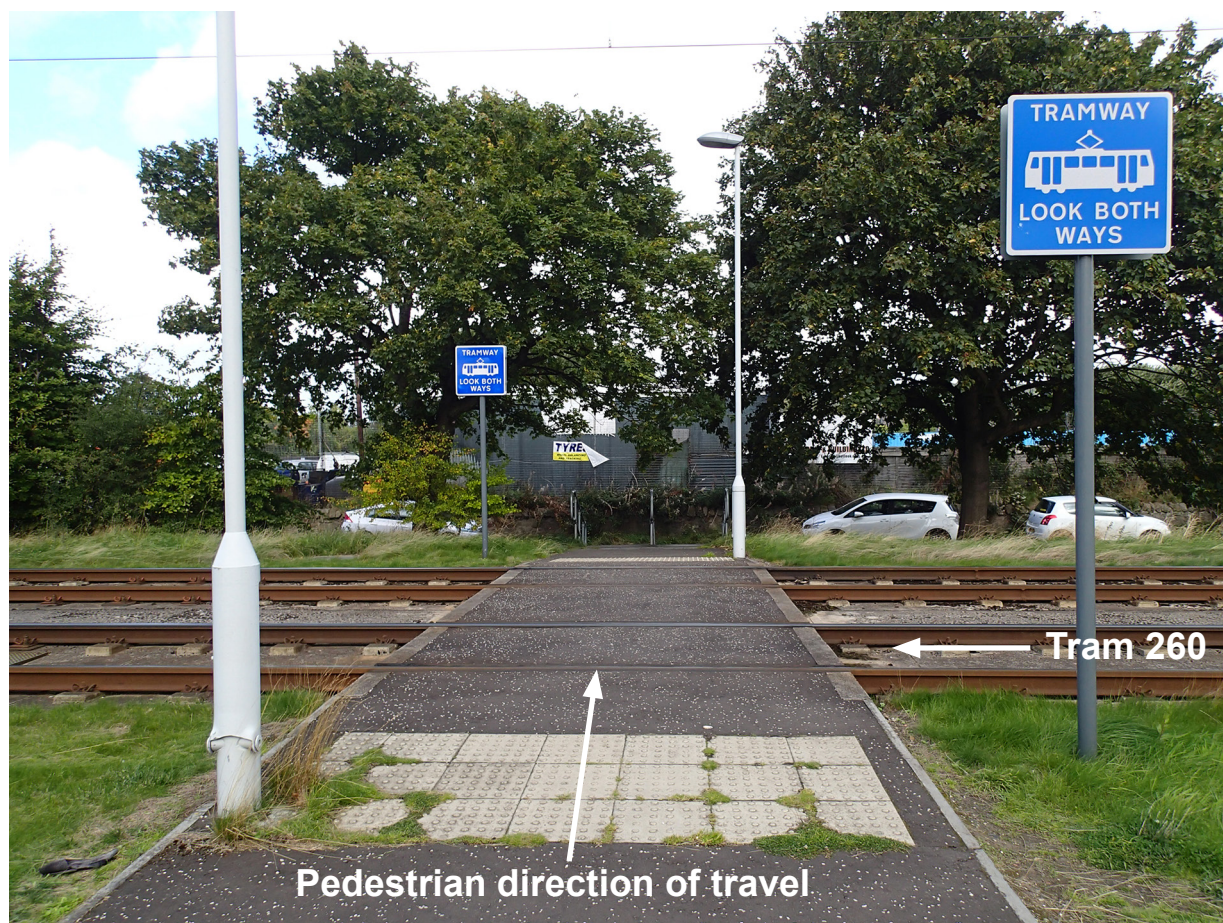
- 5 Trams run on two tracks, one for each direction of travel (figure 3). The maximum permitted speed on both tracks at the time of the accident was 70 km/h (44 mph). The crossing is in an off-street section of the tramway and pedestrians must look both ways and judge when it safe to cross. Unlike crossings in the on-street sections of the system, there are no pedestrian light signals.

Figure 3: The approach to the footpath crossing looking north

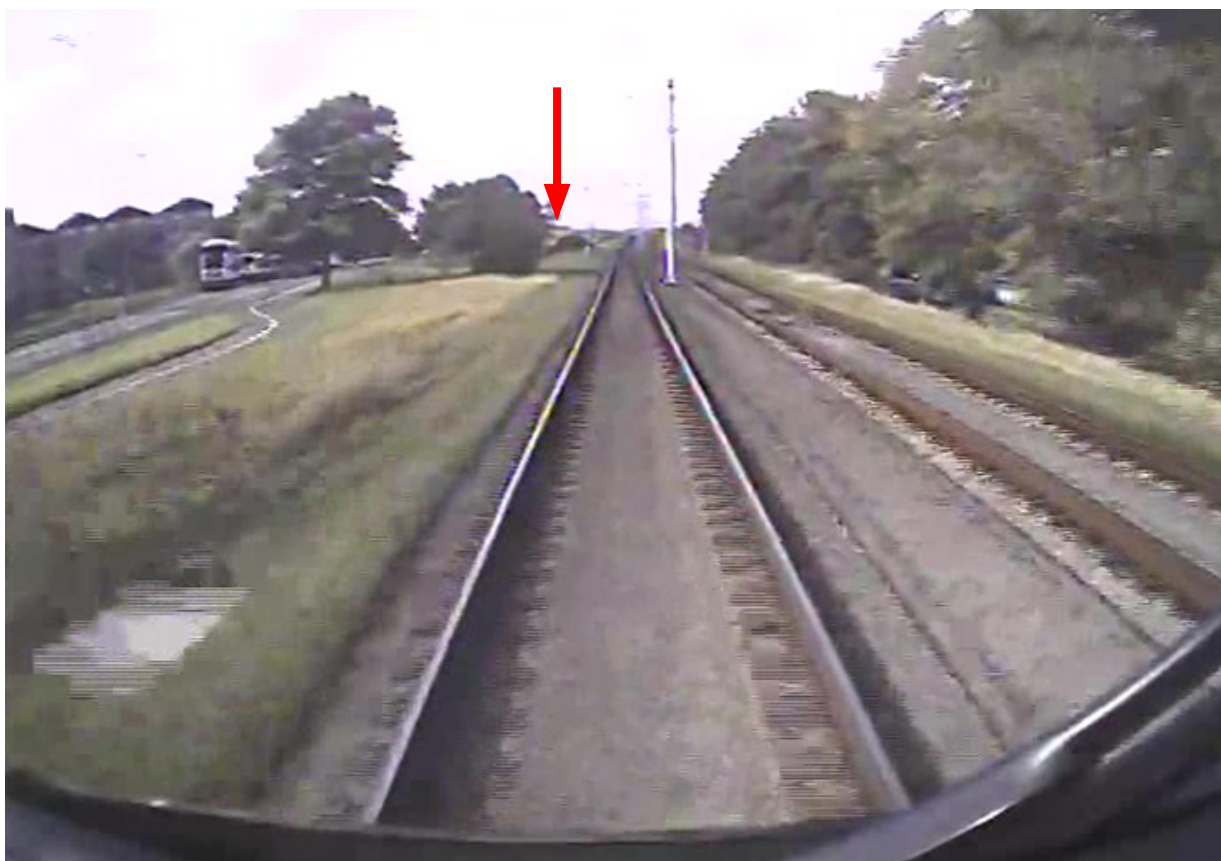
Figure 4: Image from the FFCCTV of tram 260 at around 73 metres from the crossing and 4.6 seconds before the collision. The arrow indicates the location from which the pedestrian emerges very shortly afterwards.

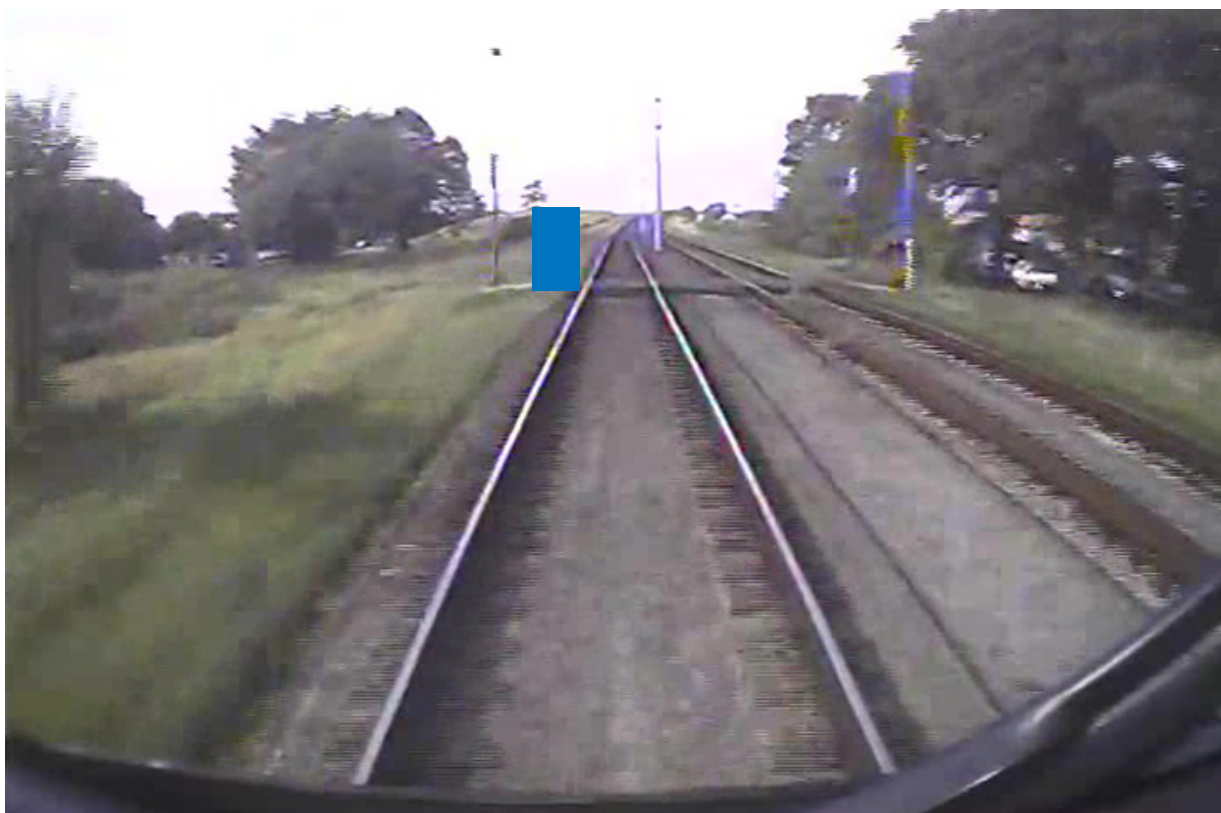
Figure 5: Edited image from the FFCCTV of tram 260 at around 18 metres from the crossing and 1.2 seconds before the collision. The rectangle indicates the location of the pedestrian.

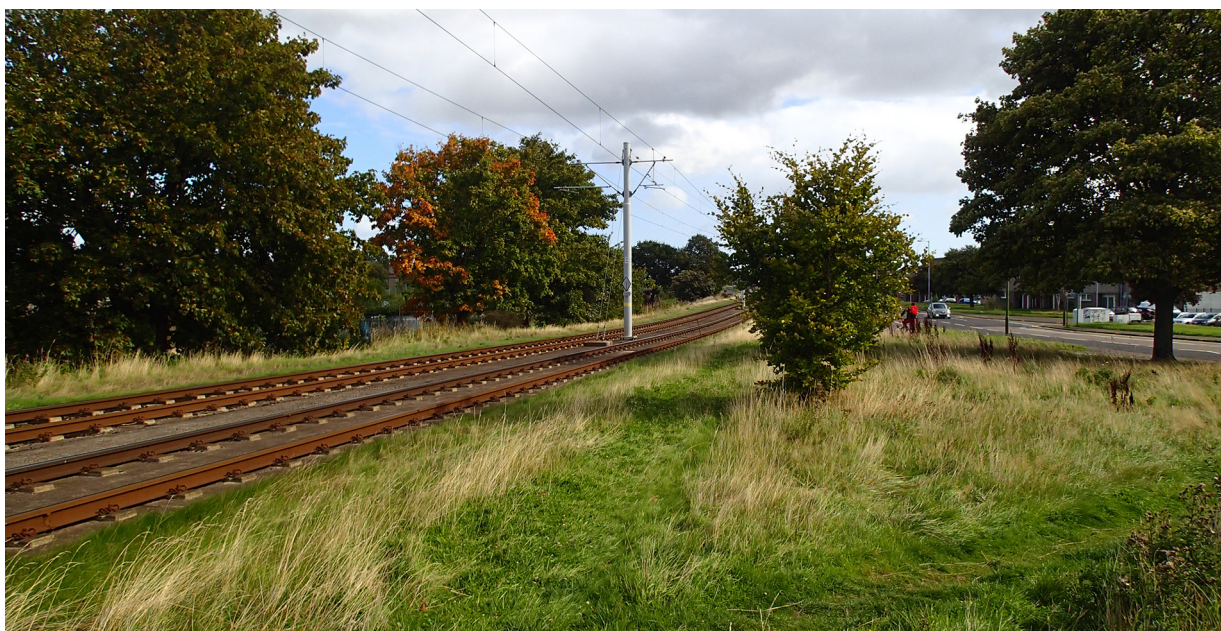
42 Photographs taken following the accident show that airport bound trams would be visible from the footpath when viewed from distances closer than approximately 6 metres from the nearest running rail of the crossing (figure 6). Images from the FFCCTV of the tram show that the pedestrian became visible when at this distance from the crossing, and the images suggest that the pedestrian did not look, or change his stride beyond this point until just before the collision.

Figure 6: The view to the east from the footpath at 6 metres from the crossing

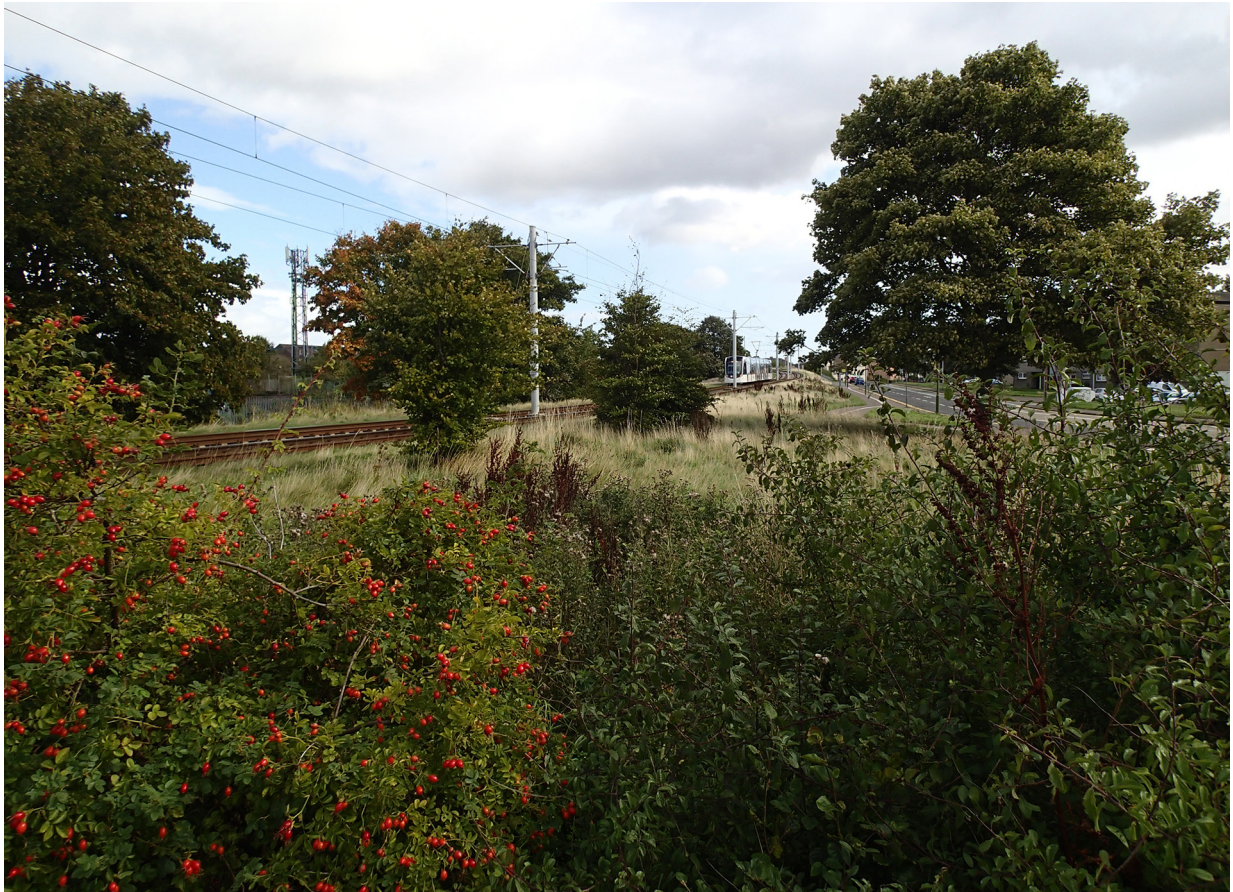
43 It is possible that the pedestrian may have looked for approaching trams while he was still some way away from the crossing as he walked towards it. However, clear views of the tramway to the east from the footpath are interrupted by bushes on the edge of the footpath (figure 7) and two trees adjacent to the track (figure 8).

Figure 7: The view to the east from the footpath at 14 metres from the crossing

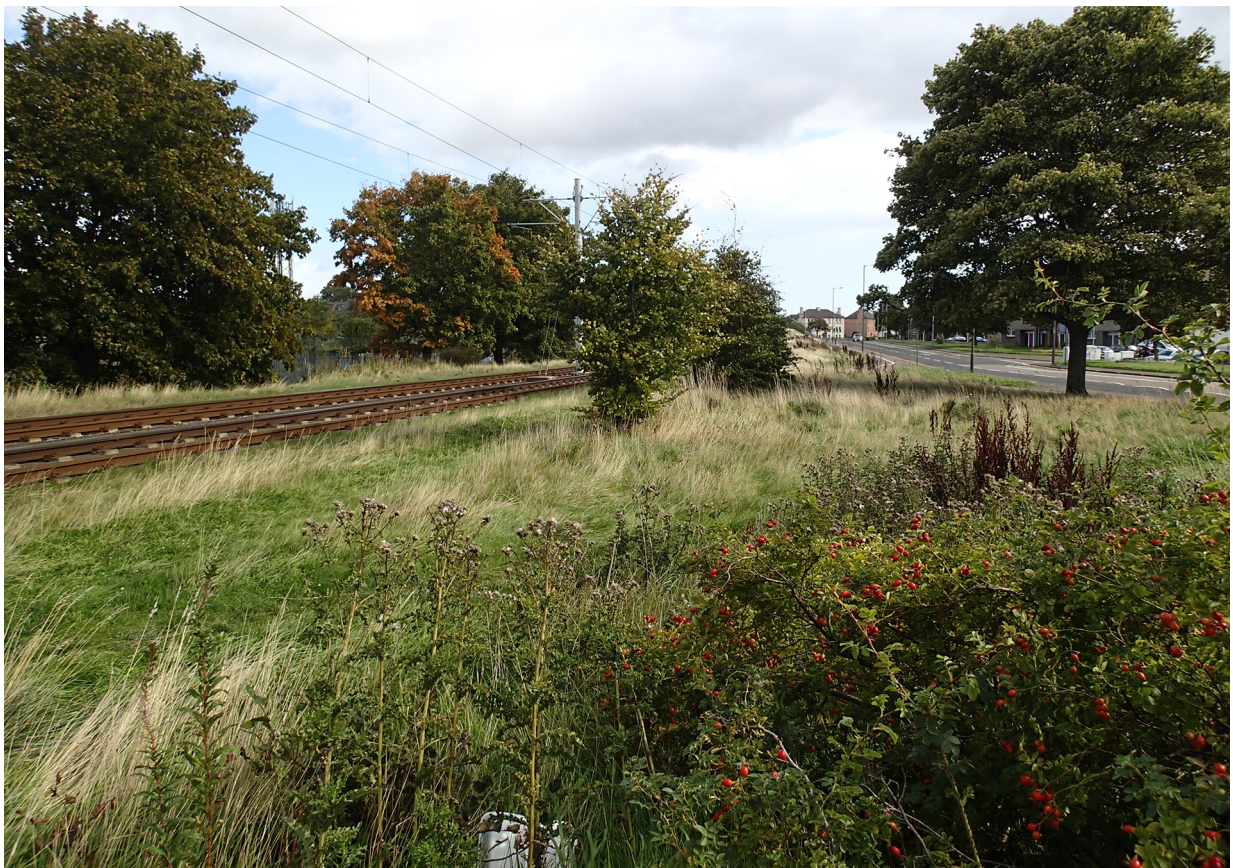
Figure 8: The view to the east from the footpath at 8 metres from the crossing

- 44 The bushes and trees also obscured an earlier sighting of the pedestrian by the tram driver. The trees have since been removed (paragraph 137).
- 45 The pedestrian had passed a D4 medical examination¹ required for driving public service vehicles in May 2017. That type of medical examination includes an assessment of both visual acuity and visual field. Although he had previously been diagnosed with a deep cataract in the left eye, this is not thought to be a factor because his vision was adequate for bus driving. Additionally, the CCTV evidence indicates that he did not turn his head towards the approaching tram just before he started crossing the tram lines.

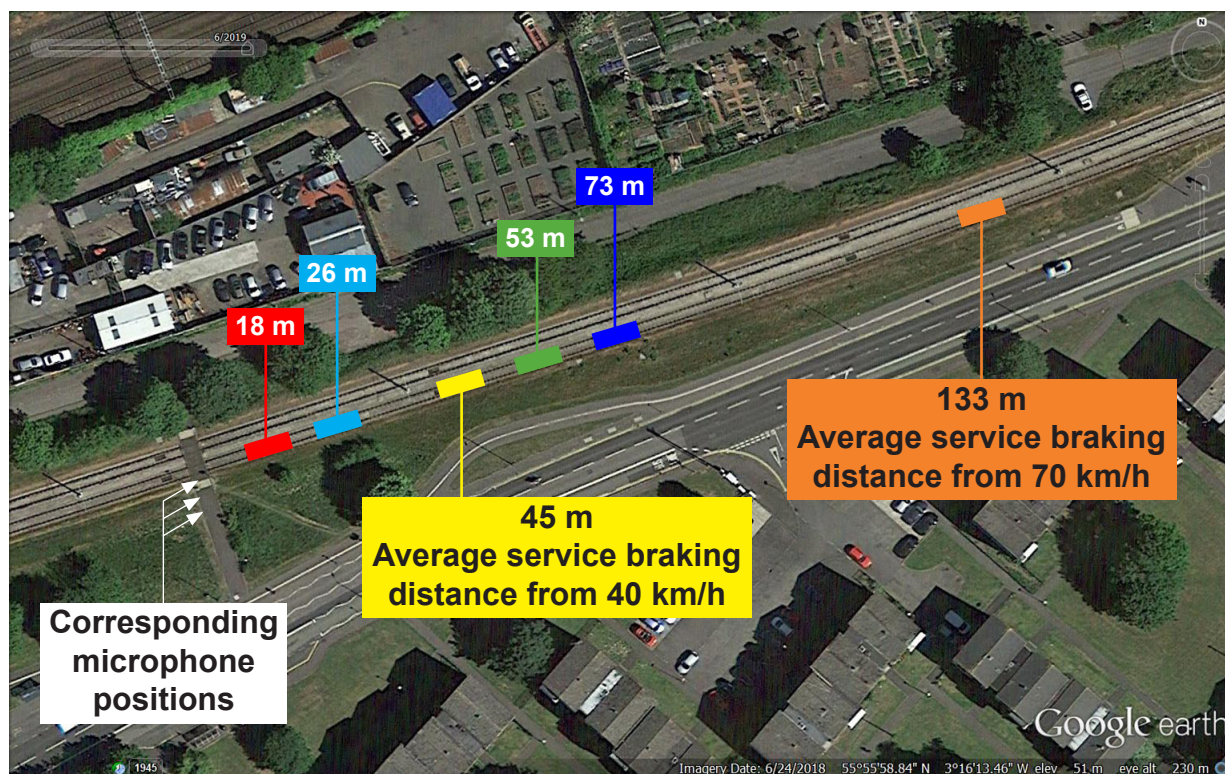
- 58 Following the accident, the RAIB commissioned a specialist consultant to carry out acoustic measurements to investigate the audibility of the bell as tram 260 approached the crossing (figure 9). Sound pressure level measurements of the tram's horn were also taken as this is an alternative method of warning provided on the tram, although it was not used on this occasion until the tram was very close to the crossing (paragraph 28). Additionally, measurements were taken of the sound pressure levels of the bell and the horn of another tram which were found to be of a similar level as those of tram 260, when both were measured on level ground in the depot.

Figure 9: Distances of tram 260 from the crossing during the sound pressure level measurements

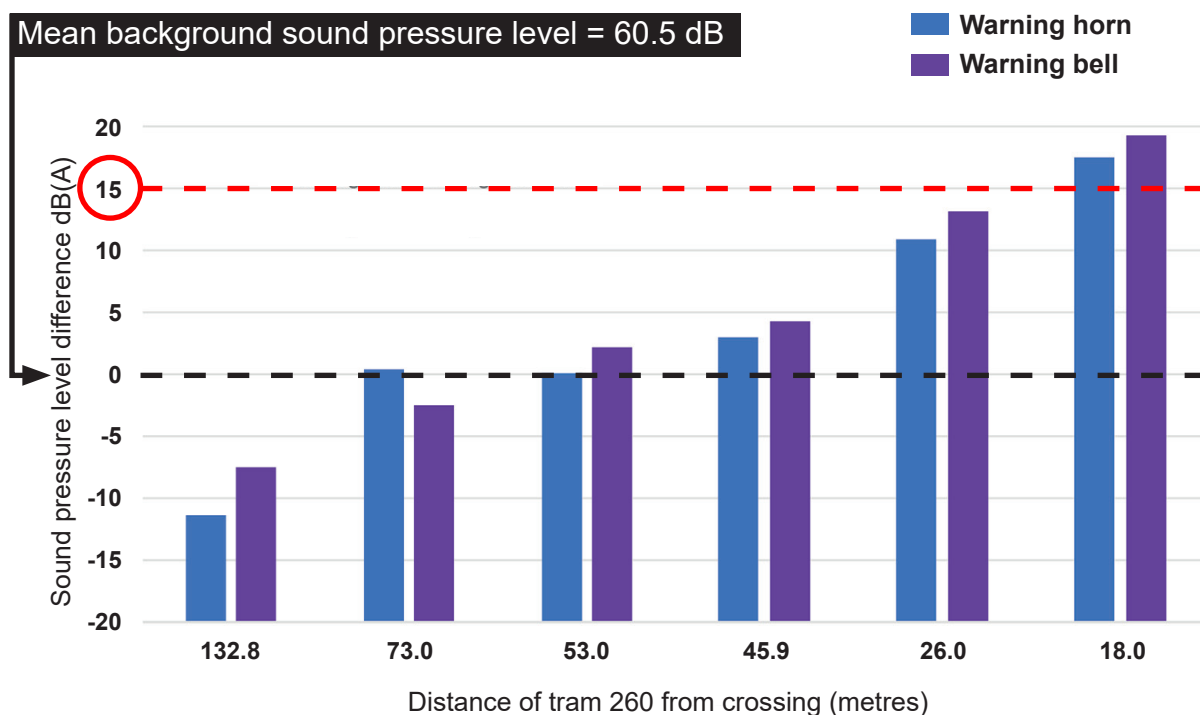
Figure 10: Sound pressure level differences of the bell and horn of tram 260 compared with the mean typical background sound level measured at the crossing, with zero on the y-axis being equivalent to the background sound pressure level of 60.5 dB(A). The red line represents a 15 dB(A) increase over the background level.

- 65 The test results also indicated that the sound pressure level of the horn is lower than that of the bell. Therefore, had the tram's warning horn been sounded earlier instead of the bell, it is unlikely to have been any more effective as a warning to the pedestrian.

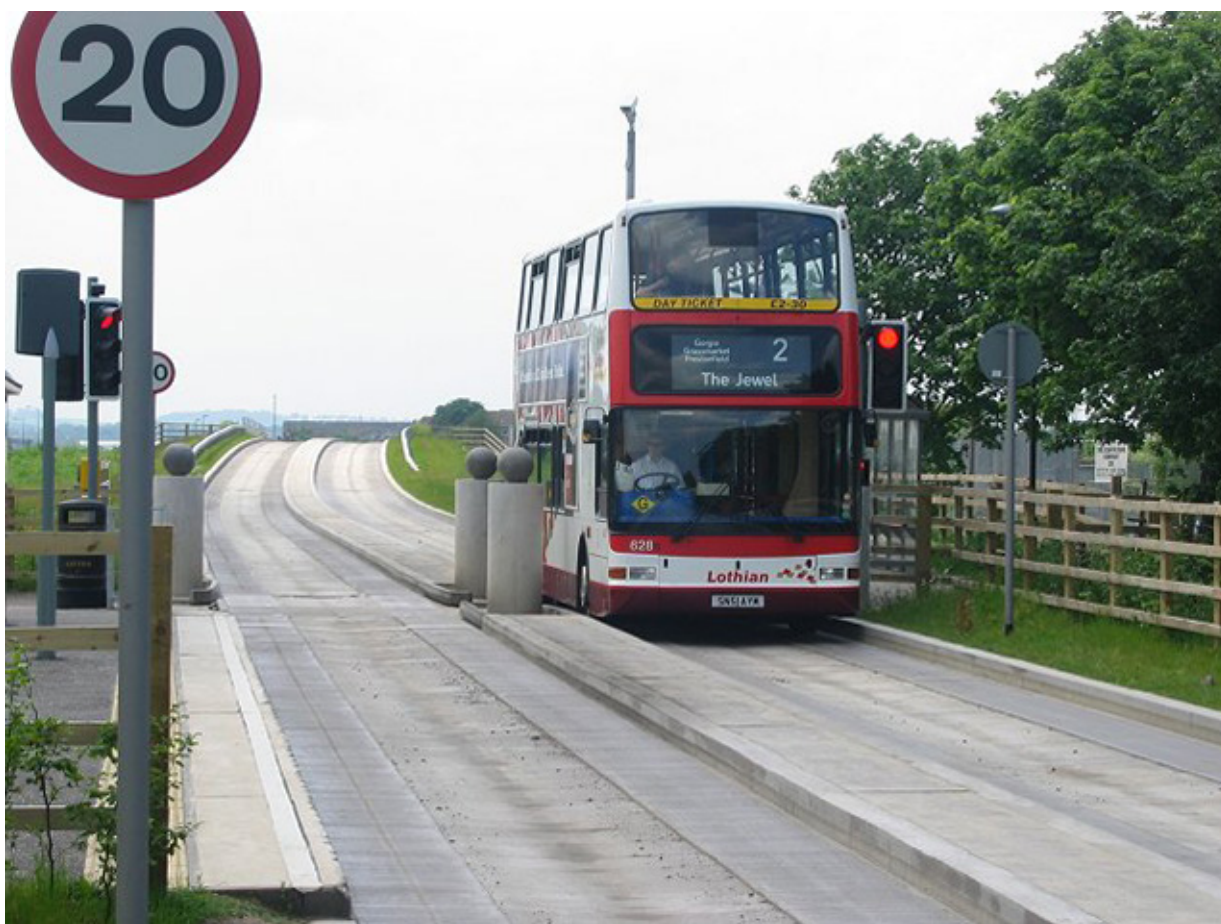
Figure 11: The Saughton East bus halt and crossing on the former West Edinburgh Busway (Richard Webb [CC BY-SA 2.0 (<https://creativecommons.org/licenses/by-sa/2.0/>)])

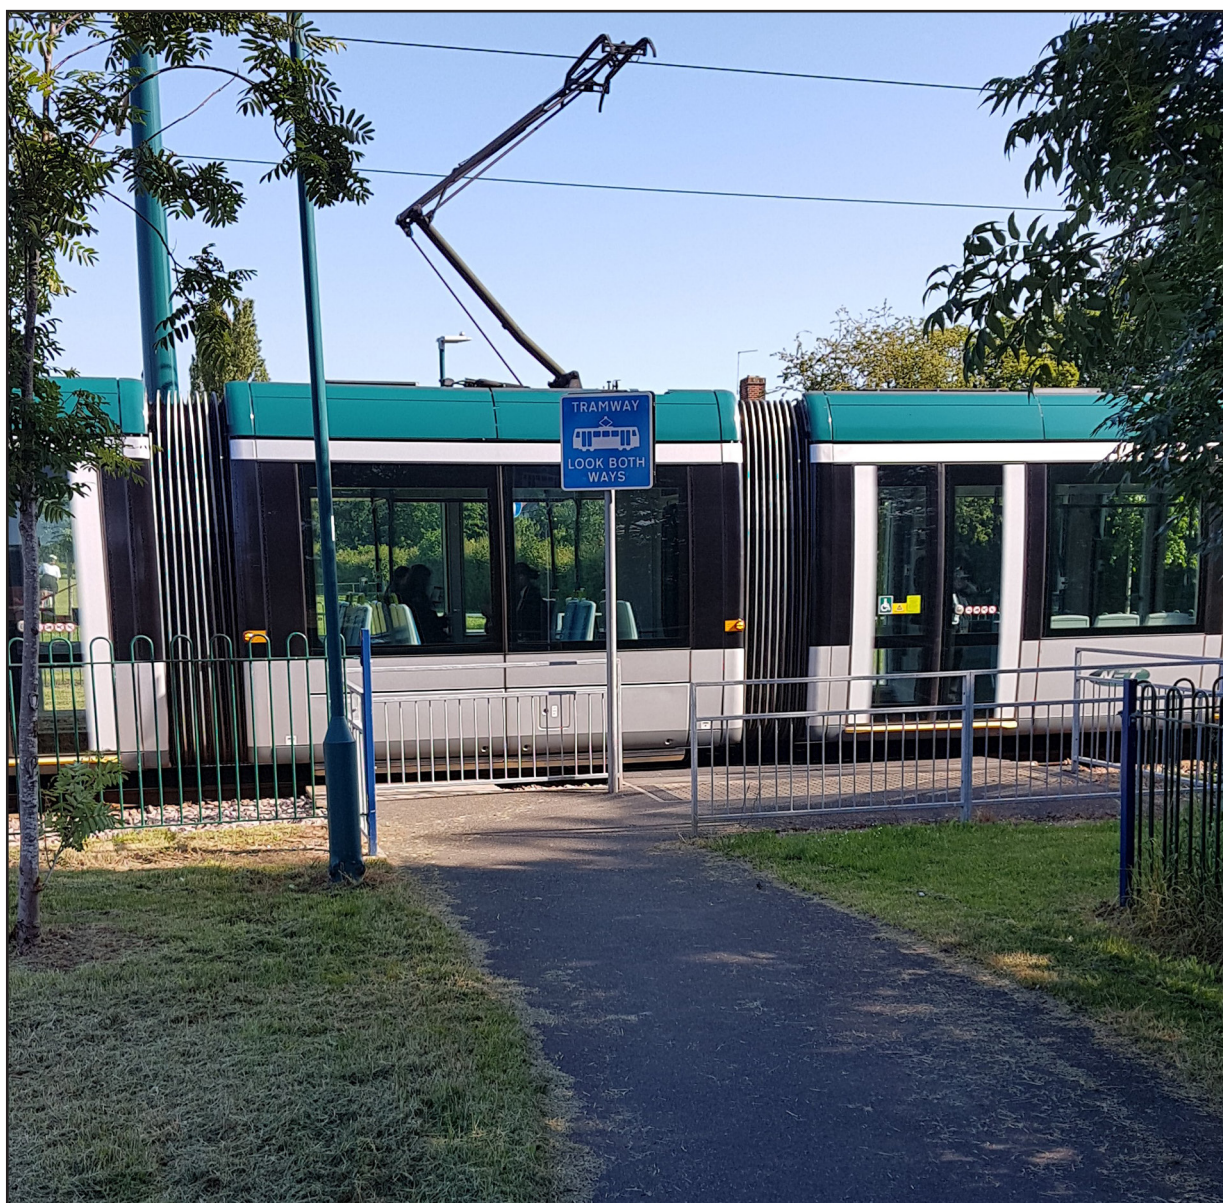
- 78 The RSP2 guidance stated that fencing or pedestrian guard rails should be provided where necessary, to guide pedestrians to face oncoming trams before they cross the track, although specific situations are not described. Chicane fencing has been used at some locations on other tramways to make pedestrians visually aware that they are entering an area of increased danger, make them alter their walking pattern and turn them to face approaching trams on the nearest track (figure 12).

Figure 12: An example of chicane fencing on a footpath crossing on the Nottingham tram system. The tram in the picture is travelling on the closer of the two tracks from right to left.
