Annual Safety Review 2024

Promoting action to prevent reoccurrence

AAIB
Air Accidents Investigation Branch

Published: 12 June 2025.

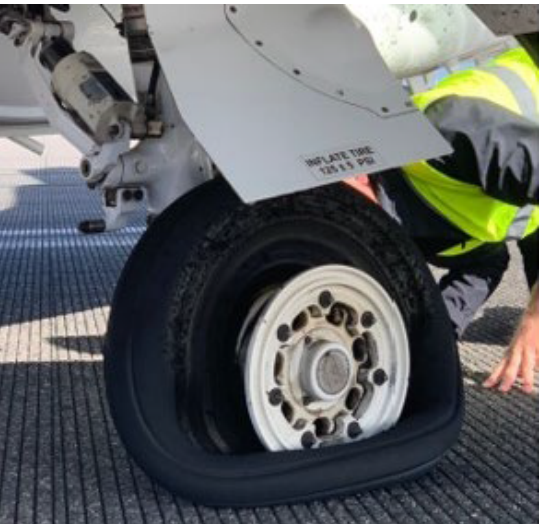
The lack of a light or caption to indicate that the parking brake is on, or an aural or visual warning that the parking brake is on when takeoff power is applied, may have contributed to the incident, as may have the lack of a ‘release parking brake’ item in the ‘Before Takeoff’ checklist.

Left and right mainwheel tyres after the incident landing

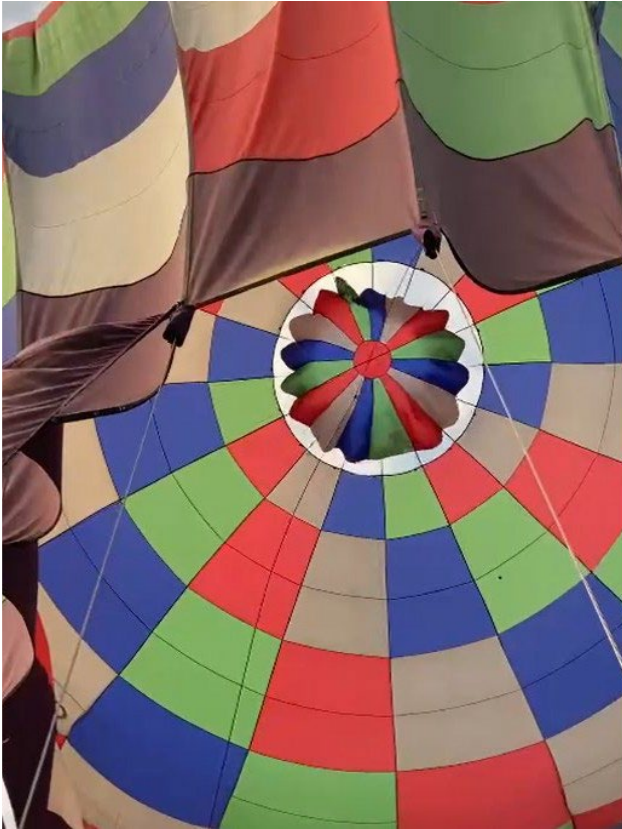
¹ There was a circular piece of material inside and at the top of a balloon envelope known as the parachute. It is operated by the pilot using a shroud line and acts as a valve to release hot air from the envelope the control ascent and descent. In some circumstances differential pressures above and around the parachute can prevent proper closure. This is known as parachute stall and may cause the uncontrolled loss of hot air.

Example parachute in a stalled condition
(Looking up through the balloon envelope from the basket)

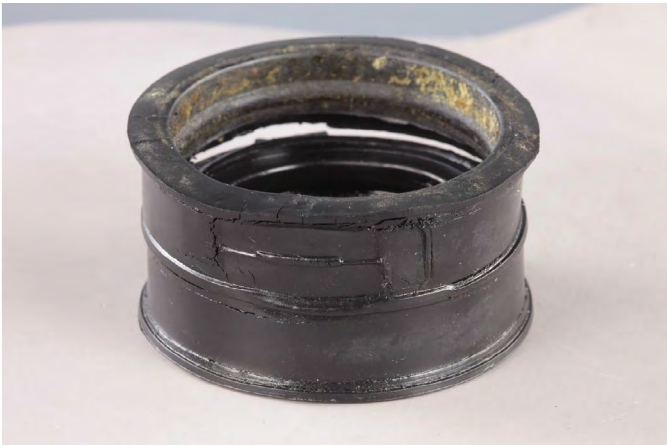
The loss of engine power was probably caused by an age-related split in the rubber coupling attaching the carburettor to the engine’s plenum chamber. No issues with the engine were identified during a 100-hour engine service or the subsequent check flight, carried out in January 2023. The location of the coupling and its mounting clips made inspection problematic. The engine manufacturer’s manual for the engine stated that the coupling had a 1,000 hour, or five-year life but there was no evidence that the coupling had been replaced since the aircraft had been built in 2006.

Split carburettor coupling from G-CDFK

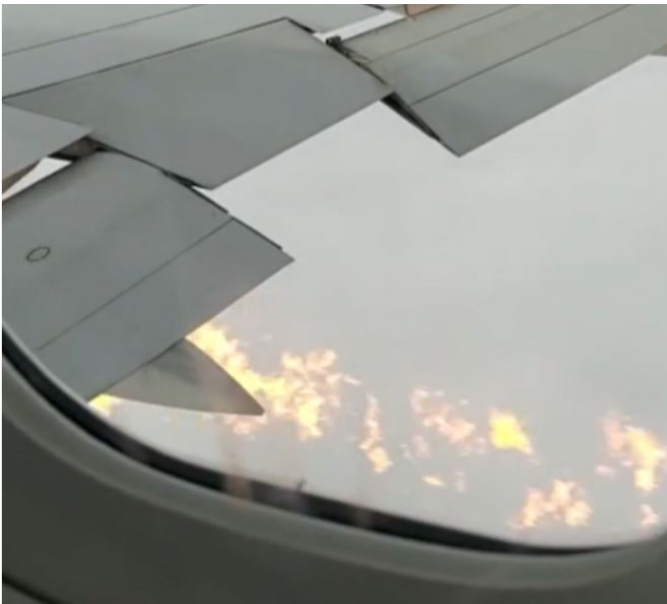
Due to the high engine vibration, the flight crew diverted the aircraft to Prestwick Airport. During the diversion, fuel escaping from the wing was ignited by the hot engine exhaust, and this was recorded on video by a passenger, but the flames extinguished before the landing. The aircraft landed promptly, with full emergency service attendance. After the aircraft arrived on stand, the airport fire service noticed the fuel coming from the right wing and put provisions in place to capture the fuel, preventing it igniting on the hot engine or brakes. The passengers were rapidly disembarked, with no injuries.

Image from a passenger’s video

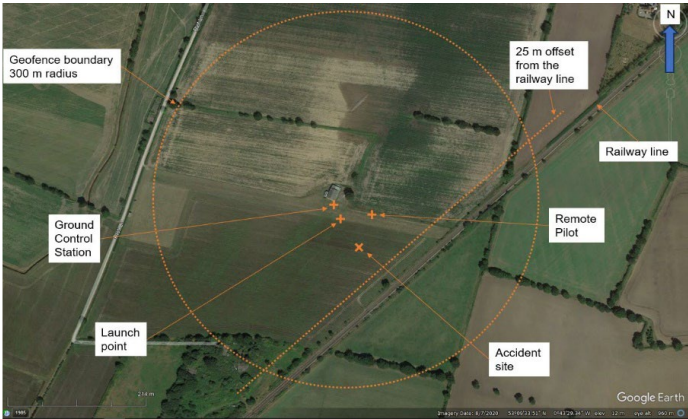
Accident site and geofence

The operator no longer uses the manual mode and has promoted the use of standardised phraseology between the ground control station operator and the remote pilot. Further action has been taken to consider and apply a suitably sized geofence for each operational flight.

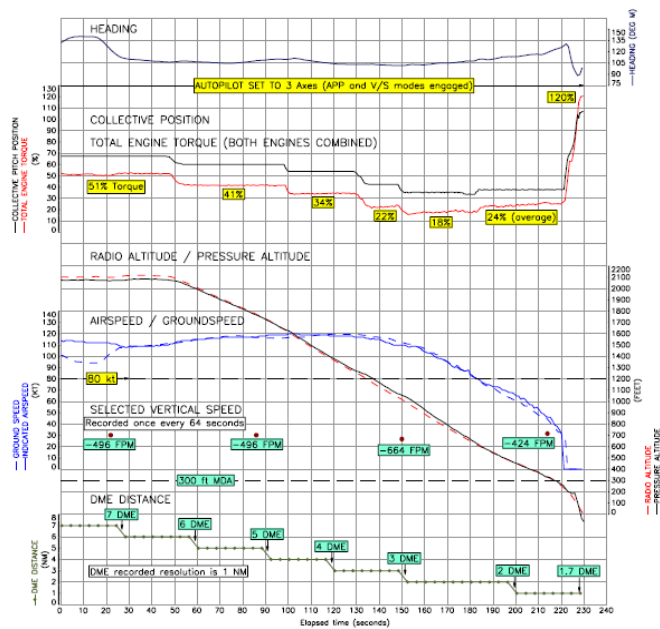
- The helicopter’s flight instruments were not monitored effectively during the latter stages of the non-precision instrument approach. This allowed the helicopter to enter a critically low energy state, from which recovery was not possible.
- Visual references had not been acquired by the Minimum Descent Altitude (MDA) and no effective action was taken to level the helicopter, as required by the operator’s procedure for an instrument approach.

G-WNSB final approach vertical profile

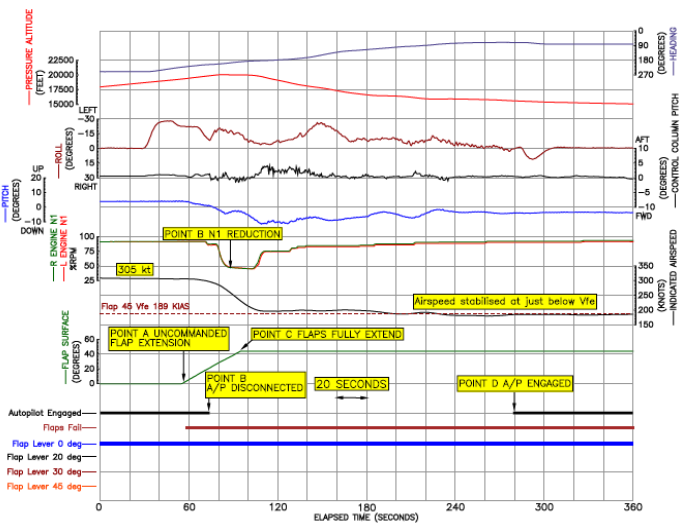
An uncommanded and unarrested flap movement requires the flaps to move without movement of the flap lever and then for a failure in the flap arrest system to stop this movement. The flap surfaces are moved by two drive motors that are commanded by the sequencing of four extend and retract relays. These four relays also form part of the system to arrest an uncommanded flap movement.

FDR data of uncommanded flap extension

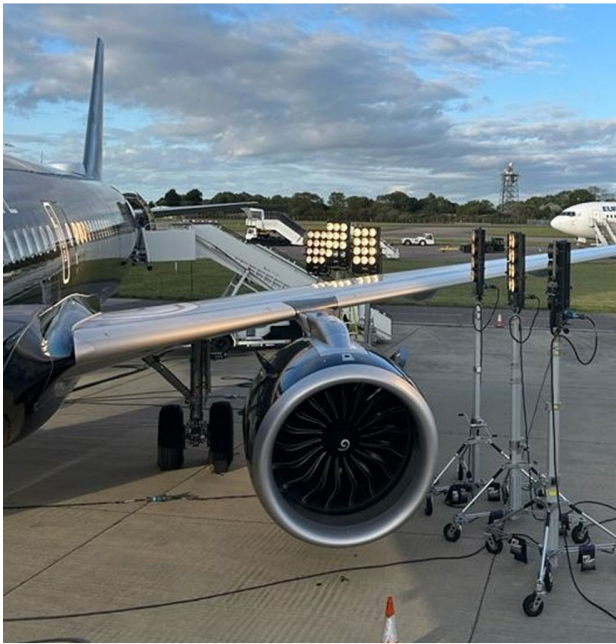
Flood lighting on the left side of the aircraft

- EASA published a Safety Information Bulletin highlighting the risk of damage when using high-intensity lighting near an aircraft

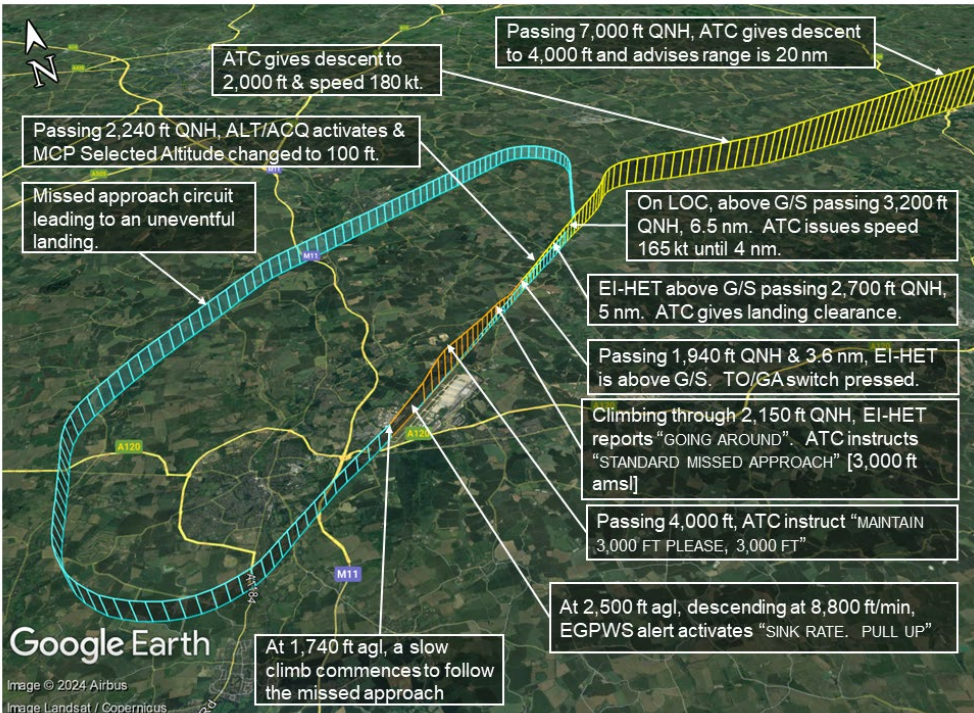
There have been several serious incidents which occurred during go-arounds with similar factors to that found in this investigation involving EI-HET. Although EI-HET is a Boeing 737-8200 [MAX], the incident could have occurred in any variant of the Boeing 737, or any other type of aircraft with similar autopilot and flight director systems.

EI-HET’s radar flightpath as it approached Stansted (yellow), the GA, level bust and descent (orange), and second approach and landing (blue).
© 2024 Google Earth, image © Airbus

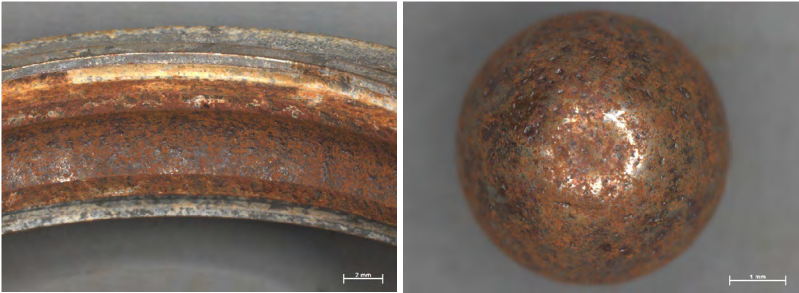
Bearing No 2 corrosion and pitting (outer race shown, inner similar)

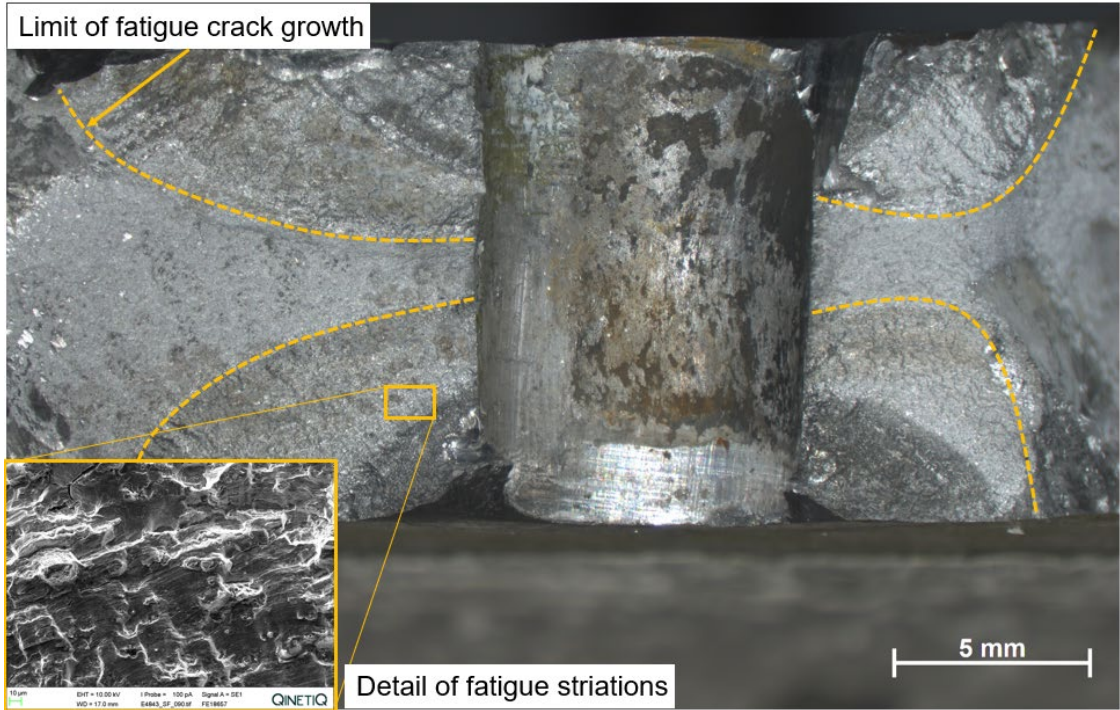
Detail of typical bolt hole showing limits of fatigue crack growth

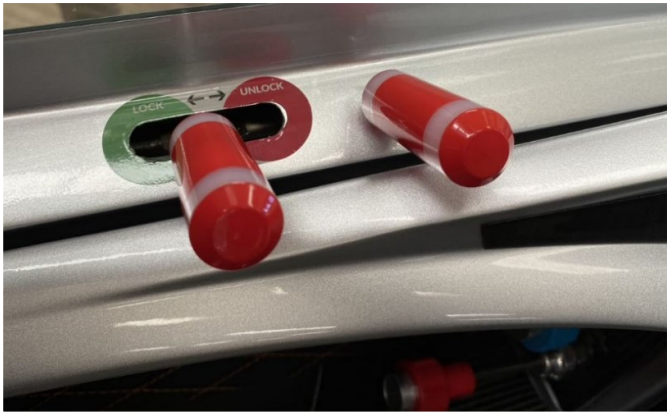
Canopy handle partly locked position when under spring pressure alone

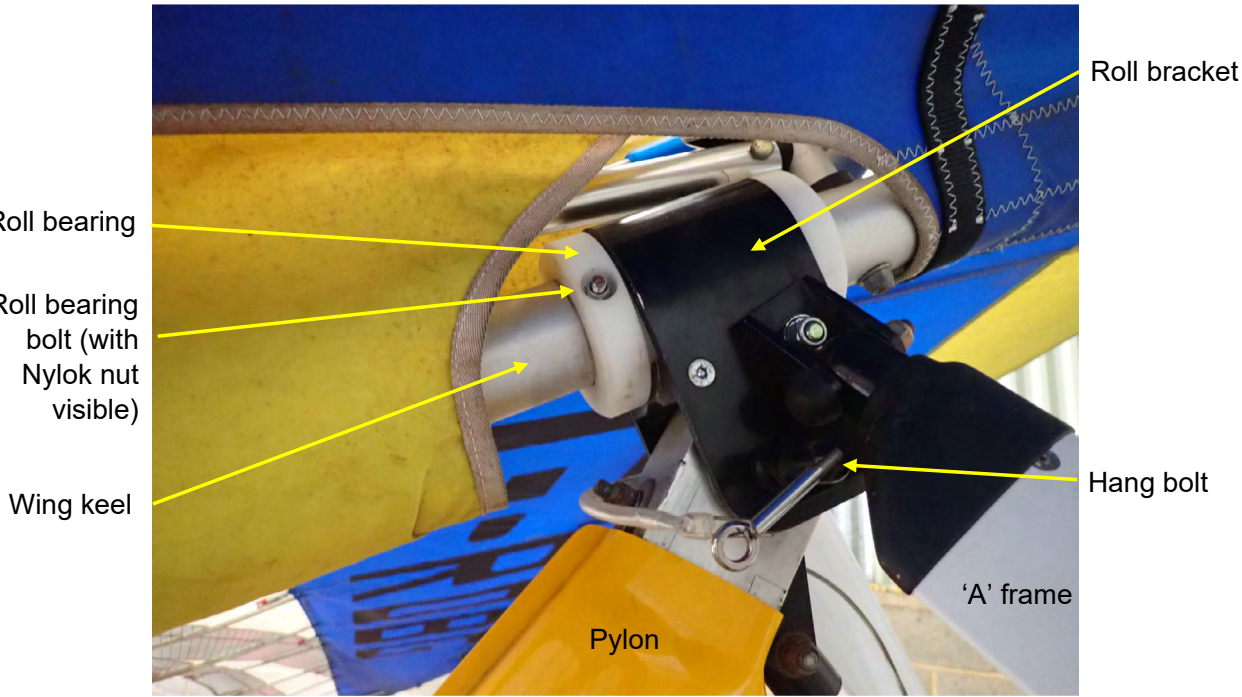
GT450 wing keel and hang bracket viewed from the right
