Serious Incident

Aircraft Type and Registration:	ATR 42-500 (600 version), G-LMSA	
No & Type of Engines:	2 Pratt & Whitney Canada PW127M turboprop engines	
Year of Manufacture:	2017 (Serial no: 1213)	
Date & Time (UTC):	23 July 2024 at 1230 hrs	
Location:	Aberdeen International Airport	
Type of Flight:	Commercial Air Transport (Passenger)	
Persons on Board:	Crew - 3	Passengers - 30
Injuries:	Crew - None	Passengers - None
Nature of Damage:	Significant damage to No 1 engine turbine assemblies and fire and heat damage to No 1 engine inside cowlings	
Commander's Licence:	Airline Transport Pilot's Licence	
Commander's Age:	40 years	
Commander's Flying Experience:	2,700 hours (of which 210 were on type) Last 90 days - 181 hours Last 28 days - 62 hours	
Information Source:	AAIB Field Investigation

Synopsis

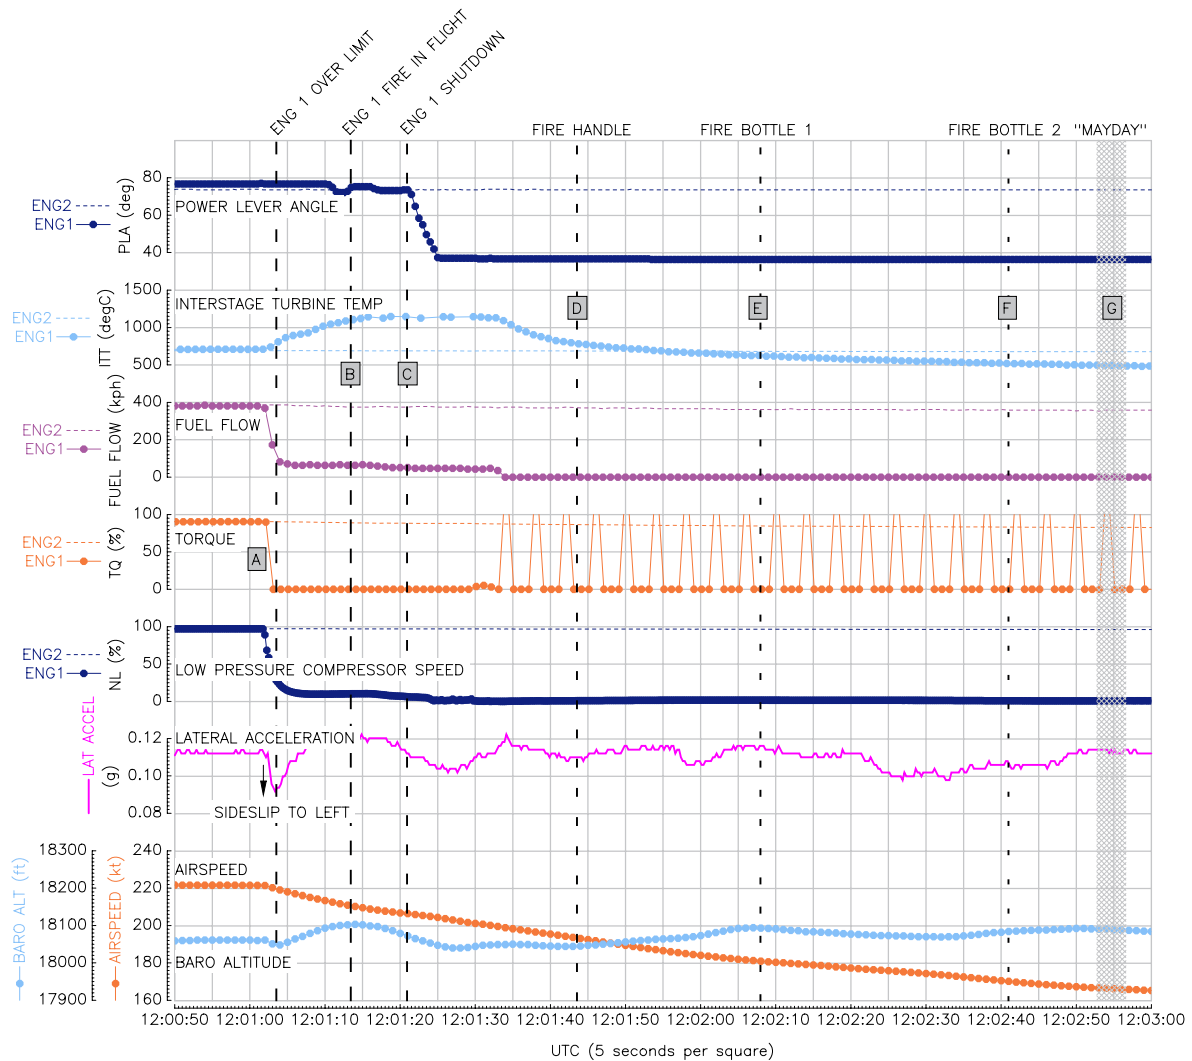
Figure 4

Recorded data for the event

[A] 12:01:02 (t0) – The torque on No 1 engine reduced from 90 to 0% within one second, with corresponding drops in fuel flow and N_L , a rise in No 1 engine ITT, and aircraft sideslip to the left. This was followed by a master warning and ENG 1 OVER LIMIT message just over one second later.

[B] 12:01:13 (t0+11) – Master warning and ENG 1 FIRE IN FLIGHT message.

- [C] 1201:21 (t0+19) – Master warning and ENG 1 SHUTDOWN message.
- [D] 1201:43 (t0+41) – (From CVR) crew stated fire handle 1 pulled.
- [E] 1202:08 (t0+66) – (From CVR) crew stated engine fire bottle 1 discharged.
- [F] 1202:41 (t0+99) – (From CVR) crew stated engine fire bottle 2 discharged.
- [G] 1202:53 (t0+111) – (From CVR) crew declare a MAYDAY.

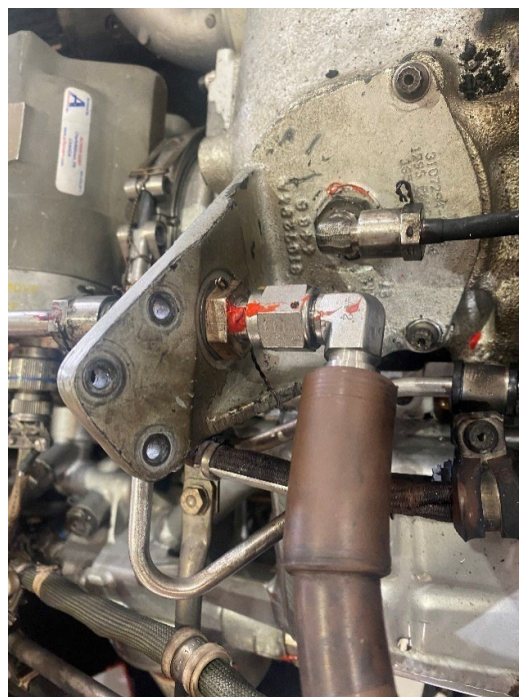
Figure 9

There was evidence of fire around the No 1 engine cowlings and an inspection of the area inside the cowling revealed additional fire damage and sooting. The fuel return line was found loose and leaking at the HMU outlet.

With the motive flow valve de-energised, the flow of fuel leaking from the motive flow pipe when disconnected was measured at 165 ml/min. It was not possible to determine the flow rate at the time of the fire as the connection had been re-tightened to stem the leak whilst the aircraft was parked.

The end fitting had been marked with indicator material. When the fitting was re-tightened, the marks aligned, and the leak stopped.

Due to the routing of the fuel return line away from the end fitting, a 90° elbow, it was possible to use the line as a lever to manually loosen the fitting (Figure 9).

Fuel return line connection to HMU after engine removed from aircraft
(line temporarily fitted to show routing)

The engine failure was violent as witnessed by the rapid reduction in torque and tears in the elastomer anti-vibration mounts and it is considered possible that the reaction to this sudden reduction in torque could have caused the fuel return line to 'whip' and loosen the connection and for consequent engine vibrations to have loosened it further. There is no secondary locking on the connection and the line leaves the HMU via a 90° elbow which would add leverage to any loosening forces.

The fuel leak was from the connection between the HMU and the fuel return line which had become loose. The reason for this could have been either that the connection had not been tightened correctly when it was installed or that it had become loose due to the forces of the engine failure 'whipping' the fuel return line. Maintenance records, interviews with the maintenance staff and indicator markings appeared to confirm that it had been tightened correctly, and the aircraft manufacturer was not aware of any other cases where this connection had become loose.

The aircraft manufacturer has commenced a safety review to identify any possible safety actions which would further reduce the likelihood of leakage from the fuel return line. This review will be completed by the end of 2025.
