Serious Incident

Aircraft Type and Registration:	Cessna 152, G-BSZW	
No & Type of Engines:	1 Lycoming O-235-L2C piston engine	
Year of Manufacture:	1977 (Serial no: 152-81072)	
Date & Time (UTC):	24 February 2024 at 1539 hrs	
Location:	Blackbushe Airport, Surrey	
Type of Flight:	Training	
Persons on Board:	Crew - 1	Passengers - 1
Injuries:	Crew - None	Passengers - None
Nature of Damage:	Rudder control bellcrank fractured	
Commander's Licence:	Commercial Pilot's Licence	
Commander's Age:	27 years	
Commander's Flying Experience:	1,265 hours (of which 1,100 were on type) Last 90 days - 66 hours Last 28 days - 15 hours	
Information Source:	Aircraft Accident Report Form submitted by the pilot and further AAIB enquiries

Synopsis

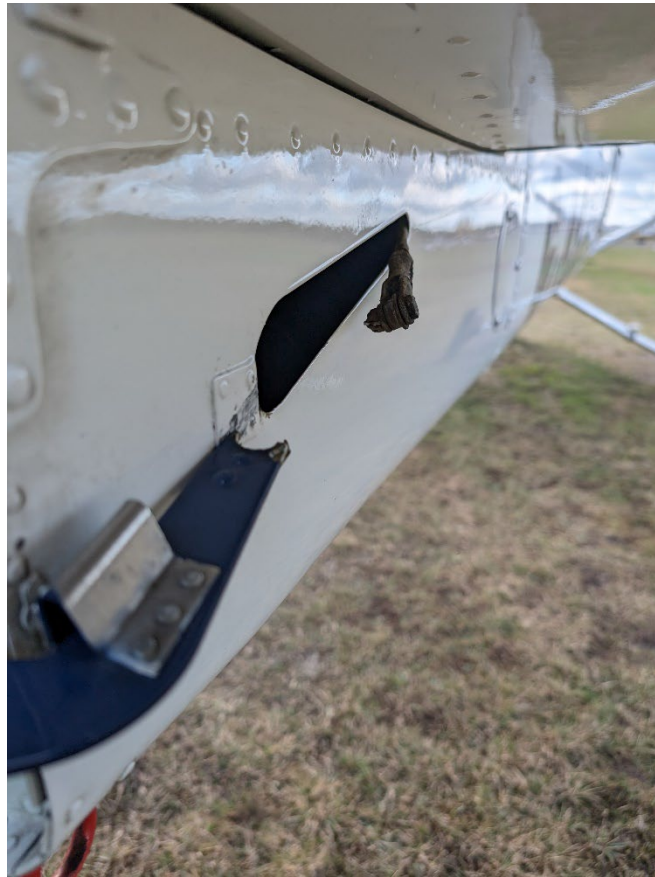
Figure 1

Upon subsequent inspection of the rudder, it was noted that right rudder cable linkage had snapped at the point where it attached to the rudder bellcrank (Figure 1).

View from rear of aircraft looking forward, showing right side rudder bellcrank and detached rudder cable clevis

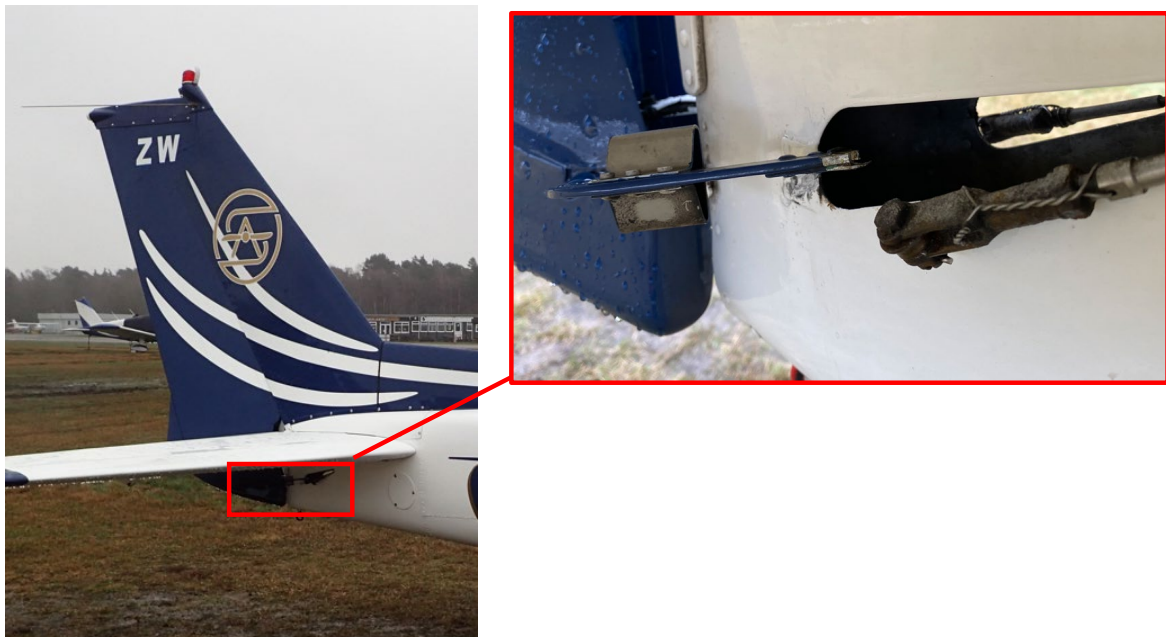
**Figure 2**

Examination of the aircraft revealed that the rudder bellcrank had failed across its full width at the attachment point for the right rudder cable, such that the rudder cable was no longer connected to the rudder (Figure 2). The tip of the bellcrank was missing, presumably having separated in-flight.

Contact and paint transfer between the inboard edge of the bellcrank and the airframe rub-plate was evident, indicating the bellcrank had been fouling on the structure. However, the paint on the rub-plate was not fully worn through. Corresponding mechanical wear was present on the inner edge of the bellcrank with full paint removal and the underlying metal worn to an uneven, but shiny finish. Paint was also absent on the outboard edge of the bellcrank in the area of the failure. Surface corrosion was visible on the right and left rudder cable clevis at the bellcrank attachment.

Side view of rudder showing failed bellcrank (inset)

Following the bellcrank failure, a new rudder assembly was fitted to the aircraft. The maintenance organisation reported that the original rudder was later inspected and found to be straight along its entire length. A new bellcrank assembly was installed and the original rudder was subsequently refitted to G-BSZW at the next scheduled maintenance check. A rigging/range of movement check was carried out at that time and the bellcrank did not come in to contact with the fuselage.

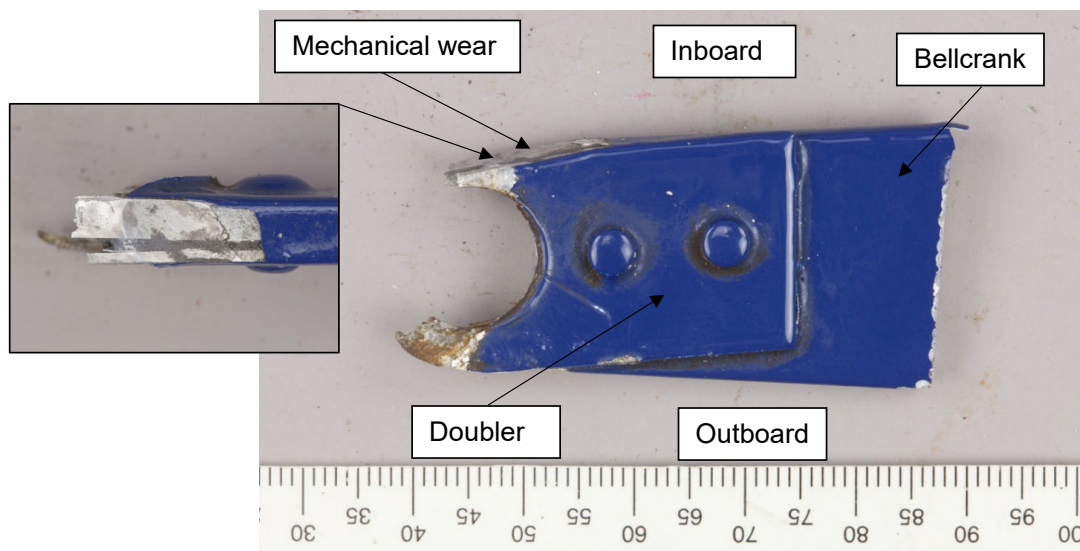
**Figure 3**

The maintenance organisation retained the main body of the bellcrank, but the left and right bellcrank ends and the corresponding clevis assemblies were removed for metallurgical examination. The mechanical wear on the inboard edge of the right side bellcrank had resulted in extensive material removal and smearing but it appeared that the wear had reached a point where it had stopped progressing, possibly due to the rudder bumper stops limiting further contact (Figure 3).

View on lower surface of bellcrank, showing failure across attachment hole and mechanical wear (inset)

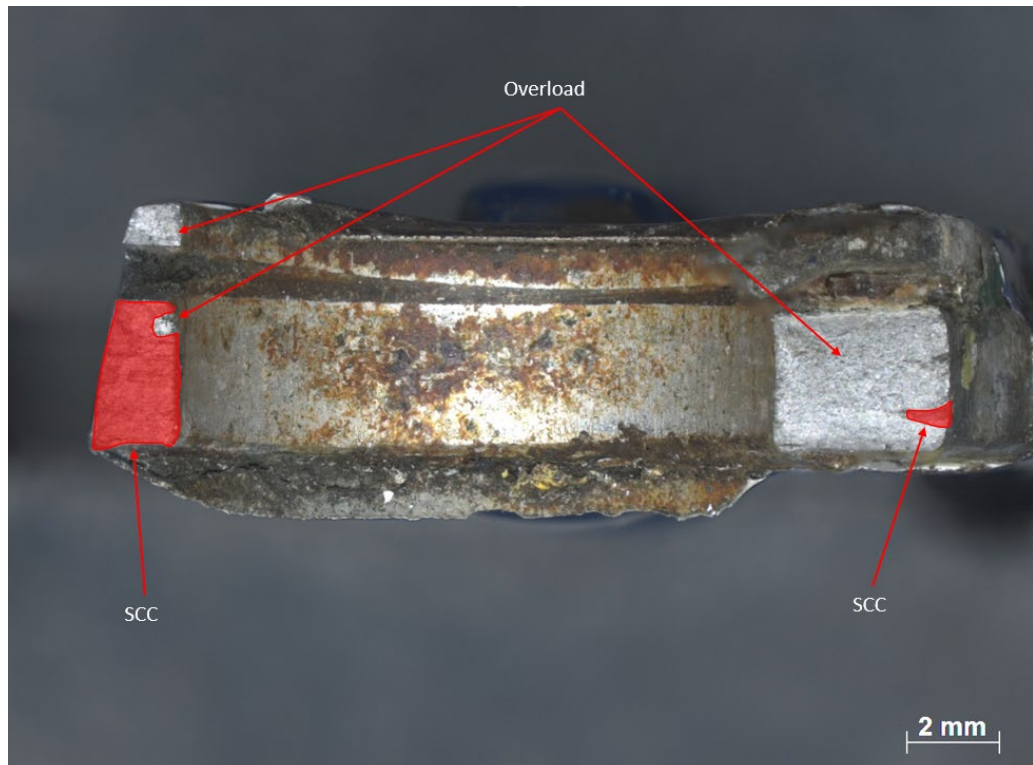
Figure 4

Examination of the fracture surface identified that the failure was predominantly due to stress corrosion cracking (SCC), denoted by red shading in Figure 4.

Also of note was a small area of intergranular fracture on the outboard side of the fracture surface, which appeared to be the start of SCC. The paint on the outboard edge of the bellcrank was also missing, so corrosion protection had been compromised.

End-on view of fracture surface showing predominant failure mode of SCC

The failure occurred as a result of SCC which initiated on the inboard edge of the bellcrank, in a location where the bellcrank had been fouling against the fuselage rub-plate. The resulting wear left bare metal exposed on the inboard edge of the bellcrank without any corrosion protection, leading to the initiation of corrosion on this surface. The associated material removal would have substantially reduced the cross section of the bellcrank inboard of the attachment hole, leading to increased stress in this area. The combination of corrosion and increased stress precipitated the initiation of a stress corrosion crack, which propagated through the thickness of the bellcrank, until it finally failed in overload when insufficient material remained to carry the loads imparted by the rudder control circuit. A second, much smaller SCC initiation site was also present at the outboard edge of the bellcrank, where the surface protection was also compromised, but the cracking had not progressed to the same extent as that on the inboard side.

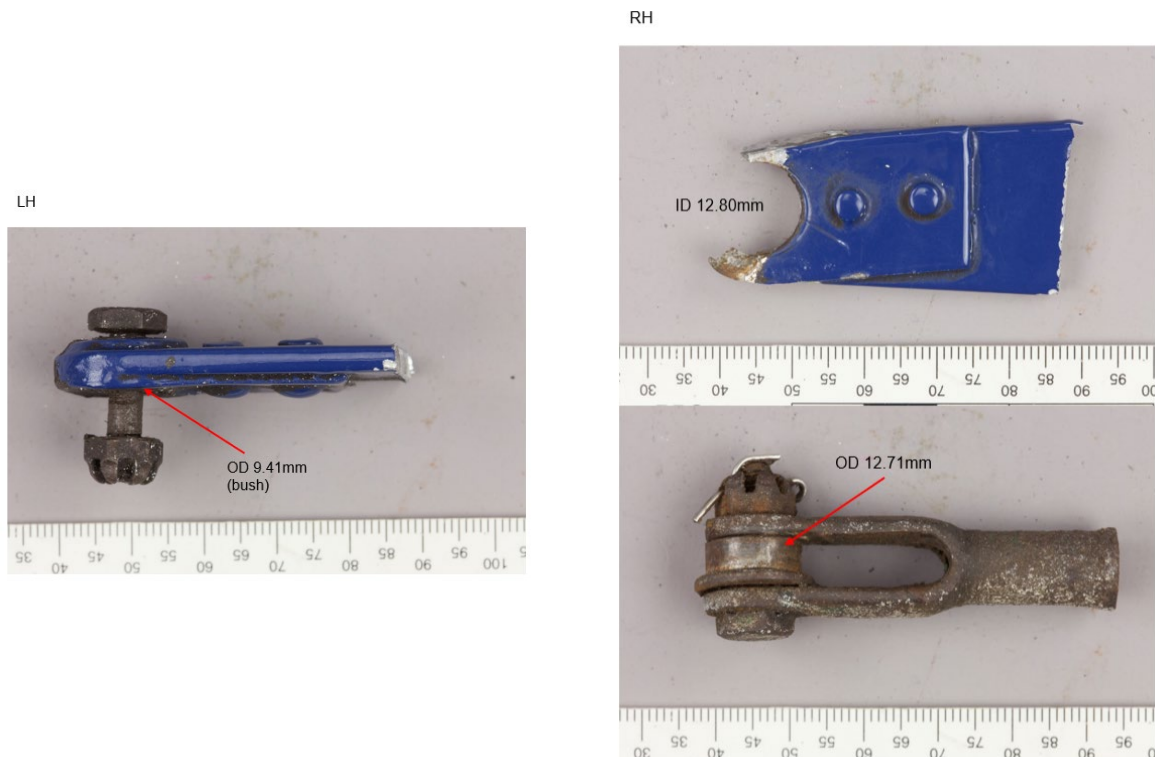
**Figure 5**

According to the Cessna 152 Illustrated Parts Catalogue (IPC), the rudder cable clevis is attached to the bellcrank by a bolt, plain bush and a castellated nut secured by a split pin. During the examination of the failed bellcrank, it was noted the bolt stack for the right rudder cable clevis included an additional washer and top-hat style bush, rather than a plain bush. The outer diameter of the top-hat bush was 12.71 mm and the internal diameter of the bellcrank attachment hole was 12.80 mm. By comparison, the outer diameter of the bush in the left side bellcrank attachment hole was 9.41 mm (Figure 5). The aircraft manufacturer stated that the bushings should be the same size and that the hole should be centred.

G-BSZW bellcrank attachment dimensions

The bolt stack attaching the right rudder cable to the rudder bellcrank did not conform to the C152 IPC. The bushing was larger and of a different style to that specified, which indicates that the attachment hole had been oversized at some point. This could also have contributed to the reduced cross section of the bellcrank.
