AAIB Bulletin

6/2025

Aircraft Type and Registration:	Airbus Helicopters EC175 B, G-MCSH	
No & Type of Engines:	2 Pratt & Whitney Canada PT6C-67E turboshaft engines	
Year of Manufacture:	2018 (Serial no: 5034)	
Date & Time (UTC):	17 February 2023 at 0900 hrs	
Location:	Elgin Oil Platform, North Sea	
Type of Flight:	Commercial	
Persons on Board¹:	Crew - None	Passengers - None
Injuries:	Crew - N/A	Passengers - N/A
Nature of Damage:	Four rotor blades detached. Damage to helicopter fuselage	
Commander's Licence:	Airline Transport Pilot's Licence	
Commander's Age:	38 years	
Commander's Flying Experience:	4,703 hours (of which 2,159 hours were on type) Last 90 days - 91 hours Last 28 days - 30 hours	
Information Source:	AAIB Field Investigation

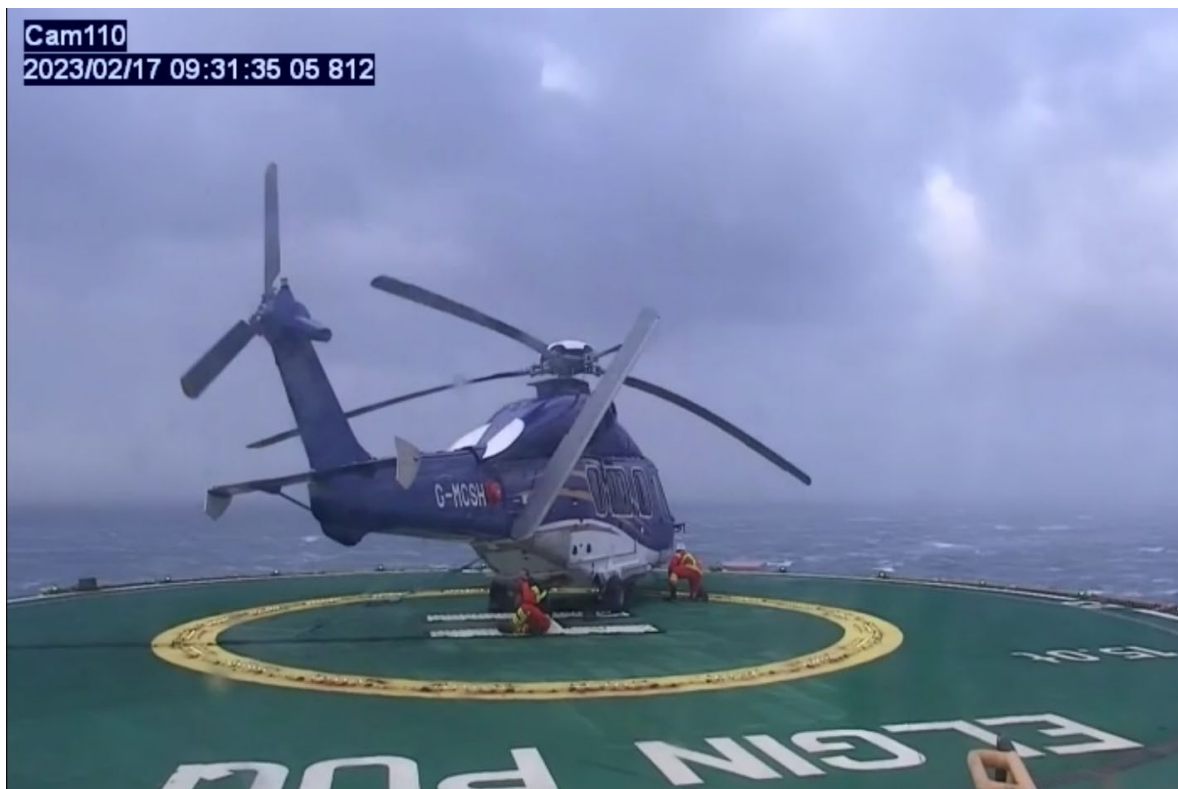
Figure 1

CCTV image of G-MCSH blade fracturing and striking fuselage close to helideck crew member trying to secure the rear of the helicopter
(courtesy Total Energies E&P UK Limited)

The four remaining blades continued to rotate, with increasingly strong wind conditions causing them to sail. Over the next 1 hour 40 minutes three of the remaining blades lifted at different times to the point where they also failed. The broken blades remained on the helideck and were later recovered.

The four broken main rotor blades had all fractured in the aerofoil section just outboard of where the root transitions to the aerofoil. Each of the fractured blades had failed in bending associated with being forced upward.

The left side of the helicopter fuselage showed multiple impact marks indicating where the failed blades had struck it, including cracks and holes to the left pilot's seat door window and the loss of the external emergency door handle.

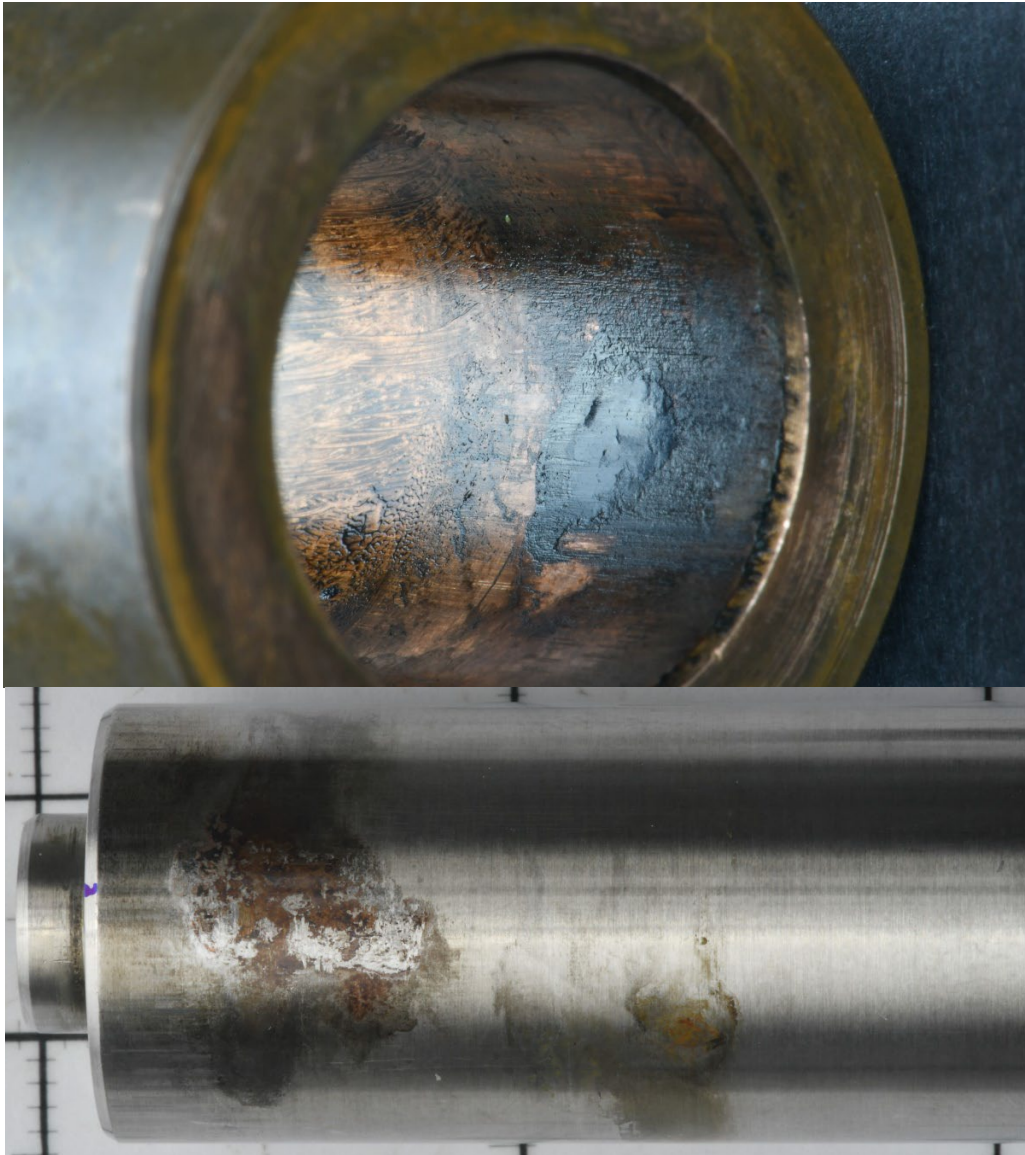
Figure 12

Removal of the right pad guide from its associated ring required differential heating and considerable force to separate the components. The components were designed to move freely within one another but examination by the helicopter manufacturer's laboratory identified deposits of 'coked' organic products had caused them to seize (Figure 12). The origin of the deposits could not be determined.

Fretting and deposits on inner diameter of ring (upper image) and associated damage on pad guide (bottom)

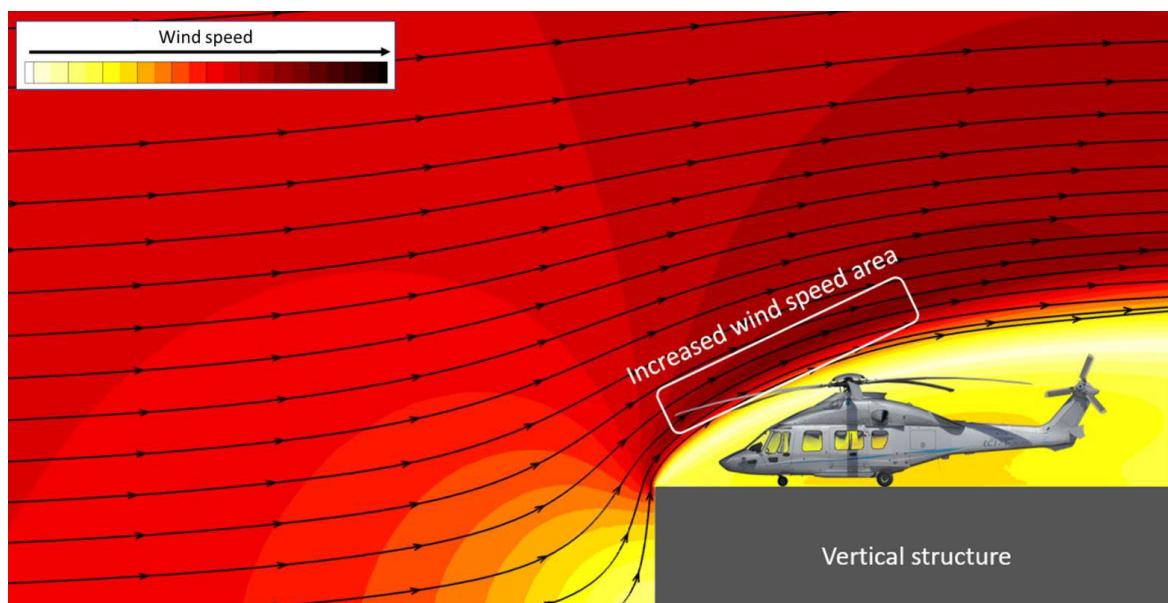
Figure 13

On 11 October 2023 Airbus published SIN No. 3947-S-00 (Appendix 2) describing the 'cliff edge' effect that local topography can have on windspeed and direction. The phenomenon is where wind is funnelled over a structure causing an up draft. This updraft increases the wind incidence of the rotor blades causing them to lift furthermore into the updraft, exacerbating the issue (Figure 13).

Extract from Airbus SIN 3947-S-00 describing cliff edge effect on rotor blades near the edge of vertical structures

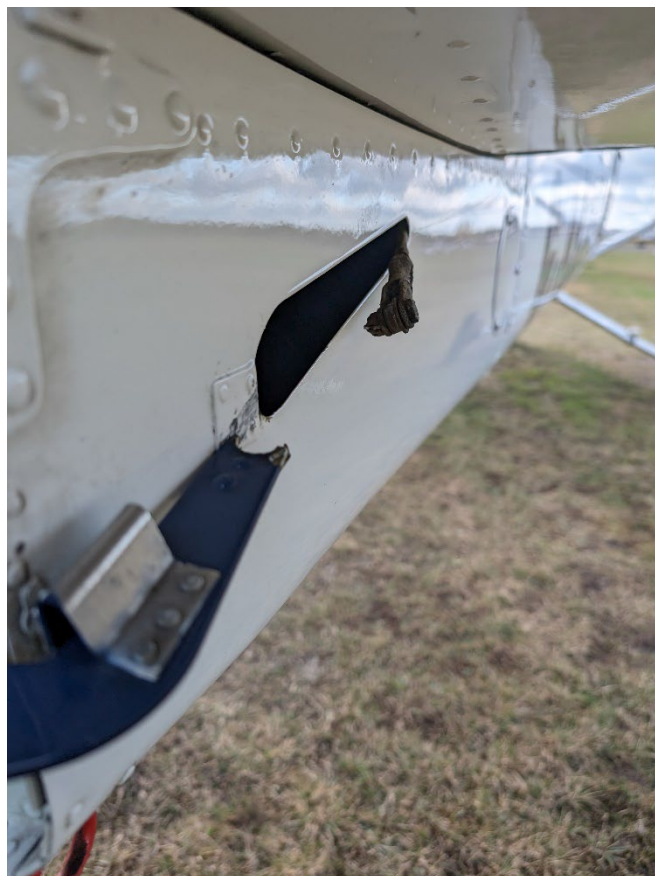
Figure 1

Upon subsequent inspection of the rudder, it was noted that right rudder cable linkage had snapped at the point where it attached to the rudder bellcrank (Figure 1).

View from rear of aircraft looking forward, showing right side rudder bellcrank and detached rudder cable clevis

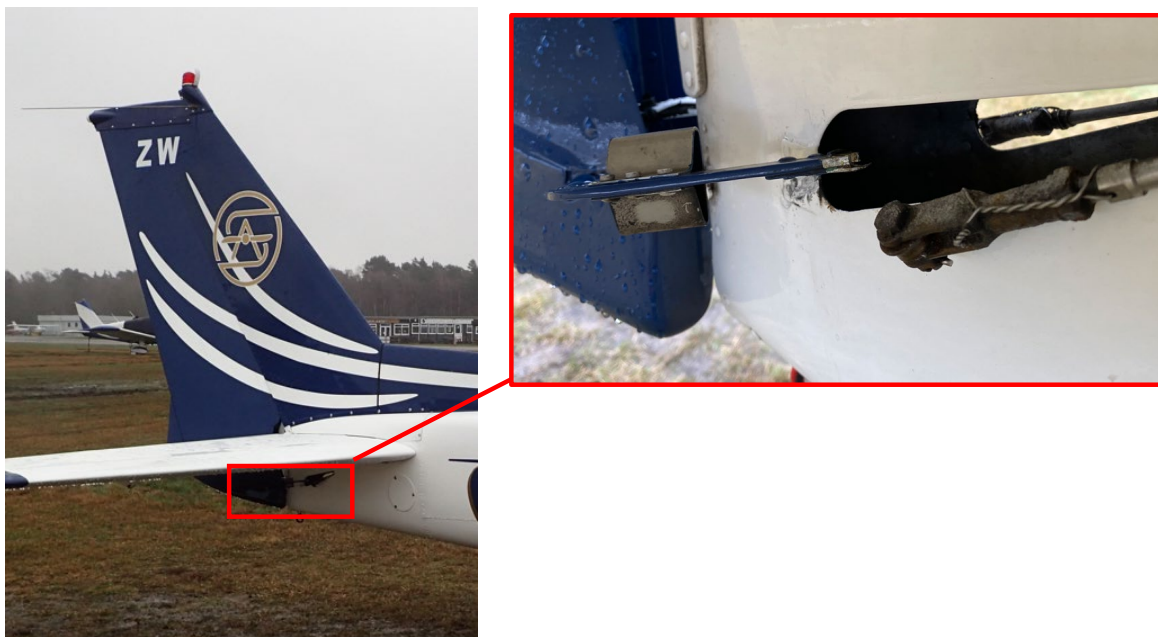
**Figure 2**

Examination of the aircraft revealed that the rudder bellcrank had failed across its full width at the attachment point for the right rudder cable, such that the rudder cable was no longer connected to the rudder (Figure 2). The tip of the bellcrank was missing, presumably having separated in-flight.

Contact and paint transfer between the inboard edge of the bellcrank and the airframe rub-plate was evident, indicating the bellcrank had been fouling on the structure. However, the paint on the rub-plate was not fully worn through. Corresponding mechanical wear was present on the inner edge of the bellcrank with full paint removal and the underlying metal worn to an uneven, but shiny finish. Paint was also absent on the outboard edge of the bellcrank in the area of the failure. Surface corrosion was visible on the right and left rudder cable clevis at the bellcrank attachment.

Side view of rudder showing failed bellcrank (inset)

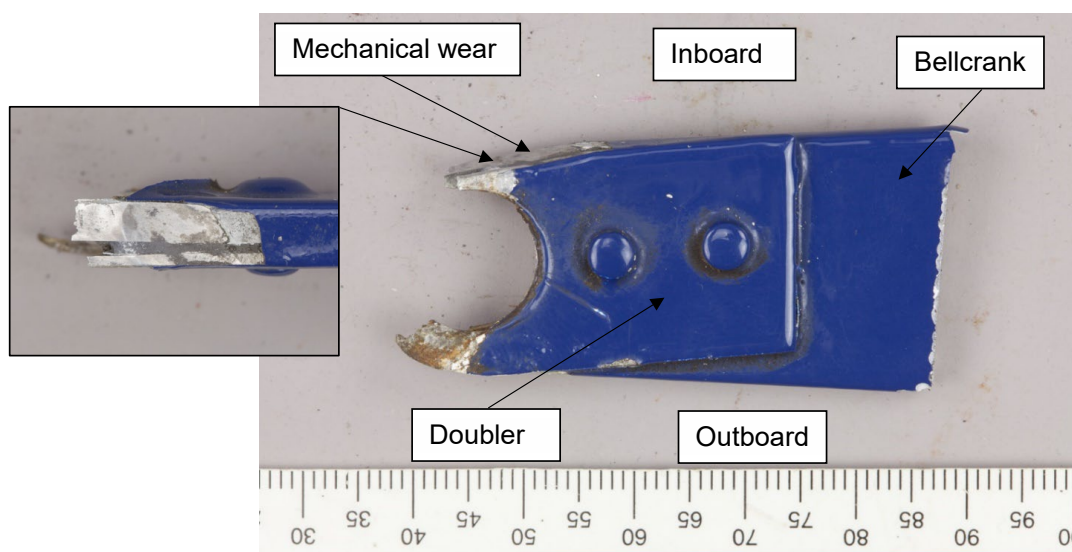
**Figure 3**

The maintenance organisation retained the main body of the bellcrank, but the left and right bellcrank ends and the corresponding clevis assemblies were removed for metallurgical examination. The mechanical wear on the inboard edge of the right side bellcrank had resulted in extensive material removal and smearing but it appeared that the wear had reached a point where it had stopped progressing, possibly due to the rudder bumper stops limiting further contact (Figure 3).

View on lower surface of bellcrank, showing failure across attachment hole and mechanical wear (inset)

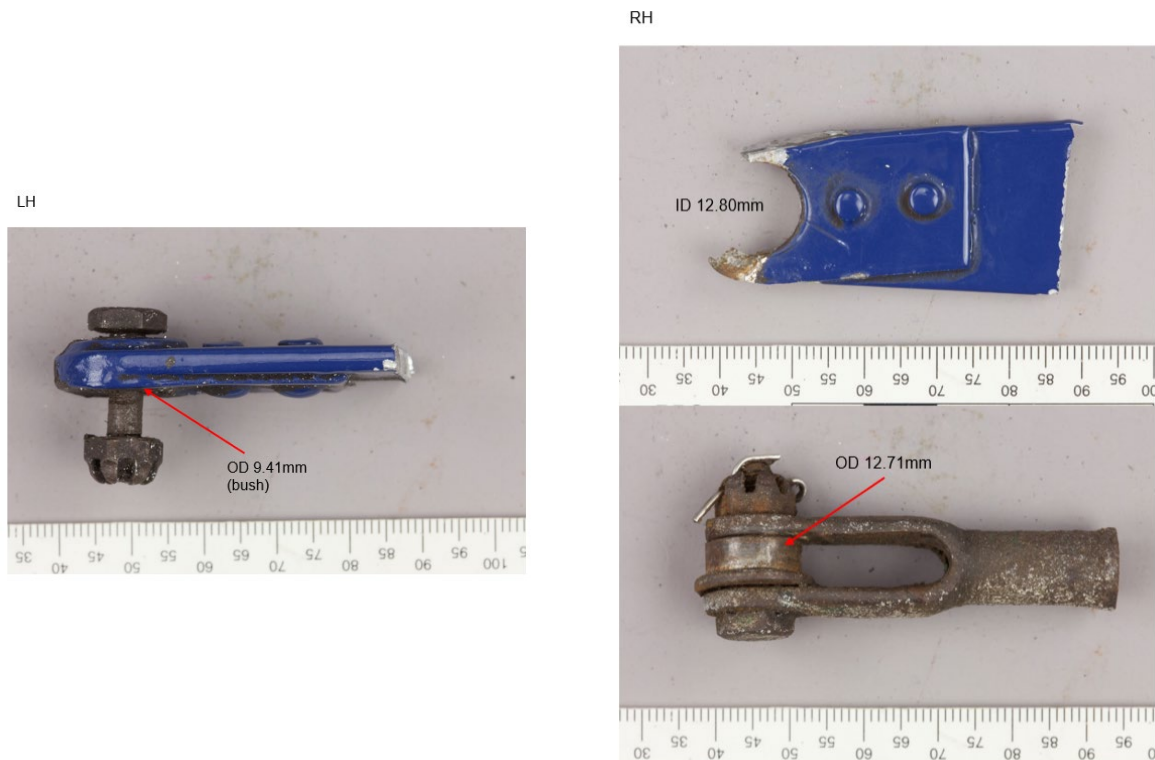
**Figure 5**

According to the Cessna 152 Illustrated Parts Catalogue (IPC), the rudder cable clevis is attached to the bellcrank by a bolt, plain bush and a castellated nut secured by a split pin. During the examination of the failed bellcrank, it was noted the bolt stack for the right rudder cable clevis included an additional washer and top-hat style bush, rather than a plain bush. The outer diameter of the top-hat bush was 12.71 mm and the internal diameter of the bellcrank attachment hole was 12.80 mm. By comparison, the outer diameter of the bush in the left side bellcrank attachment hole was 9.41 mm (Figure 5). The aircraft manufacturer stated that the bushings should be the same size and that the hole should be centred.

G-BSZW bellcrank attachment dimensions
