Accident

Aircraft Type and Registration:	Piper PA-23-250, G-BKJW	
No & Type of Engines:	2 Lycoming IO-540-C4B5 piston engines	
Year of Manufacture:	1971 (Serial no: 27-4716)	
Date & Time (UTC):	6 July 2023 at 1845 hrs	
Location:	1 nm south-west of Bagby Airfield, North Yorkshire	
Type of Flight:	Private	
Persons on Board:	Crew - 1	Passengers - None
Injuries:	Crew - 1 (Fatal)	Passengers - N/A
Nature of Damage:	Aircraft destroyed and burnt	
Commander's Licence:	Private Pilot's Licence	
Commander's Age:	21 years	
Commander's Flying Experience:	440 total hours (3 hours on type) to 2 June 2023 ¹ Last 90 days – 46 hours to 2 June 2023 ¹ Last 28 days – not known ¹	
Information Source:	AAIB Field Investigation

Synopsis

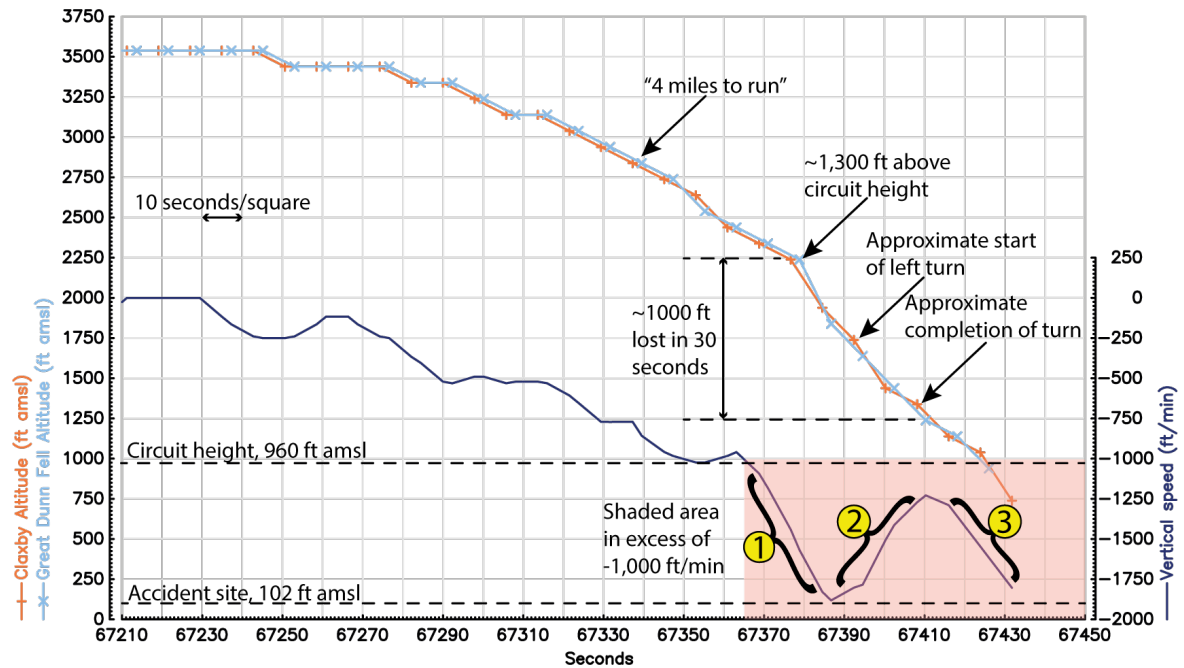
Figure 2

Two of the en route NATS radar heads, at Claxby and Great Dunn Fell, tracked G-BKJW until radar coverage was lost just prior to the accident. Altitude data from these radar sites, as well as the descent rate calculated using both sets of radar data, are shown in Figure 2. The last radar return for G-BKJW at 18:43:52 was 875 m south-southeast of the accident site and the reported altitude was 740 ft amsl. The descent rate data shows that 70 seconds prior to the last radar return, G-BKJW's descent rate increased markedly reaching 1,800 ft/min (point 1 on Figure 2), before briefly reducing toward 1,000 ft/min (point 2), and then increasing again until radar coverage was lost (point 3). The average groundspeed during the rapid descent prior to the turn on to base was about 168 kt. An overview of the final radar ground track from Claxby is shown in Figure 3.

Altitude data and calculated descent rate derived from radar for G-BKJW

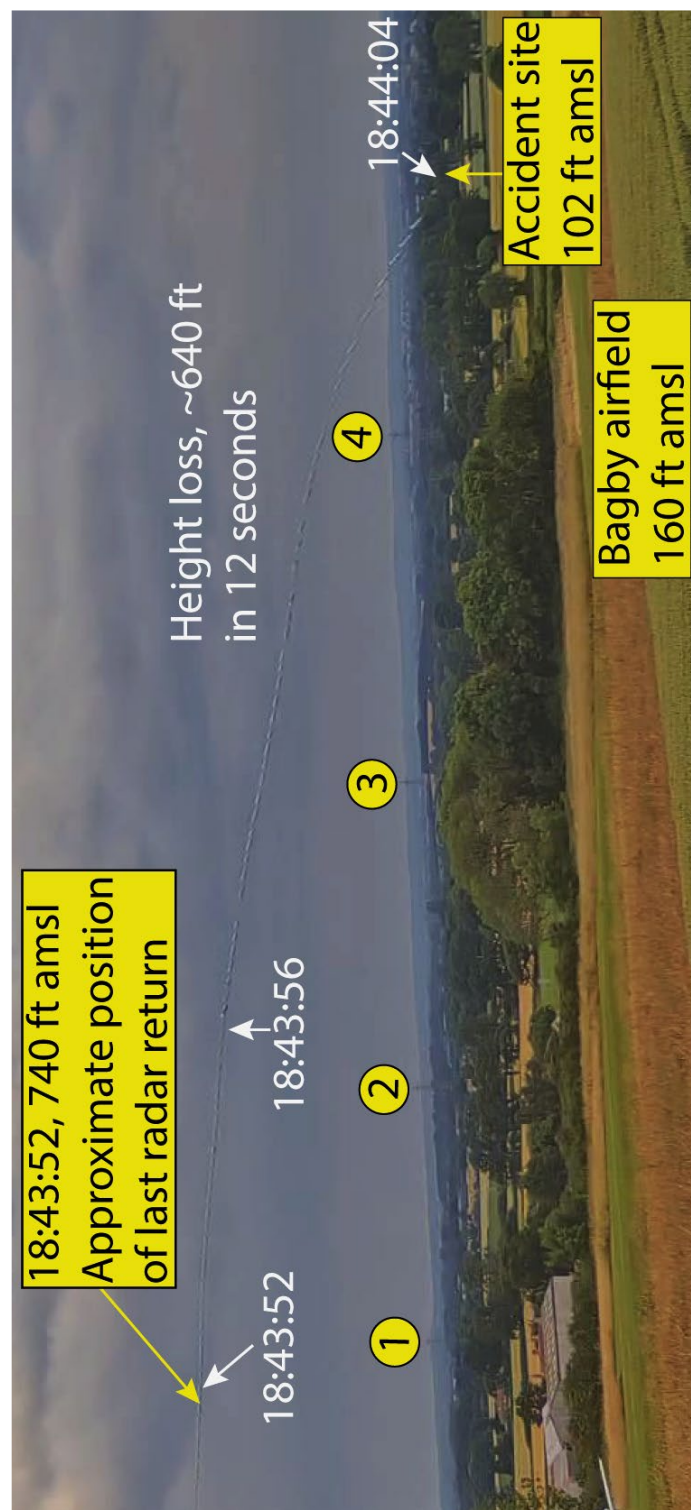
Figure 4

Composite CCTV image of G-BKJW descent into terrain

Several electricity pylons are visible in this image, numbered 1 through 4, and G-BKJW's groundspeed was calculated by timing the passage of the aircraft between these points, using an assumed ground path for G-BKJW between the position of the last radar return and the accident site. These calculations resulted in an estimate for G-BKJW groundspeed of approximately 122 kt, although the associated error in these calculations may be as much as ± 18 kt. With the reported 10 kt wind from the south, G-BKJW's airspeed would have been approximately 112 kt ± 18 kt. A close-up of the aircraft's final descent is shown in Figure 5.

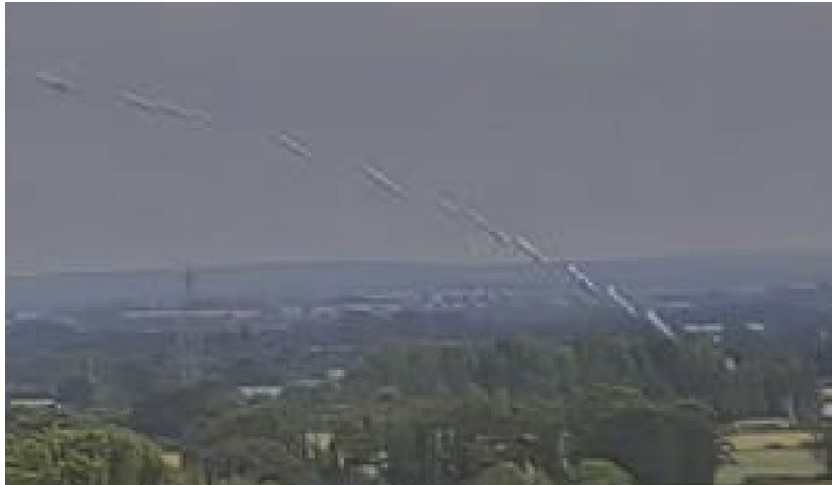
Figure 5

Close-up of final descent from composite CCTV image

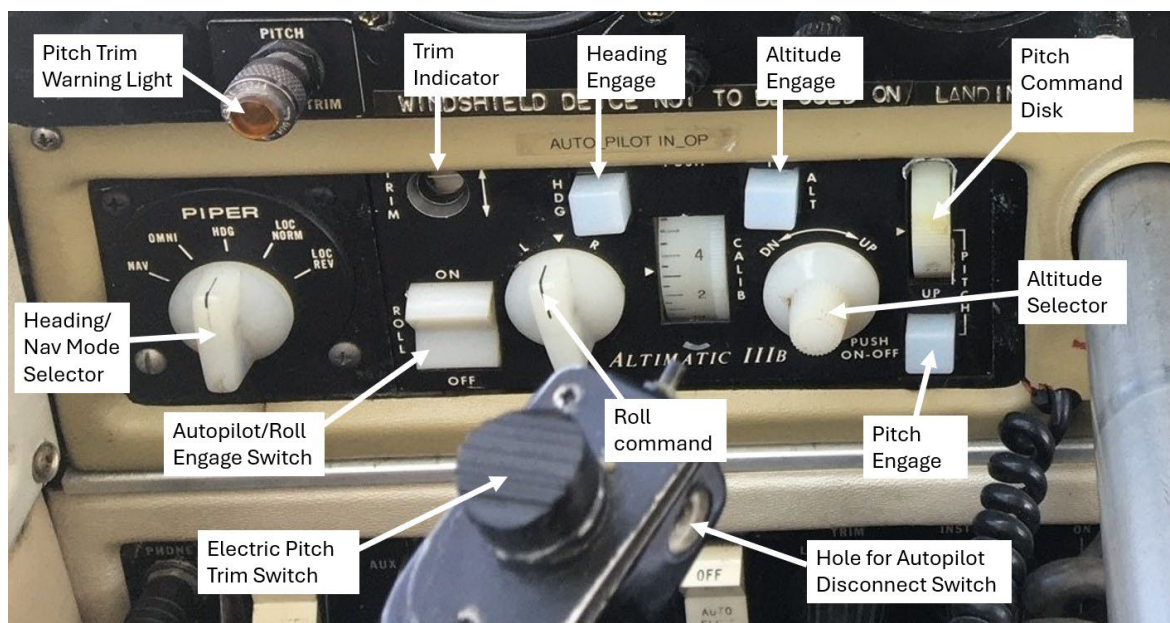
**Figure 12**

The aircraft was equipped with a Piper Altimatic IIIB autopilot system that was placarded inoperative but known to have some functionality. The build record for G-BKJW revealed that this system had been fitted at original manufacture. It was an analogue autopilot system that had three servos to control the ailerons, the stabilator and the pitch trim tab respectively. Its control console was fitted to the lower instrument panel on the pilot's left side (Figures 11 and 12). The autopilot was turned on by pressing the Autopilot/Roll engage switch. This would engage the autopilot in roll mode which could then maintain a selected bank angle or be used to track a heading after pressing the heading engage button. The pitch mode was engaged using a separate Pitch Engage button. Prior to engaging the pitch mode it was important to centre the trim indicator using the Pitch Command Disk. If this was not done the aircraft would pitch up or down upon pitch mode engagement. Once the pitch mode was engaged the Pitch Command Disk could be used to select a desired pitch angle up to 8° nose-up or 6° nose-down, or the Altitude Selector could be used to select a desired altitude. The autopilot was disengaged by either pressing the Autopilot/Roll Engage switch OFF, or by pressing the autopilot disconnect switch on the control yoke; however, the yoke mounted disconnect switch was not fitted on G-BKJW – there was an empty hole for it (Figure 12).

Altimatic IIIB Autopilot Console fitted to G-BKJW

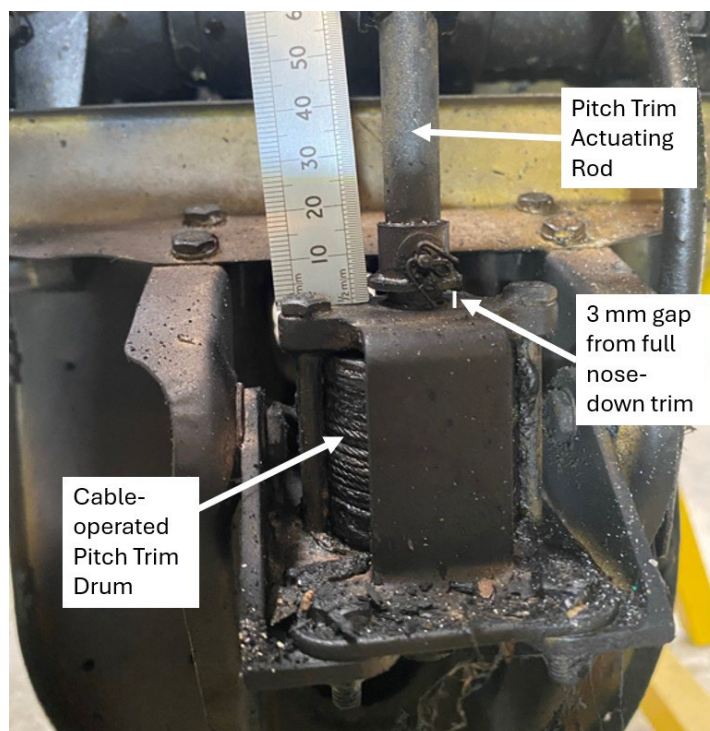
**Figure 16**

The pitch trim tab moved freely and in the correct direction (opposite to the direction of the stabilator) when the stabilator was moved up and down, in its function as an anti-servo tab. The pitch trim tab actuating arm was connected to a rod that was actuated by the cable-operated pitch trim drum. The pitch drum translates up or down when the cable is pulled one way or the other. The drum was found to be in position 3 mm from full drum up, which corresponded to 3 mm from full nose-down trim position (Figure 16). The full range of travel was 13 mm and so it was 10 mm away from full nose-up position. The drum moved freely when the cable was pulled in either direction. It was possible that post-impact break-up forces applied some unequal pressure to the cable causing the pitch trim drum to move.

Position of pitch trim drum post-accident

The pitch trim cable was found to be continuous between the pitch trim drum and the trim handle in the cockpit. Attempts were made to check the rigging of the trim tab, with the stabilator in the neutral position, but the tab was warped from the fire and no longer had a flat surface for accurate angular measurement.

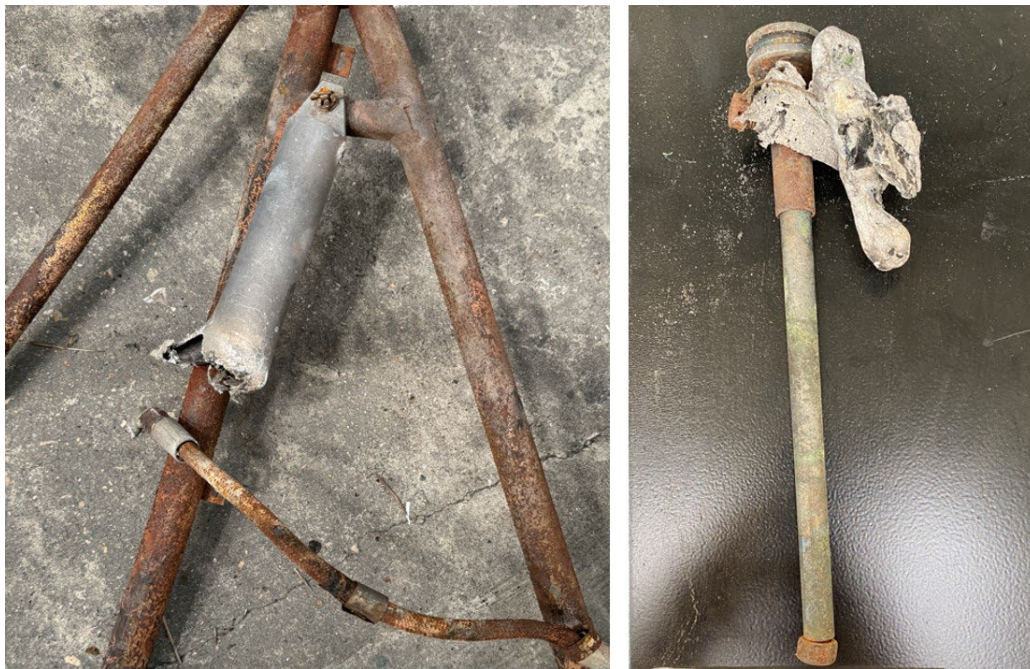
Figure 17

The flap actuator ram had separated from the flap actuator cylinder due to impact forces and fire damage (Figure 17). Once the ram is detached the flaps are free to move and so it was not possible to determine the flap position at impact. The flap actuating components, including the bell crank, flap push-pull rods, torque tube and the torque tube supporting bearing blocks, had suffered multiple failures. These components, including the actuator ram, were sent to a metallurgical lab for detailed forensic examination. The forensic organisation concluded that all the fractures were the result of overload, and that there was no evidence of any progressive crack growth such as fatigue. They also concluded that:

'The overload failure and deformation observed in the flap actuator ram and flap actuator ram rod end is not considered to be consistent with overload which may have occurred if the flaps had been extended while the aircraft was above the maximum permissible speed for flap deployment. If this had occurred, it would be expected that the flap actuator ram would have been in tension, which is not consistent with the degree of deformation/bending observed. This suggests that the failure of the flap actuator ram and rod end was the result of the aircraft impacting the ground.'

Remains of flap actuator cylinder (left) and flap actuator ram (right)

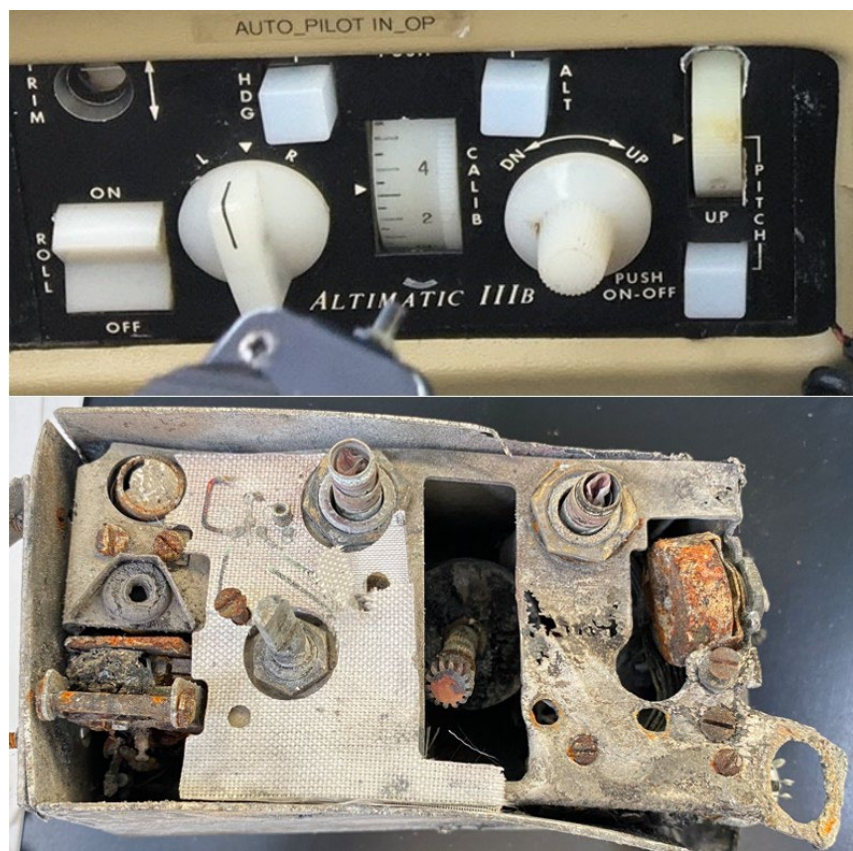
Figure 18

The autopilot and electric trim components were examined with the assistance of an avionics engineer familiar with the autopilot system. The Autopilot Console had suffered significant impact and fire damage (Figure 18). As the Roll ON/OFF switch was a magnetically-held-on switch, the loss of electrical power at impact would have released it so it was not possible to determine if the autopilot was turned on at the time of impact. There were no tungsten

filament remains from the lights inside the HDG, ALT or Pitch ON/OFF buttons, so it could not be determined if these lights had been on at impact. The circuit breaker panel was destroyed with multiple loose circuit breakers so it could not be determined if the autopilot or electric pitch trim circuit breakers were in or out.

Remains of Autopilot Console (lower image)

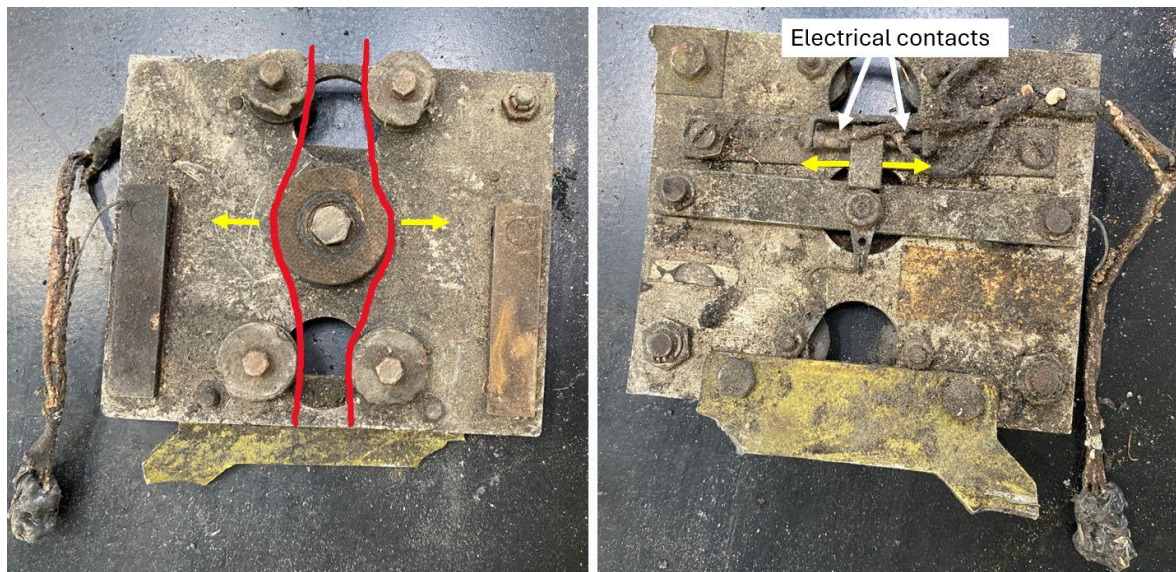
Figure 20

The stabilator control cables had separated from the pitch trim sensor (Figure 20). The central pulley could be moved sideways and contact could be made with each of the electrical contacts on its reverse side. There was some resistance to movement when moving it side to side, but this could have been the result of fire and impact damage, with the panel being slightly bent. The damage meant that it was not possible to determine if the sensor may have stuck in one position.

Pitch trim sensor (red lines show path of stabilator control cables)

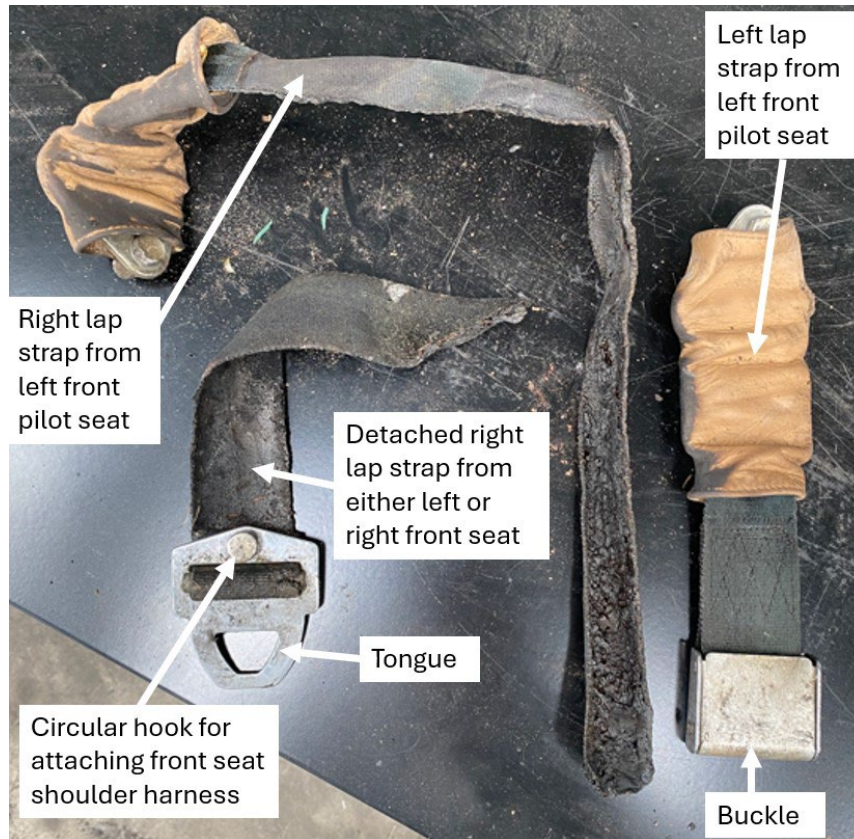
Figure 21

All the seats had separated from the floor structure, and some were thrown clear of the main wreckage, including the front left pilot seat, which was identified by matching the damage at its base with the damage of the left front seat support structure. The left lap strap, with its buckle, was still securely attached to the left side of this seat. The right lap strap was also securely attached to the right side of the seat, but the strap had burnt through and was missing the part of the strap with the tongue that would be inserted into the buckle (Figure 21). A detached right lap strap was found with a tongue that had a circular hook designed to attach a front seat shoulder harness; however, it could not be determined if this was from the front left or front right seat. Both front seat shoulder harnesses and inertial reels were severely fire damaged.

Lap strap remains from left front pilot seat (after removing the bolts attaching them to the seat) and tongue strap from either the left or right front seat
