# ***AAIB Bulletin***

***6/2025***

Published: 12 June 2025.

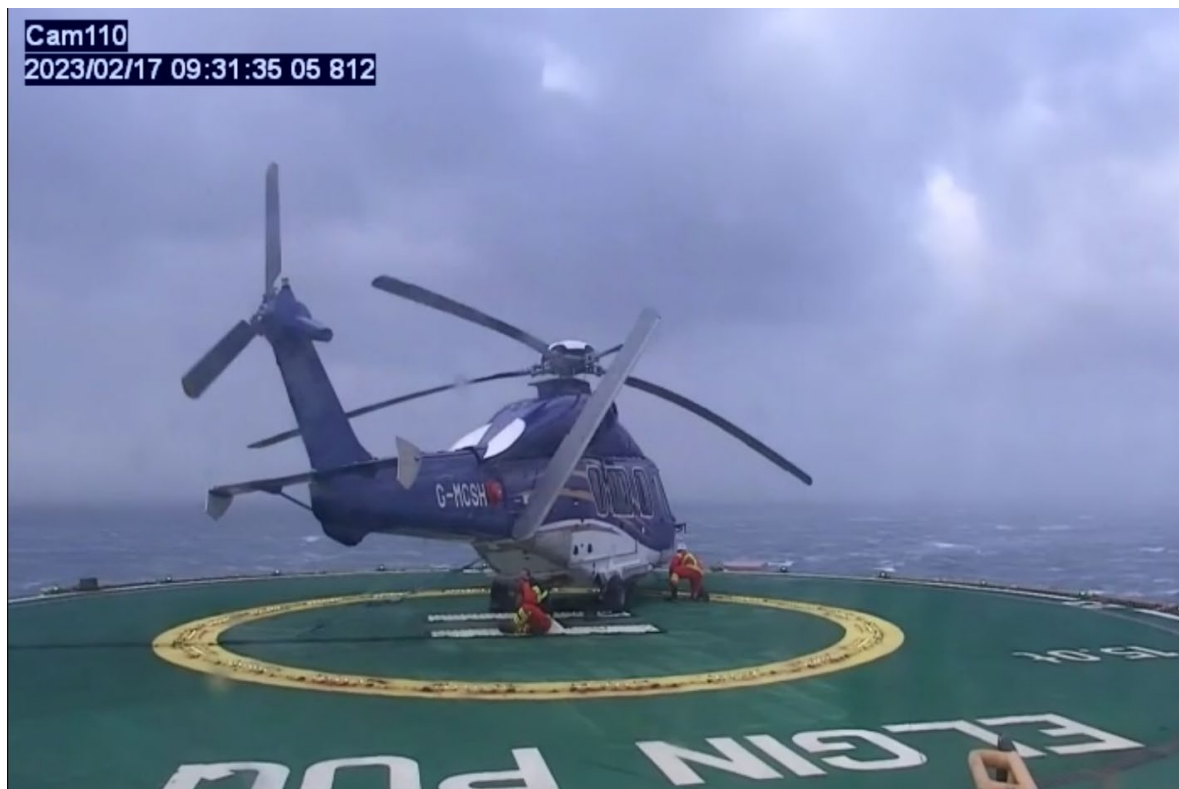
**Figure 1**

CCTV image of G-MCSH blade fracturing and striking fuselage close to helideck crew member trying to secure the rear of the helicopter  
(courtesy Total Energies E&P UK Limited)

The four remaining blades continued to rotate, with increasingly strong wind conditions causing them to sail. Over the next 1 hour 40 minutes three of the remaining blades lifted at different times to the point where they also failed. The broken blades remained on the helideck and were later recovered.

The four broken main rotor blades had all fractured in the aerofoil section just outboard of where the root transitions to the aerofoil. Each of the fractured blades had failed in bending associated with being forced upward.

The left side of the helicopter fuselage showed multiple impact marks indicating where the failed blades had struck it, including cracks and holes to the left pilot's seat door window and the loss of the external emergency door handle.

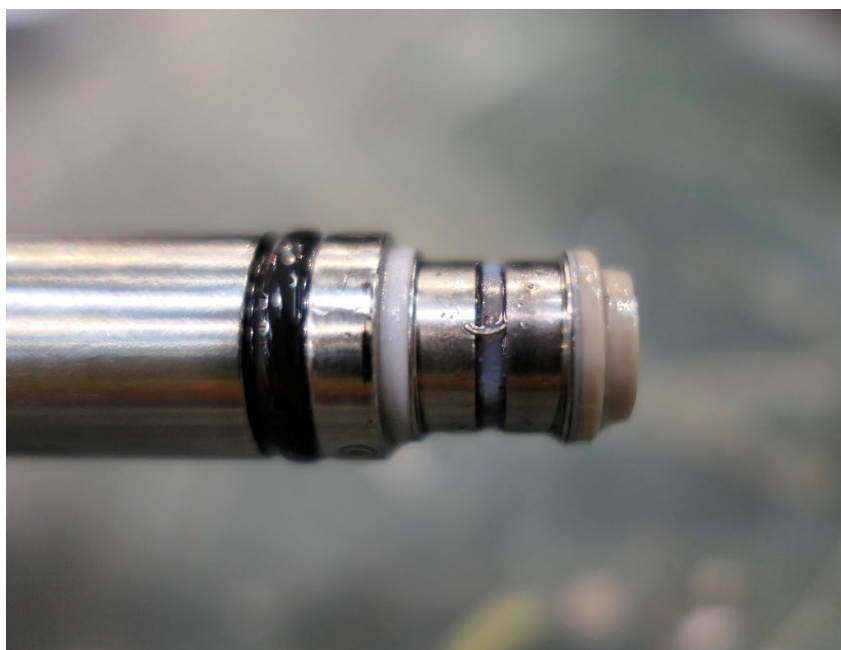
**Figure 8**

On removal of the TGB chip detector, it was found that a fragment of a spring reinforced seal was the cause of the TGB XMSN CHIP caution (Figure 8). The sliding collar assembly fitted to the TGB on G-MCSH had previously been replaced due to a similar seal fragment causing a chip caution. This was associated with the failure of a seal, damaged when the sliding collar assembly was fitted.

Fragment on tail rotor gearbox chip detector

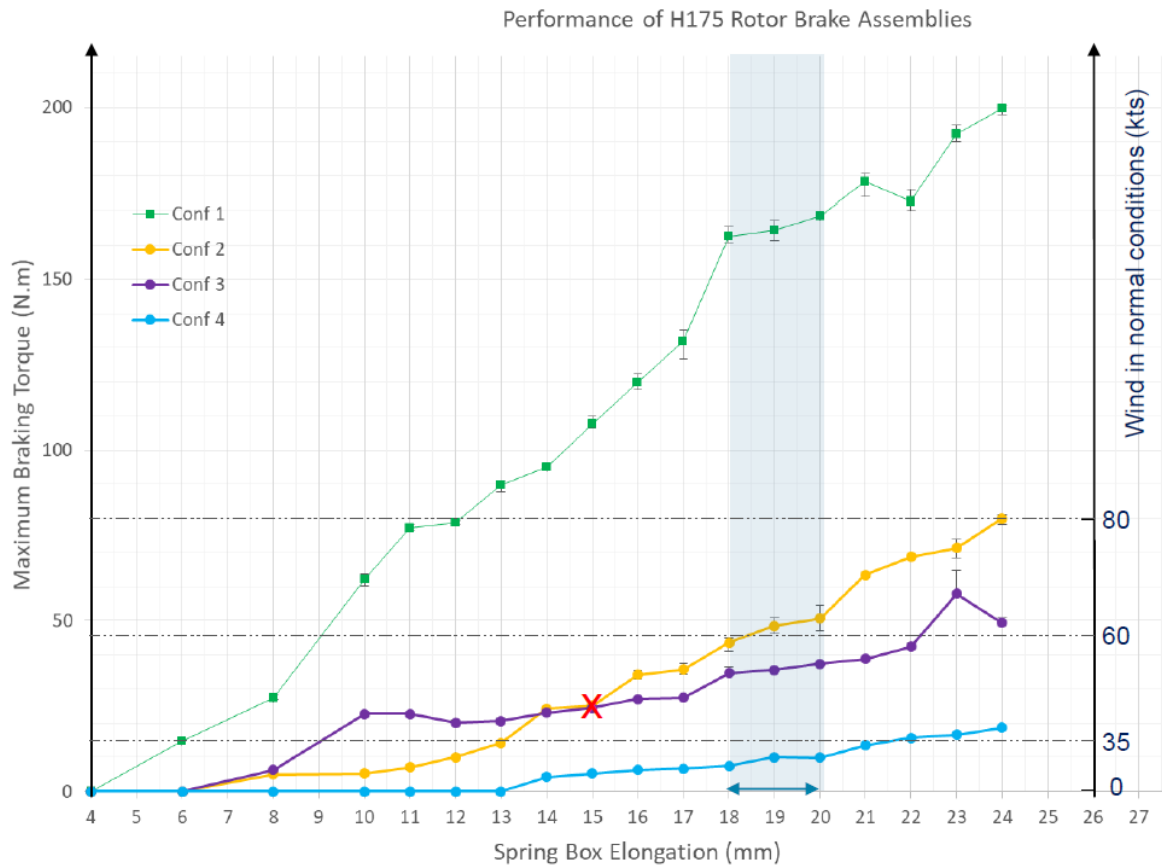
The rotor brake was found to be partially seized, such that when the brake was applied only one of the pad springs would compress. This resulted in uneven pressure being applied to the brake disc, thus reducing the braking force that could be applied to slow and stop the rotor system. The spring box setting was measured to be 15 mm in comparison to 18–20 mm when the brake is setup in accordance with the AMM.

**Figure 9**  
Breakout test results of rotor brake assemblies

The maximum braking torque, which was the torque applied through the gearbox when the brake started to slip, could be directly linked to the torque on the rotor head and equated to the load imparted on the rotor by the wind when acting horizontally within the arc of  $\pm 30^\circ$  from the nose of the helicopter.

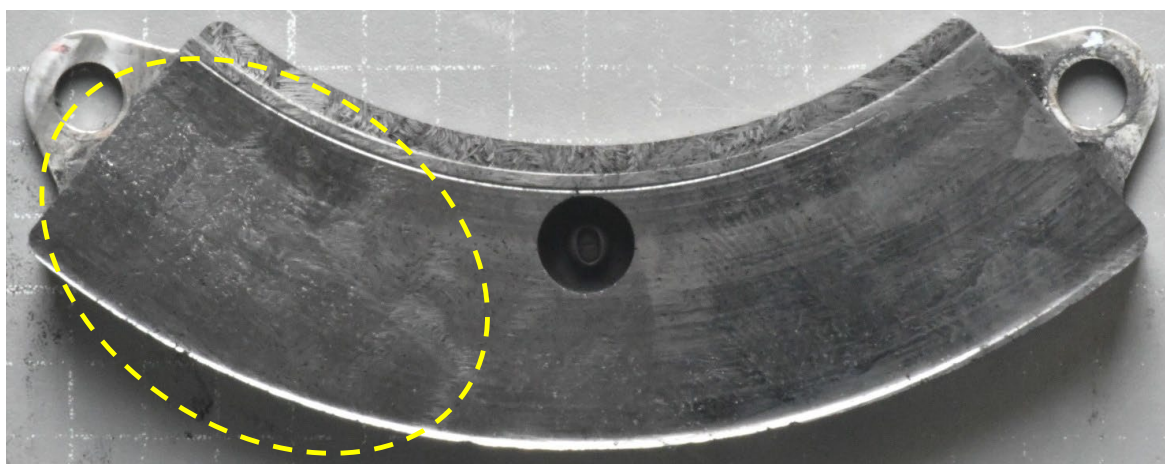
**Figure 10**

The examination identified that the right brake pad guide had seized in its ring and would not allow movement of the brake pad on that side. The left brake guide was free to move and, therefore, when the brake was applied, the mobile pad moved unevenly only contacting the disc over approximately 1/3 of the brake pad area (Figure 10). Similarly, the fixed pad exhibited uneven but opposite wear (Figure 11).

Mobile rotor brake pad showing area of most wear

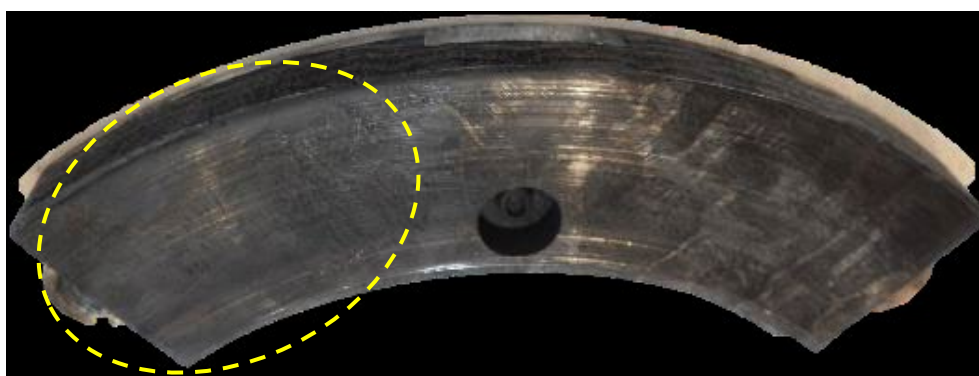
**Figure 11**

Fixed rotor brake pad showing area of most wear

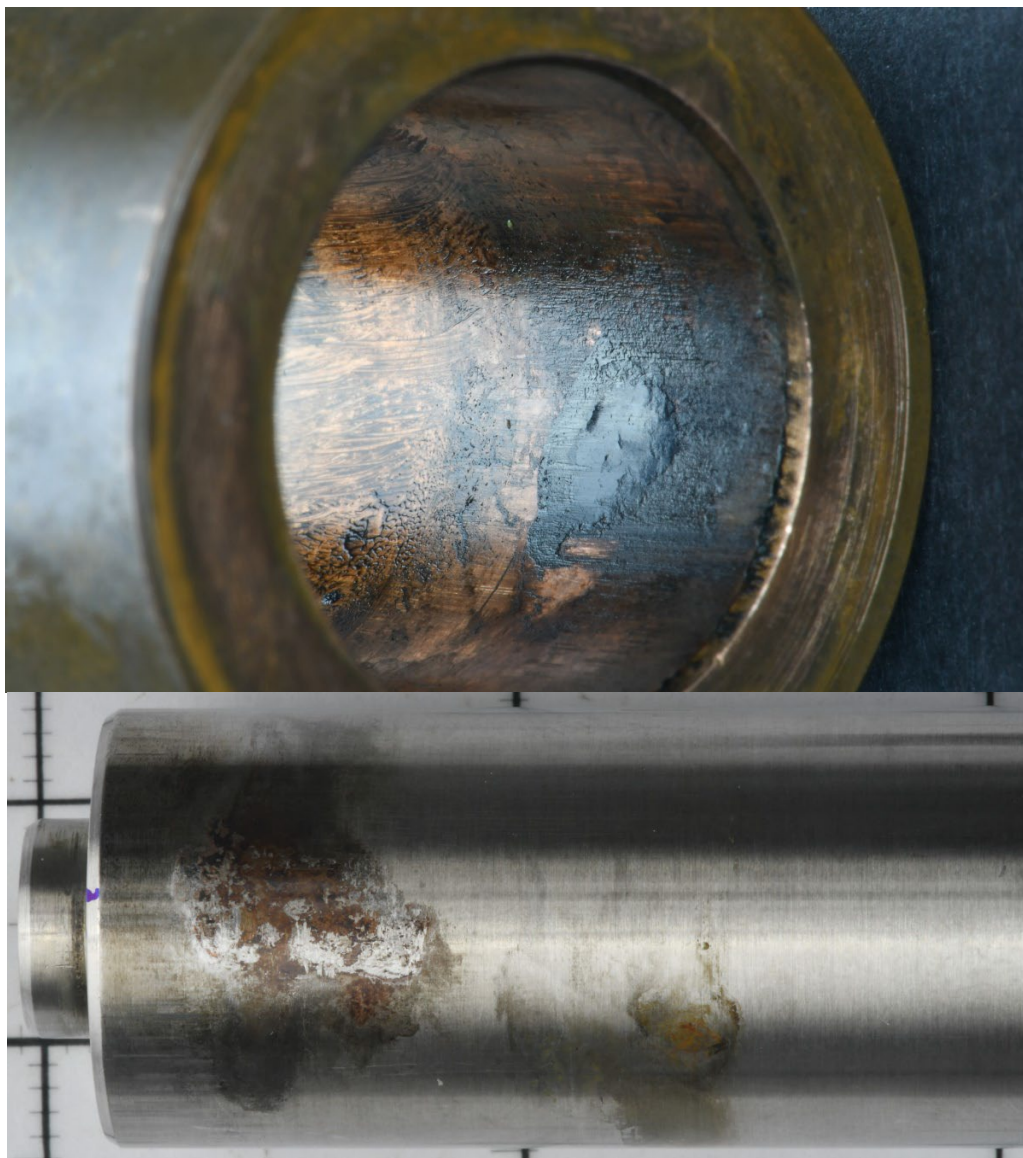
**Figure 12**

Removal of the right pad guide from its associated ring required differential heating and considerable force to separate the components. The components were designed to move freely within one another but examination by the helicopter manufacturer's laboratory identified deposits of 'coked' organic products had caused them to seize (Figure 12). The origin of the deposits could not be determined.

Fretting and deposits on inner diameter of ring (upper image) and associated damage on pad guide (bottom)

Having decided to remain on the platform, the failure of the rotor brake to operate effectively allowed the rotor head to continue turning. The investigation found that the rotor brake right pad guide was seized within its ring, the cause of which was identified to be a build up of organic material at the interface between components.

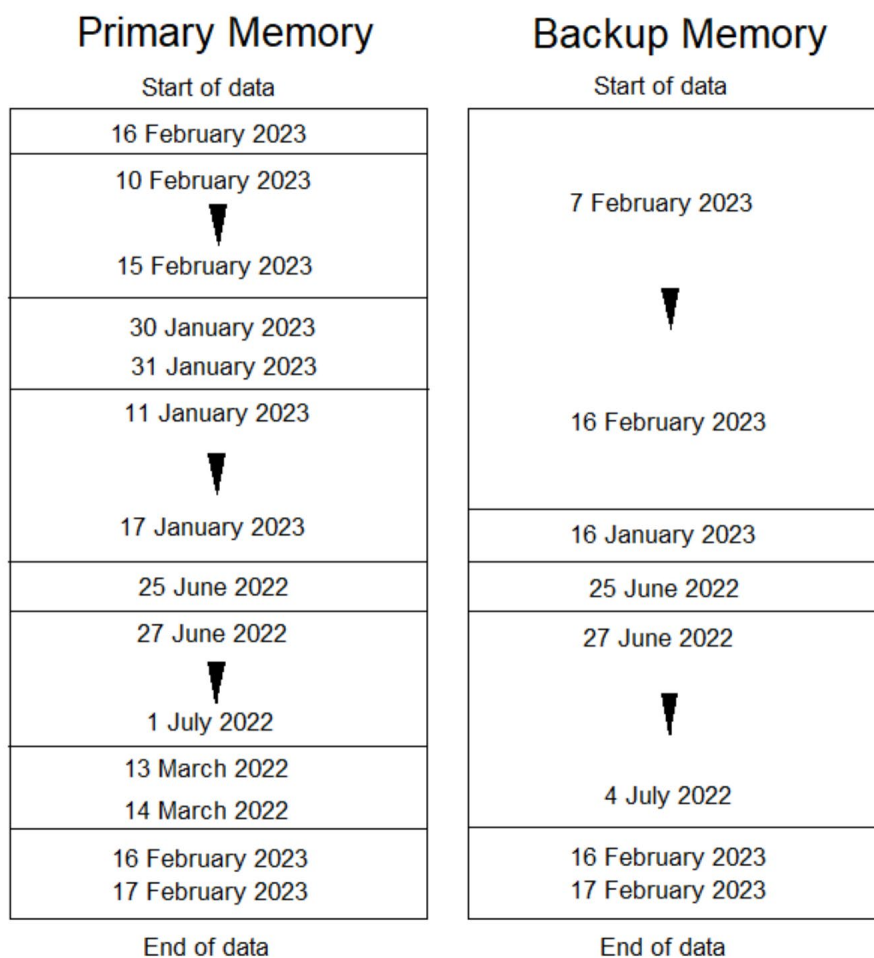
**Figure 17**

- A loss of chronological flight data recording by the FA5000 CVFDR caused by rapid cycling of input power at initial startup.
- The loss of chronological recording of flight data has occurred on EC175, UH-72 (EC145) and EC155 helicopters fitted with FA5000 CVFDRs.
- When a loss of chronological recording occurred, only the most recent 15 hours of flight data was not affected.
- The loss of chronological recording is resolved by Service Bulletin (SB) SB001- FA5000 that installs software 840-E5498-12 to the FA5000 series of CVFDRs.

G-MCSH –flight data within the primary and backup memory

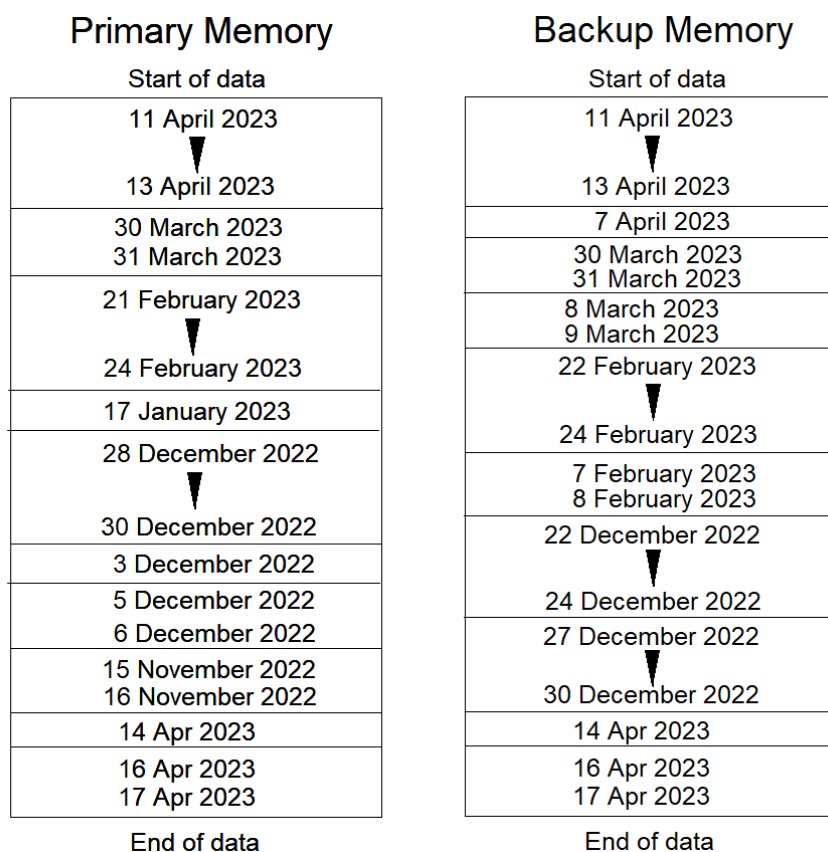
**Figure 18**

The FA5000 CVFDR<sup>19</sup> from G-MCSO was subsequently downloaded at the AAIB. This showed the same loss of chronological recording as G-MCSH (Figure 18). The CVFDR was fitted new to G-MCSO in 2020, of which it had since operated for about 2,100 hours with no FDRS fault having been indicated.

G-MCSO – flight data within the primary and backup memory

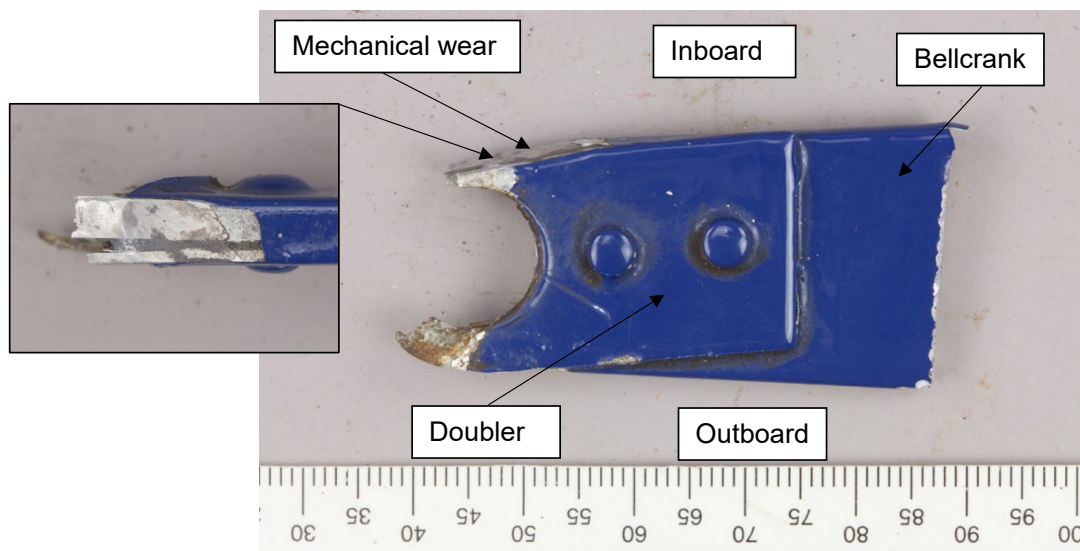
**Figure 3**

The maintenance organisation retained the main body of the bellcrank, but the left and right bellcrank ends and the corresponding clevis assemblies were removed for metallurgical examination. The mechanical wear on the inboard edge of the right side bellcrank had resulted in extensive material removal and smearing but it appeared that the wear had reached a point where it had stopped progressing, possibly due to the rudder bumper stops limiting further contact (Figure 3).

View on lower surface of bellcrank, showing failure across attachment hole and mechanical wear (inset)

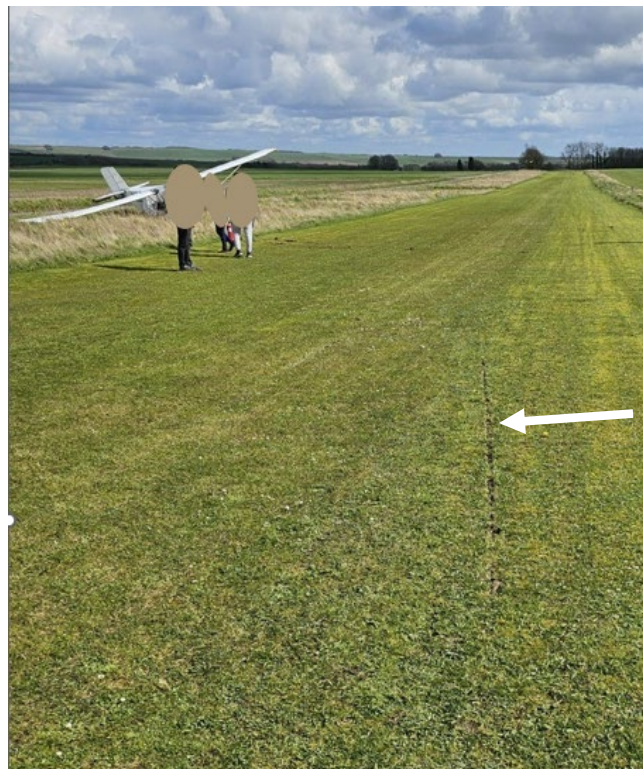
**Figure 1**

Aircraft's final resting position, looking along Runway 10 in landing direction and showing a runway witness mark  
(Image used with permission)

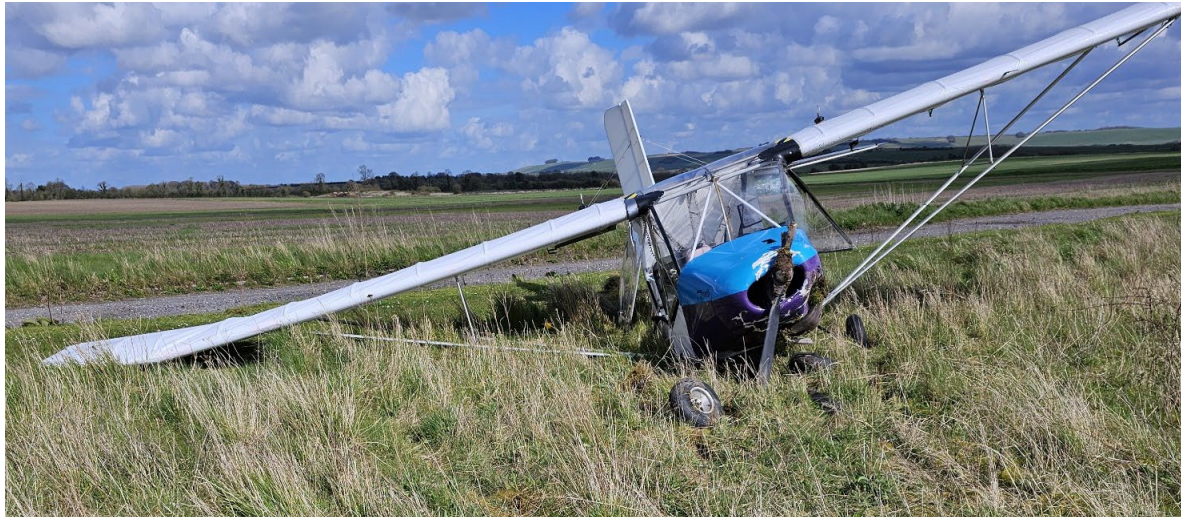
**Figure 2**

Aircraft's final resting position, illustrating damage sustained  
(Image used with permission)
