# Annual Safety Review 2024

**AAIB**  
Air Accidents Investigation Branch

I am pleased to present the 2024 Annual Safety Review, which provides a comprehensive overview of occurrences reported to the Air Accidents Investigation Branch (AAIB) during the year, along with the safety actions taken or planned in response to our investigations.

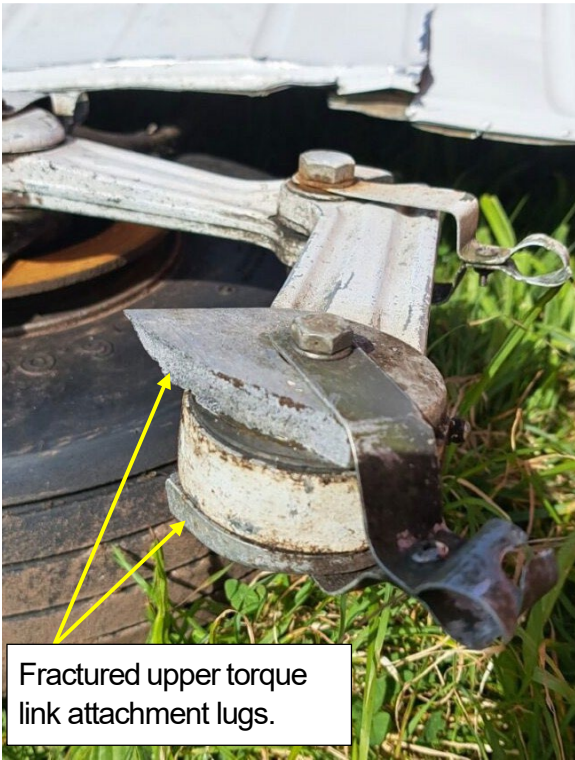
While Service Bulletin SB1131A is still current, the EASA AD mandating it was cancelled in 2020 as EASA determined that an acceptable level of safety existed. Cast main landing gear cylinders are still fitted to aircraft and fatigue cracking of the lugs continues to occur. To ensure that an acceptable level of safety still exists for the cast cylinders fitted to PA-28 and PA-32 aircraft, and to provide appropriate guidance on inspecting the cylinders, the following Safety Recommendation is made to the CAA.

Fractured upper torque link attachment lugs.

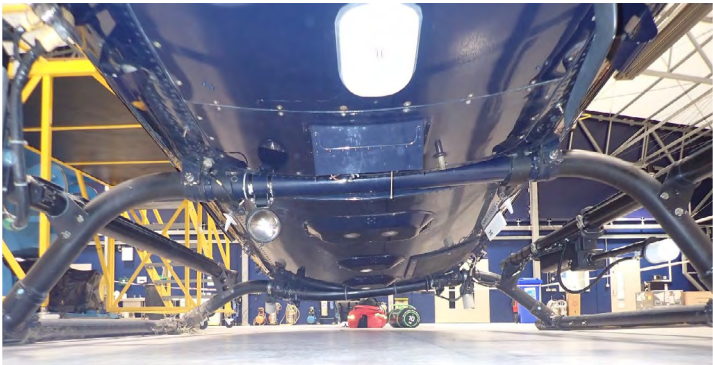
This Serious Incident occurred during the demonstration of an engine failure after takeoff emergency procedure on a revalidation flight for the commander’s type rating instructor qualification. The engine failure was simulated by the commander reducing Engine No 1’s throttle to idle. Shortly afterwards the commander increased the throttle setting, but Engine No 1 did not respond. During attempts to resolve the problem, the throttle setting for Engine No 2 was inadvertently reduced, resulting in insufficient power being available for continued safe flight. The commander rejected the takeoff and executed a firm landing within the airfield boundary.

**G-MPSB landing gear (viewed from front looking rear)**

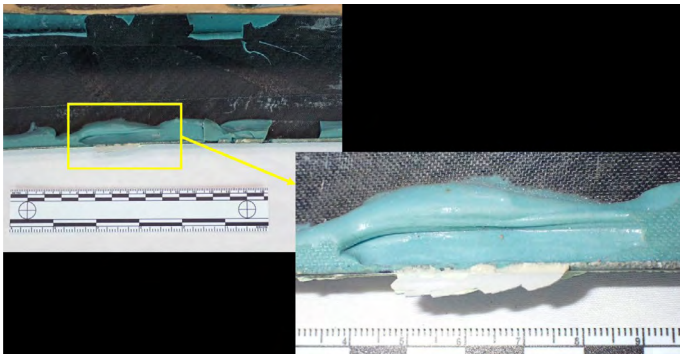
The investigation identified a lack of appropriate bonding between the inner and outer canopy frame around the front of the canopy. This caused localised and increased stresses within the transparency which under flight loads promoted fatigue crack development. When these cracks reached a critical length, catastrophic failure resulted.

Area of epoxy bond showing there was no contact with the inner frame

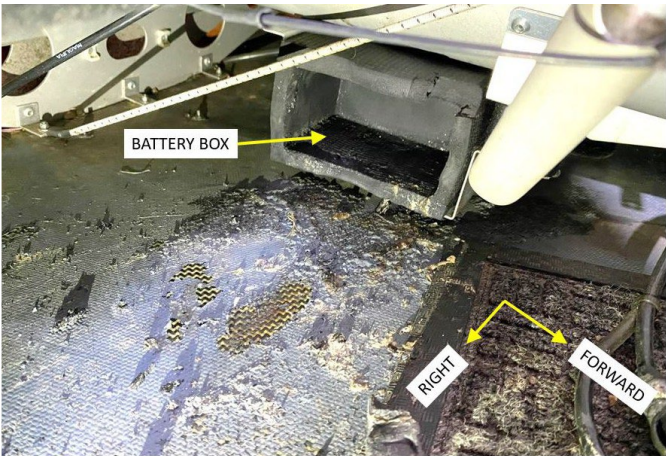
The investigation did not identify the cause of the battery fire. The location of the battery within the aircraft’s cabin exposed the occupants to significant hazards when the battery caught fire, as the battery box did not contain the combustion products or heat from the fire.

**Damage to the cabin floor caused by the battery fire**

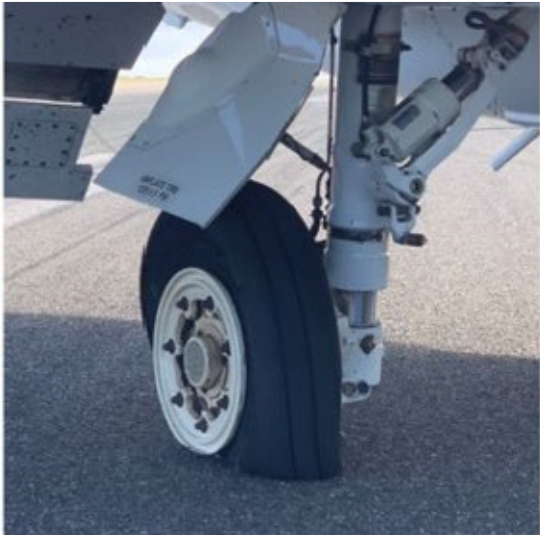
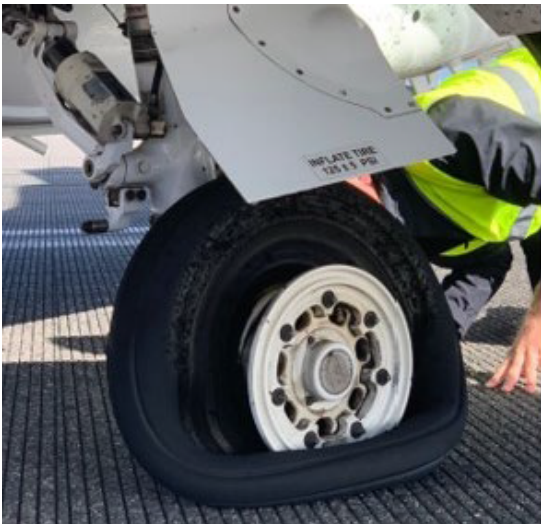
The lack of a light or caption to indicate that the parking brake is on, or an aural or visual warning that the parking brake is on when takeoff power is applied, may have contributed to the incident, as may have the lack of a ‘release parking brake’ item in the ‘Before Takeoff’ checklist.

**Left and right mainwheel tyres after the incident landing**

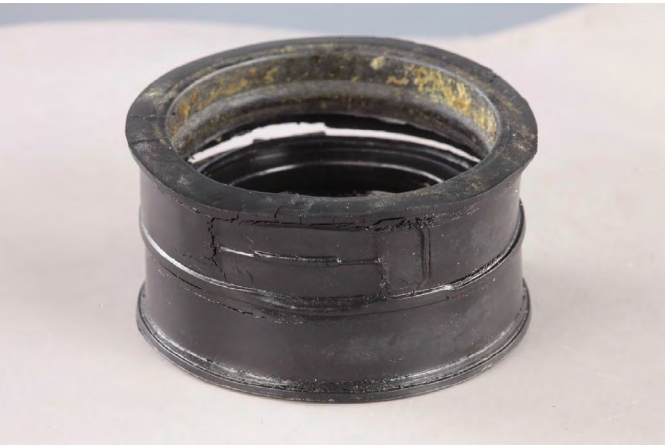
The loss of engine power was probably caused by an age-related split in the rubber coupling attaching the carburettor to the engine’s plenum chamber. No issues with the engine were identified during a 100-hour engine service or the subsequent check flight, carried out in January 2023. The location of the coupling and its mounting clips made inspection problematic. The engine manufacturer’s manual for the engine stated that the coupling had a 1,000 hour, or five-year life but there was no evidence that the coupling had been replaced since the aircraft had been built in 2006.

**Split carburettor coupling from G-CDFK**

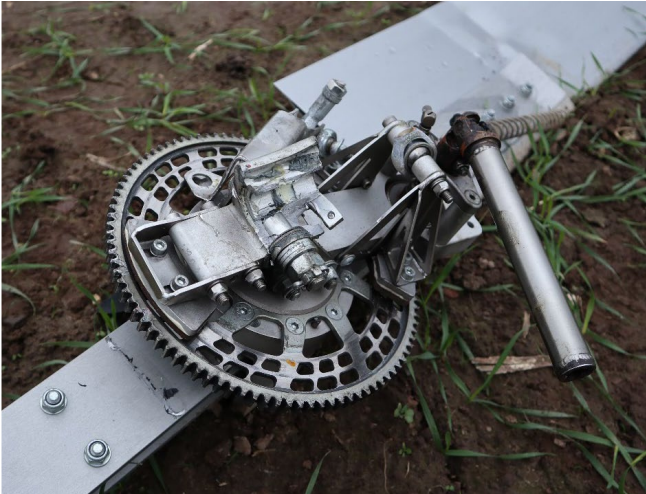
The gyroplane was found to have been correctly released to service. There were no maintenance issues identified relevant to the accident. A number of operational factors were considered and it was likely that the pilot inadvertently allowed the aircraft to enter a low g flight regime close to, or potentially exceeding, that prohibited by the Cavalon Pilot’s Operating Handbook.

**Rotor head showing gimbal block failure, rotor blade deformation and teeter stop contact mark**

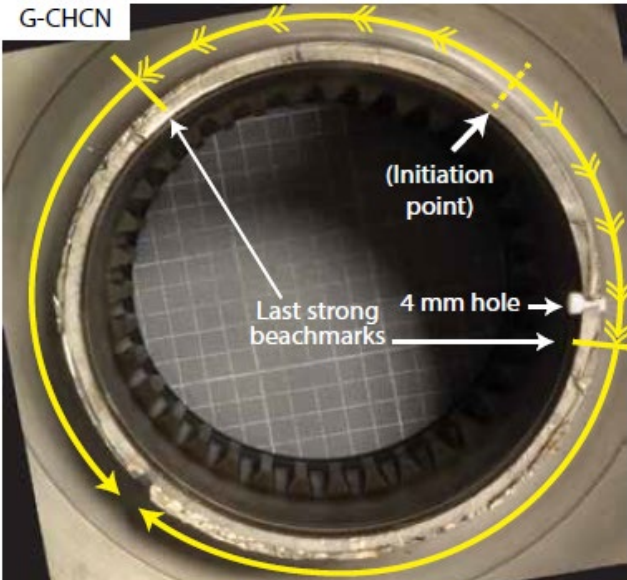
While operating over the North Sea, in daylight, the crews of G-REDW and G-CHCN experienced a loss of main rotor gearbox oil pressure, which required them to activate the emergency lubrication system. This system uses a mixture of glycol and water to provide 30 minutes of alternative cooling and lubrication. Both helicopters should have been able to fly to the nearest airport; however, shortly after the system had activated, a warning illuminated indicating that the emergency lubrication system had failed. This required the crews to ditch their helicopters immediately in the North Sea. Both ditchings were successful and the crew and passengers evacuated into the helicopter’s liferafts before being rescued. There were no serious injuries.

**G-CHCN fracture surface**

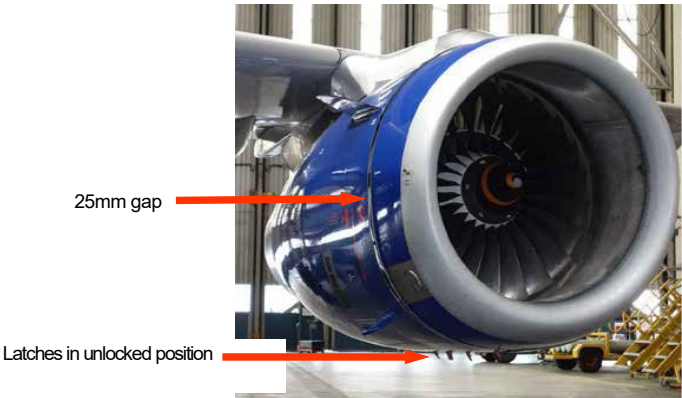
During takeoff from Runway 27L at London Heathrow Airport, the fan cowl doors from both engines detached from the aircraft, damaging the airframe and a number of aircraft systems. The flight crew elected to return to Heathrow and on the approach to land on Runway 27R, leaking fuel from a damaged fuel pipe on the right engine ignited and an external fire developed. The left engine continued to operate satisfactorily throughout the flight. The right engine was shut down promptly, reducing the intensity of the fire, and the aircraft landed safely. It was brought to a stop on the runway and the emergency services were quickly in attendance. The fire in the right engine was extinguished and the passengers and crew evacuated via the emergency escape slides on the left side of the aircraft.

Fan cowl doors on the hold-open device; latches in unlocked position

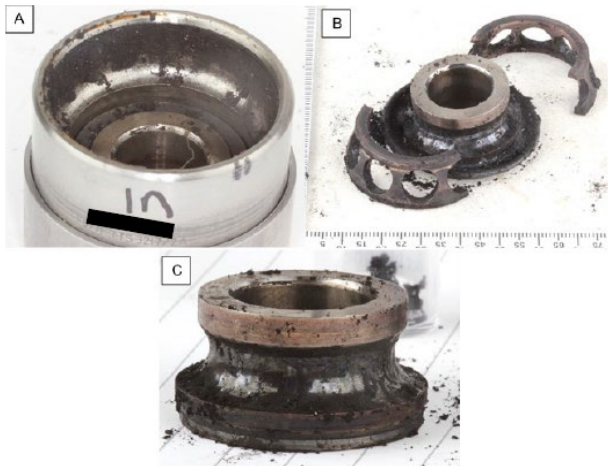
At 1937 hrs the helicopter, carrying the pilot and four passengers, lifted off from the centre spot of the pitch at the King Power Stadium. The helicopter moved forward and then began to climb out of the stadium on a rearward flightpath while maintaining a northerly heading and with an average rate of climb of between 600 and 700 ft/min. Passing through a height of approximately 250 ft, the pilot began the transition to forward flight by pitching the helicopter nosedown and the landing gear was retracted. The helicopter was briefly established in a right turn before an increasing right yaw rapidly developed, despite the immediate application of corrective control inputs from the pilot. The helicopter reached a radio altimeter height of approximately 430 ft before descending with a high rotation rate. At approximately 75 ft from the ground the collective was fully raised to cushion the touchdown.

(A) Inboard row, outer race, (B) Inboard row inner race and fractured cage, (C) Inboard row inner race

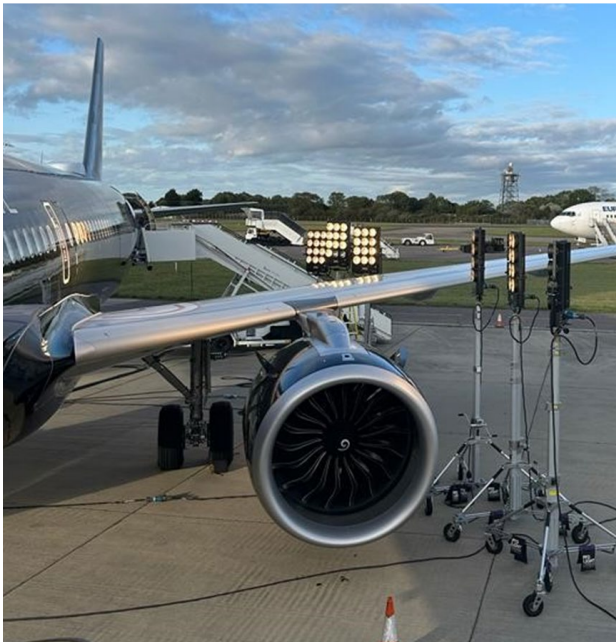
Flood lighting on the left side of the aircraft

- EASA published a Safety Information Bulletin highlighting the risk of damage when using high-intensity lighting near an aircraft

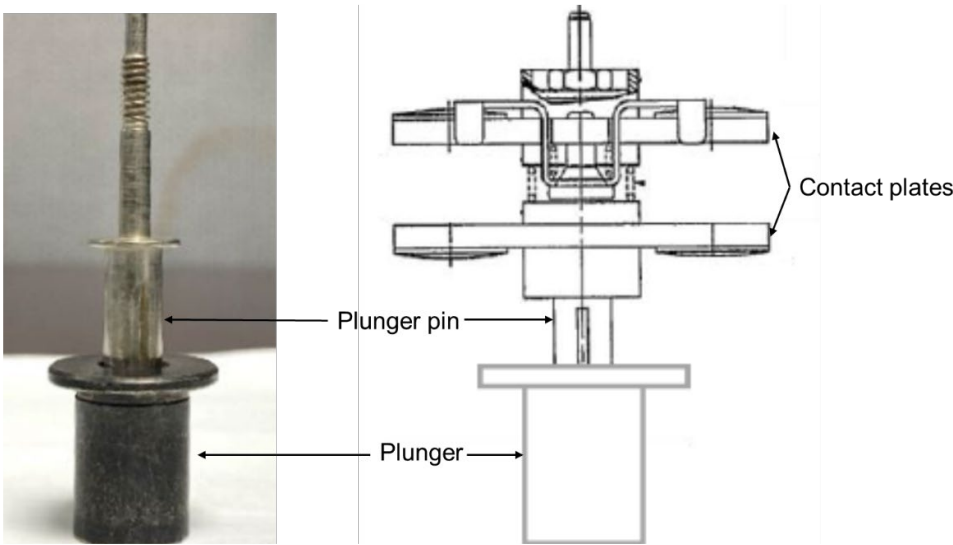
The failure of this contactor, designated as 95PA in the circuit, fitted in EI-GPN was caused by a slippage between the plunger and pin assembly operating under increased cycles. The slippage resulted in poor connection, localised arcing and subsequent loss of continuity across its A1 and A2 terminals. A definitive cause of the pin and plunger slippage with the 95PA contactor fitted to EI-GPN and several other contactors manufactured during 2015, could not be fully determined.

**Plunger and pin assembly (the plunger and pin photograph shows both components prior to insertion)**

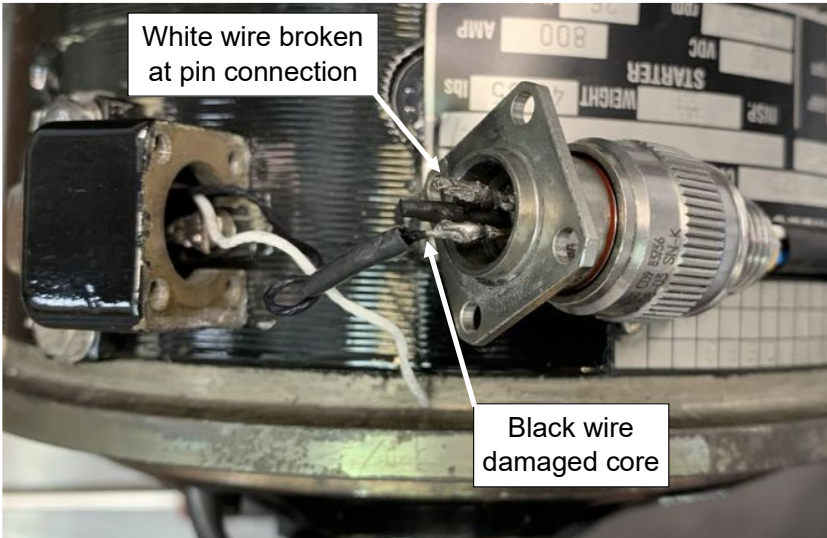
Speed sensor connector with heat-shrink sleeve removed from wires

- An analysis of standard practice manuals to check the method of wire stripping specified, followed by an update of the relevant Technical Instruction to bring it in line with the standard practices.
- Clarified that tool choice is performed in the following order for each task: CMM, Standard Practice, Technical Instruction.
- The Method Department technicians have been informed of the issue and, where a method is not specified, they will assist the technician in assessing the best way to strip the wire.
- Wire stripping has been declared as an industrial process and training is to be performed.
- Technicians have been informed that the preferred method of wire stripping is to use thermal wire strippers.

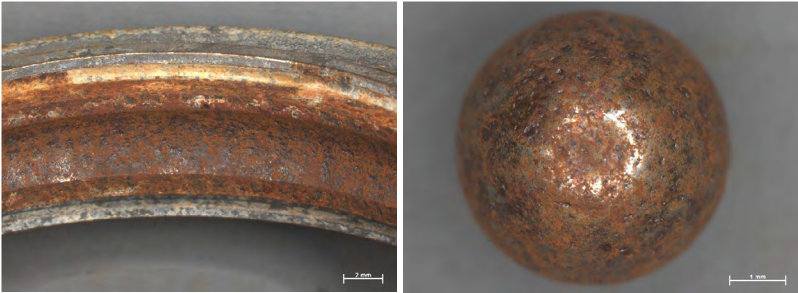
A number of faults with the rudder control system were uncovered during the investigation but the major cause of the extreme rudder stiffness was the degradation of the steel rudder rear quadrant support bearings due to corrosion. The sealed nature of the bearings and their installed location precluded visual inspection of their condition. Moisture ingress in the vicinity of the bearings had likely contributed to their degraded condition. The installation of the rudder damper may also have contributed to the rudder stiffness, albeit to a lesser extent.

**Bearing No 2 corrosion and pitting (outer race shown, inner similar)**

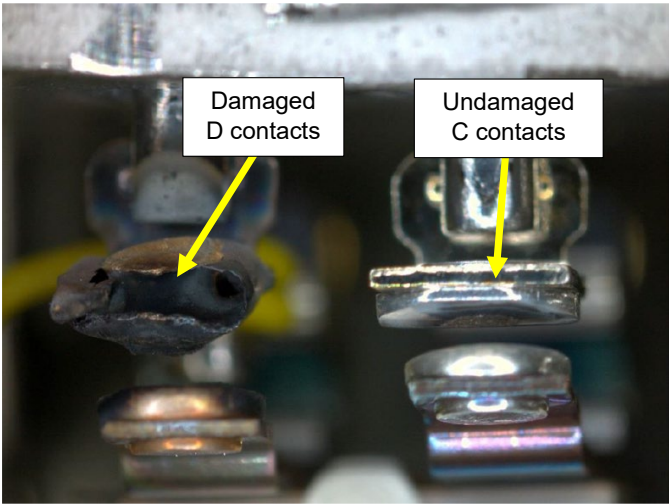
**Damaged D contact (left) and undamaged C contact (right)**

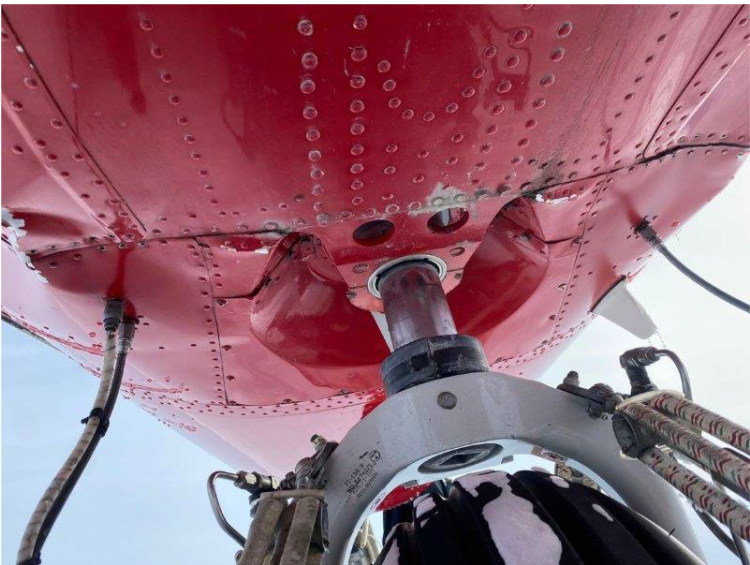
**Damage to aircraft skin around the nose gear**

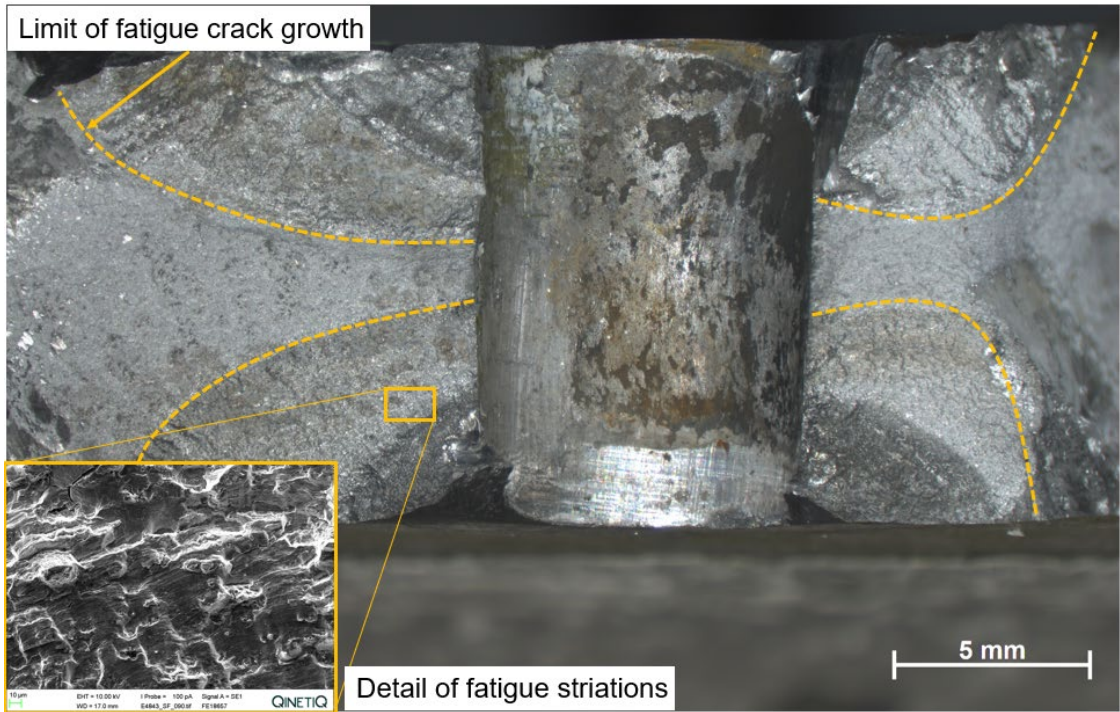
Detail of typical bolt hole showing limits of fatigue crack growth

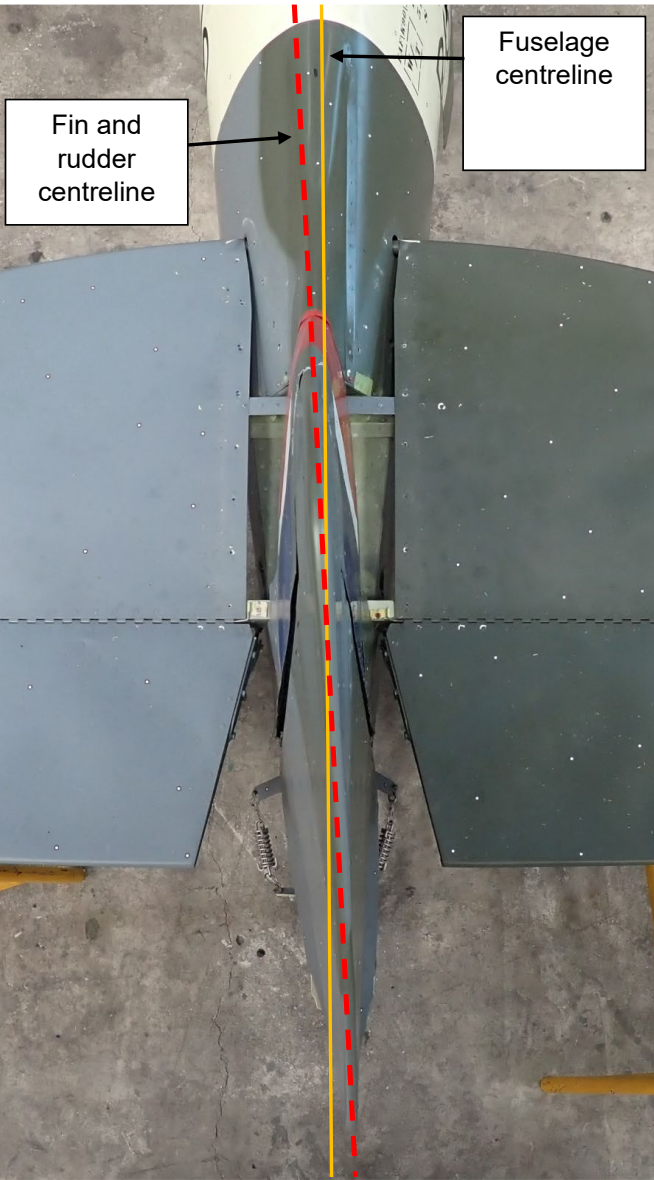
**Fin and rudder misalignment from above with the rudder horn aligned with the fin leading edge**

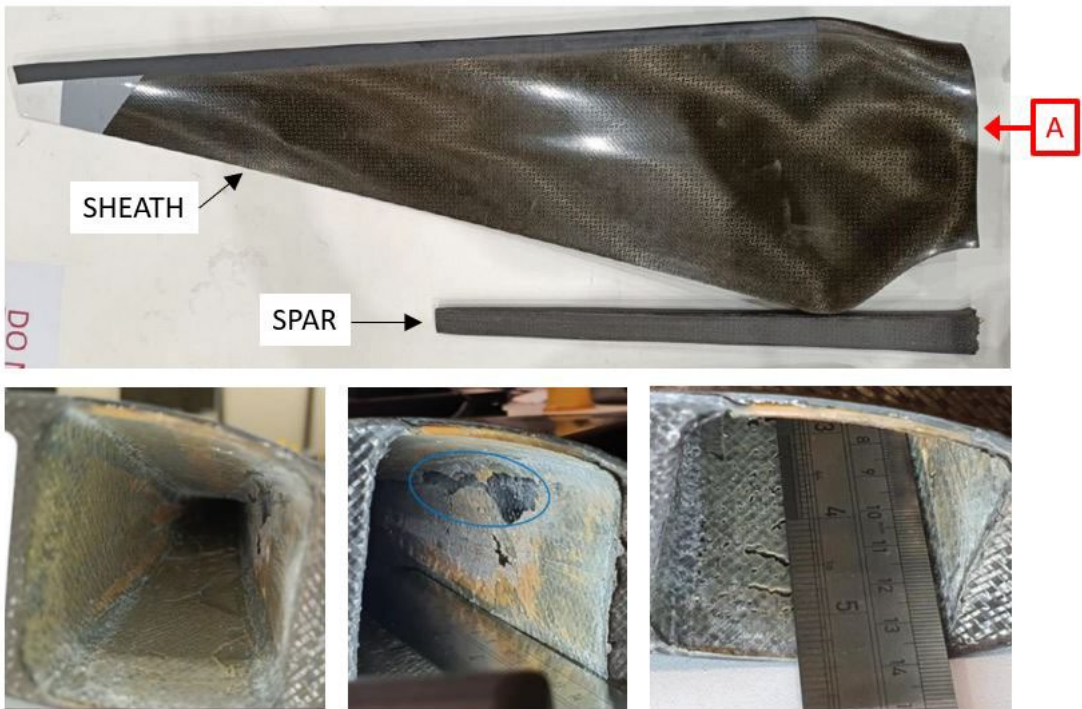
**Released propeller blade including failed spar-to-sheath adhesive bond (lower three images, viewed in direction ‘A’)  
(courtesy of manufacturer)**

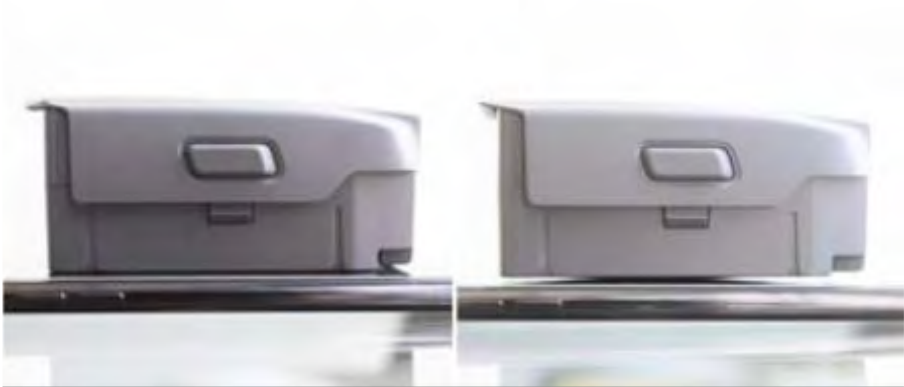
Battery without swelling with a flat underside (left) compared with one with swelling evident (right). (Used with permission)
