# ***AAIB Bulletin***

# ***7/2025***

Published: 10 July 2025.

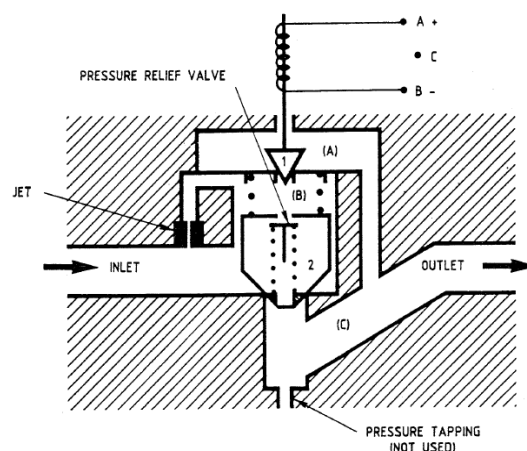
**Figure 8**

The solenoid is de-energised when the electric fuel pump press switch is selected IN; this is the normal flight condition. In this de-energised condition, the needle valve (1) opens and allows the fuel pressure in the valve chambers to equalise. Fuel pressure from the HMU can then push up piston (2) which allows fuel to flow to the engine feed jet pump in the header tank. In this condition when there is no fuel flow from the HMU, a small flow of fuel from outlet to inlet is expected due to the valve design.

Testing of the motive flow valve confirmed it was operating normally and that, with the valve de-energised, a small flow from outlet to inlet is expected due to the valve design. The leak from the loose fuel return line connector to the HMU was consistent with this flow rate. In

Due to the fuel system design, specifically that of the motive flow valve, fuel continued to leak from the loosened fuel return line after the crew, as part of the Engine fire or Severe Mechanical Damage checklist, operated the fire handle to shut down the engine. It continued

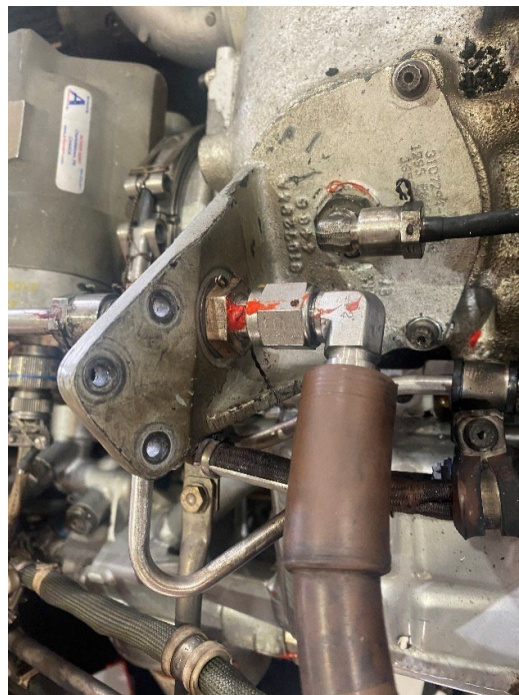
**Figure 9**

There was evidence of fire around the No 1 engine cowlings and an inspection of the area inside the cowling revealed additional fire damage and sooting. The fuel return line was found loose and leaking at the HMU outlet.

With the motive flow valve de-energised, the flow of fuel leaking from the motive flow pipe when disconnected was measured at 165 ml/min. It was not possible to determine the flow rate at the time of the fire as the connection had been re-tightened to stem the leak whilst the aircraft was parked.

The end fitting had been marked with indicator material. When the fitting was re-tightened, the marks aligned, and the leak stopped.

Due to the routing of the fuel return line away from the end fitting, a 90° elbow, it was possible to use the line as a lever to manually loosen the fitting (Figure 9).

Fuel return line connection to HMU after engine removed from aircraft  
(line temporarily fitted to show routing)

The engine failure was violent as witnessed by the rapid reduction in torque and tears in the elastomer anti-vibration mounts and it is considered possible that the reaction to this sudden reduction in torque could have caused the fuel return line to 'whip' and loosen the connection and for consequent engine vibrations to have loosened it further. There is no secondary locking on the connection and the line leaves the HMU via a 90° elbow which would add leverage to any loosening forces.

The fuel leak was from the connection between the HMU and the fuel return line which had become loose. The reason for this could have been either that the connection had not been tightened correctly when it was installed or that it had become loose due to the forces of the engine failure 'whipping' the fuel return line. Maintenance records, interviews with the maintenance staff and indicator markings appeared to confirm that it had been tightened correctly, and the aircraft manufacturer was not aware of any other cases where this connection had become loose.

The aircraft manufacturer has commenced a safety review to identify any possible safety actions which would further reduce the likelihood of leakage from the fuel return line. This review will be completed by the end of 2025.

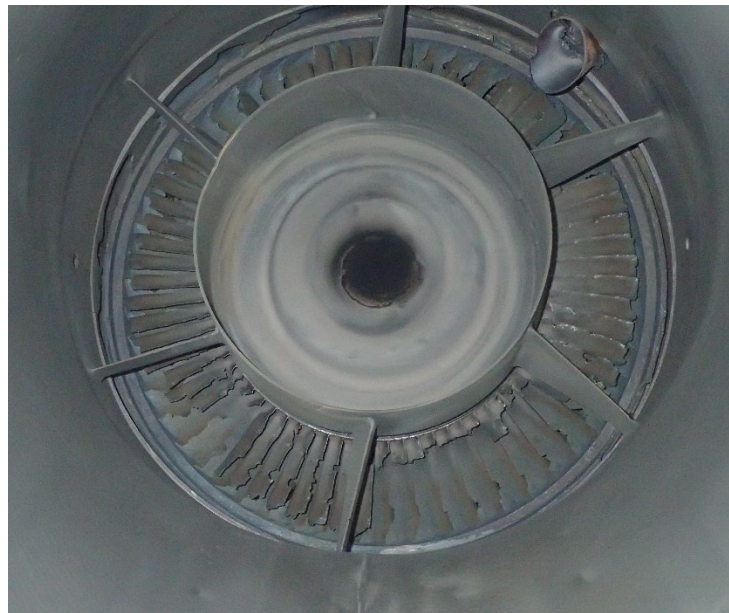
**Figure 10**

Initial inspection of the engine identified that the second stage power turbine had suffered significant damage, and further damage was visible to the other turbine stages (Figure 10).

Damage to No 1 engine second stage power turbine, looking from exhaust outlet

The disassembly inspection identified that the No 6 main bearing, located aft of the low-pressure turbine, had suffered significant degradation resulting in the loss of location of the turbine assembly which then contacted the surrounding parts causing the damage seen to the turbines and their casings. This bearing has been sent to the engine manufacturer's laboratories for detailed failure analysis under supervision of TSB Canada.

The No 1 engine suffered a contained failure. This was due to significant degradation of its No 6 main bearing which resulted in the rotating high-pressure turbine being no longer correctly located. This allowed the rotating parts to contact adjacent parts causing significant damage to the turbine stages.

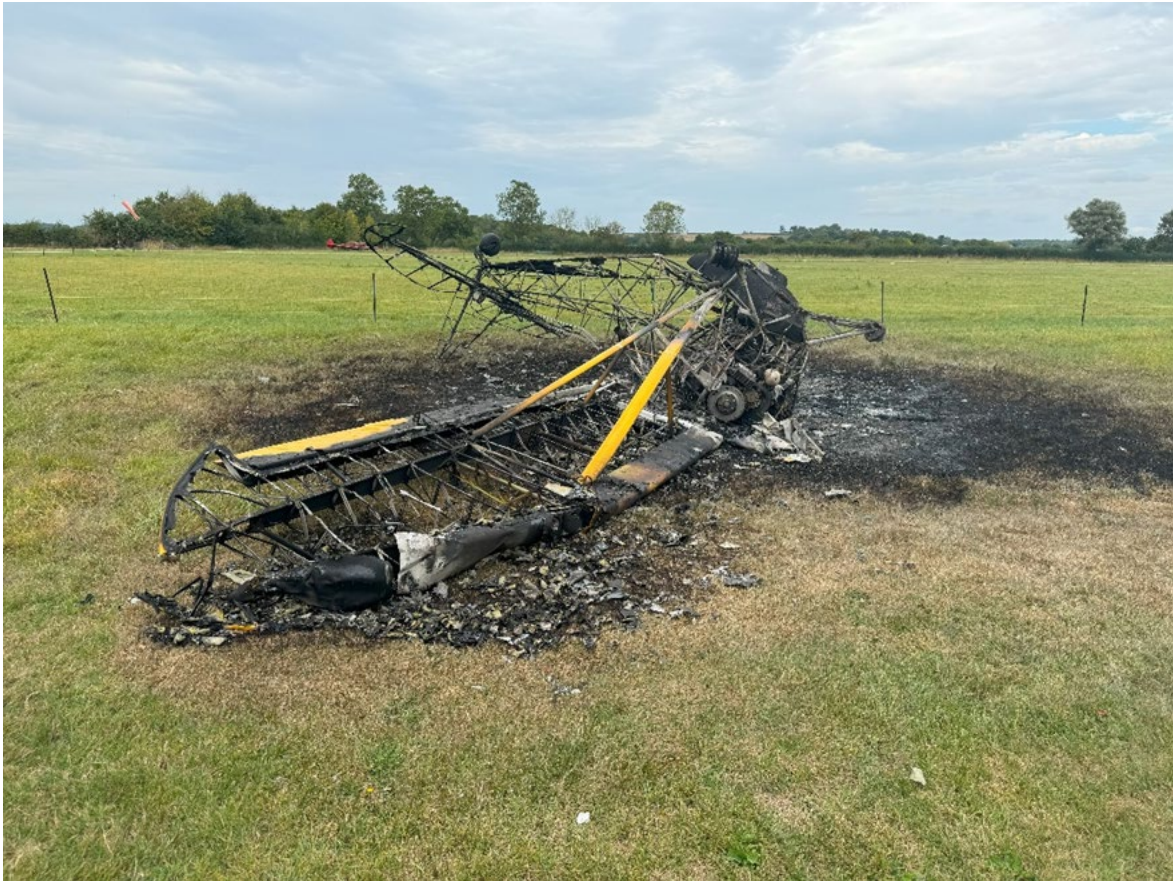
**Figure 4**

While video footage of the accident shows the aircraft initially coming to rest on its nose with the tail almost vertically above it, during the subsequent post-accident fire the tail settled to the ground with the top of the vertical stabilizer resting on the floor. The fuselage was inverted and there was significant damage to the structure (Figure 4).

G-CUBX showing significant post impact fire damage

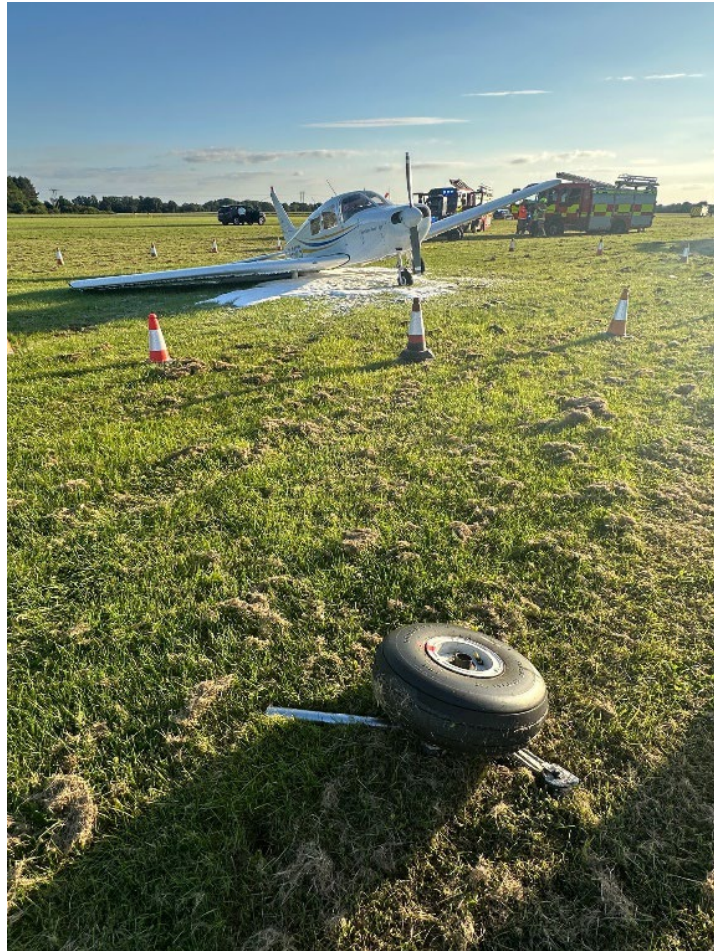
**Figure 1**  
G-SACS after landing

A student pilot and instructor were conducting a practice forced landing (PFL) lesson, which also included two touch-and-go landings. No issues were identified by the instructor or student, but immediately after taking off after the second touch-and-go the ground crew in a rescue vehicle radioed the aircraft to inform that the right main wheel had become detached and was hanging by a hose. The instructor took control and flew along the runway where the ground crew and the pilot of another aircraft visually confirmed the issue. She then flew several further circuits to burn fuel, and allow time for emergency services to arrive, before landing on grass Runway 28. Upon landing the aircraft veered to the right by approximately 90° and came to a stop with the right wheel detached from the hose. Both instructor and student exited the aircraft unharmed (Figure 1).

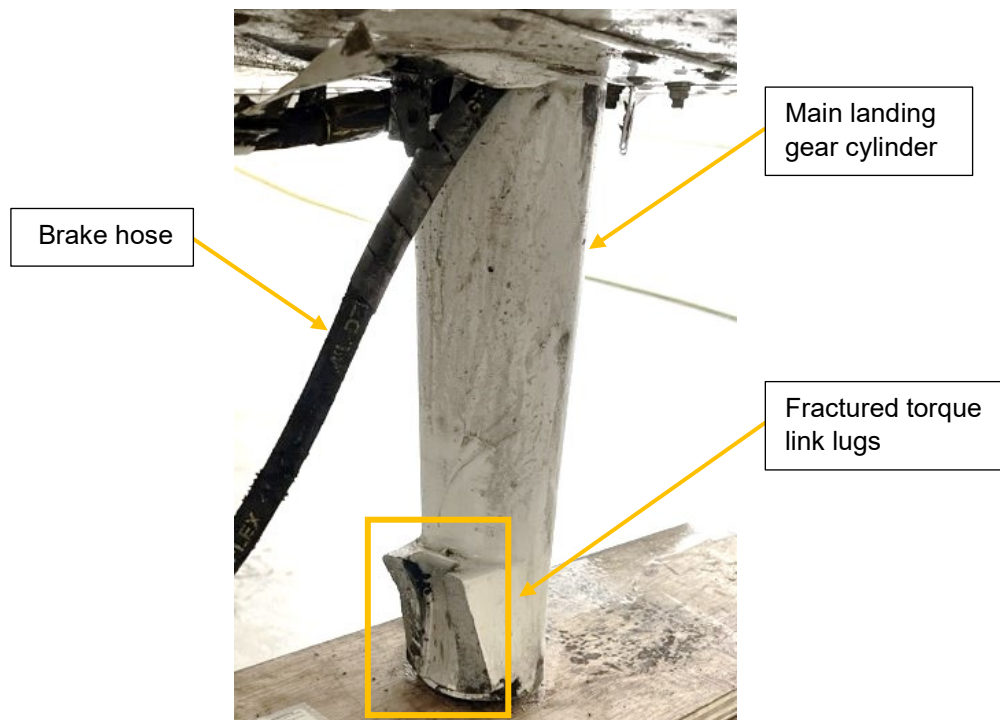
**Figure 2**

The torque link attachment lugs on the main landing gear cylinder had fractured, allowing the oleo and wheel assembly to fall free of the cylinder but remain attached to the aircraft by the brake hose.

Fractured torque link attachment lugs
