Grounding and subsequent loss of the prawn trawler *Sustain* (UL 45) on Rubha Camas a' Mhaoraich, Loch Broom, Scotland on 16 November 2023

SUMMARY

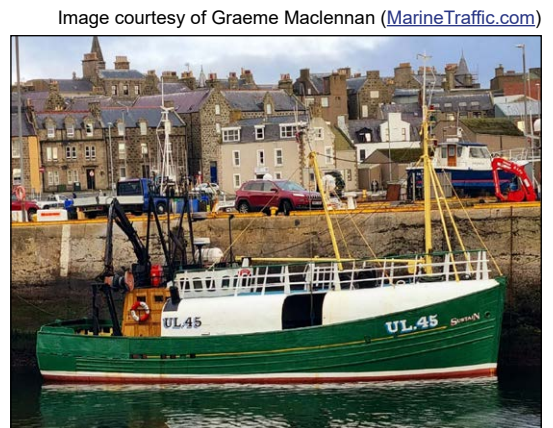
Sustain

On the evening of 16 November 2023, the fishing vessel *Sustain* went aground on rocks at the entrance to Loch Broom, north-west Scotland, while on the way back to dock in Ullapool. The crew were safely evacuated unharmed the following day. The vessel had departed Ullapool in the early hours of that morning to complete day 4 of its fishing run. *Sustain* remained aground despite the crew's efforts to refloat the vessel and attempts by the Royal National Lifeboat Institution to establish a tow. The vessel was eventually declared a constructive total loss after being damaged in poor weather. It was broken up and removed by a team of specialist divers in early 2024.

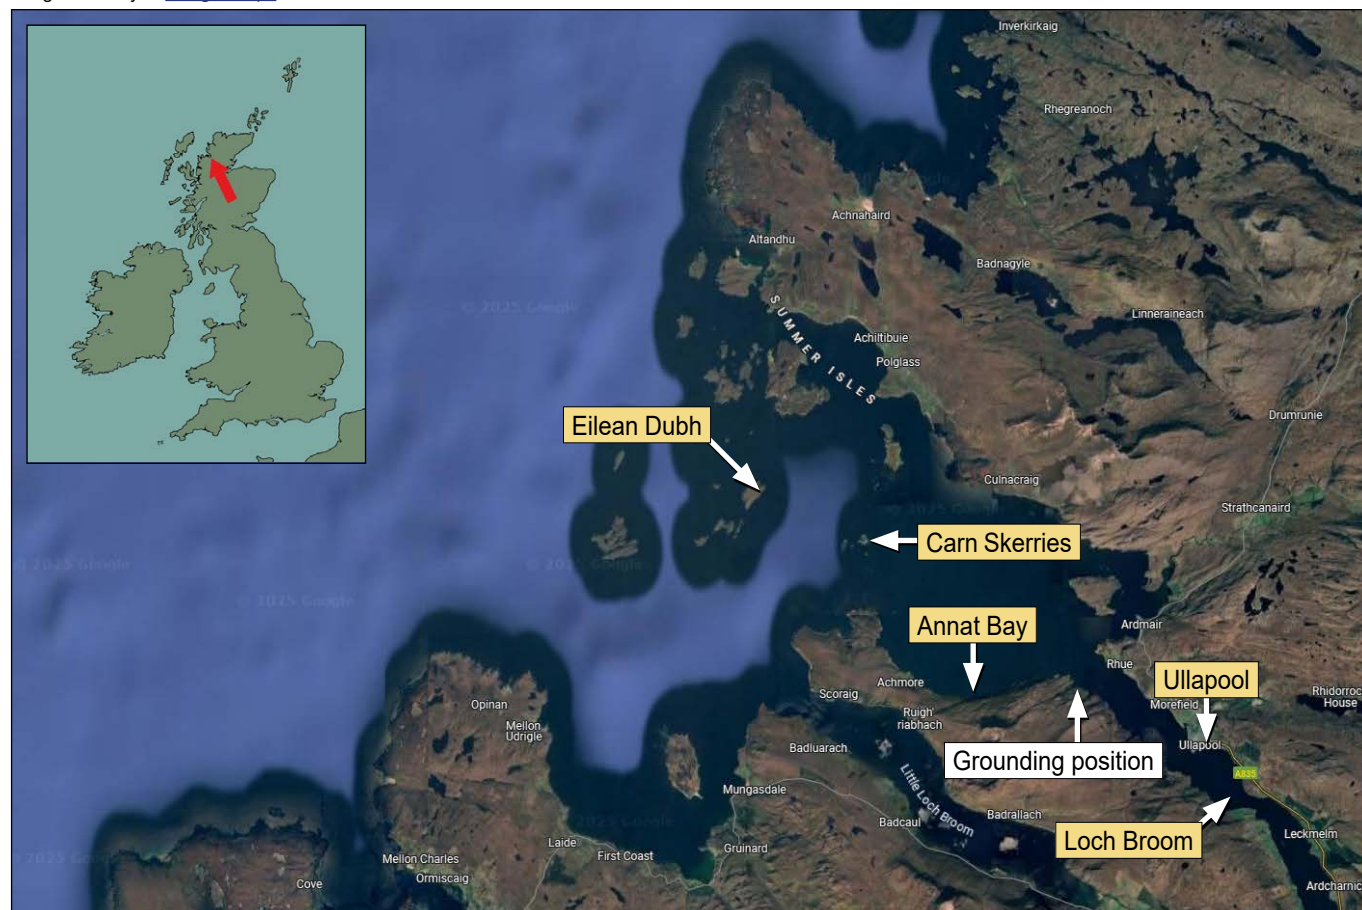
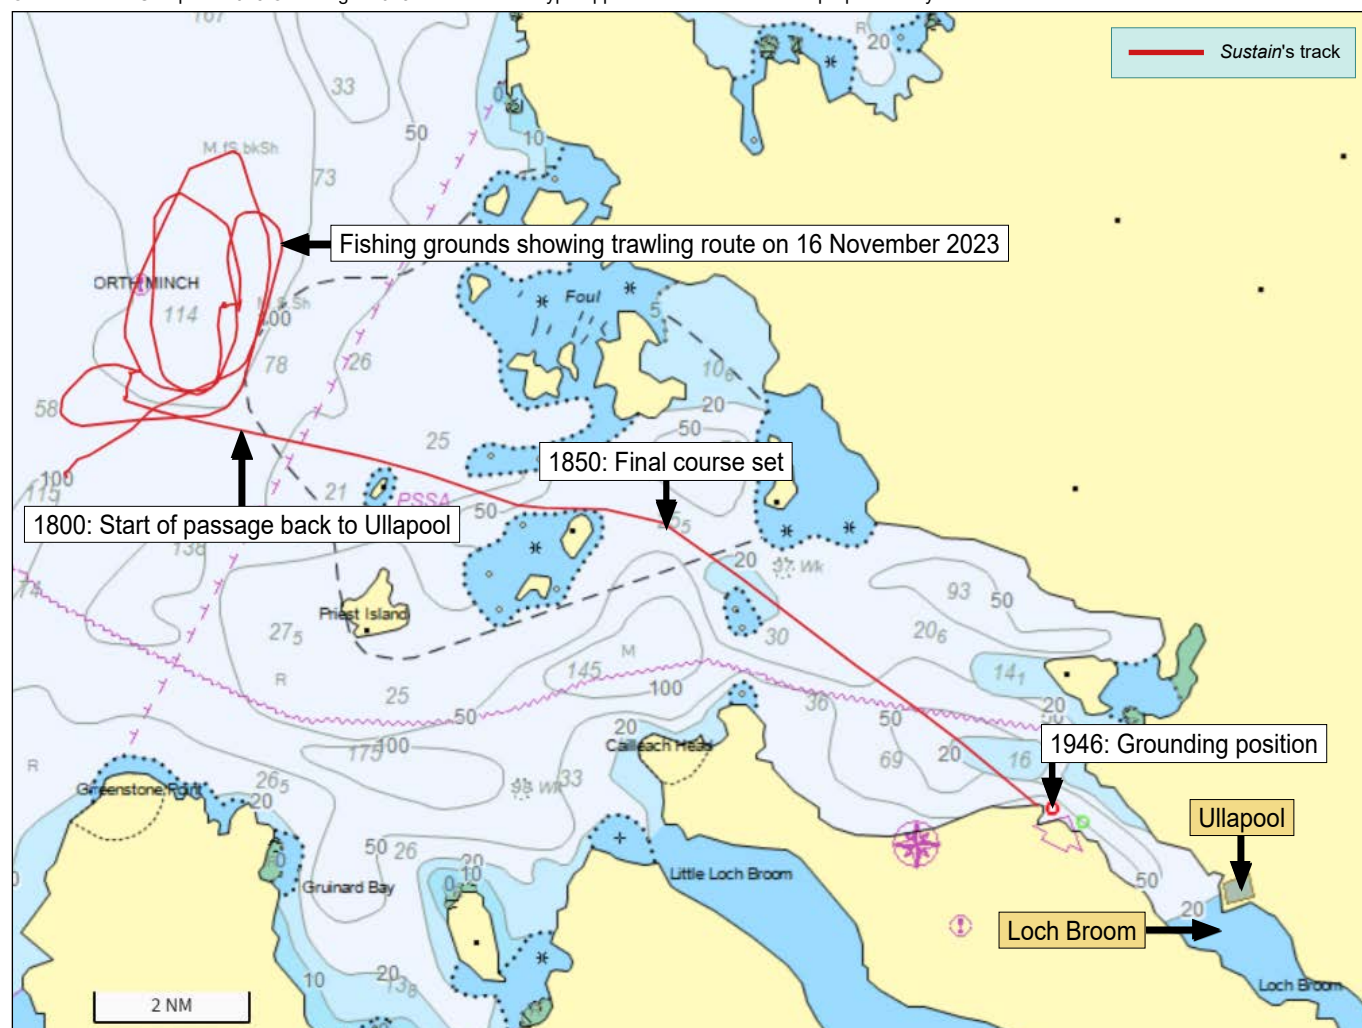
Figure 1: Fishing grounds and *Sustain's* passage back to Loch Broom

Sustain transited through the Summer Isles and past the Carn Skerries, marking the entrance to Loch Broom. At about 1930, as the vessel steamed past Annat Bay, the skipper felt tired so opened the wheelhouse windows to let some fresh air in, had a cup of coffee, then sat in the wheelhouse chair. Sometime later, the skipper fell asleep.

At 1946, *Sustain* grounded on rocks at Rubha Camas a' Mhaoraich in Loch Broom (**Figure 1**) while making 7.7 knots (kts). The skipper awoke and took the vessel's engine out of gear and the deckhands, who were working below, came up to see what had happened. The skipper and one deckhand checked the area around the vessel to determine what the vessel had struck. The other deckhand checked the forepeak for damage or water ingress. The crew tried to move the vessel with its engine and by adjusting the power block and trawl doors, but were unable to do so.

A download of the vessel's plotter data indicated that, after passing the island of Eilean Dubh, the skipper set a course into the autopilot that would take *Sustain* into Loch Broom and pass about 2 cables² north-east of the Rubha Camas a' Mhaoraich. After passing the Carn Skerries, the COG drifted 3° to starboard.

The small course drift of 3° to starboard after passing Carn Skerries, likely caused by a change in the tidal stream or wind, was enough to put the vessel on course with rocks at the southern entrance to Loch Broom.

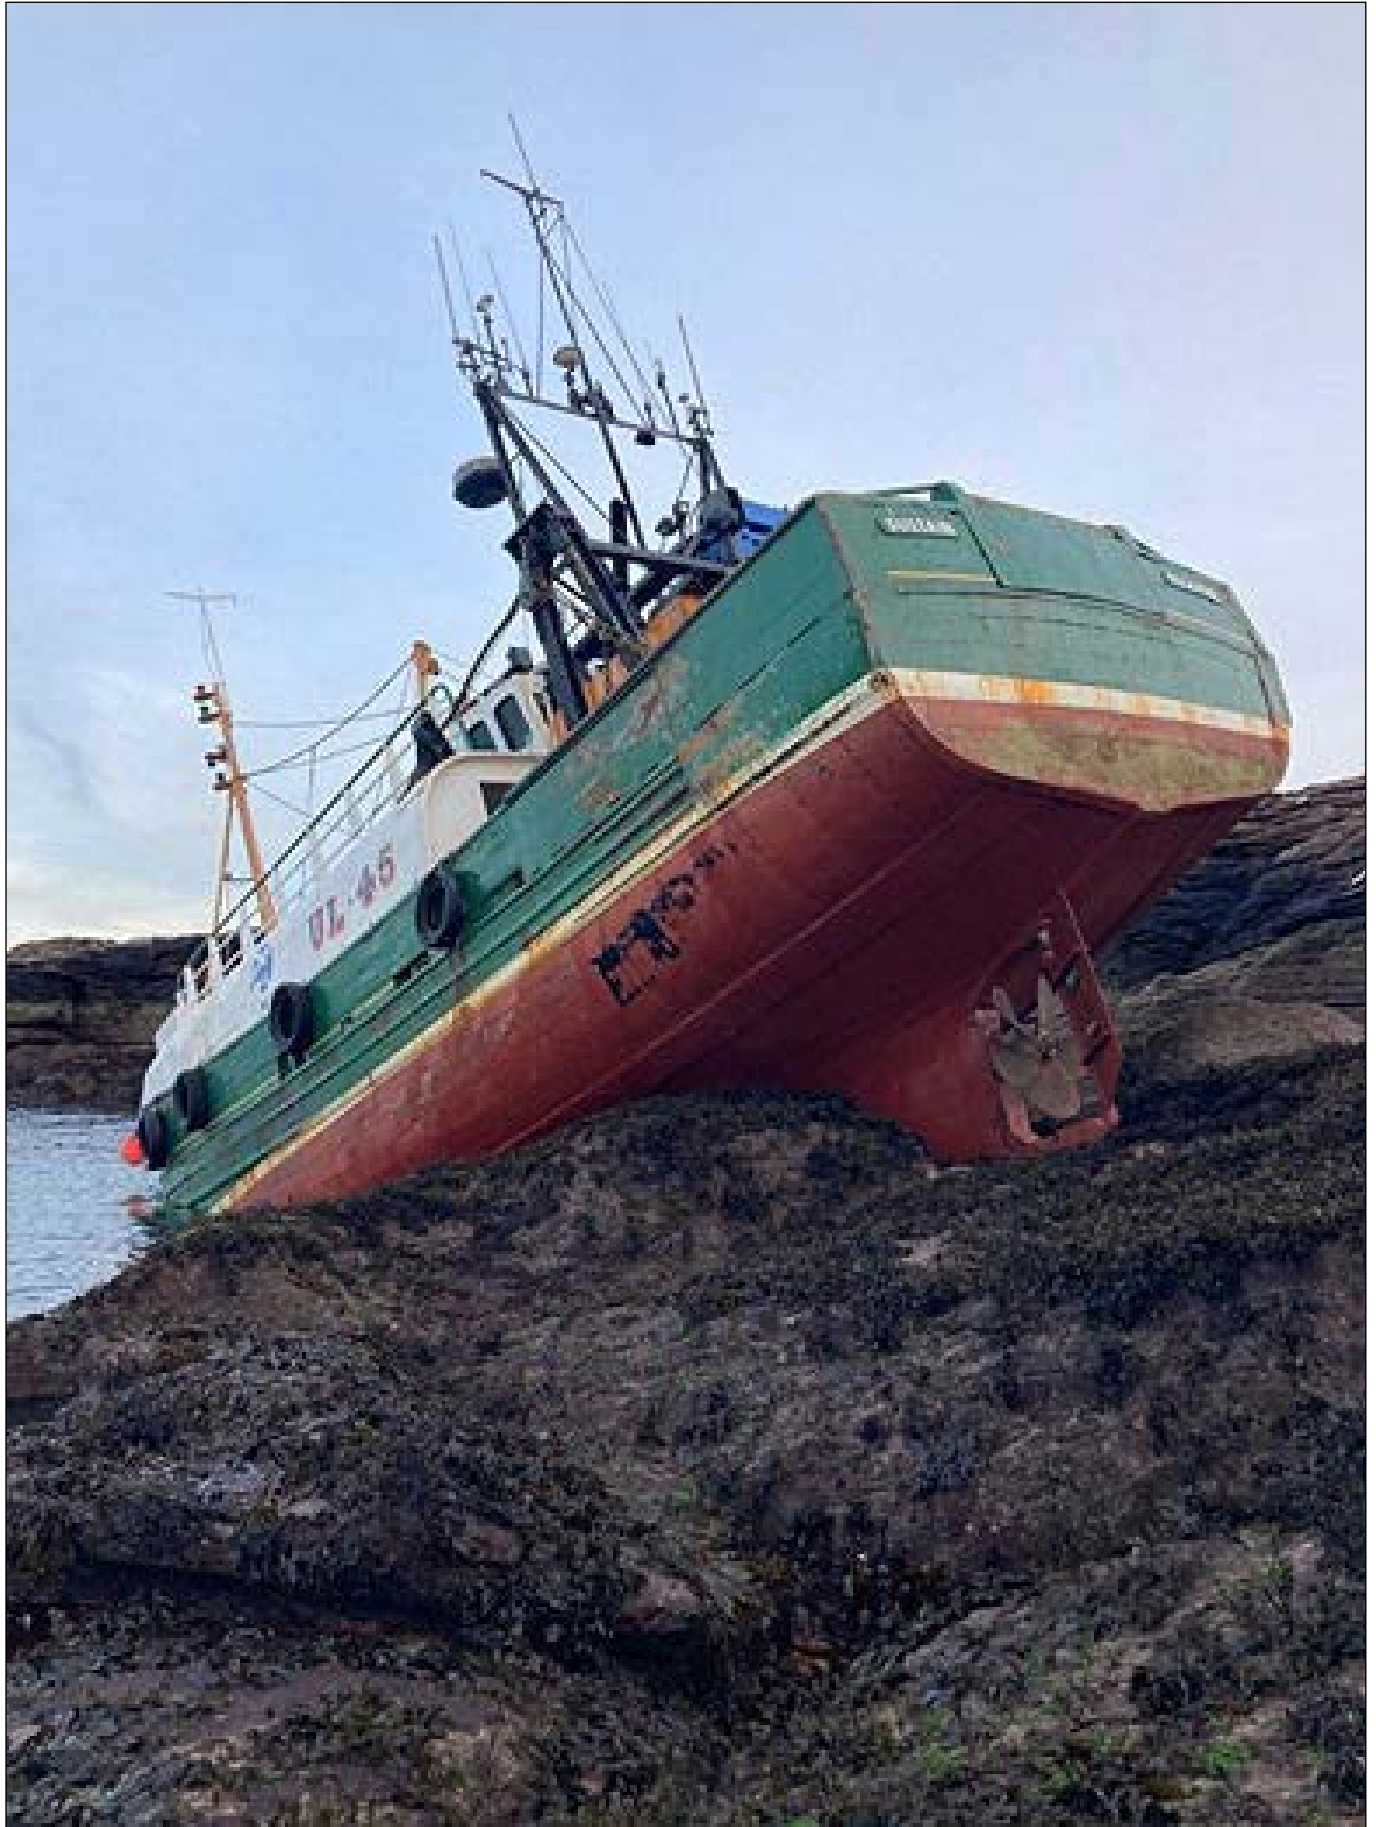
By 18 November, *Sustain's* hull had breached and was partially submerged at high water. On 21 November, all remaining fuel and salvageable gear was removed from the vessel. The following week the wind increased and the vessel sustained further damage before being declared a constructive total loss at the end of November. The wreck was located in a narrow gully (**Figure 2**), close to a ferry route. In early 2024, over a period of weeks, *Sustain* was dismantled piece by piece and removed from the site by a team of specialist divers.

Figure 2: *Sustain* grounded in gully on Rubha Camas a' Mhaoraich
