**Accident**

| <b>Aircraft Type and Registration:</b> | Grob G109B, G-CHYB | |
| <b>Date &amp; Time (UTC):</b> | 27 August 2024 at 1545 hrs | |
| <b>Location:</b> | A419 near Aston Down Airfield, Gloucestershire | |

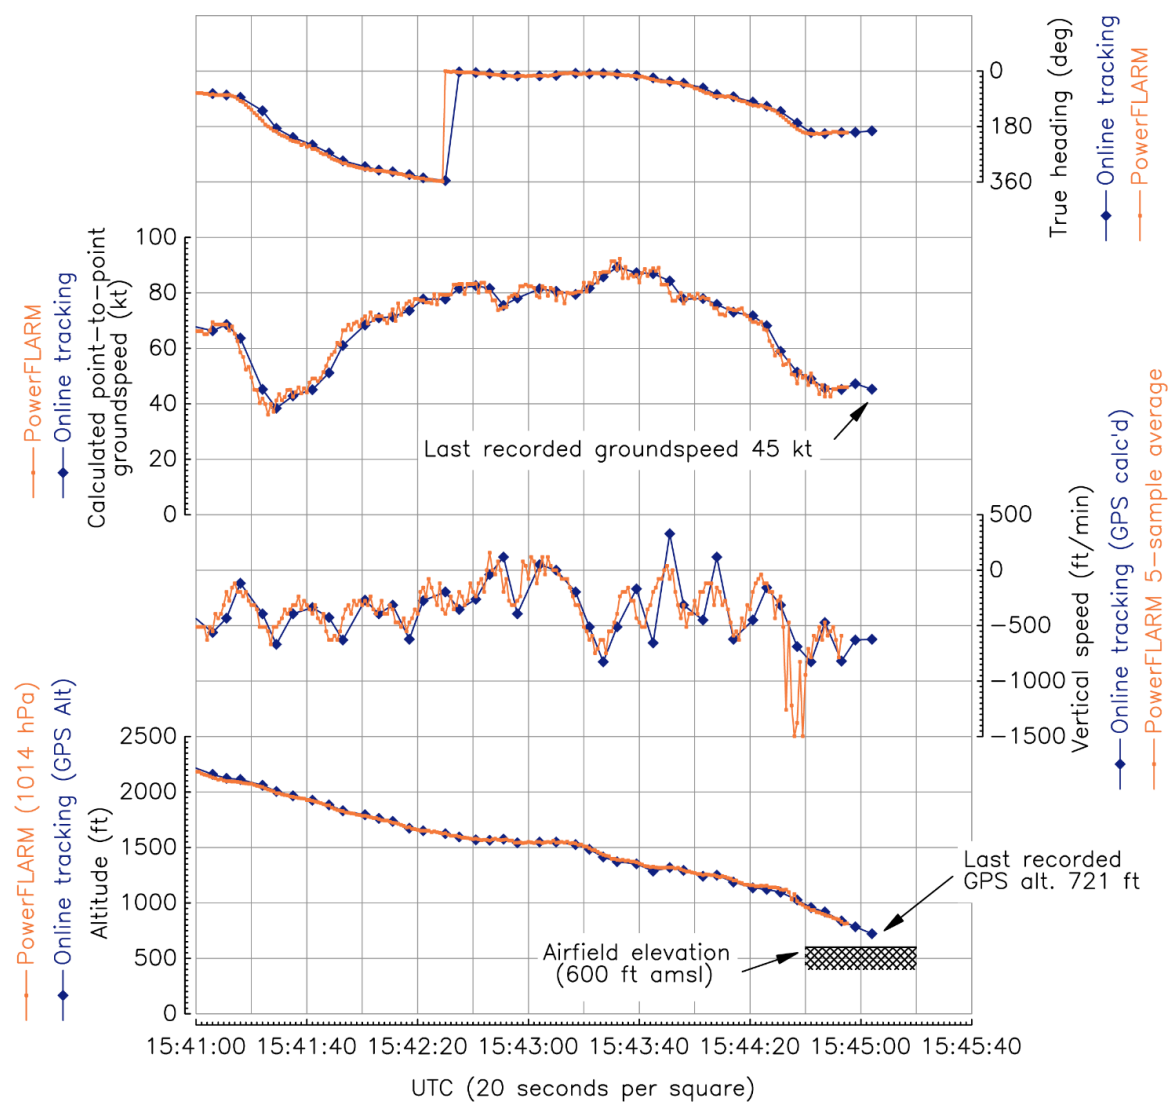
**Figure 2**

The PowerFLARM logged GPS position and pressure altitude once per second. The last recorded position was about 275 m short from where G-CHYB came to rest. FLARM logs from a glider tracking website also contained the GPS data, and, although at a lower sample rate, included two additional data points time-stamped after the PowerFLARM recording ended. It was not determined why the PowerFLARM recording stopped prematurely.

Figure 2 shows the groundspeed and altitude data from these data sources. The recorded groundspeed shortly before the accident corresponds to a calculated airspeed of about 60 kt based on the forecast wind conditions (see [Meteorology](#) section).

Pertinent parameters recorded during G-CHYB's base turn and approach

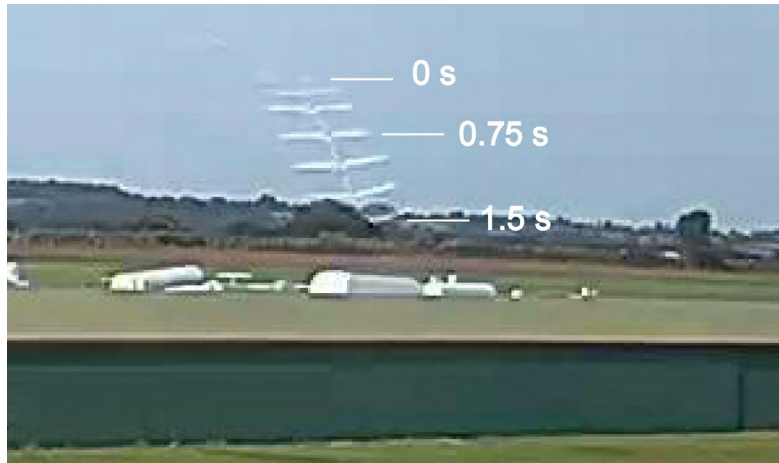
**Figure 3**

A security camera captured the final seconds of the flight. G-CHYB became visible in the video just before it was seen to pitch down steeply. Figure 3 illustrates a composite image of frames taken at 0.25 second intervals from when G-CHYB became visible in the video.

Composite image showing G-CHYB as it descended towards a tree beside the A419

In this event, as the aircraft reached approximately 100 ft agl the pilot felt he was somewhat low on approach and intended to make control inputs to reduce the ROD. It is likely that the strong habits formed by his experience caused him to make the intended inputs on the incorrect controls, so he pushed firmly with his left hand expecting that to retract the airbrake while pulling back with his right hand to raise the pitch attitude. The outcome was that the aircraft pitched down rapidly, and more airbrake deployment increased the ROD. Both those on board were surprised by the rapid pitch down and did not immediately recognise the cause. It is probable that both suffered a startle response and were unable to take appropriate corrective action in the timeframe available. The aircraft struck the trees alongside the A419 approximately 1.5 seconds after the pitch down began.

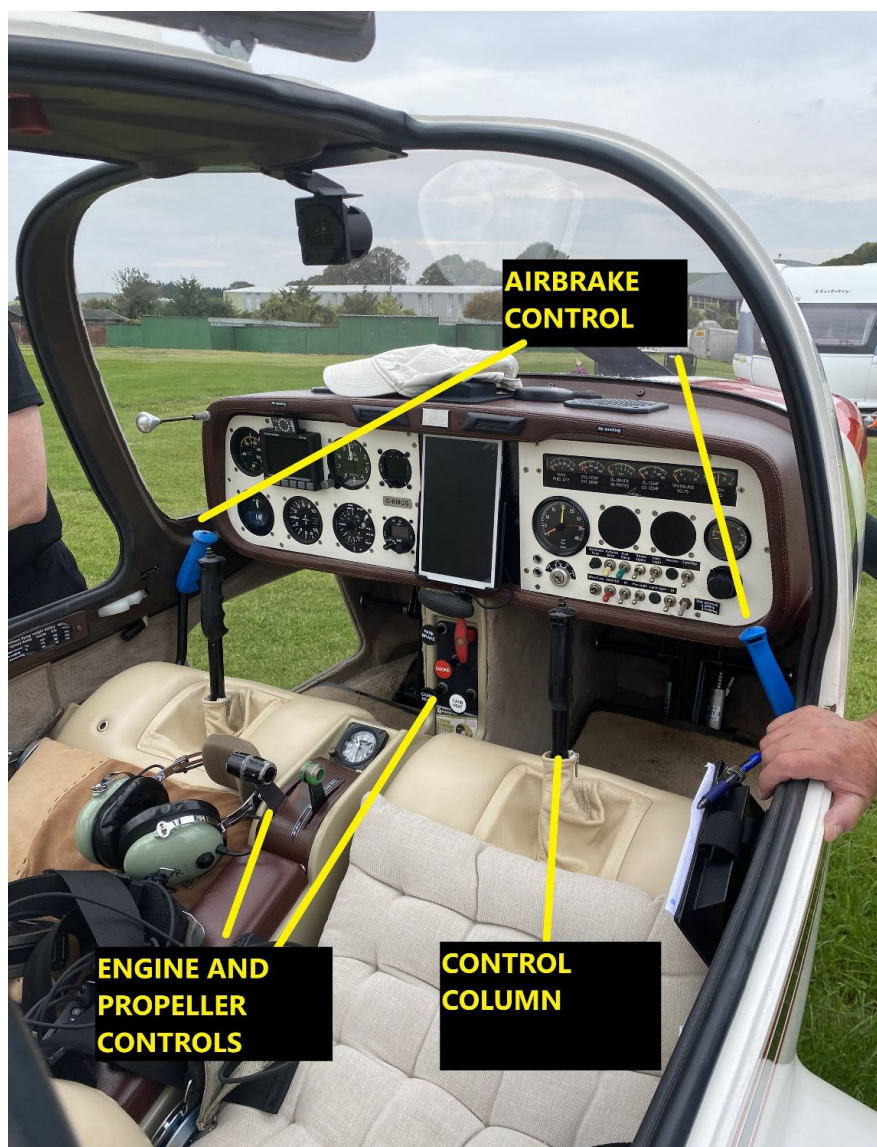
**Figure 5**  
Cockpit control positions

The aircraft has side-by-side seating and dual controls. Each seat has a control column located centrally in front of the pilot. Engine and propeller controls are on the centre console of the cockpit. The airbrake controls are outboard of each seat (Figure 5). When in powered flight the operating pilot uses the control column and the engine/propeller controls. The engine is normally left to run at idle when in gliding mode, while the pilot uses the control column and airbrake to control the aircraft. As a result of this arrangement pilots are required to change hands on the flying controls when changing from powered to gliding flight. A modification is available for the aircraft to add an additional throttle control to the left side of the instrument panel which allows the left seat occupant to operate the airbrakes and engine controls without changing hands (Figure 5). However, this modification was not fitted to the accident aircraft and it does not change the control configuration for the right seat occupant.

The intent was to make the final approach to land with the aircraft being operated in glider mode. In glider mode the pilot controls airspeed with pitch and ROD using the airbrakes. As the right seat airbrakes are mounted on the cockpit wall, a pilot in that seat operating in glider mode would have their left hand on the control column and their right hand on the airbrake. Most gliders are operated with the airbrake in the pilot’s left hand and the control column in the right hand.

control column and his right hand was on the airbrakes. The passenger was controlling ROD with airbrake and airspeed with pitch, which is usual for an approach in a glide. He has significant experience of flying gliders, so the control principle was familiar to him. However, the passenger had limited experience of operating with the control column in his left hand and no previous experience of operating a Grob 109 from the right seat. His established practice would therefore have been to make control adjustments to pitch with his right hand and adjustments to ROD with his left hand. If the aircraft was low on approach the required adjustment from a pilot would be to reduce ROD by retracting airbrake and then to compensate for airspeed by slightly raising the pitch attitude. This would require a firm push on the airbrake control and a small input on the control column.
