**Accident**

| <b>Aircraft Type and Registration:</b> | Guimbal Cabri G2, G-FICH | |
| <b>Location:</b> | Leicester Airport | |

**Synopsis**

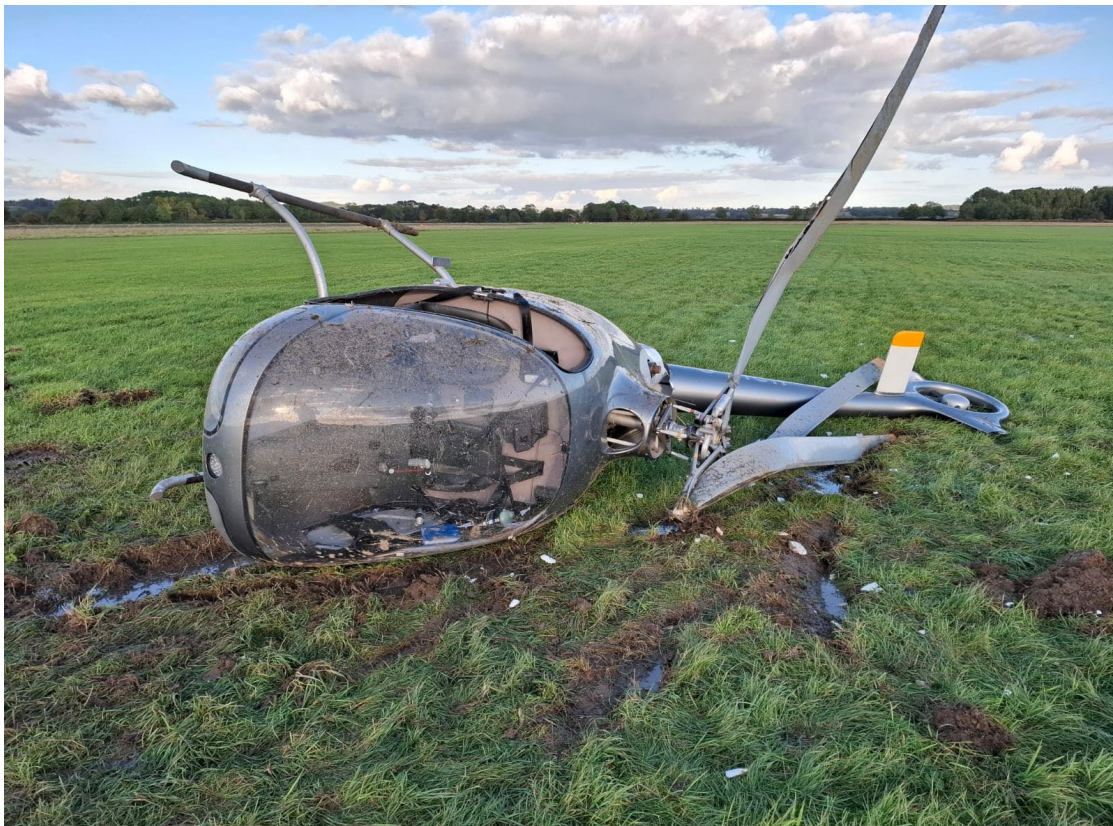
**Figure 1**  
Accident site

The helicopter came to rest on its left side (Figure 1) close to the location in which it had been hovering. The cabin and cockpit area had minor damage. The main rotor blades were severely damaged, the tail boom had separated, the right door had detached, and the skids had slid sideways to the right. The maintenance organisation attended the accident site and disconnected the tail rotor control rod from the tail rotor control unit, so that the tail boom could be removed to ease transportation of the helicopter back to a hangar for examination.

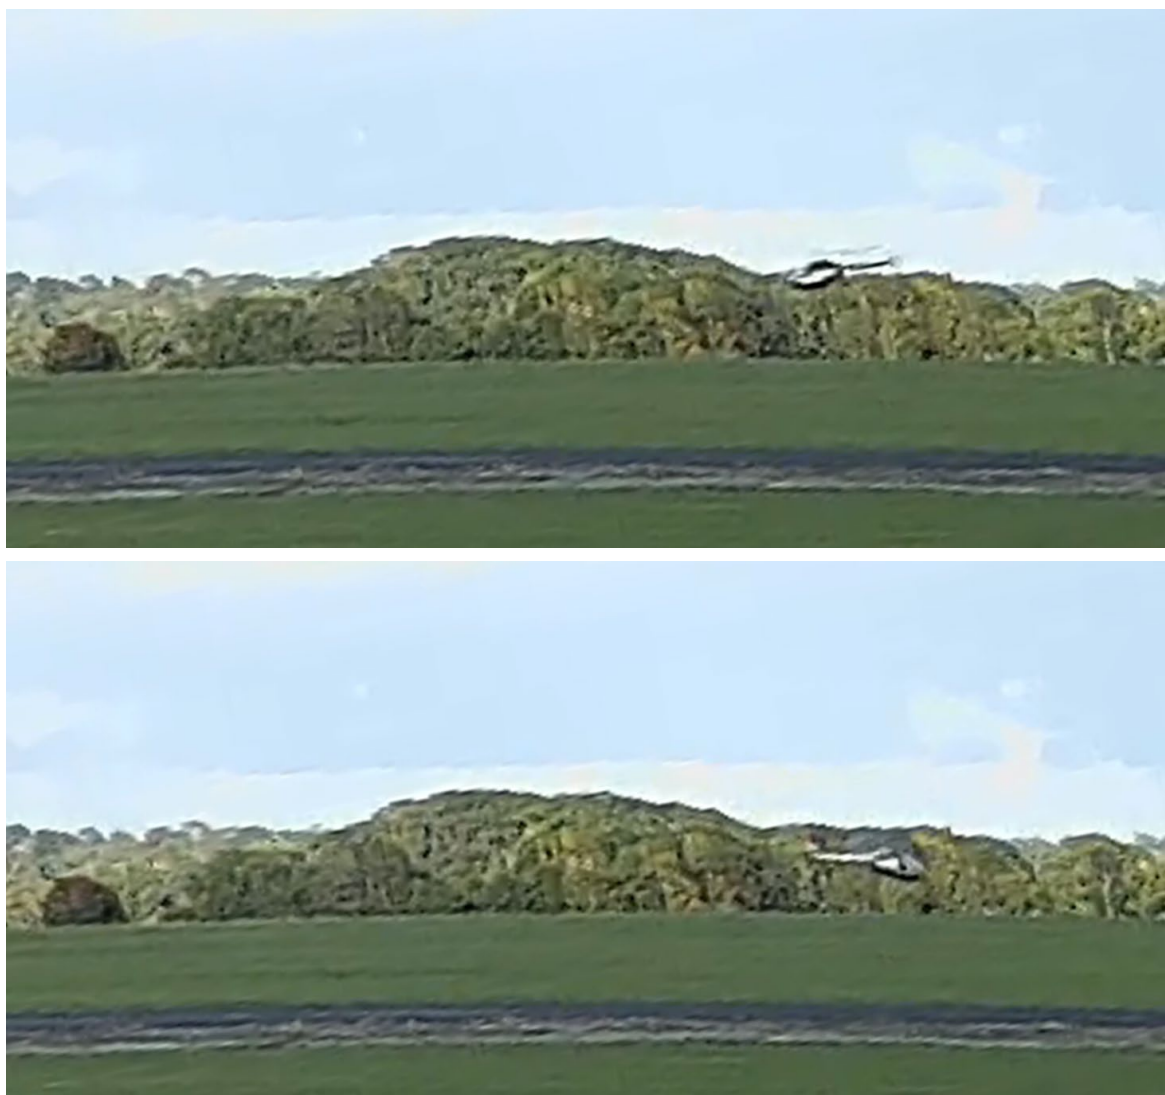
**Figure 3**

The CCTV showed G-FICH moving forward very slowly as it was brought to a hover approximately into wind. It then yawed rapidly to the left and continued yawing, roughly level in pitch and height for the first rotation. The second rotation saw G-FICH descend closer to the ground, but the helicopter climbed vertically during the third rotation which would likely have been the result of an increase in the collective. The fourth rotation saw G-FICH descend before contact with the ground initially with the rear of the skids and the tail.

Two still images from the CCTV are shown in Figure 3 showing one of the turns to the left prior to striking the ground.

CCTV still images from Leicester Airport

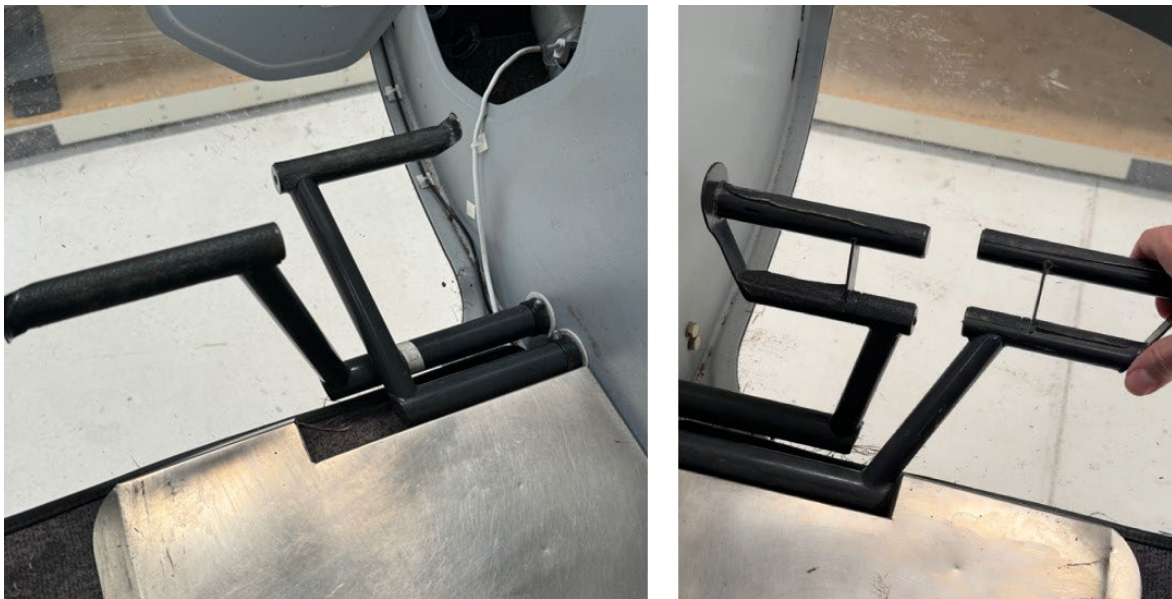
**Figure 4**

G-FICH was fitted with dual controls with yaw pedals on both sides. The pedals on the right side were adjustable, with two positions, which allows pilots to reduce the distance between

the pedals and seat by 80 mm, by pivoting the top of the pedal aft (Figure 4). The left side had the standard non-adjustable pedals.

Left side fixed pedals (left image) and right side adjustable pedals (right image)  
on G-FICH

Yaw control of G-FICH was lost during a hovering exercise. It is likely that full opposite pedal was not applied and/or held for sufficient time. This may have been because the commander was more familiar with flying using the adjustable pedals than those fitted on the left side of G-FICH. Whilst the commander was not injured in the accident, he died from an unrelated medical condition seven days later.

The aircraft manufacturer has agreed to install adjustable pedals on the left side as a standard fit on new models of Cabri G2.

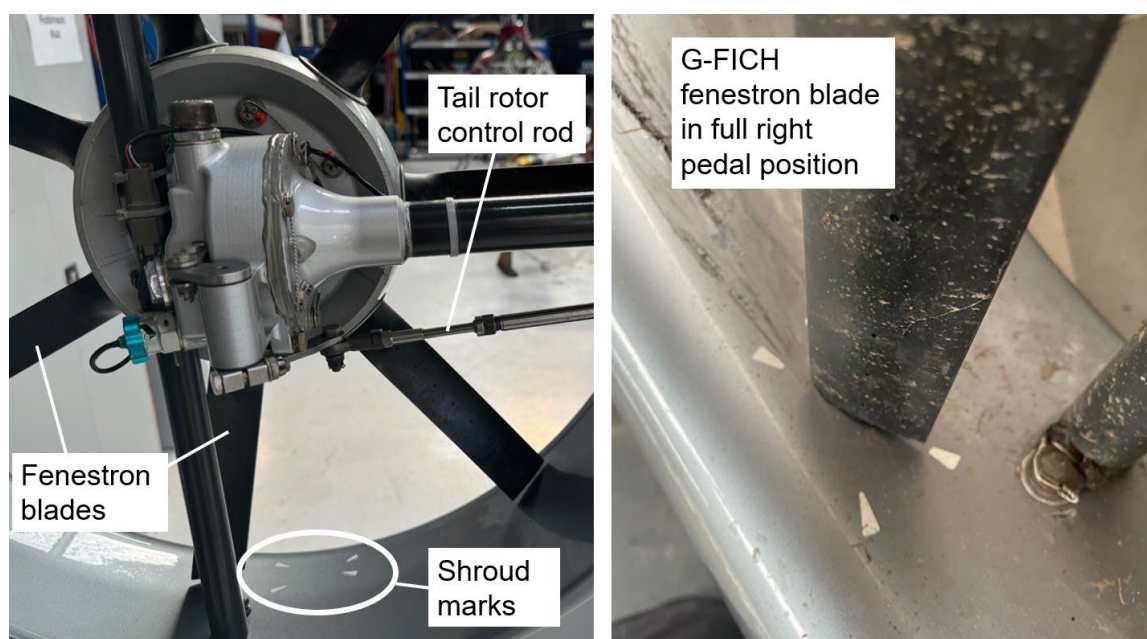
**Figure 5**

The helicopter was manufactured in 2015 and had accumulated 4,862 hours at the time of the accident. The last 50-hour maintenance check had been completed on 22 September 2024. The only defect noted during this check was the map bag touching the Emergency Locating Transmitter test switch – this was rectified. The last disconnection of the tail rotor control rod was during the 2,200-hour maintenance check which was completed on 25 January 2024. The helicopter had been operated for 465 hours since this maintenance and, according to the flying training school, instructors regularly checked that full yaw travel could be reached by rotating the fenestron blades by hand and checking the travel against the 'shroud marks' on the fenestron shroud during their pre-flight checks (Figure 5).

Shroud marks (left image) and fenestron blades aligned with the shroud mark for full right pedal on G-FICH (right image)

The pre-flight check list in the Flight Manual<sup>5</sup> contained a tail rotor blades condition and slack check, but it did not contain a check of the blades against the shroud marks. As a result of the findings of this investigation, the aircraft manufacturer plans to add the following pre-flight check in the next revision of the Flight Manual:

*'Tail rotor blades max pitch.....Aligned with shroud marks'.*

The aircraft manufacturer has stated that it will amend the pre-flight checklist in the next revision of the Flight Manual to include a check that the tail rotor blades can be aligned with the fenestron shroud marks.
