Grounding and subsequent loss of the prawn trawler *Sustain* (UL 45) on Rubha Camas a' Mhaoraich, Loch Broom, Scotland on 16 November 2023

SUMMARY

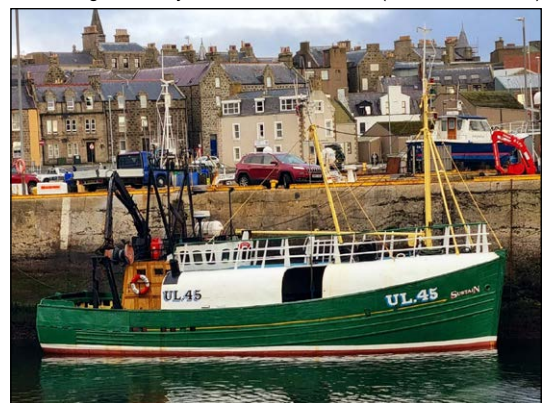
Sustain

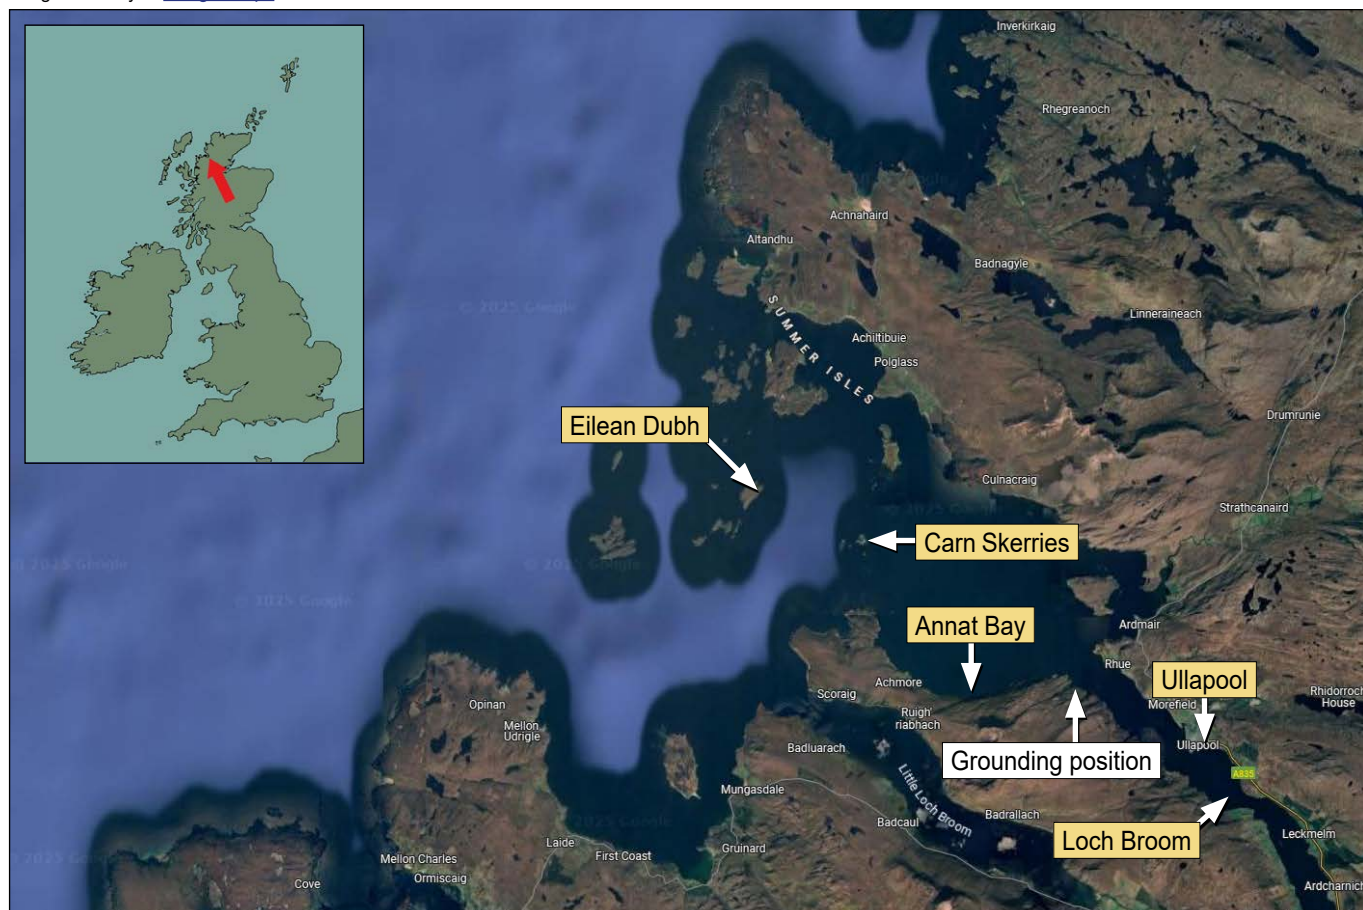
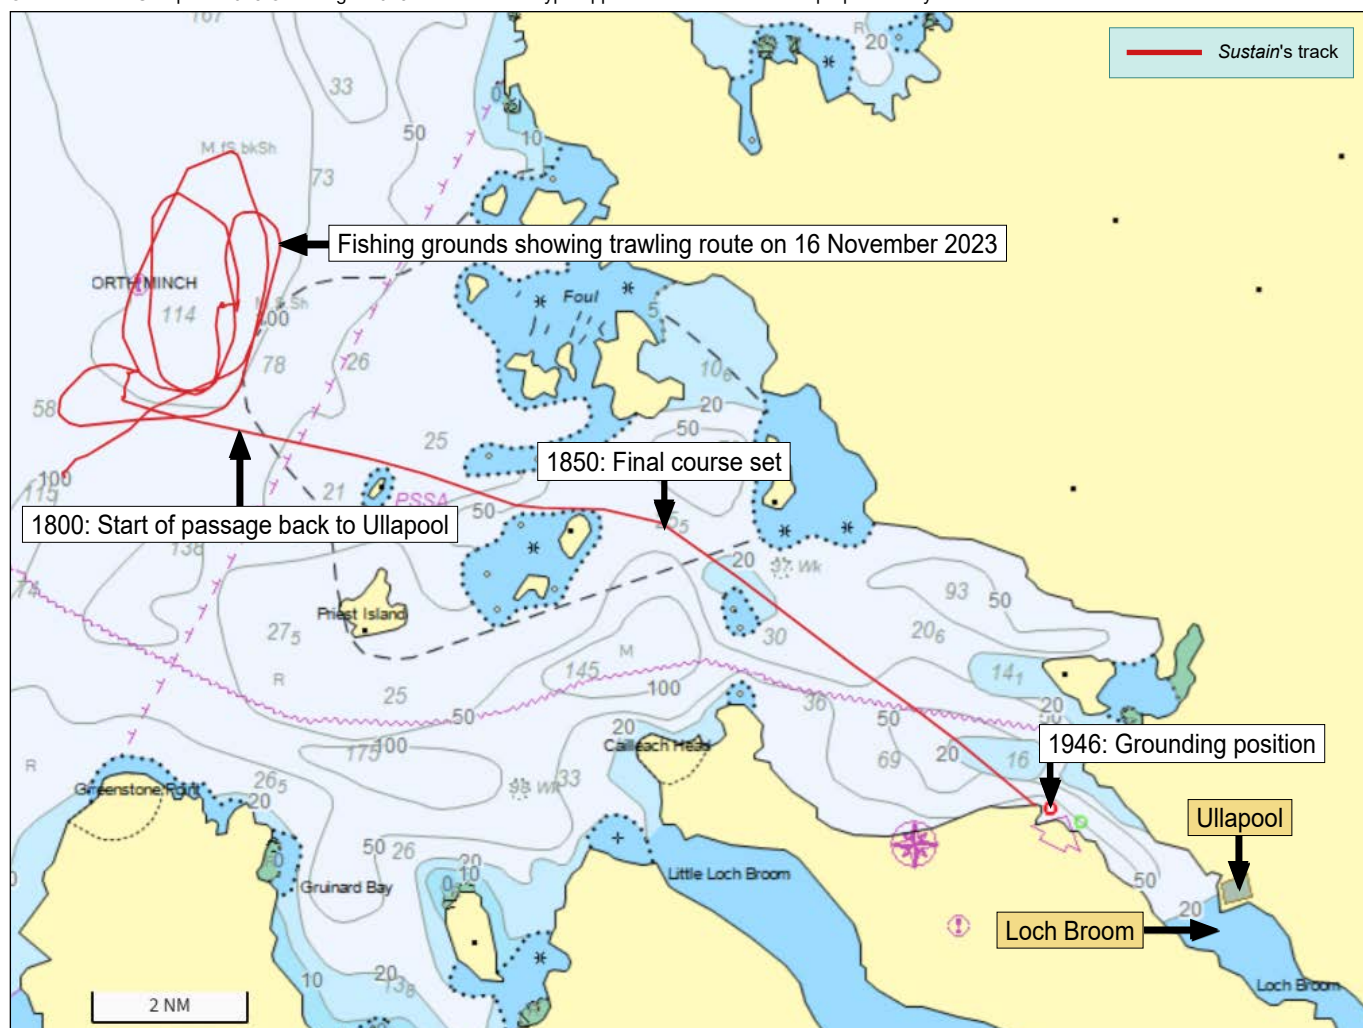
Figure 1: Fishing grounds and Sustain's passage back to Loch Broom

A download of the vessel's plotter data indicated that, after passing the island of Eilean Dubh, the skipper set a course into the autopilot that would take *Sustain* into Loch Broom and pass about 2 cables² north-east of the Rubha Camas a' Mhaoraich. After passing the Carn Skerries, the COG drifted 3° to starboard.

The small course drift of 3° to starboard after passing Carn Skerries, likely caused by a change in the tidal stream or wind, was enough to put the vessel on course with rocks at the southern entrance to Loch Broom.

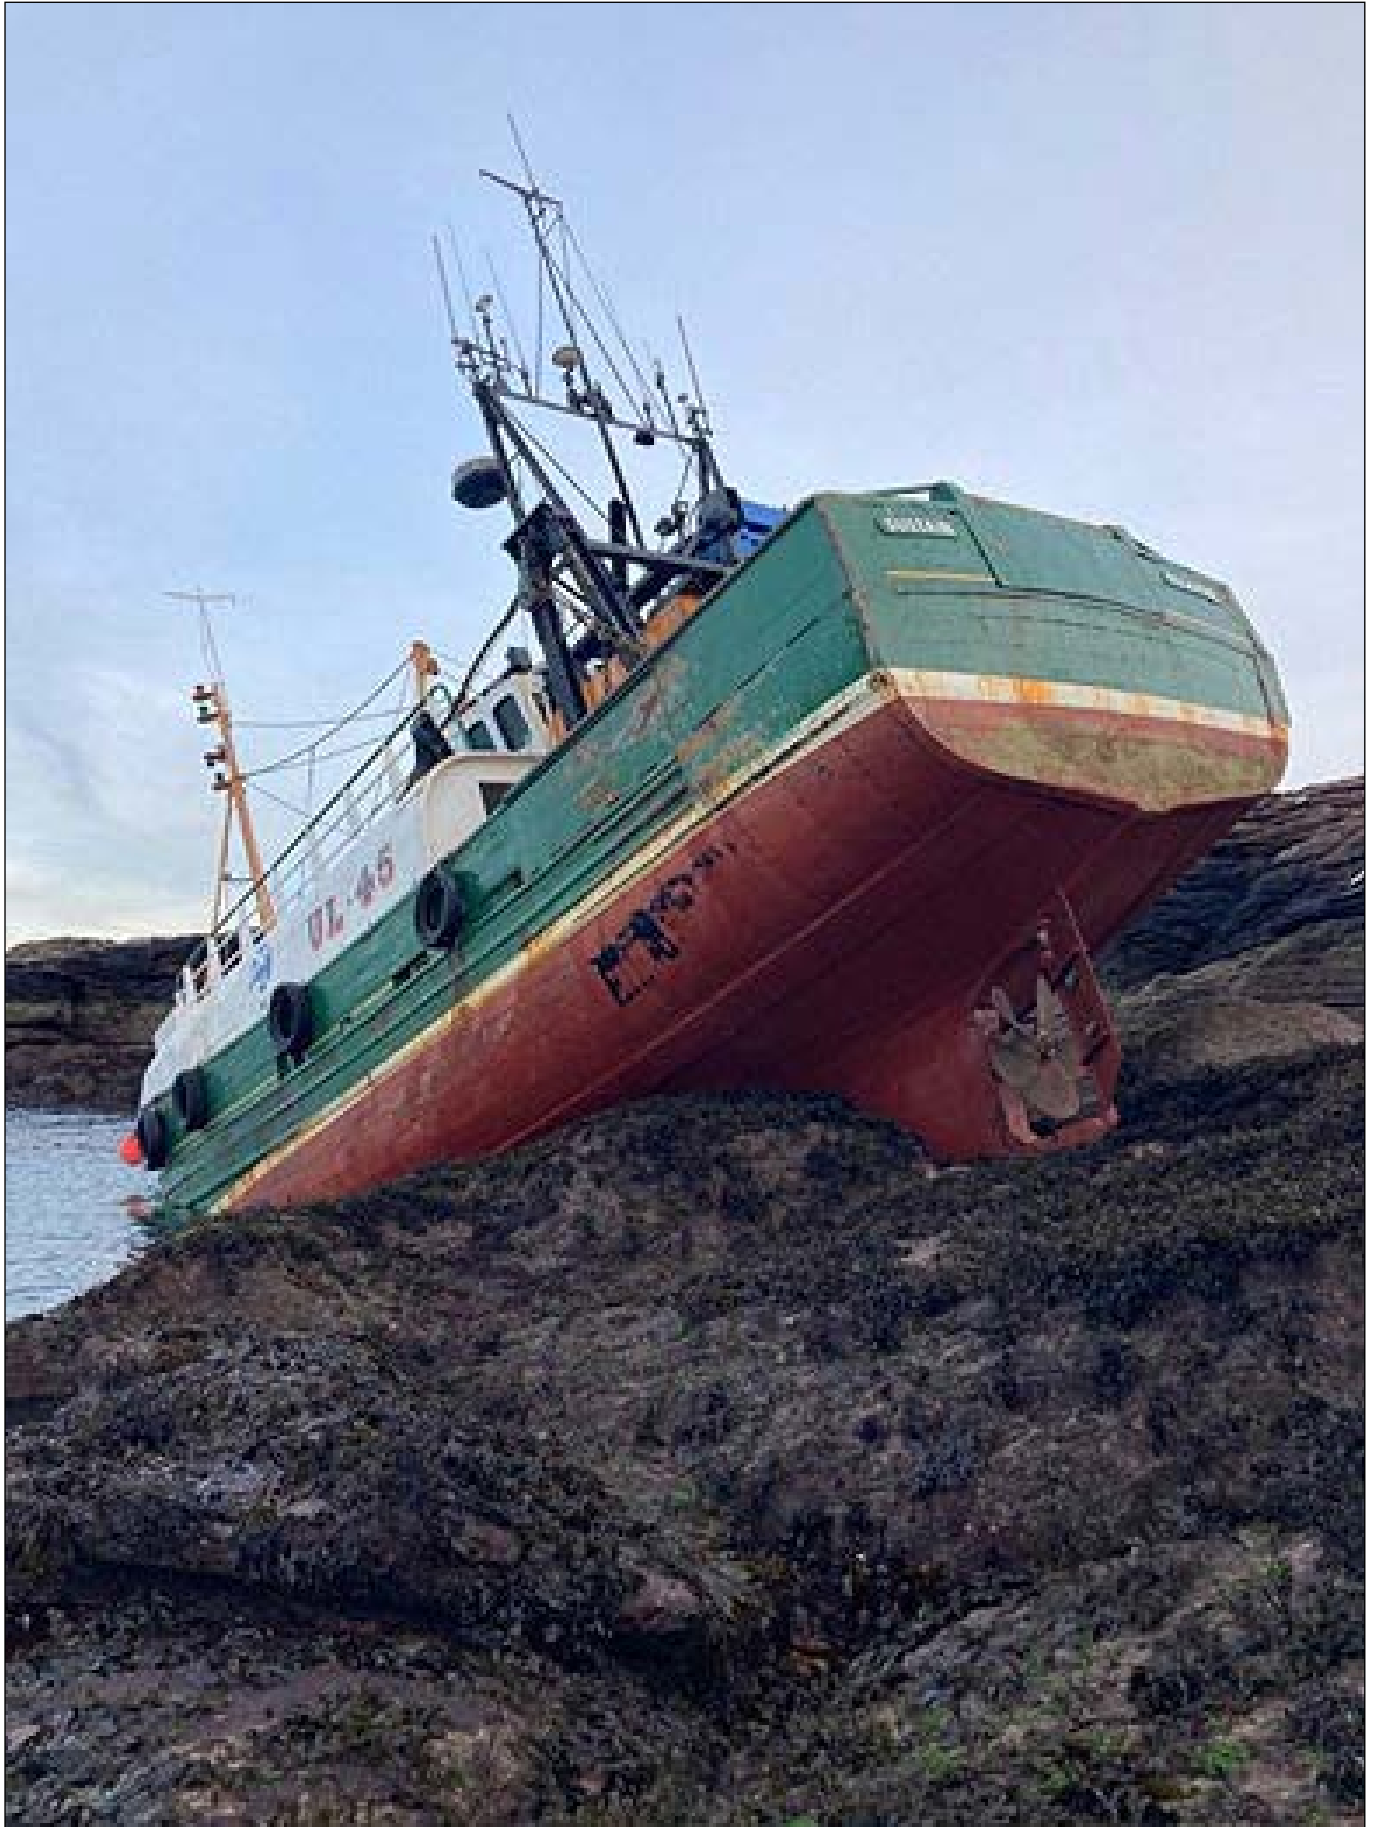
At 1946, *Sustain* grounded on rocks at Rubha Camas a' Mhaoraich in Loch Broom (**Figure 1**) while making 7.7 knots (kts). The skipper awoke and took the vessel's engine out of gear and the deckhands, who were working below, came up to see what had happened. The skipper and one deckhand checked the area around the vessel to determine what the vessel had struck. The other deckhand checked the forepeak for damage or water ingress. The crew tried to move the vessel with its engine and by adjusting the power block and trawl doors, but were unable to do so.

By 18 November, *Sustain's* hull had breached and was partially submerged at high water. On 21 November, all remaining fuel and salvageable gear was removed from the vessel. The following week the wind increased and the vessel sustained further damage before being declared a constructive total loss at the end of November. The wreck was located in a narrow gully (**Figure 2**), close to a ferry route. In early 2024, over a period of weeks, *Sustain* was dismantled piece by piece and removed from the site by a team of specialist divers.

Figure 2: *Sustain* grounded in gully on Rubha Camas a' Mhaoraich
