Fatal man overboard from the lone-operated creel fishing vessel *Nista* (LK121) north of Belnahua, north-west Scotland on 13 December 2023

SUMMARY

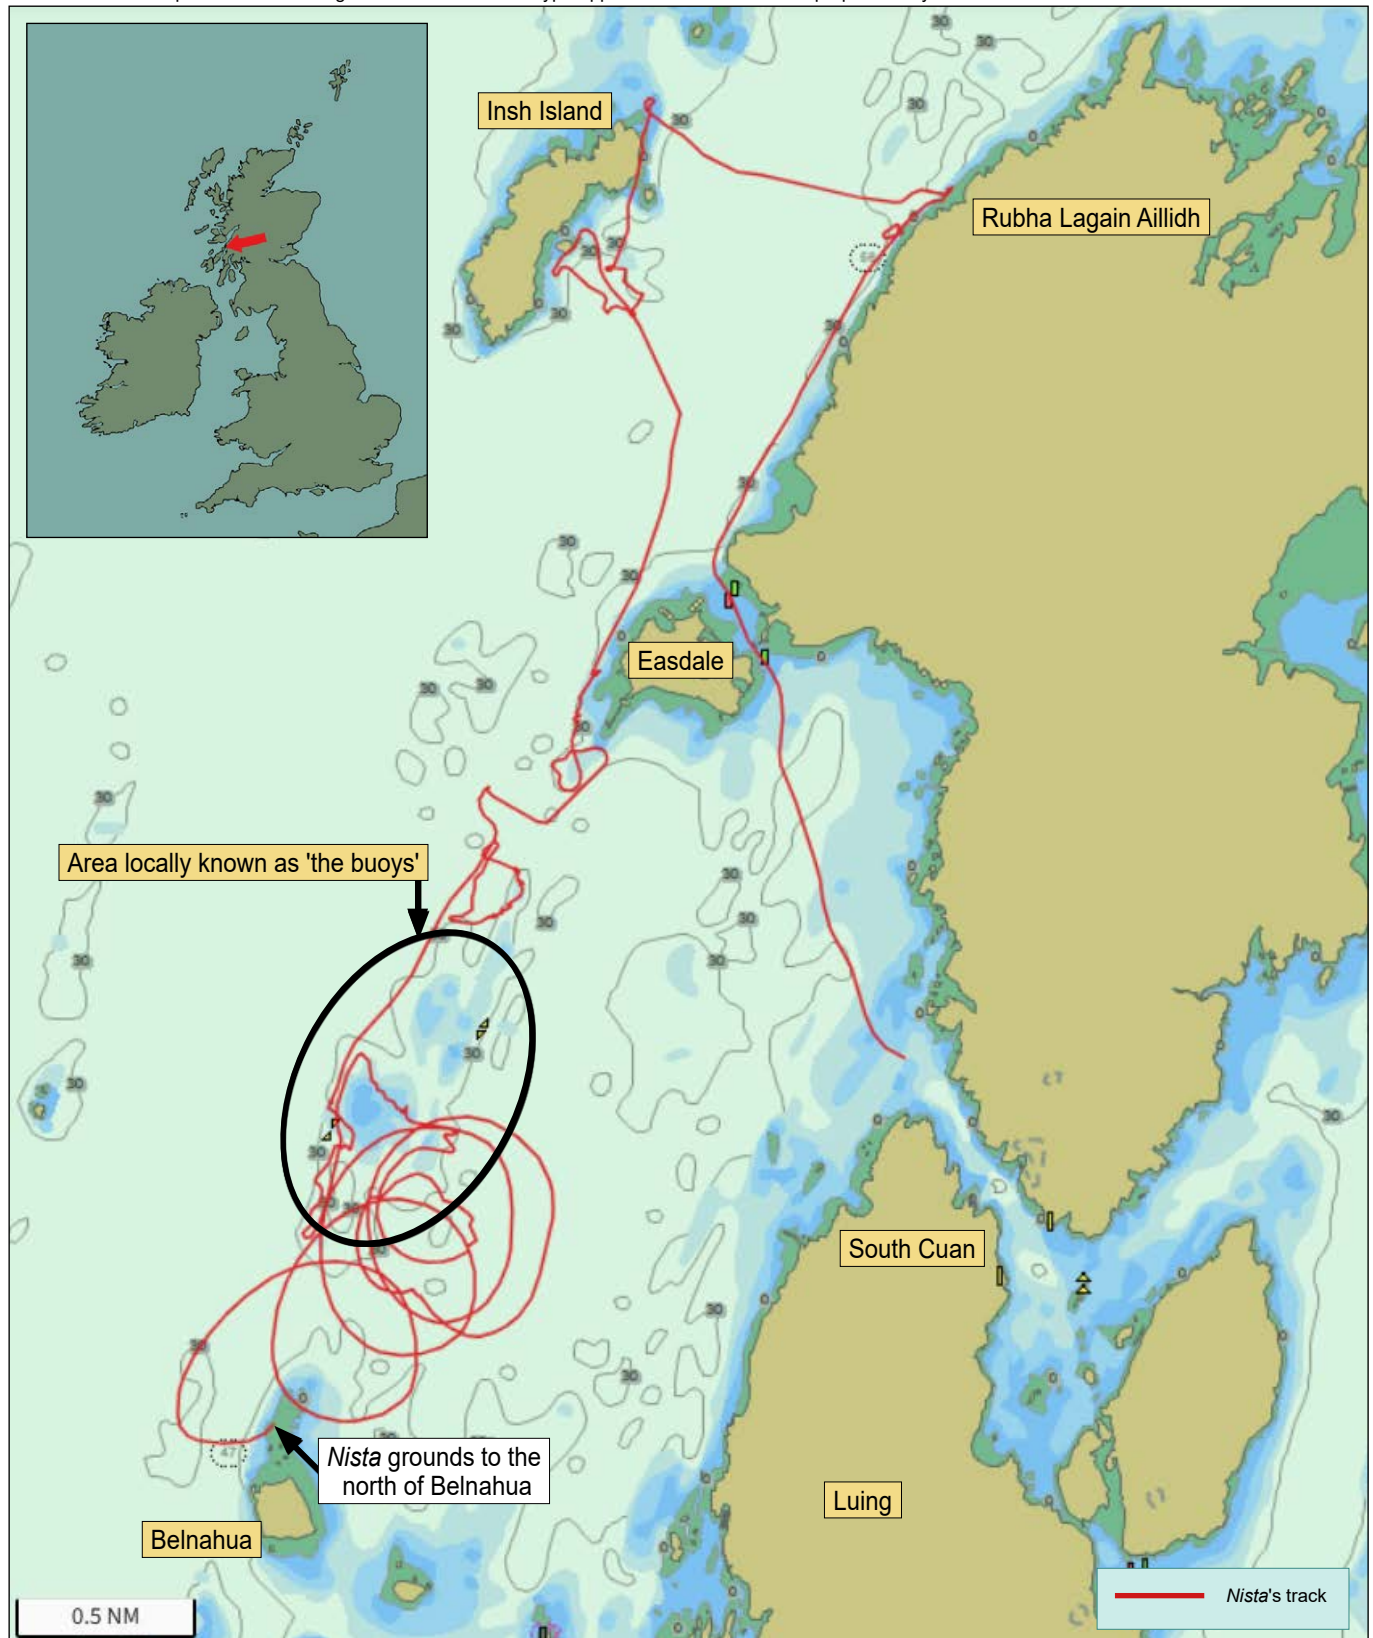
Figure 1: Passage of *Nista* on 13 December 2023 and (inset) accident location

At about 0840 on 13 December 2023, *Nista* departed South Cuan on the isle of Luing, Scotland and steamed north to Rubha Lagain Aillidh, arriving at 0919 (**Figure 1**). *Nista* then travelled west to Insh Island, arriving at 0928, and then headed south, arriving at Easdale an hour later to lift and shoot one fleet of creels.
