Report on the investigation of  
the capsize and foundering of the fishing vessel

***Njord* (SH 90)**

150 miles north-east of Peterhead, Scotland

on 6 March 2022

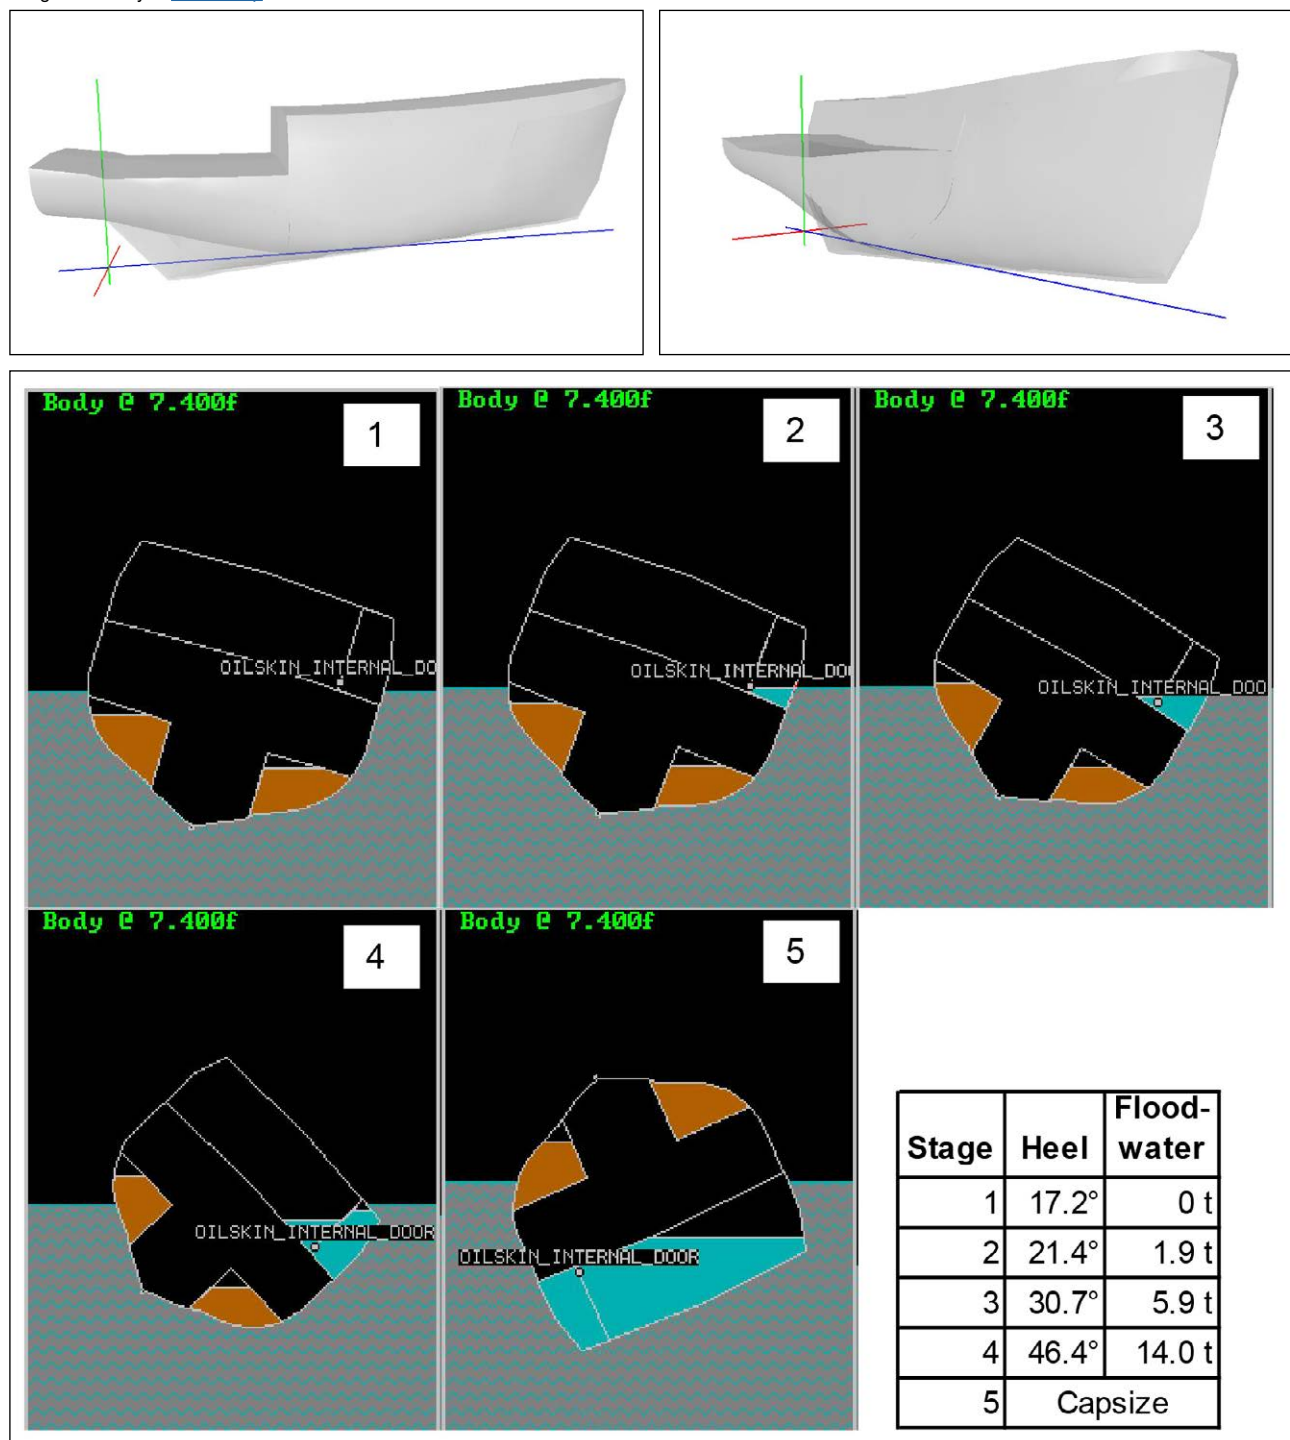
**Figure 11:** *Njord*'s likely flooding sequence

The results of the scenario A loading condition indicated that 3.10t was required to act at the net lashing position for progressive flooding to immerse the starboard passageway drain hole (downflooding point 2) and begin flooding the passageway. The digital model demonstrated that a list of 46.6° would capsize the vessel before flooding of the lower accommodation through an internal door (internal downflooding point 4) would occur (**Figure 11**).

The results of the scenario B loading condition indicated that *Njord* would have immediately capsized without downflooding if a load of 9.9t or more had been applied to the net lashing position. It would not have been possible to apply sufficient net load to submerge the fish landing hatch (downflooding point 1) before capsize occurred.

The results of the scenario C loading condition indicated that a weight of 4.4t was required to act at the net lashing position to immerse the starboard passageway drain hole, (downflooding point 2) and commence progressive downflooding.

The results of the scenario D loading condition indicated that a weight of 7.4t applied to the net lashing position would be required to bring the vessel to a 16.4° angle of list, sufficient to initiate downflooding through the starboard passageway drain hole (downflooding point 2).

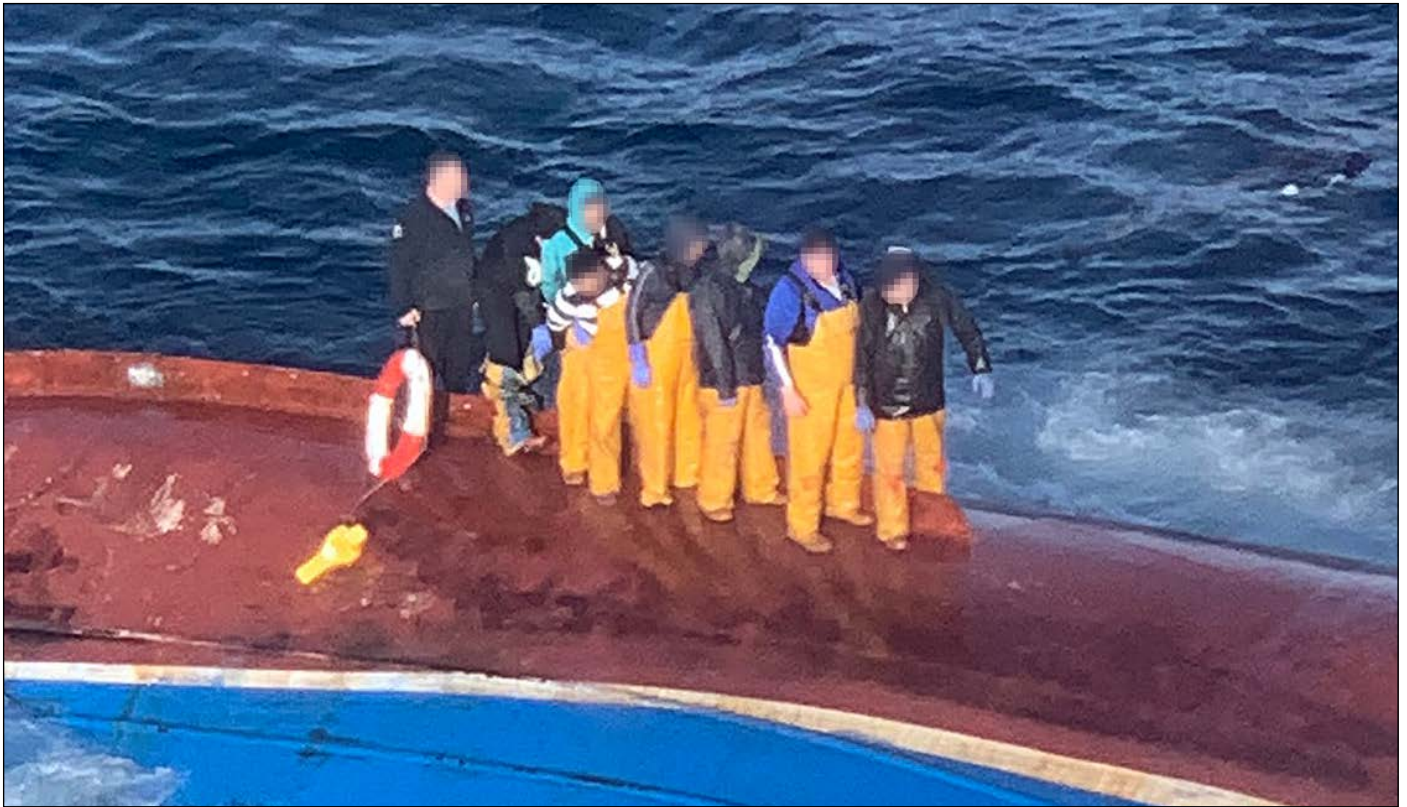
The crew standing on the upturned hull of *Njord*
