RE: Request for Information – RFI4832

Specialist Field:	Marine Consultant and Surveyor
On behalf of:	Homes and communities Agency
Subject:	Condition / Cost of Disposal

INSPECTION OF SRN4 HOVERCRAFT FOR HAZARDS

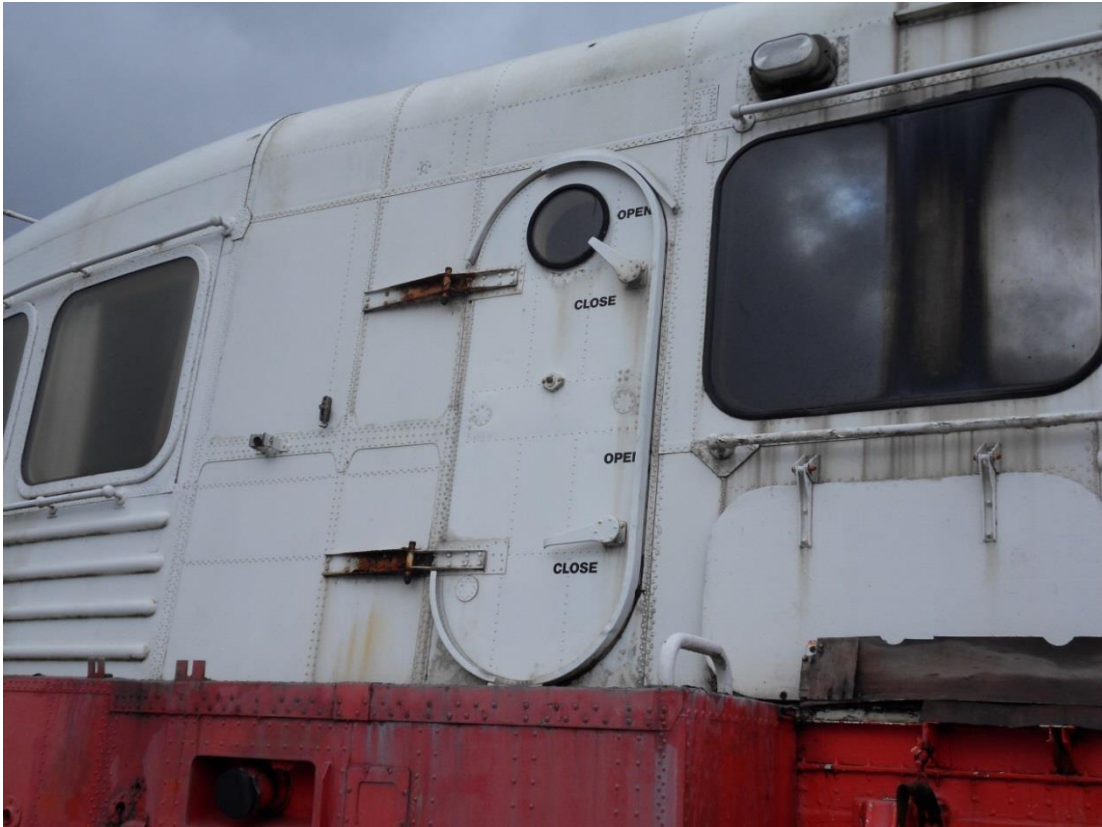
4.4 The superstructure is showing extensive paint blistering, especially in the vicinity of joints and rivets. There are numerous dents and deformations and some splits in areas of the metal skin. The majority of the doors are damaged with splitting of the skin from the frame. Steel hinges and fastenings are heavily corroded, through rusting. Internal examination of the deckhead showed white powdery residue on the alloy. This is a corrosion product made up of hydroxides of aluminium. It is characteristic of poor preservation and long exposure to a salt water environment.

Photograph 3 - Typical Condition

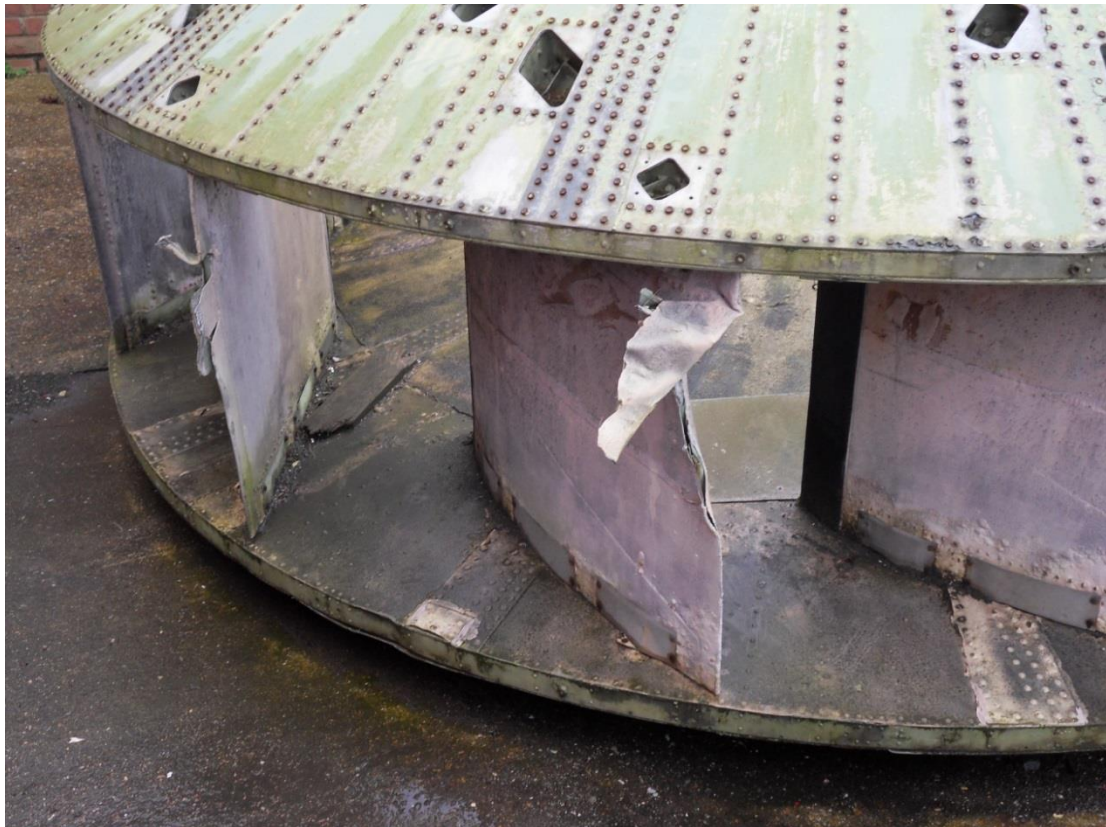
Photograph 4 - Damaged lift fan showing corroded bolts

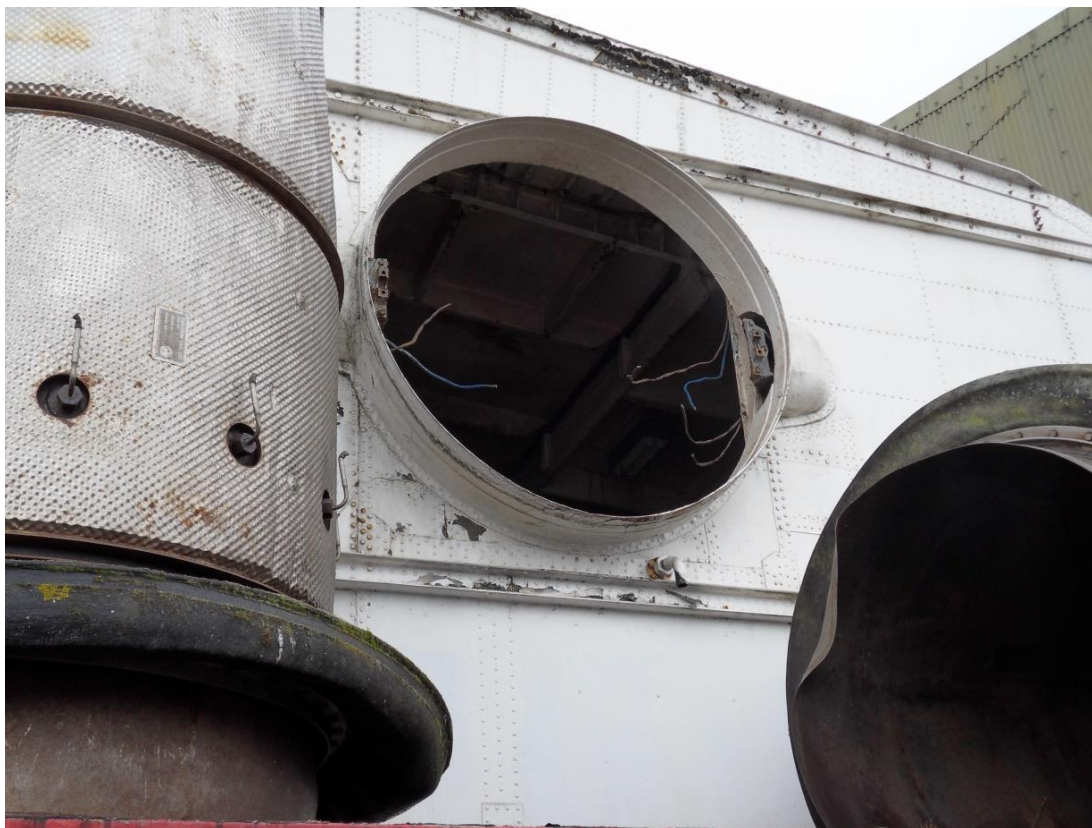
Photograph 5 - Exhausts removed from empty engine compartment 'Princess Margaret'

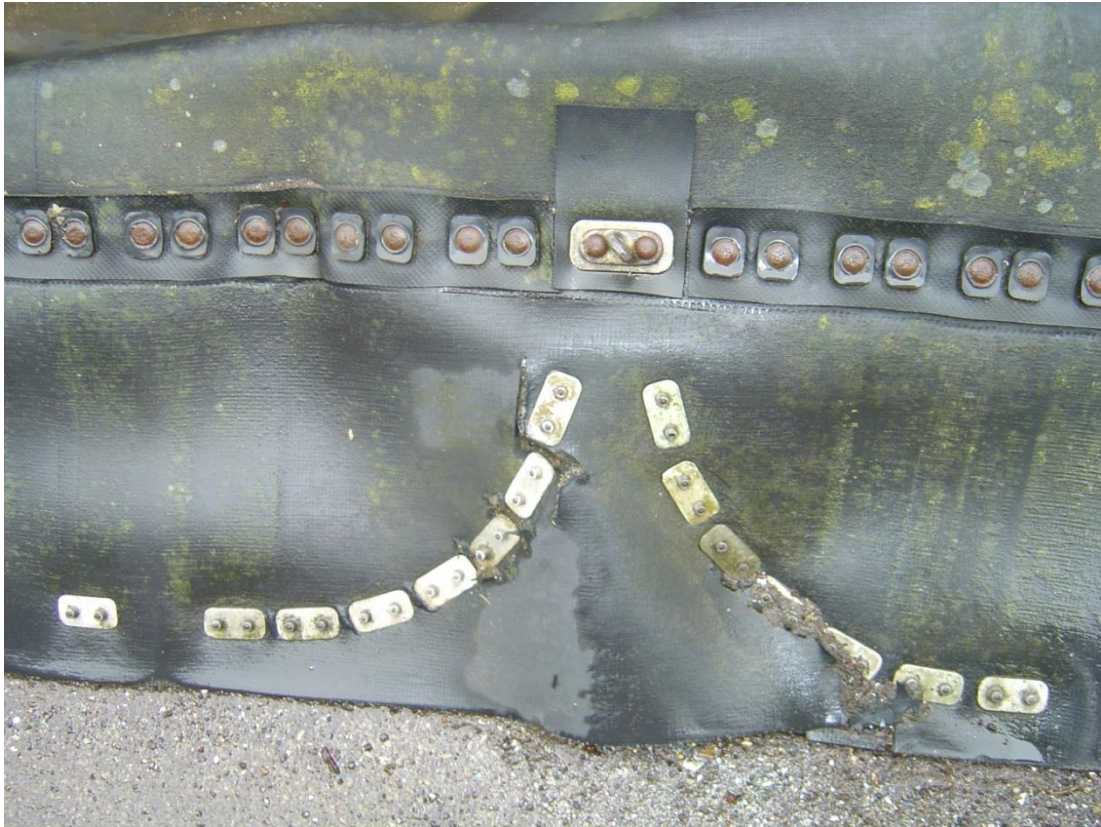
- 4.3 The skirt is of nylon mesh overlaid with neoprene. The skirts of both crafts have aged and lost flexibility. The neoprene has ‘perished’ and is cracking in numerous places. The skirt is not serviceable. The skirt is attached to the hovercraft by ‘hinges’ consisting of two stainless steel plates joined by a steel pin. Most of the pins and the associated fastenings for the plates are corroded.

Photograph 6 - Damaged skirt 'Princess Anne'

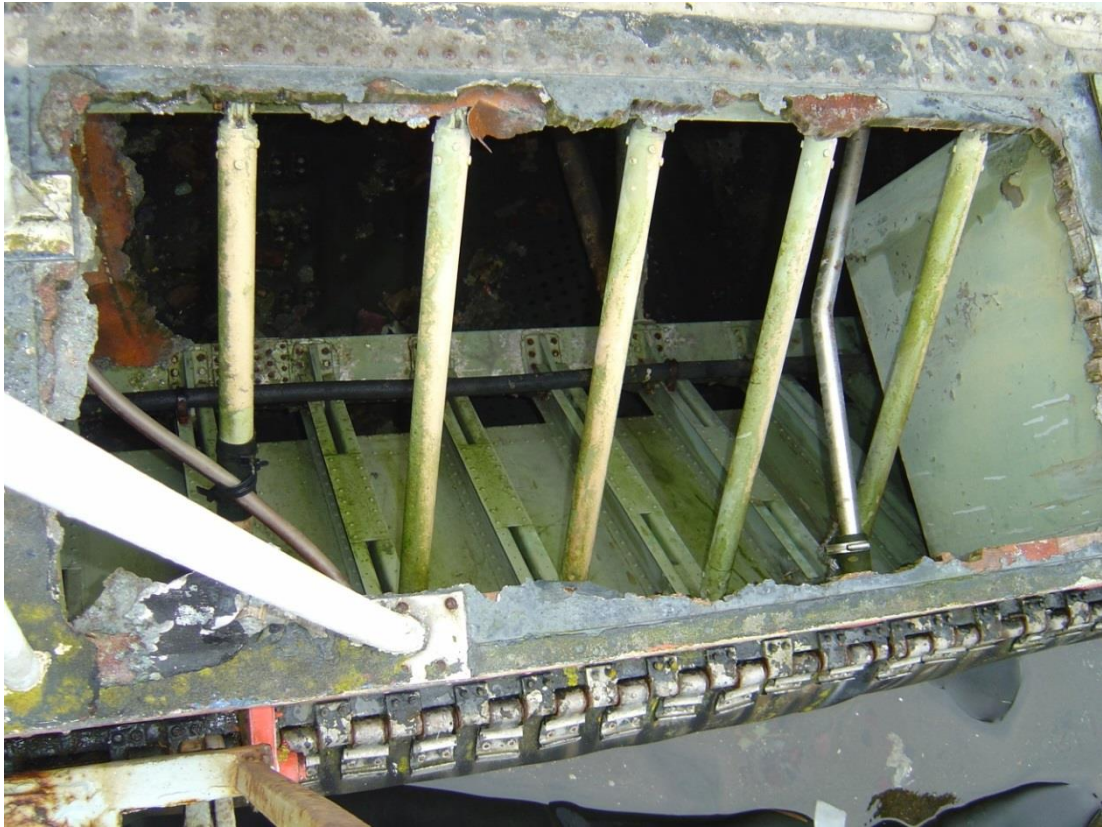
- 4.2 The construction of the side decks and skirt forming the outer chamber of the plenum is cruder. There is no equivalent on an aircraft and every effort was made to save weight using early composite techniques. The decks are of balsa wood and mesh overlaid with FRP over duralumin struts. The wood / fibre composite is delaminating owing to unchecked water ingress over a prolonged period. In some areas it is broken and/or missing.

Photograph 7 - Damage to side deck 'Princess Anne'

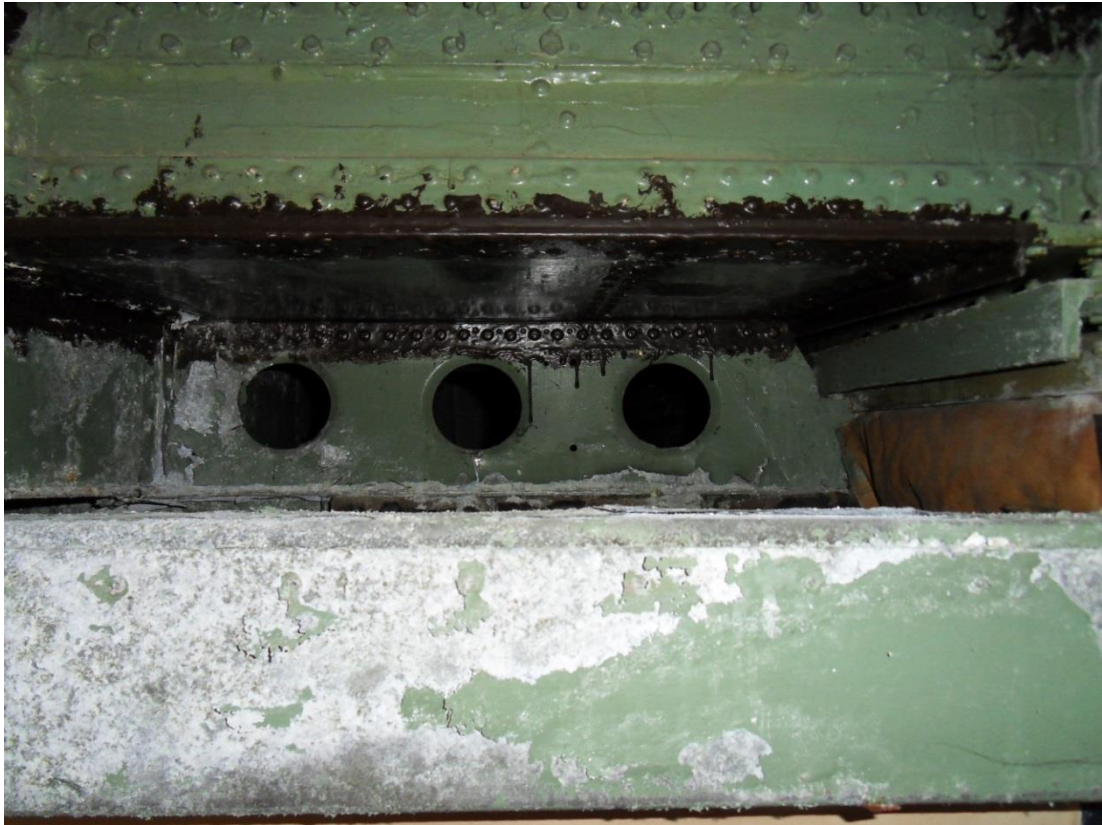
4.5 Internal inspection of 'PRINCESS ANNE' showed pinholing in the deckhead above the car deck, through which daylight was visible. There is no fire suppression system or structural fire protection of any significance. The deck of the vehicle deck has in places been overlaid by doubling plates. This is a crude form of repair which can itself form further corrosion hot spots.

Photograph 8 - Deckhead interior showing corrosion deposits

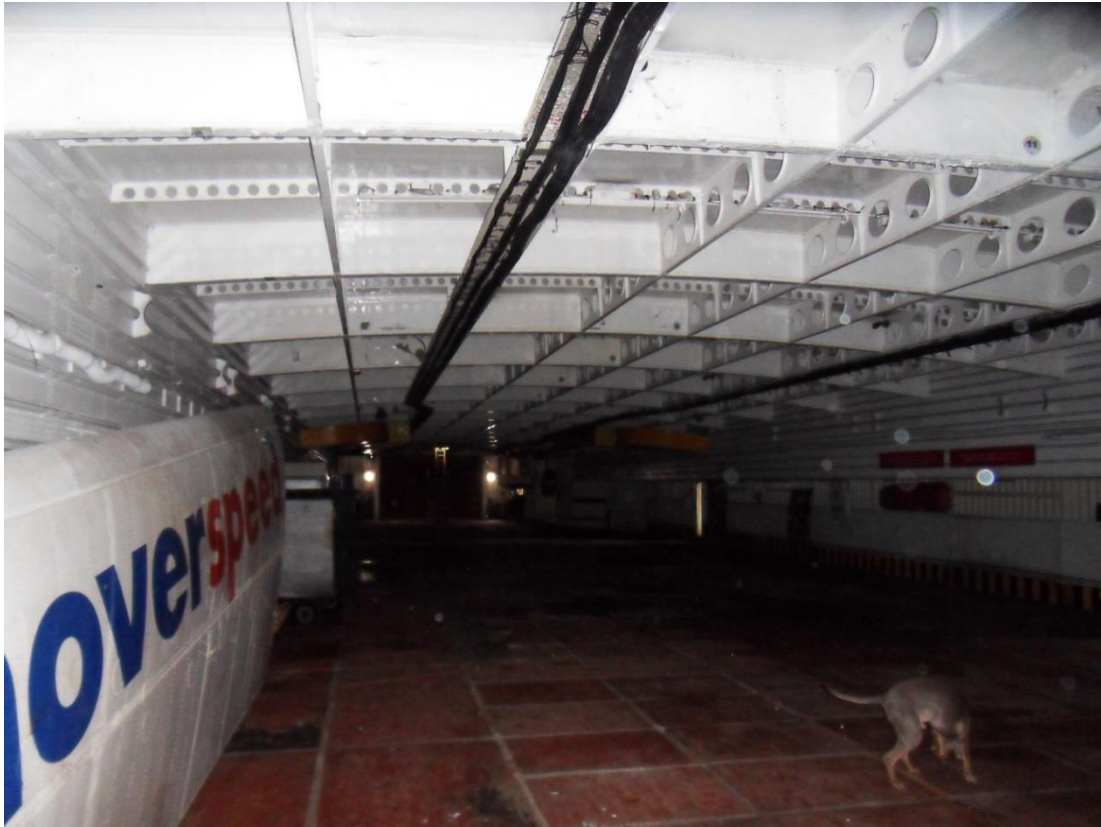
Photograph 9 - Car deck showing lack of structural fire protection

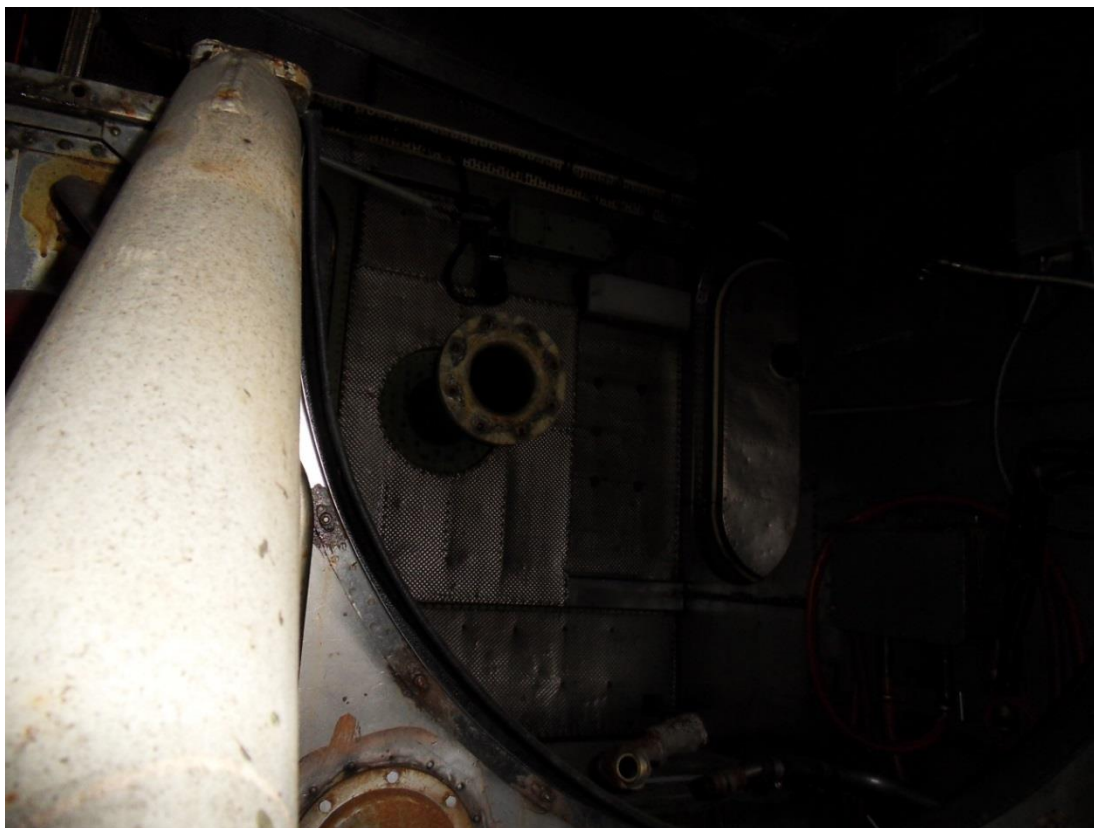
Photograph 10 - Empty machinery compartment 'Princess Anne'

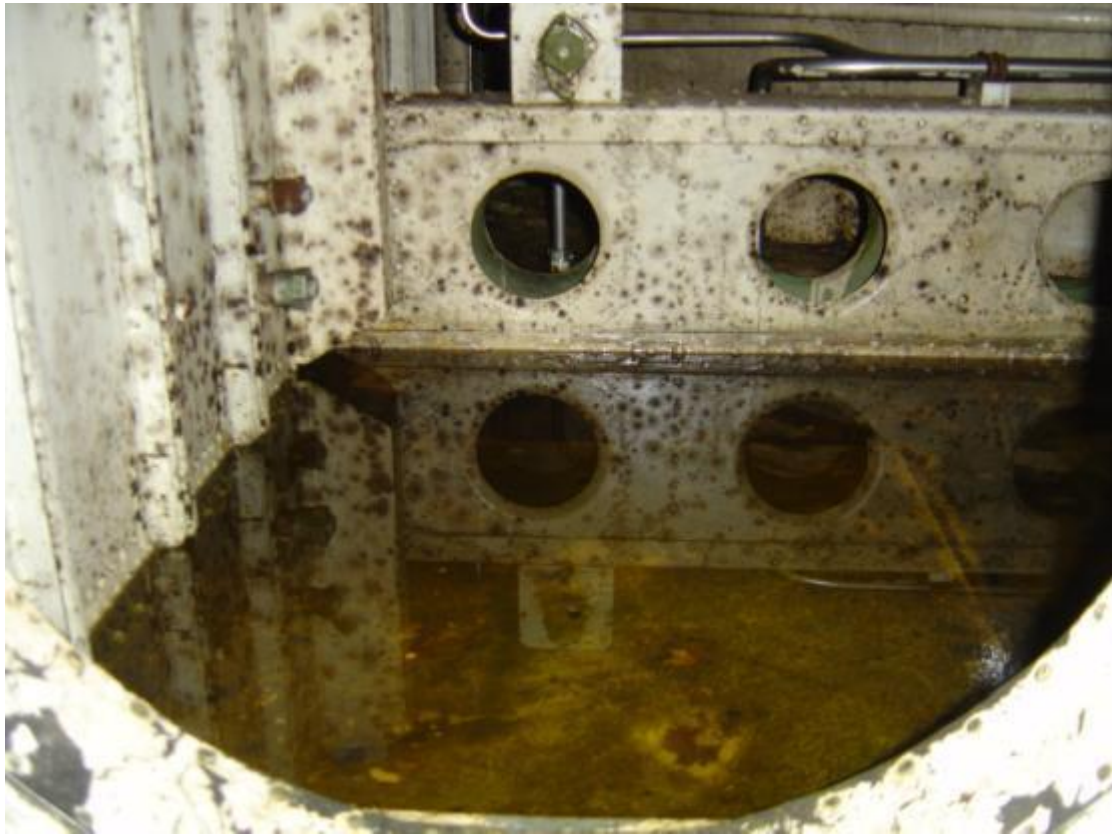
Photograph 5 - Fluid in bottom of volute space

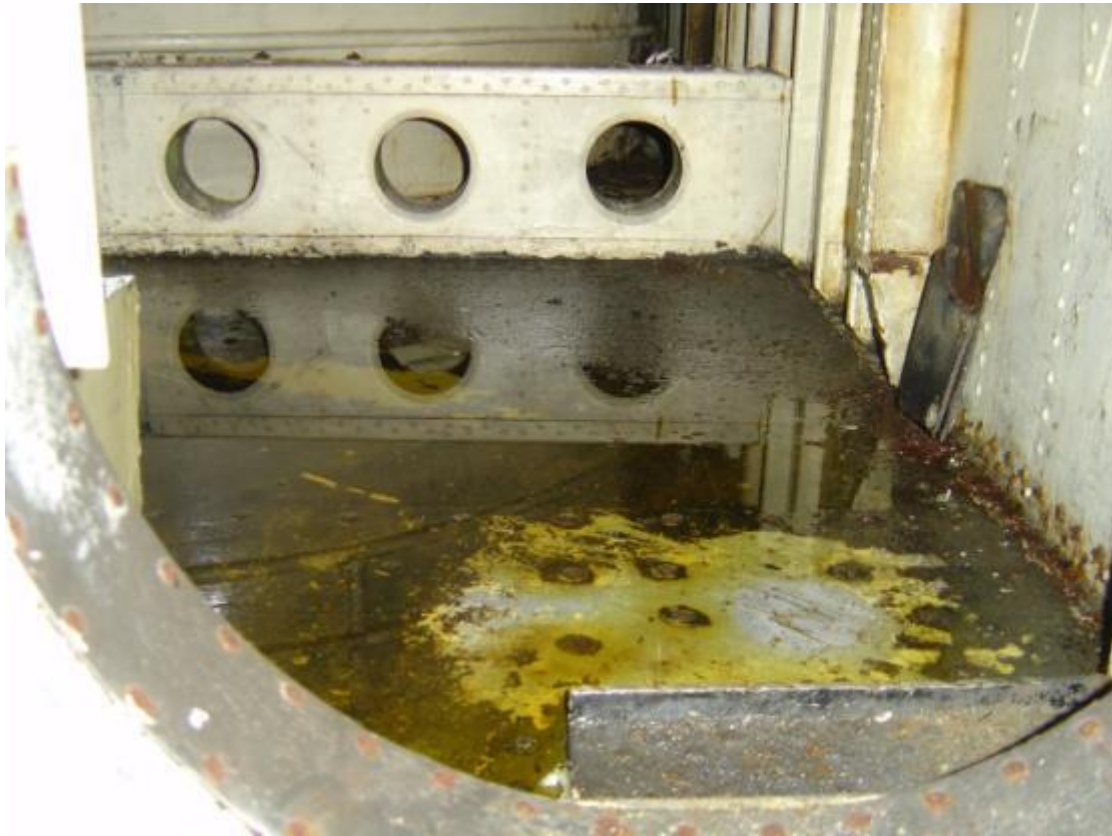
Photograph 6 - Fluid in after volute space

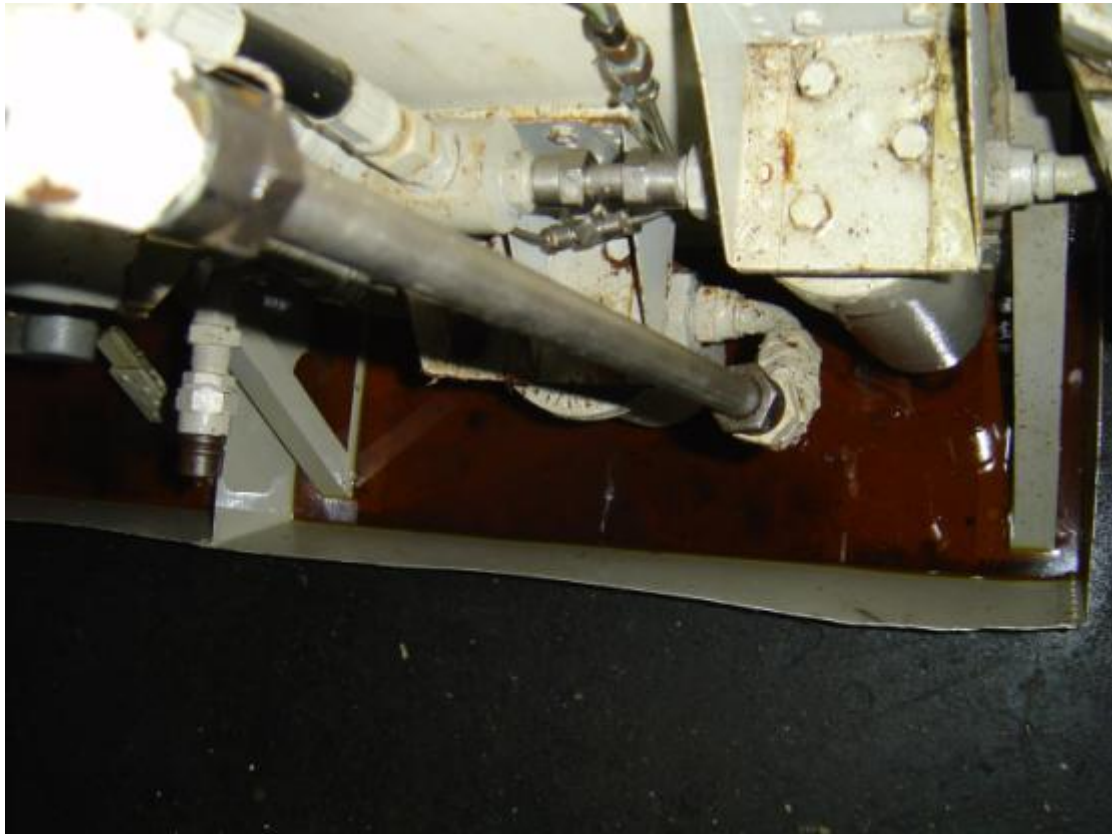
Photograph 9 - Save all tray containing spilt fluid

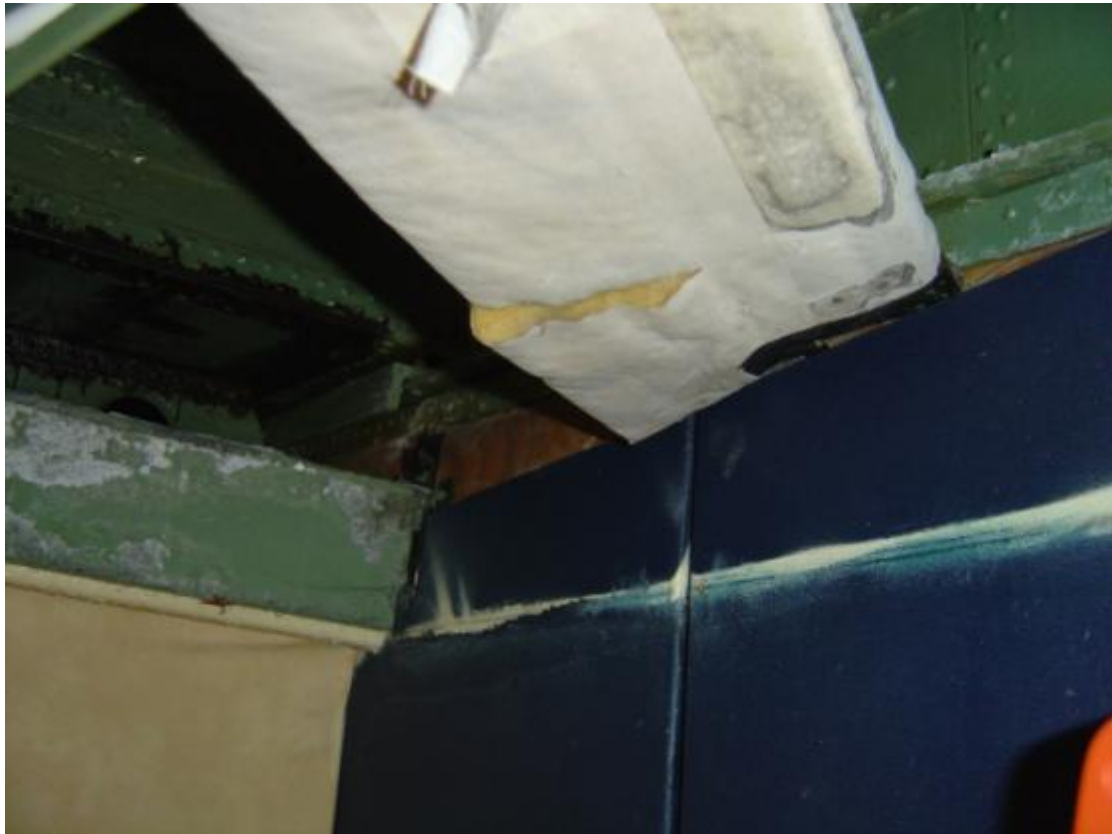
Photograph 19 - Insulation slab in cabin deck head

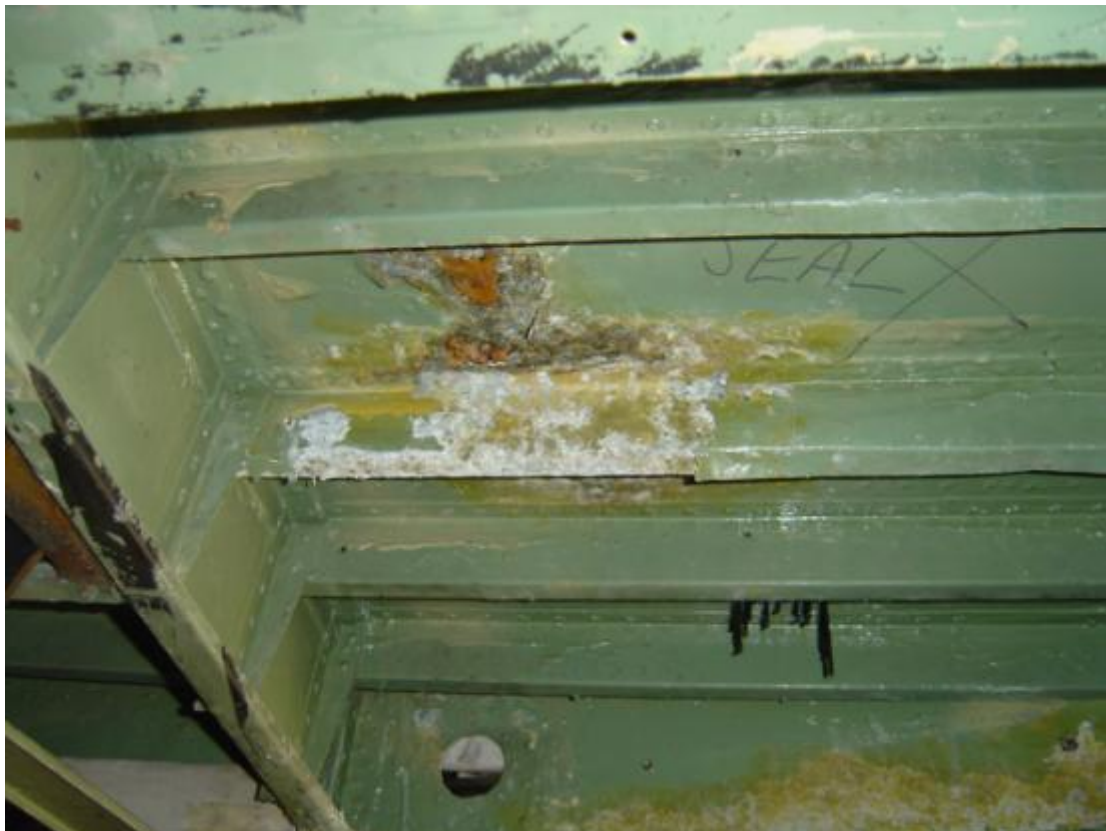
Photograph 29 - Corrosion in deck head

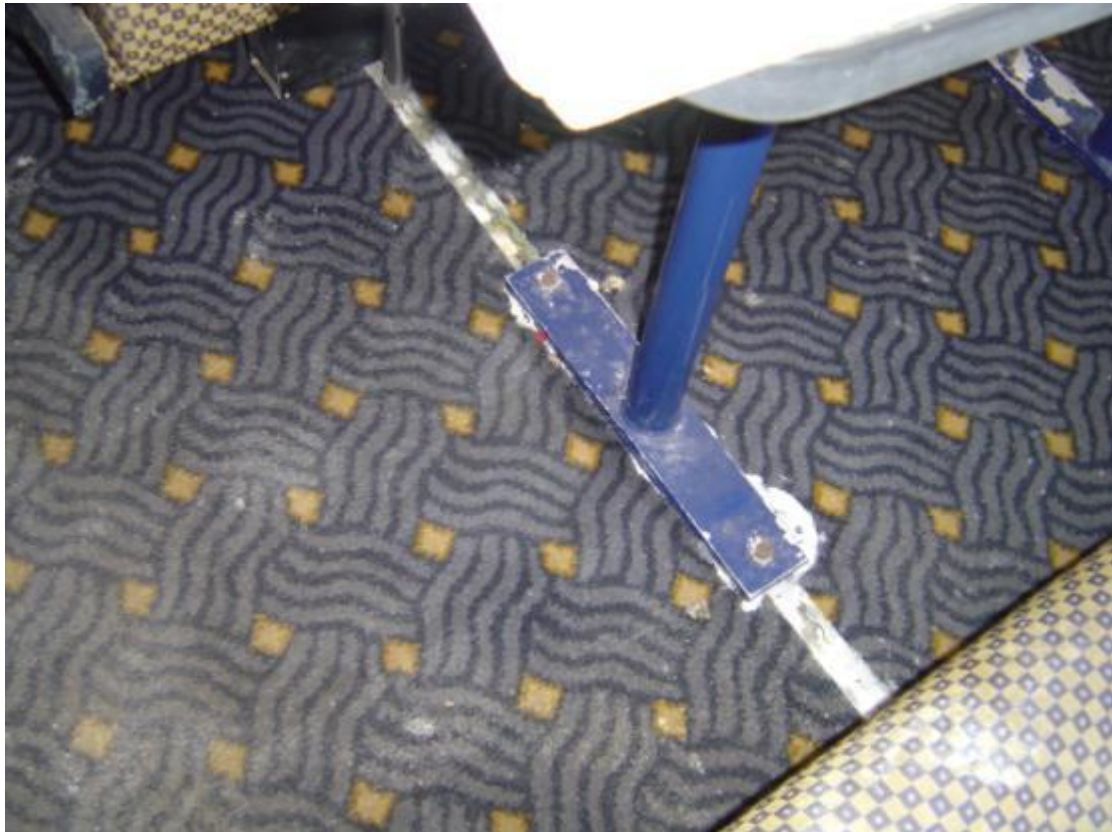
Photograph 30 - Carpet and corrosion on track

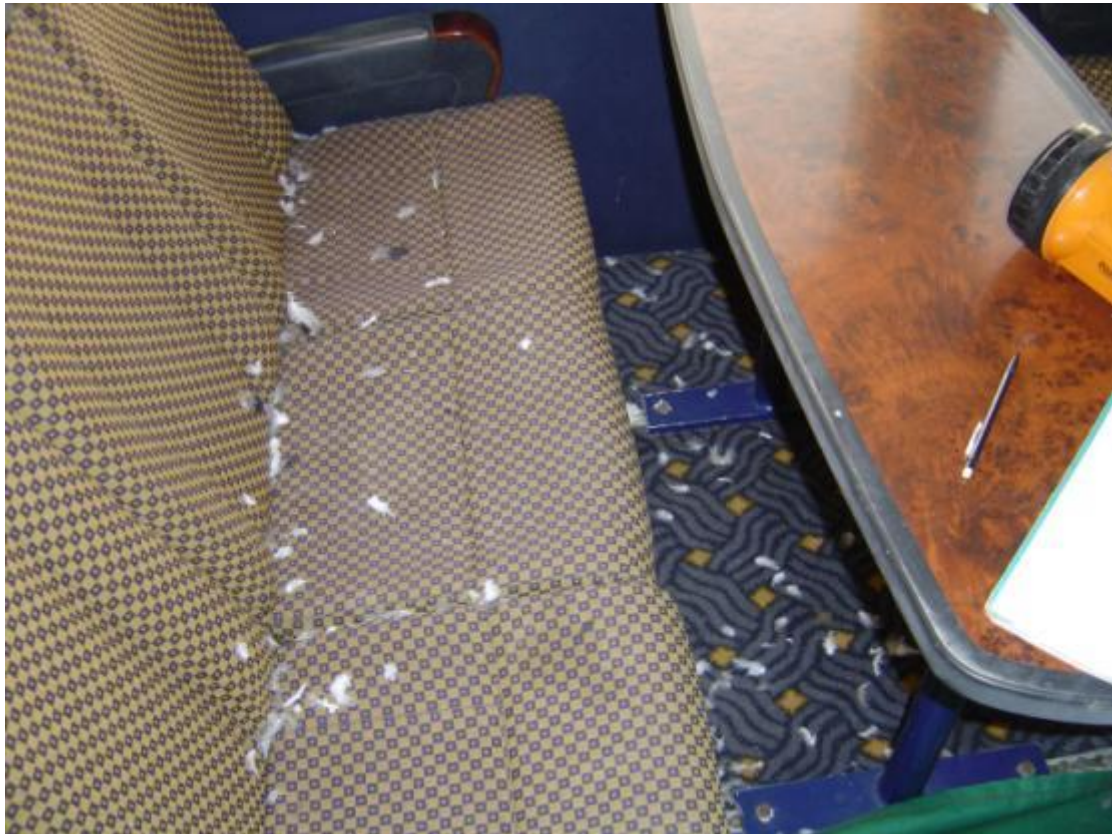
Photograph 31 - Bird feathers

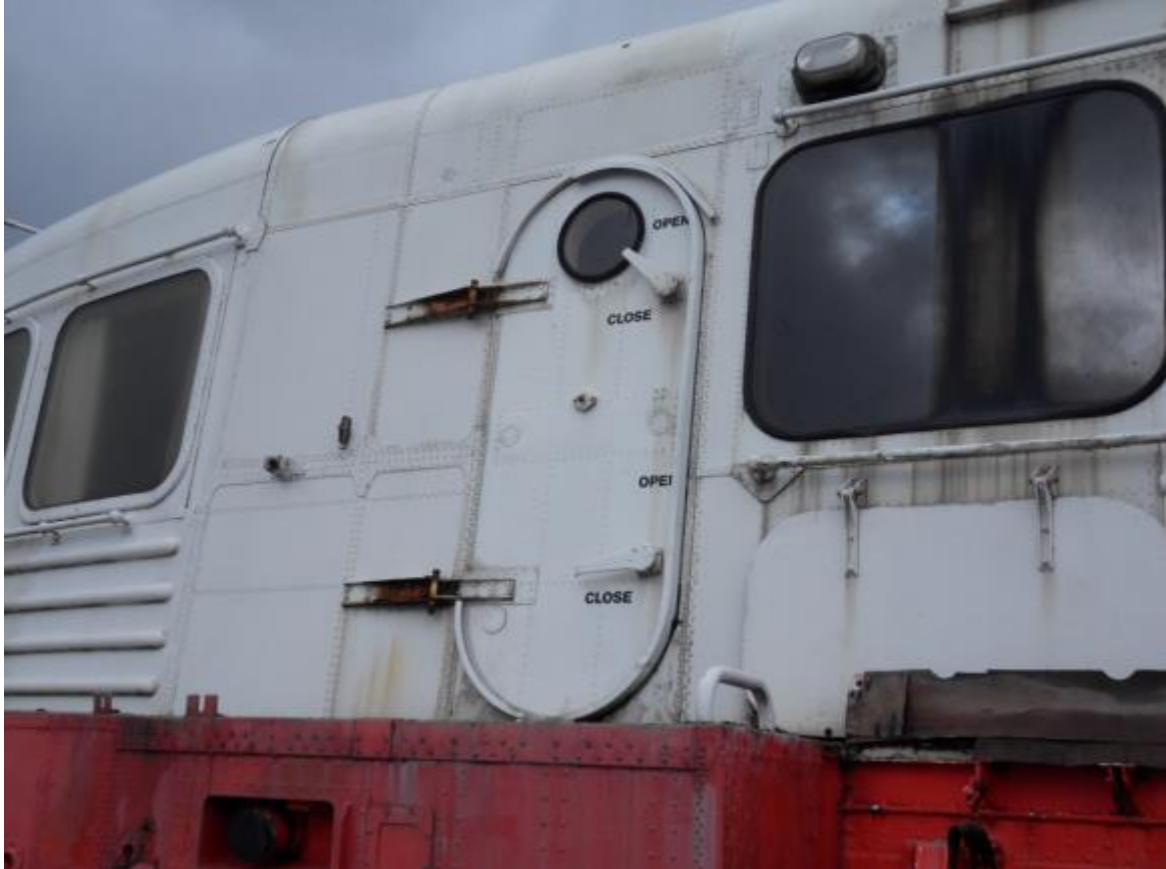
Photograph 2 - Typical condition

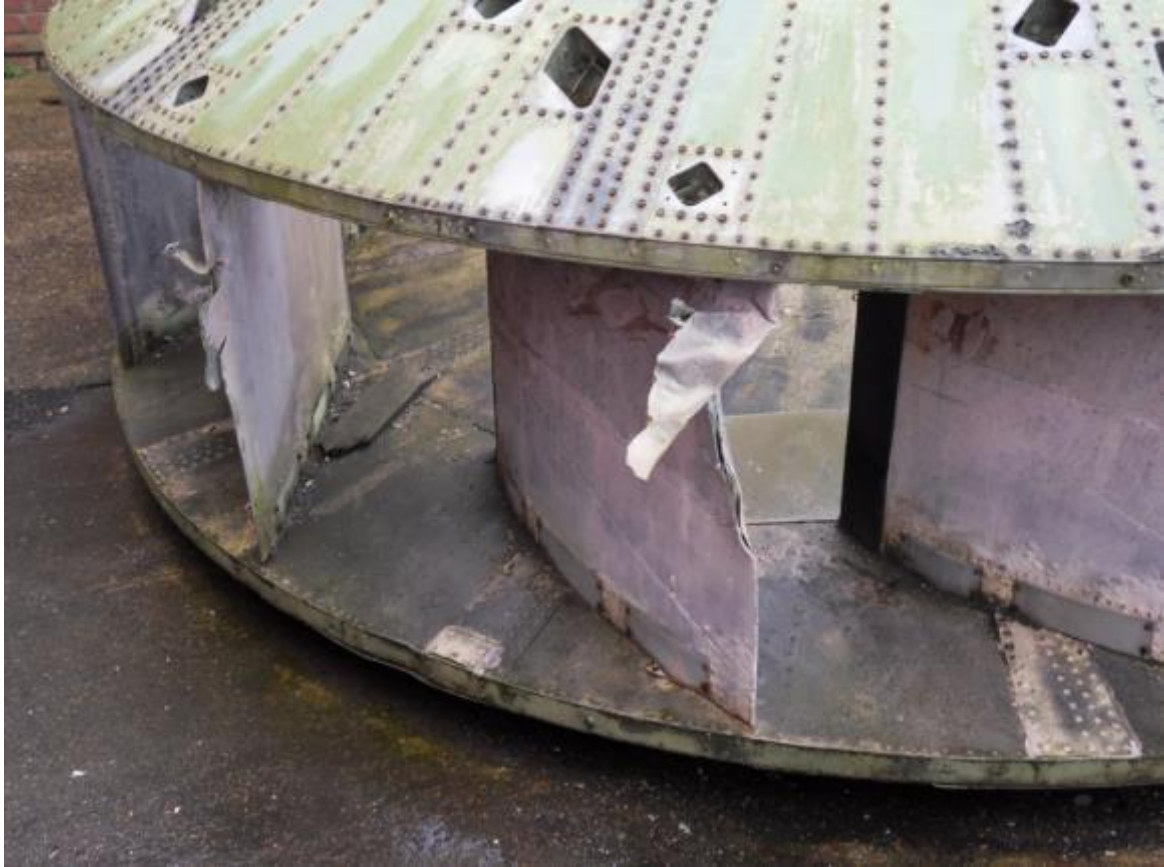
Photograph 3 - Damaged lift fan showing corroded bolts

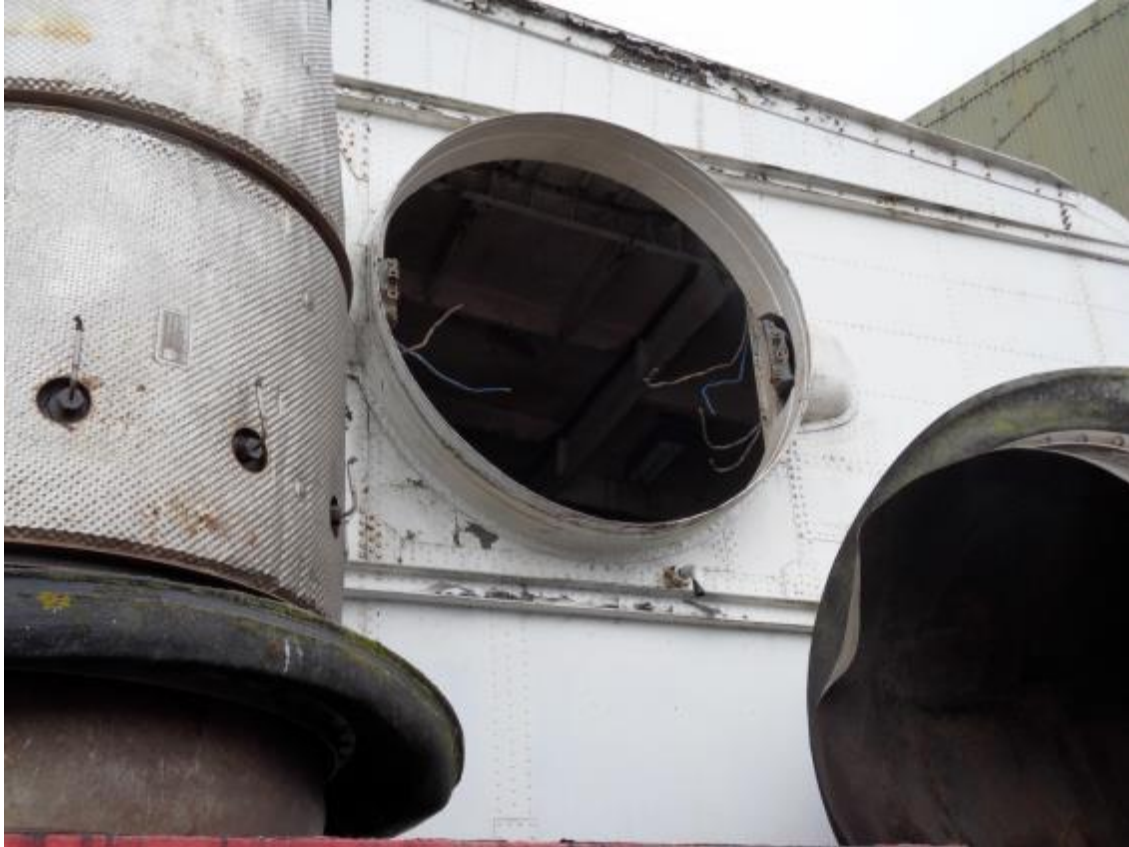
Photograph 4 - Exhausts removed from empty engine compartment 'Princess Margaret'

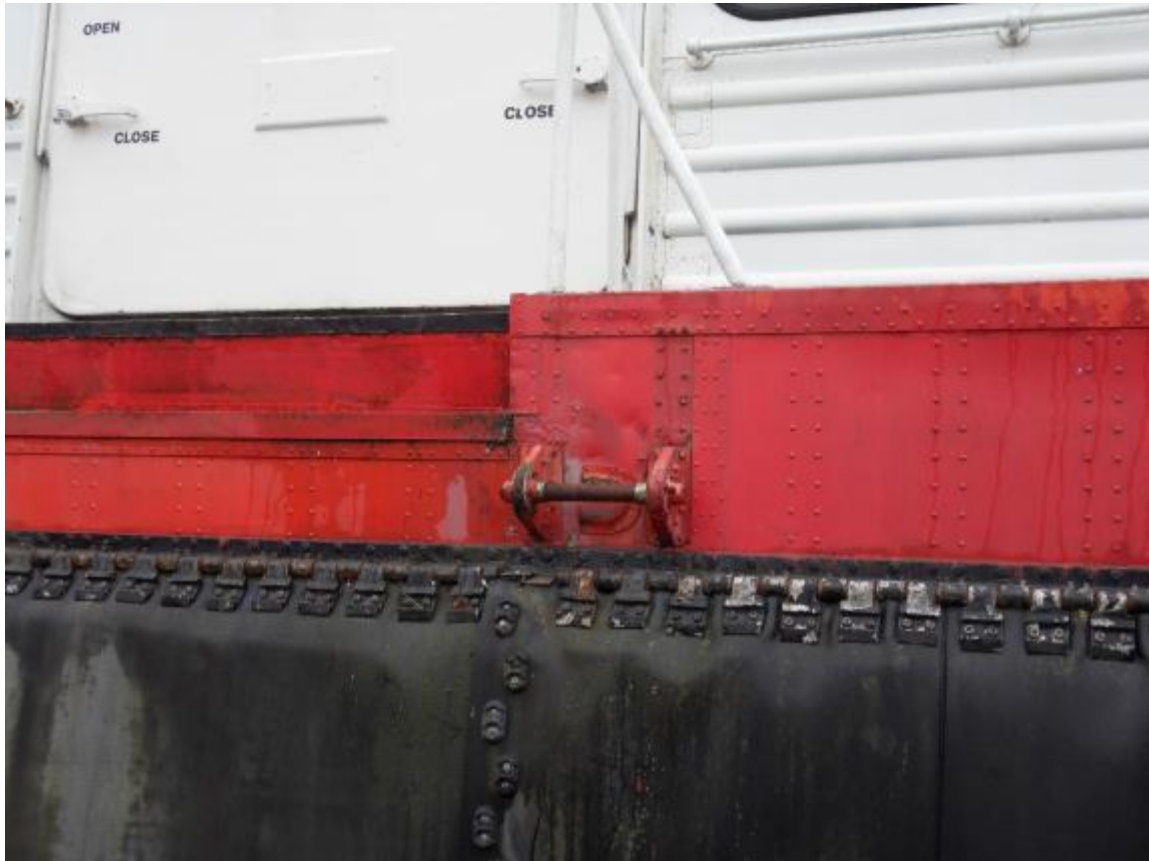
Photograph 5 - Damaged skirt of 'Princess Anne'

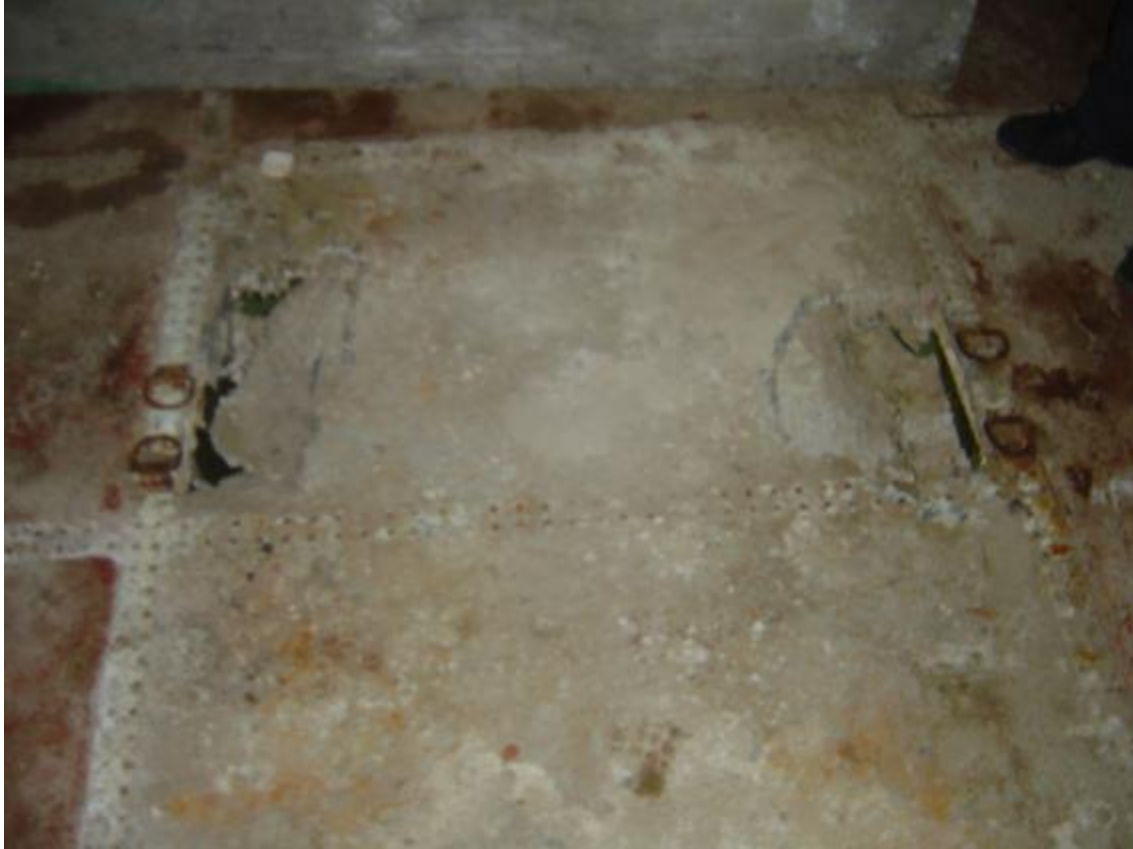
Photograph 6 – Damage to deck beneath loose steel plate

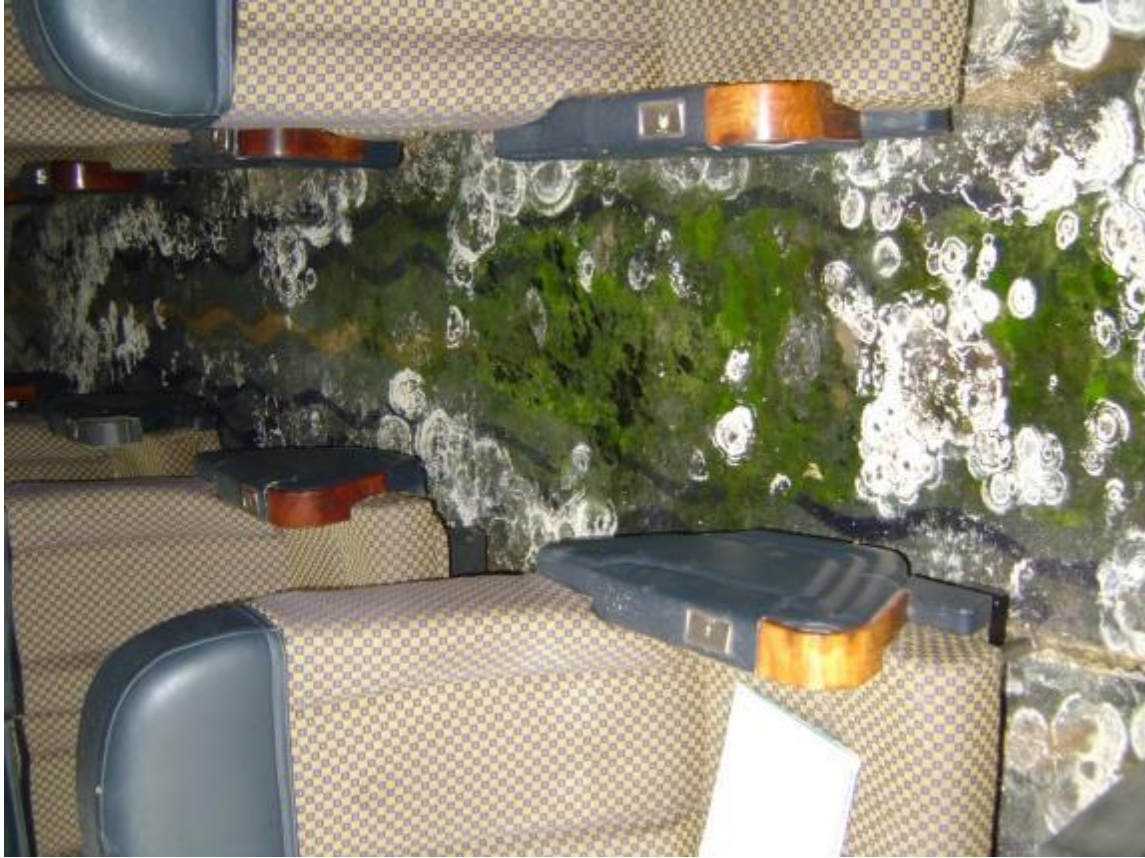
Photograph 16 - Mould on cabin deck

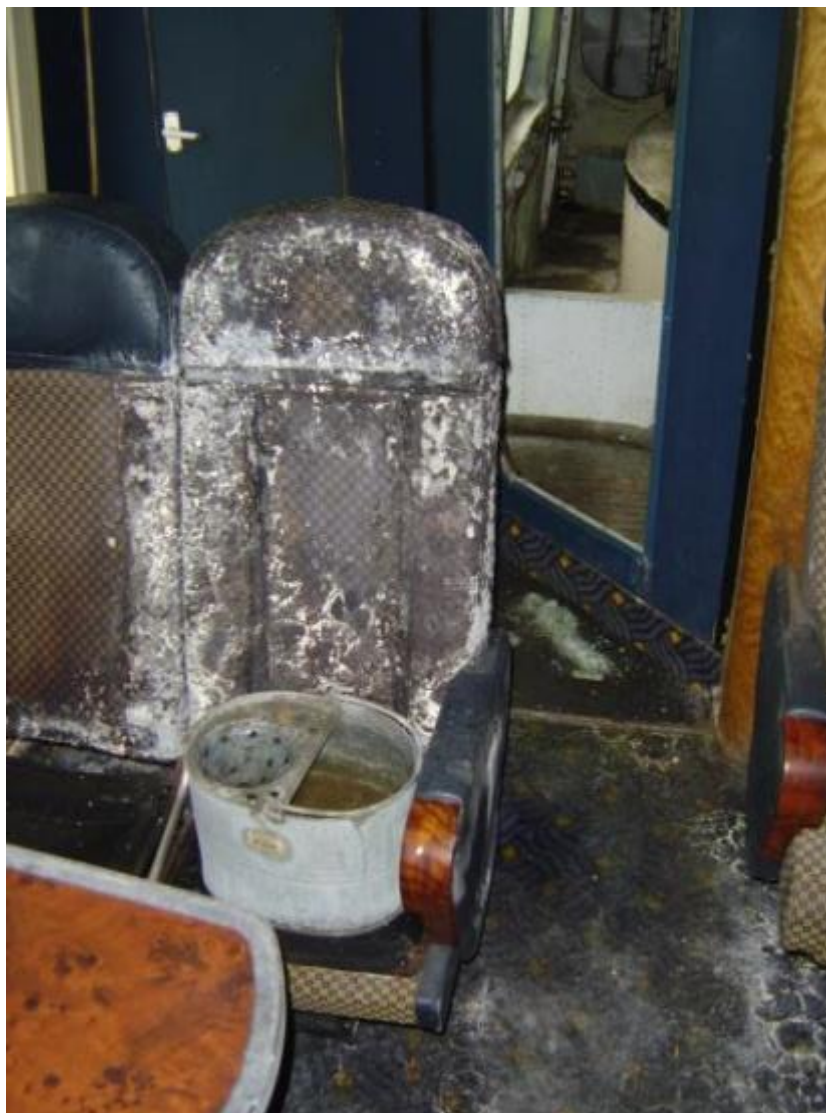
Photograph 17 – Mould on seat

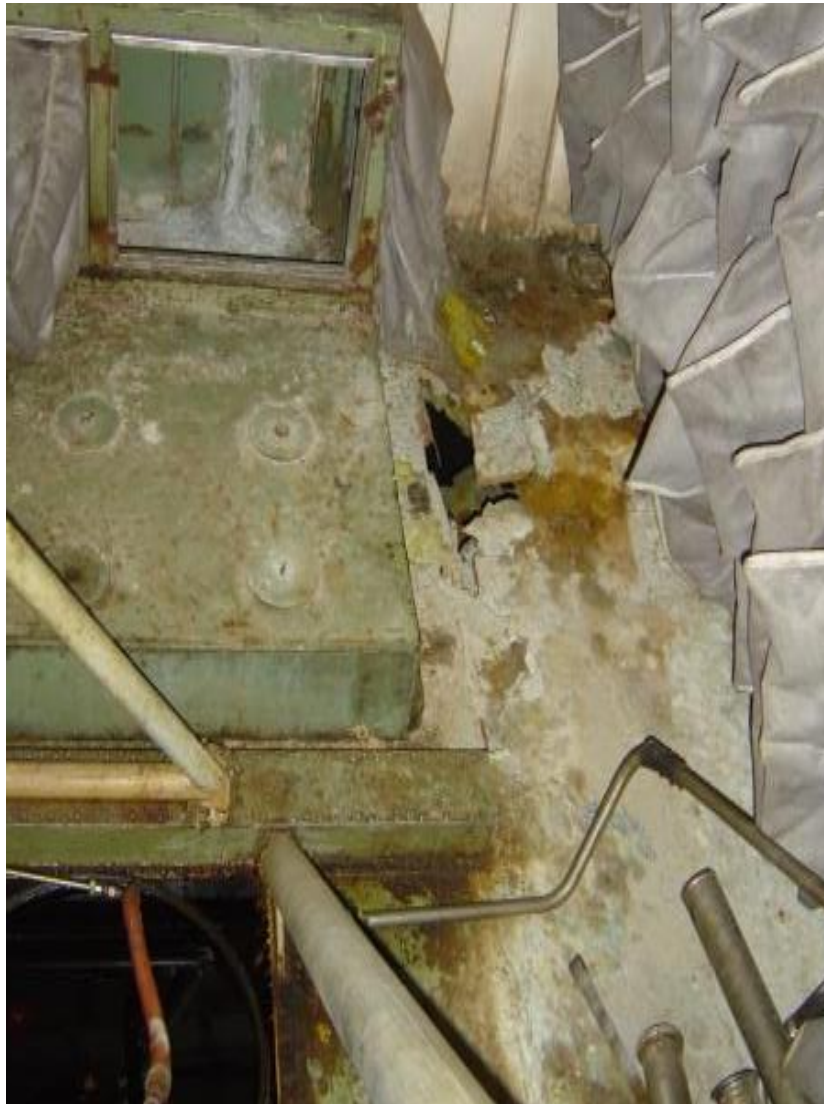
Photograph 19 - Hole in machinery compartment
