Person struck by train on Gartell Light Railway, Somerset, 17 April 2025

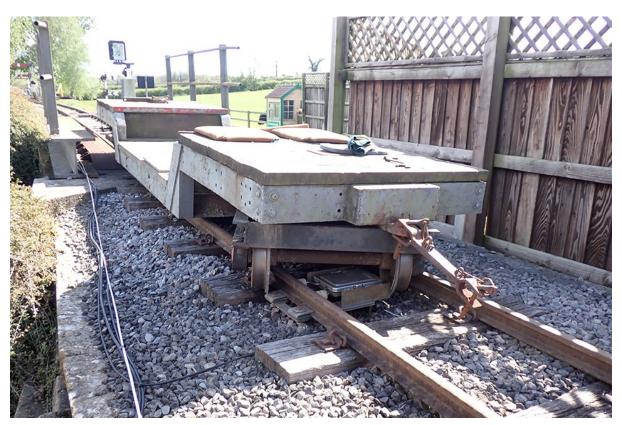
Incident wagon showing derailed leading bogie and signalling equipment fitted between the rails.

As the train approached the crossing and slowed down, the volunteer seated on the leading end of the well wagon, shown as position 5 in the diagram below, alighted from the train to open the gate. As they did so, their boot caught on either a track fixing or signalling equipment, dragging their leg under the wagon's leading left-hand wheel. When the other volunteers heard the injured person shout, they all immediately alighted and instructed the train driver to reverse to release the injured person's leg. As the train did so, the leading bogie of the incident wagon fully derailed.

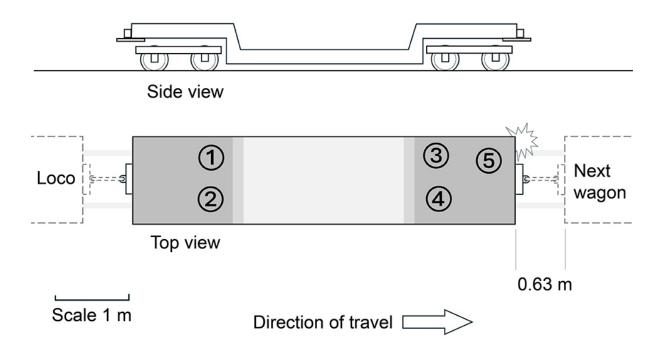
This person who was later injured joined the train and sat on the raised end section of the well wagon furthest from the locomotive. The seating layout meant that the two closest witnesses had their backs to the injured person. The two witnesses facing towards the injured person had their view blocked by their colleagues sitting opposite them. No witness reported directly observing the accident.

Diagram of well wagon showing seating positions. The injured person was in position 5.
