Accident

Aircraft Type and Registration:	Aeroprakt A32 Vixxen, G-RASP	
No & Type of Engines:	1 Rotax 912iS piston engine	
Year of Manufacture:	2023 (Serial no: LAA 411-15841)	
Date & Time (UTC):	20 June 2024 at 1015 hrs	
Location:	Near Northrepps (Cromer) Airfield, Norfolk	
Type of Flight:	Private	
Persons on Board:	Crew - 1	Passengers - 1
Injuries:	Crew - None	Passengers - None
Nature of Damage:	Substantial damage to airframe and propeller	
Commander's Licence:	Private Pilot's Licence	
Commander's Age:	69 years	
Commander's Flying Experience:	1,711 hours (of which 32 were on type) Last 90 days - 70 hours Last 28 days - 6 hours	
Information Source:	Aircraft Accident Report Form submitted by the pilot

Synopsis

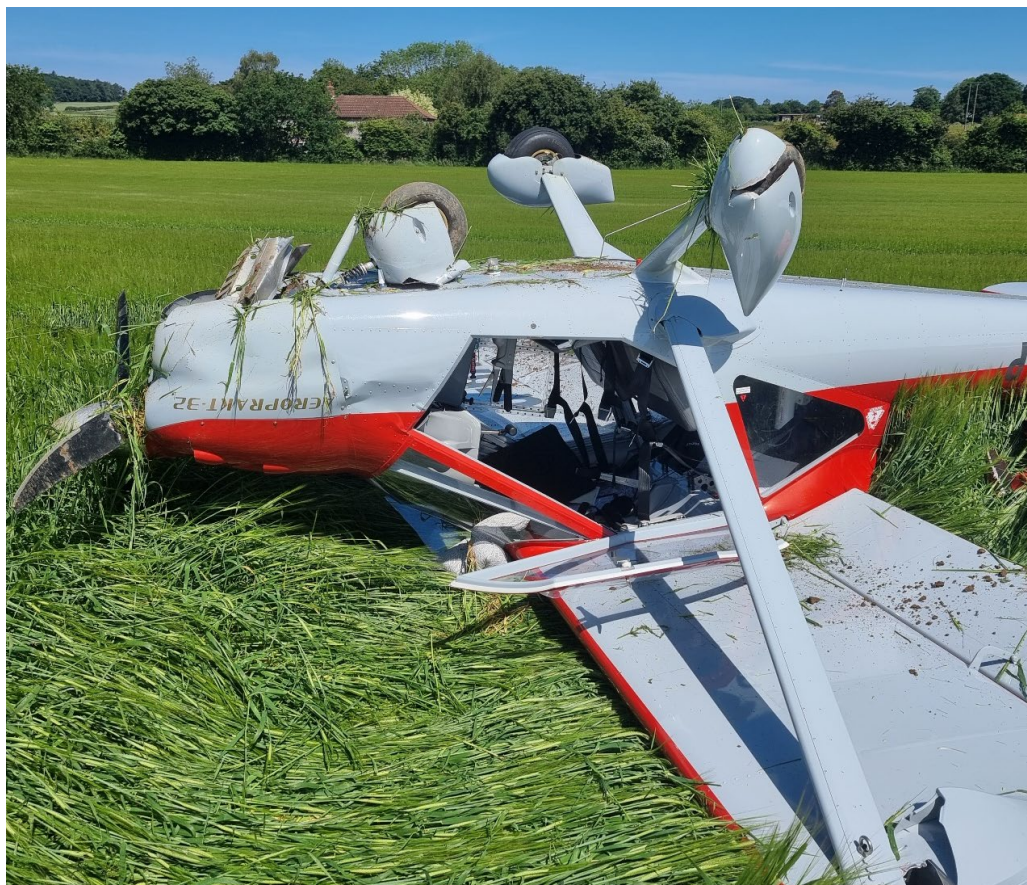
Figure 1

The pilot considered diverting to an airfield with a longer and more in-to-wind runway but was concerned that any damage to the nose leg could lead to it collapsing on touchdown, with unpredictable consequences. While the aircraft was equipped with a ballistic parachute recovery system, the pilot said he was unwilling to use it in a pre-meditated way because the outcome would be “unknown.” At this point his passenger was becoming increasingly distressed, so the pilot elected to conduct an immediate precautionary landing on the “softest soil and springiest crop” that he could find. He identified a corn field nearby and landed aligned with the furrows, using full flap for the approach. Just before touchdown he turned the fuel and battery master switches off and landed as close to the stall as he could. After touchdown the aircraft came to rest inverted (Figure 1). Both occupants were able to self-evacuate from the aircraft with only minor injuries.

G-RASP inverted after landing in crop field.
