Accident

Aircraft Type and Registration:	Europa, G-CBWP	
No & Type of Engines:	1 Rotax 912-UL piston engine	
Year of Manufacture:	2002 (Serial no: PFA 247-12930)	
Date & Time (UTC):	1 March 2025 at 1500 hrs	
Location:	East Kirkby Airfield, Lincolnshire	
Type of Flight:	Private	
Persons on Board:	Crew - 1	Passengers - None
Injuries:	Crew - None	Passengers - N/A
Nature of Damage:	Damaged beyond economical repair	
Commander's Licence:	Private Pilot's Licence	
Commander's Age:	62 years	
Commander's Flying Experience:	53 hours on type Last 90 days - 6 hours Last 28 days - 2 hours	
Information Source:	Aircraft Accident Report Form submitted by the pilot and further enquiries by the AAIB

Synopsis

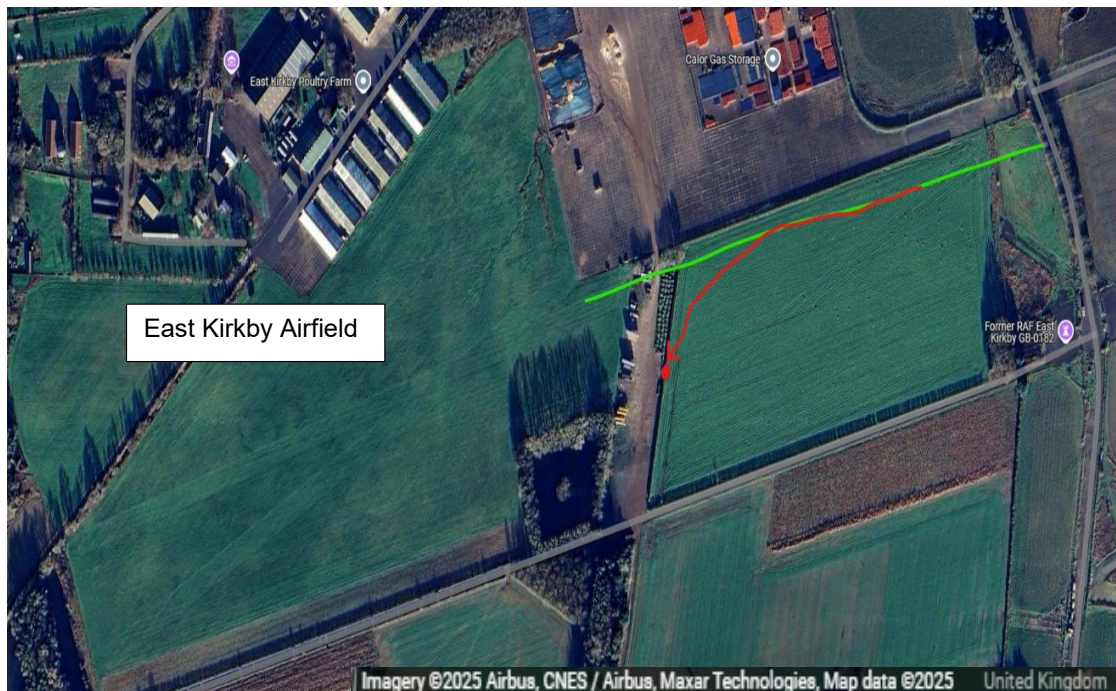
Figure 1

speed. He steered left, to avoid the hedge ahead (Figure 1), but clipped the right wing which spun the aircraft into the hedge. The pilot was uninjured.

East Kirkby Airfield showing landing direction (green) and path of the aircraft (red)

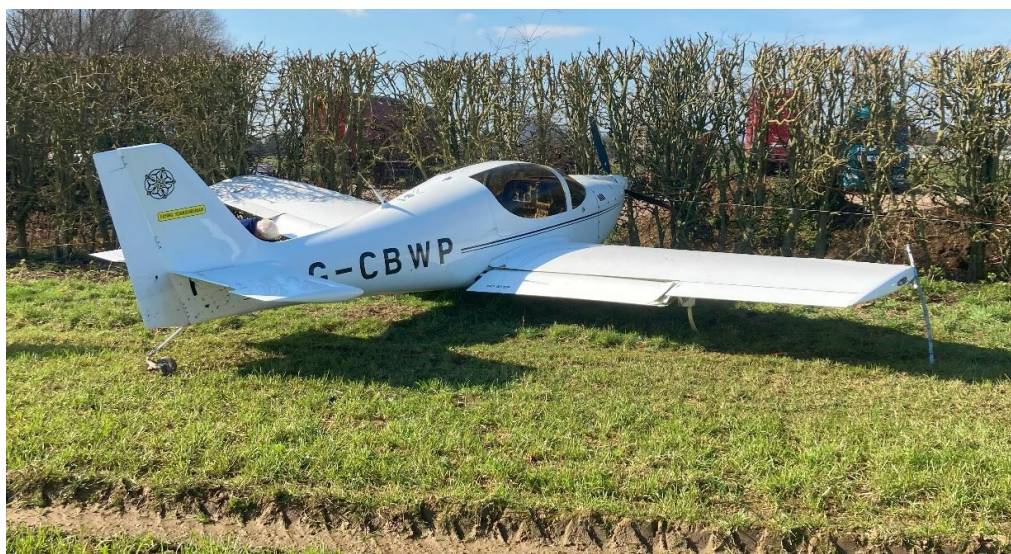
Figure 2

The aircraft was recovered from the accident site (Figure 2) but was subsequently assessed as beyond economical repair, due to extensive damage to the mounting structure of the wings.

G-CBWP after it had come to rest
