Serious Incident

Aircraft Type and Registration:	Piper PA-28-181, G-JACS	
No & Type of Engines:	1 Lycoming O-360-A4M piston engine	
Year of Manufacture:	1997 (Serial no: 2843078)	
Date & Time (UTC):	27 April 2025 at 1400 hrs	
Location:	Fowlmere Aerodrome, Cambridgeshire	
Type of Flight:	Private	
Persons on Board:	Crew - 1	Passengers - None
Injuries:	Crew - 1 (Minor)	Passengers - N/A
Nature of Damage:	Propeller destroyed and engine shock-loaded. Damage to engine cowling, right and left wings. Building struck by the aircraft also damaged	
Commander's Licence:	Private Pilot's Licence	
Commander's Age:	72 years	
Commander's Flying Experience:	219 hours (of which 153 were on type) Last 90 days - 3 hours Last 28 days - 0 hours	
Information Source:	Aircraft Accident Report Form submitted by the pilot

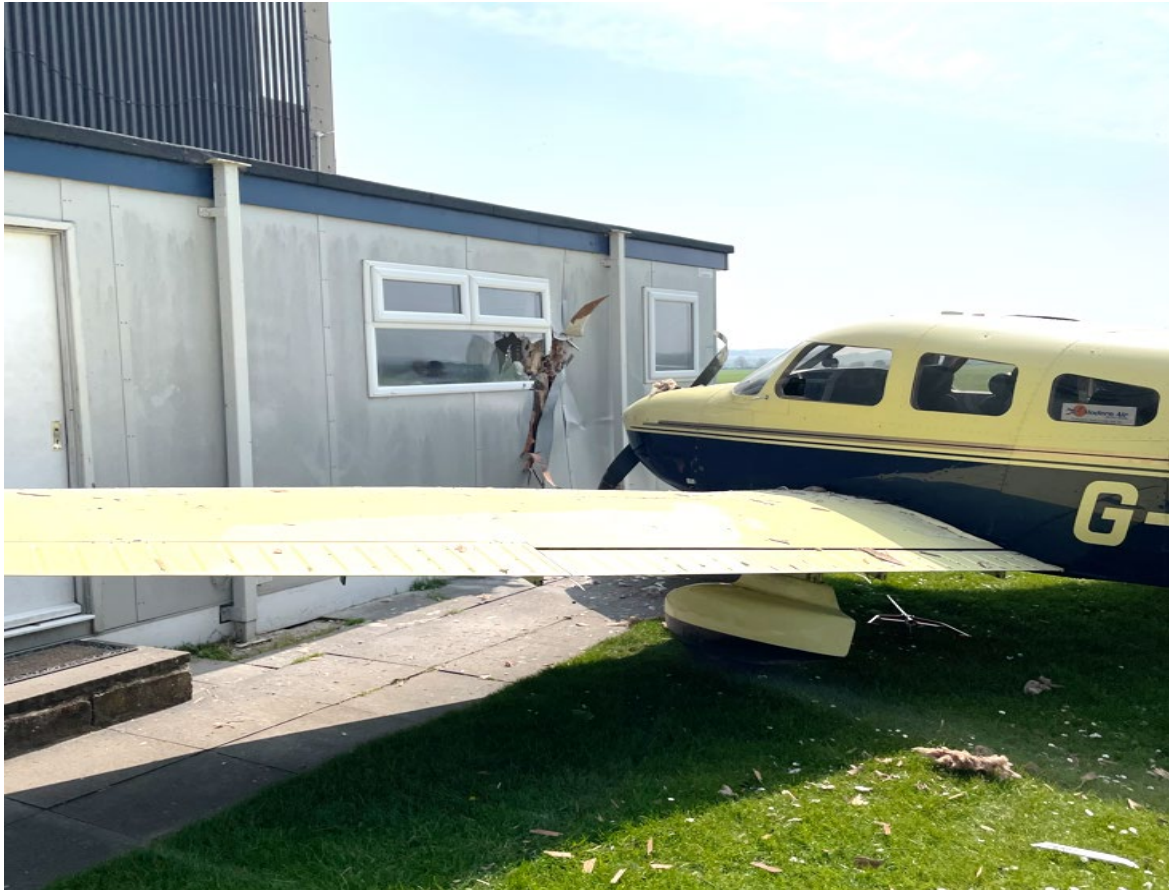
Figure 1

The engine started and immediately ran at high power. The pilot's attempts to apply the toe brakes and parking brake were unsuccessful and the aircraft, having completed a 180° right turn followed by a left turn, struck a building (Figure 1). The engine stopped on impact and the pilot, who was wearing the three-point harness, received minor injuries to his left elbow and forehead.

G-JACS after the accident

The unexpectedly high-power level delivered by the engine once it had started was due to the throttle lever being set further open than required by the aircraft's checklist. It is possible that this may have been caused by the pilot setting the throttle to $\frac{1}{4}$ open, rather than $\frac{1}{4}$ inch open as required by the pre-start checklist.

It is also likely that the parking brake was not fully applied, as the aircraft started moving immediately after the engine had started and the braking system was found to work correctly following the incident.

The throttle was set excessively open prior to engine start, resulting in an unexpectedly high-power setting when the engine started. It is likely that the parking brake was not fully applied, allowing the aircraft to move following the engine start. The pilot did not retard the throttle or apply the brakes, and the aircraft struck a building, causing minor injuries to the pilot and significant damage to the aircraft and building.

This incident highlights the importance of correctly following the aircraft checklist and also the need to anticipate an unexpected outcome during a routine task such as starting the engine.
