## Accident

<b>Aircraft Type and Registration:</b>	Westland Wasp HAS1, G-CMBE	
<b>No &amp; Type of Engines:</b>	1 Rolls Royce Nimbus 10301 turboshaft engine	
<b>Year of Manufacture:</b>	1966 (Serial no: F9664)	
<b>Date &amp; Time (UTC):</b>	15 March 2025 at 1142 hrs	
<b>Location:</b>	Marston Doles, Warwickshire	
<b>Type of Flight:</b>	Private	
<b>Persons on Board:</b>	Crew - 2	Passengers - None
<b>Injuries:</b>	Crew - None	Passengers - N/A
<b>Nature of Damage:</b>	Aircraft fuselage, main and tail rotor impact damage	
<b>Commander's Licence:</b>	Commercial Pilot's Licence	
<b>Commander's Age:</b>	66 years	
<b>Commander's Flying Experience:</b>	5,108 hours (of which 331 were on type) Last 90 days - 71 hours Last 28 days - 39 hours	
<b>Information Source:</b>	Aircraft Accident Report Form submitted by the pilot

## Synopsis

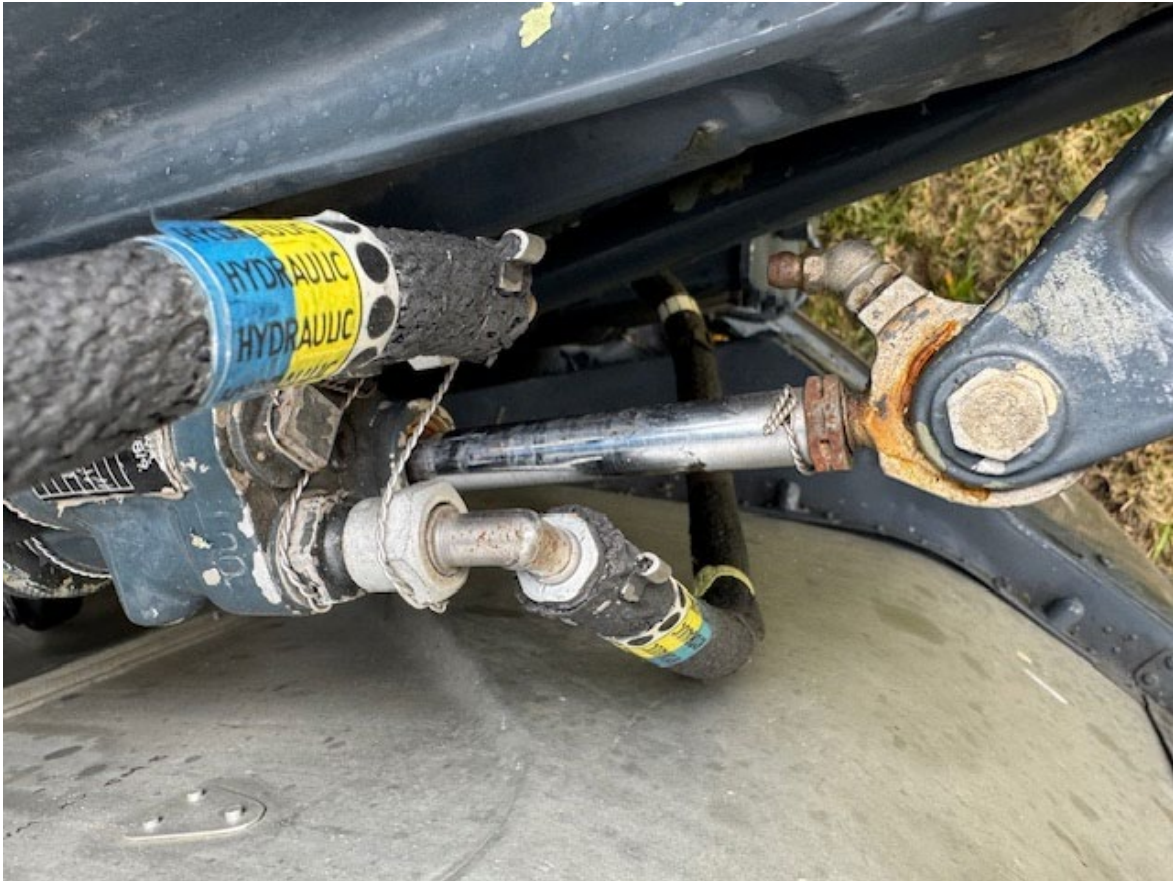
**Figure 1**

The instructor sought an independent technical assessment of the helicopter hydraulic system, flying controls and rotor head, which found no obvious evidence of system malfunction or component failure. However, it was found that the single piston hydraulic collective pitch servo jack was fully extended (Figure 1) after the accident. He considered that this may have been an artefact of the roll over and subsequent damage to the helicopter. This was plausible because the servo would not have been in hydraulic lock, therefore free to extend and retract, because the system had been set to OFF for the check. Nevertheless, it was unexpected.

Collective servo extension

The abnormally forceful upward movement of the collective lever, immediately after the hydraulic system was selected OFF, and the post-accident position of the servo jack, suggest the possibility of a transient system malfunction.
