AAIB Bulletin

8/2025

Piper PA-23-250	G-BKJW	6-Jul-23	3
-----------------	--------	----------	---

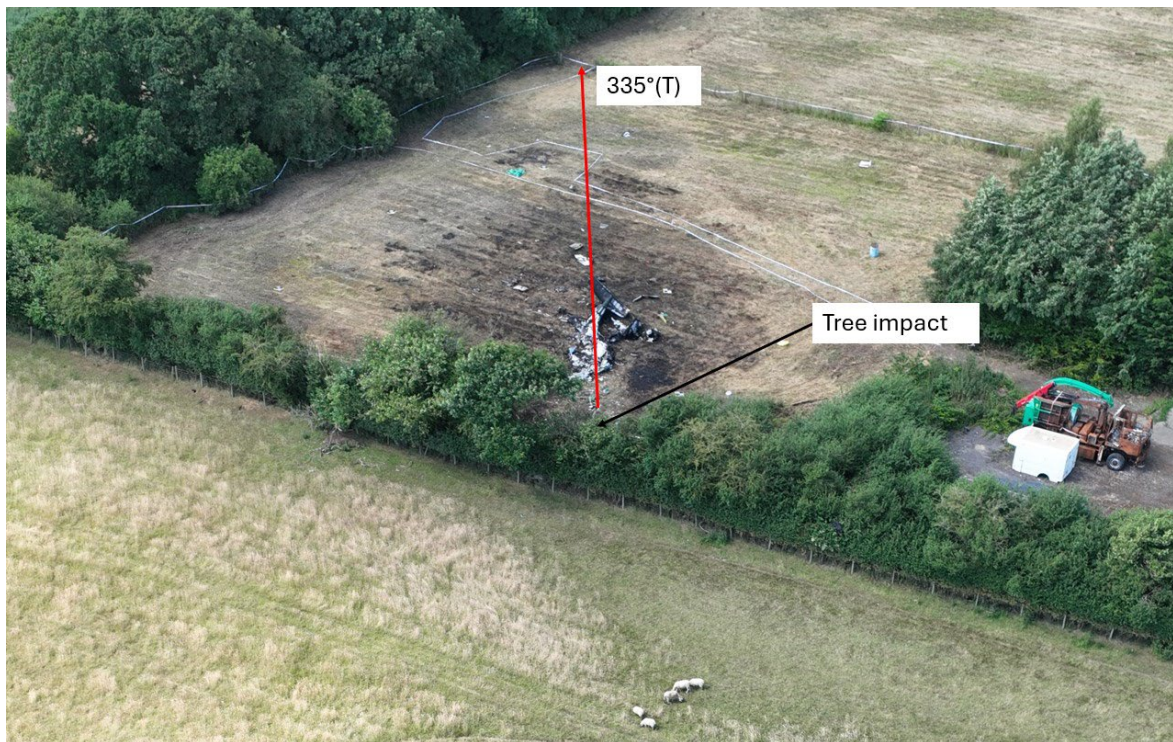
**Figure 7**

The accident site was located 1.0 nm south-west of the Runway 06 threshold at Bagby airfield (Figure 6). The site revealed that the aircraft had struck trees in a steep nose-down attitude before hitting the ground and catching fire, consistent with the CCTV video. The direction of travel from the trees to the ground and the aircraft fuselage remains was in a line of about $335^\circ(\text{T})$ (Figure 7). There was no indication of aircraft roll or yaw at impact. Both engines had created similar impact craters, and their location indicated a flight path of about 35° to 40° nose-down from tree impact to ground impact. The wreckage spread was about 47 m and the pilot's body was found 34 m beyond the remains of the fuselage. The wreckage was extensively damaged by fire, but the aircraft's tail section was relatively intact (Figure 8). The horizontal stabilator was free to move and its control cables were connected. The stabilator pitch trim drum was found in a nearly full nose-down trim position. The pre-impact flap and landing gear positions could not be determined.

Aerial view of accident site

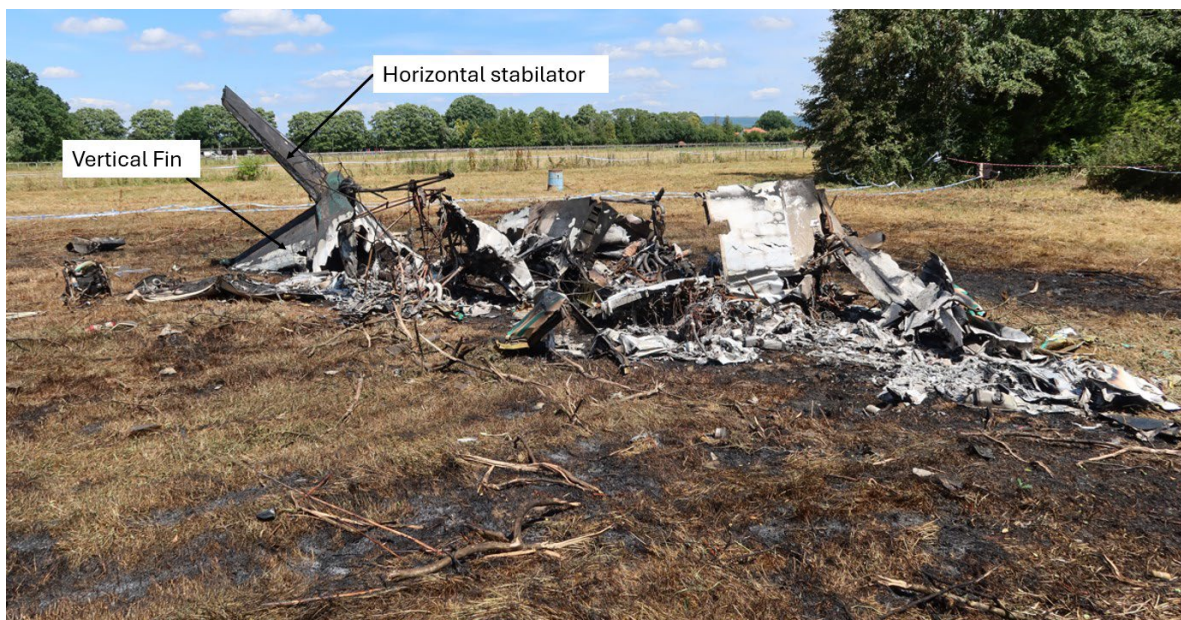
**Figure 8**

The post-impact fire destroyed a significant amount of physical evidence, but that which remained contained no identifiable defects that could have caused or contributed to the nose-dive. The one anomaly found was the position of the pitch trim drum which was 3 mm from the full nose-down position. Evidence from a flight trial on the same type of aircraft revealed that this was more nose-down than would be expected for any flap configuration in the speed range determined from the CCTV. However, the possibility of the trim having

Wreckage extensively damaged by fire

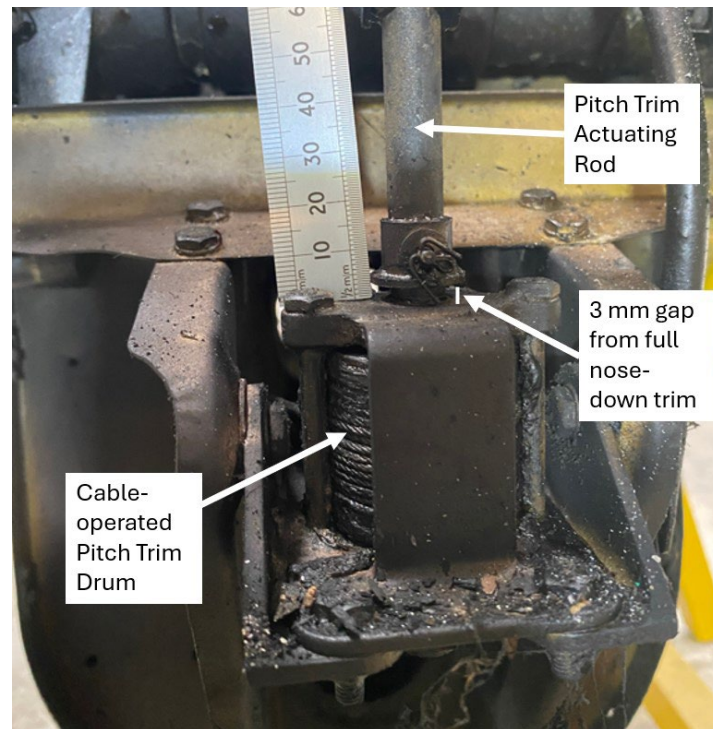
**Figure 16**

The pitch trim tab moved freely and in the correct direction (opposite to the direction of the stabilator) when the stabilator was moved up and down, in its function as an anti-servo tab. The pitch trim tab actuating arm was connected to a rod that was actuated by the cable-operated pitch trim drum. The pitch drum translates up or down when the cable is pulled one way or the other. The drum was found to be in position 3 mm from full drum up, which corresponded to 3 mm from full nose-down trim position (Figure 16). The full range of travel was 13 mm and so it was 10 mm away from full nose-up position. The drum moved freely when the cable was pulled in either direction. It was possible that post-impact break-up forces applied some unequal pressure to the cable causing the pitch trim drum to move.

Position of pitch trim drum post-accident

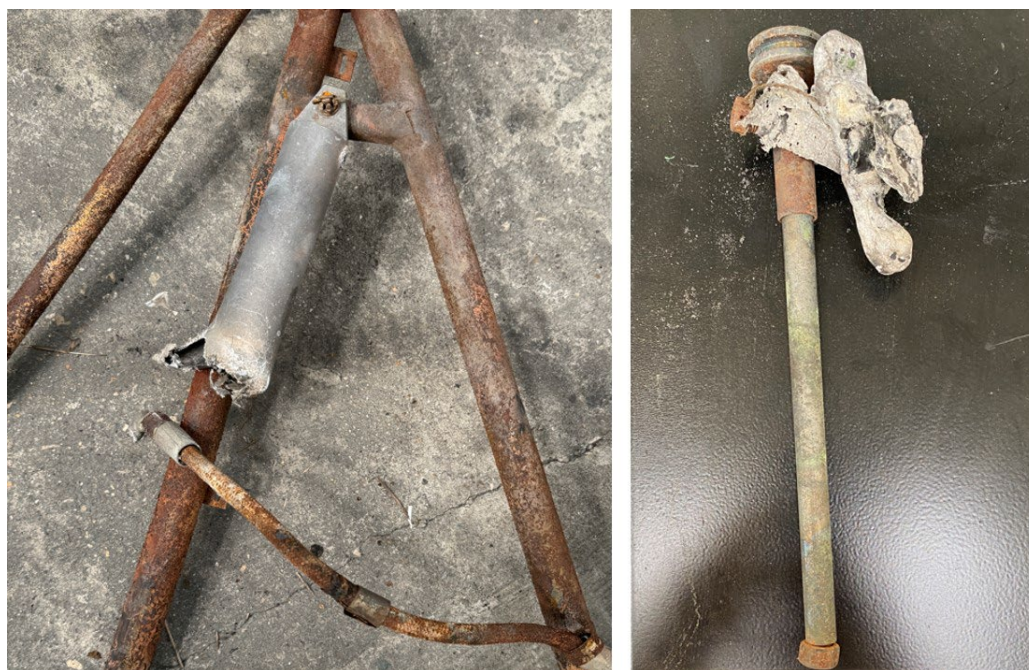
Figure 17

The flap actuator ram had separated from the flap actuator cylinder due to impact forces and fire damage (Figure 17). Once the ram is detached the flaps are free to move and so it was not possible to determine the flap position at impact. The flap actuating components, including the bell crank, flap push-pull rods, torque tube and the torque tube supporting bearing blocks, had suffered multiple failures. These components, including the actuator ram, were sent to a metallurgical lab for detailed forensic examination. The forensic organisation concluded that all the fractures were the result of overload, and that there was no evidence of any progressive crack growth such as fatigue. They also concluded that:

'The overload failure and deformation observed in the flap actuator ram and flap actuator ram rod end is not considered to be consistent with overload which may have occurred if the flaps had been extended while the aircraft was above the maximum permissible speed for flap deployment. If this had occurred, it would be expected that the flap actuator ram would have been in tension, which is not consistent with the degree of deformation/bending observed. This suggests that the failure of the flap actuator ram and rod end was the result of the aircraft impacting the ground.'

Remains of flap actuator cylinder (left) and flap actuator ram (right)

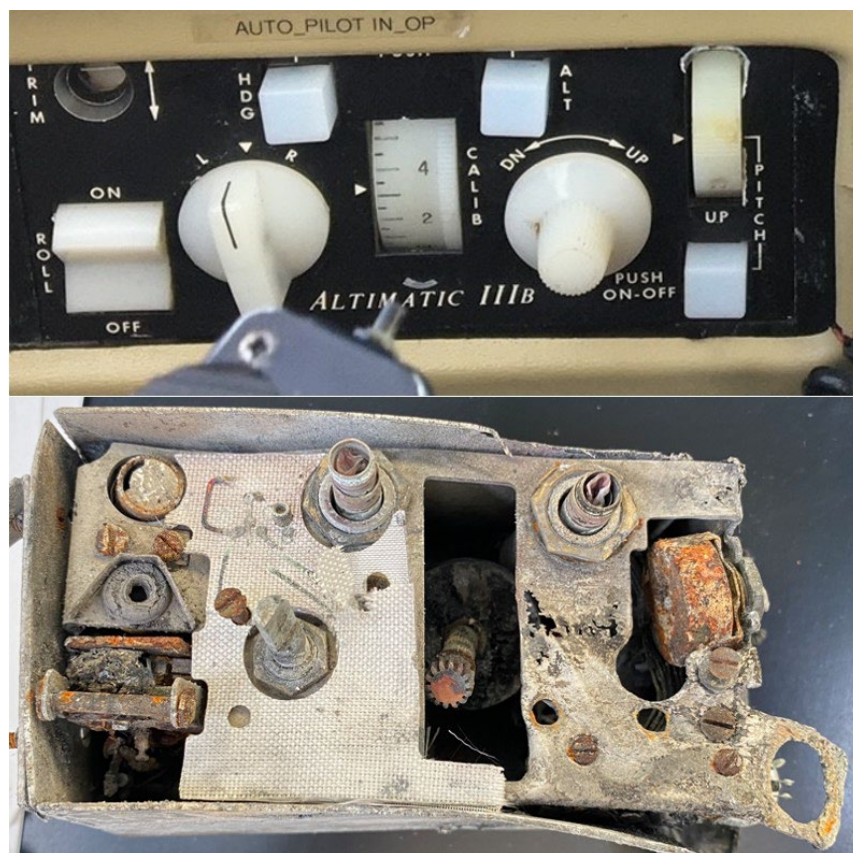
The autopilot and electric trim components were examined with the assistance of an avionics engineer familiar with the autopilot system. The Autopilot Console had suffered significant impact and fire damage (Figure 18). As the Roll ON/OFF switch was a magnetically-held-on switch, the loss of electrical power at impact would have released it so it was not possible to determine if the autopilot was turned on at the time of impact. There were no tungsten

filament remains from the lights inside the HDG, ALT or Pitch ON/OFF buttons, so it could not be determined if these lights had been on at impact. The circuit breaker panel was destroyed with multiple loose circuit breakers so it could not be determined if the autopilot or electric pitch trim circuit breakers were in or out.

Figure 18
Remains of Autopilot Console (lower image)

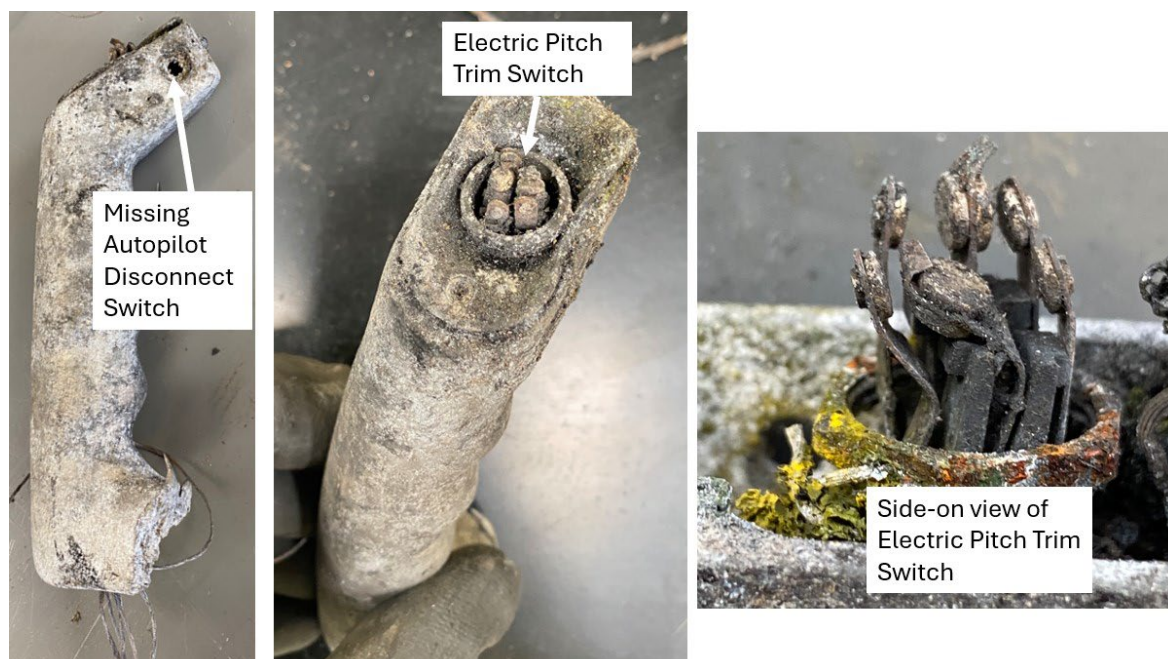
Figure 19

The left horn of the left control yoke had detached (Figure 19) and the electric pitch trim wires were broken, and their insulation had vapourised in the fire. The hole for the autopilot disengage switch was empty and an internal examination of the horn did not reveal a switch (this switch was also missing in the instrument panel photo that was taken in October 2020 – Figure 11). A detailed examination of the electric pitch trim switch did not reveal any anomalies. Some of the contact arms were bent but there was no evidence of contact welding.

Detached left horn of left control yoke with exposed electric pitch trim switch

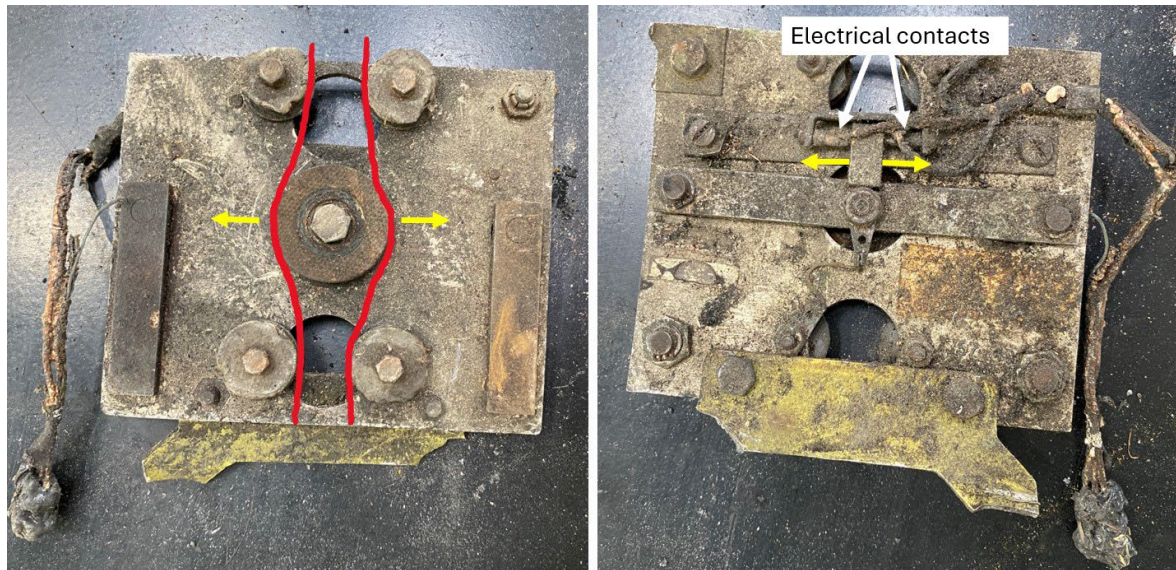
Figure 20

A single fault in the pitch trim sensor, for example the sensor sticking to one side, could cause a pitch trim runaway.

The stabilator control cables had separated from the pitch trim sensor (Figure 20). The central pulley could be moved sideways and contact could be made with each of the electrical contacts on its reverse side. There was some resistance to movement when moving it side to side, but this could have been the result of fire and impact damage, with the panel being slightly bent. The damage meant that it was not possible to determine if the sensor may have stuck in one position.

Pitch trim sensor (red lines show path of stabilator control cables)

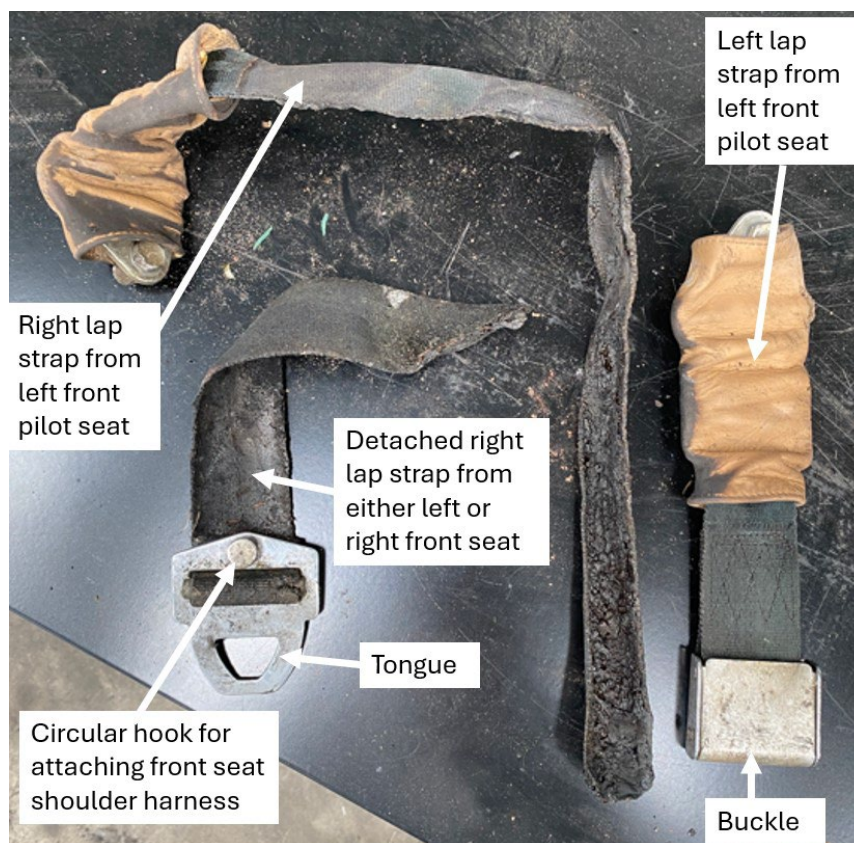
Figure 21

All the seats had separated from the floor structure, and some were thrown clear of the main wreckage, including the front left pilot seat, which was identified by matching the damage at its base with the damage of the left front seat support structure. The left lap strap, with its buckle, was still securely attached to the left side of this seat. The right lap strap was also securely attached to the right side of the seat, but the strap had burnt through and was missing the part of the strap with the tongue that would be inserted into the buckle (Figure 21). A detached right lap strap was found with a tongue that had a circular hook designed to attach a front seat shoulder harness; however, it could not be determined if this was from the front left or front right seat. Both front seat shoulder harnesses and inertial reels were severely fire damaged.

Lap strap remains from left front pilot seat (after removing the bolts attaching them to the seat) and tongue strap from either the left or right front seat

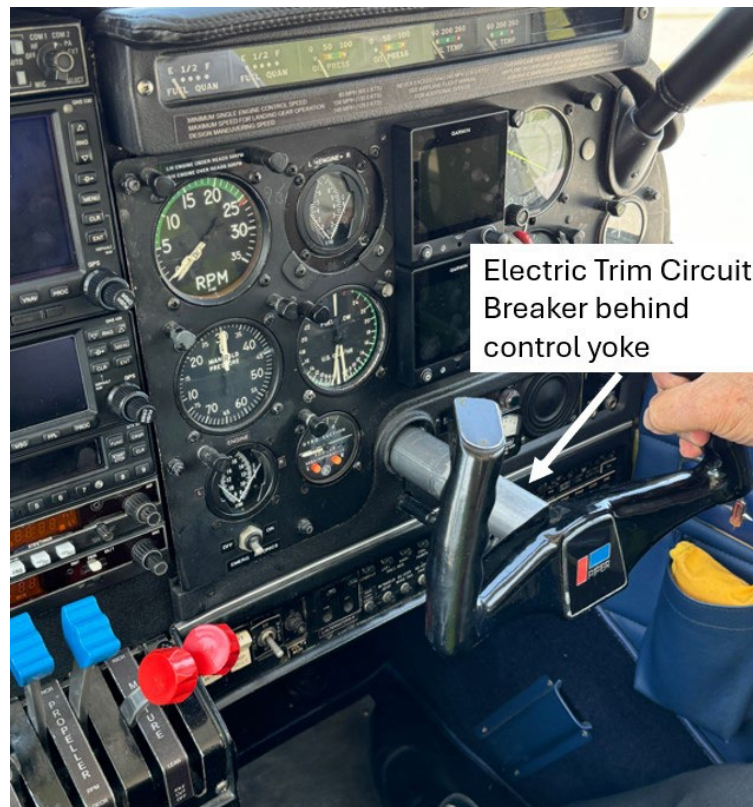
Figure 22

The electric trim circuit breaker was in the same location on the test aircraft as on G-BKJW. The test pilot, who was 1.68 m tall, stated that the circuit breaker was difficult to identify, because it was not visible from a normal seating position (Figure 22); he had to lean to see it and reach it. He found that it was not possible to hold any control force on the control yoke while simultaneously reaching for and pulling the electric trim circuit breaker. Another pilot, 1.88 m tall, sat in the left seat, also had to lean to reach the electric trim circuit breaker. The height of the accident pilot was 1.83 m.

View of location of Electric Trim Circuit Breaker from the left pilot's seat head position in test aircraft – same location as on G-BKJW. Control yoke is being held in a normal in-flight position.

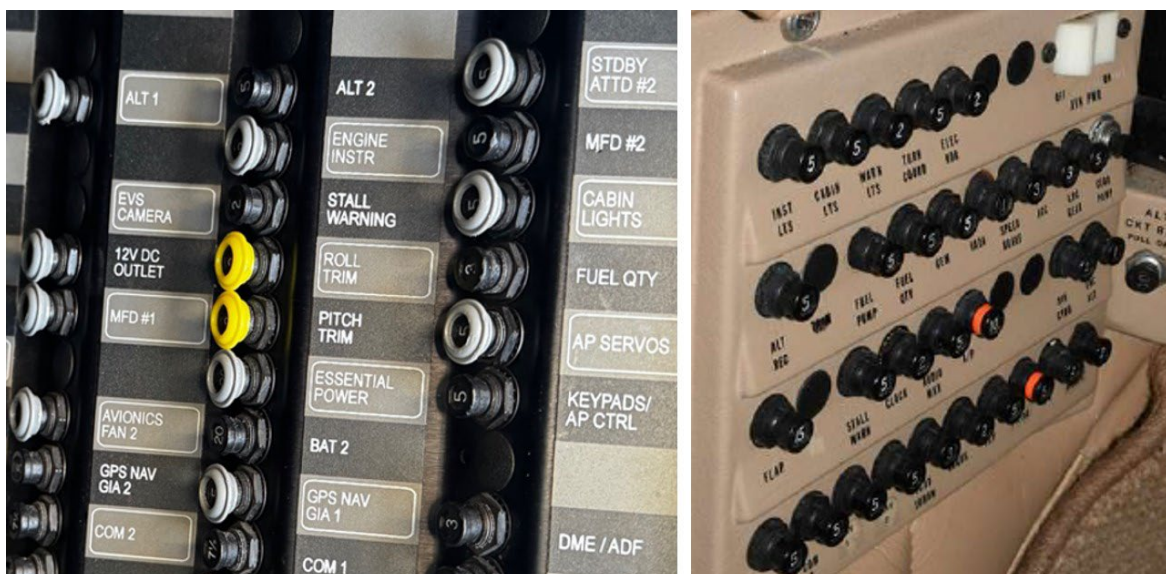
Figure 25

Coloured circuit breakers caps/collars on a Cirrus SR20 (left) and a Cessna 210 (right)

Some aircraft owners fit coloured caps or collars to autopilot and trim circuit breakers to make them easier and quicker to identify in an emergency (Figure 25). A coloured circuit breaker cap can be purchased from aviation suppliers for less than £4.

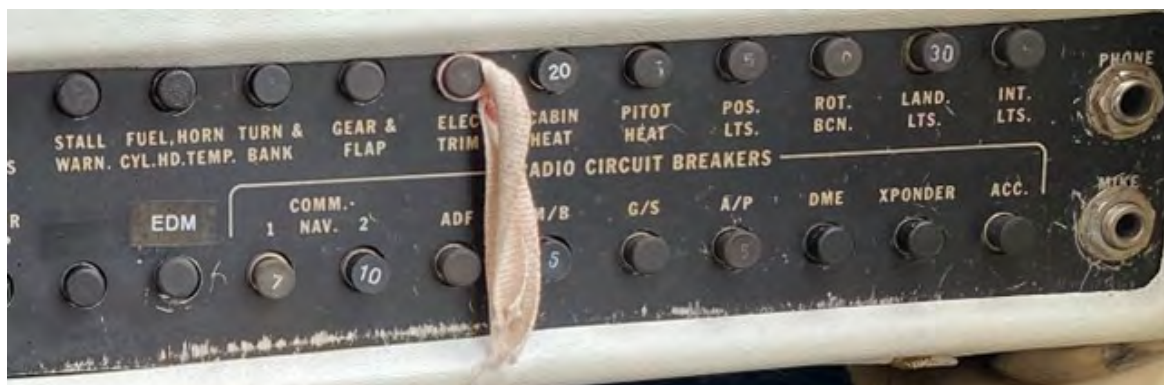
Figure 26

When the AAIB examined a PA-23-250 that was fitted with an Altimatic IIIB autopilot, it was noticed that the electric trim circuit breaker was fitted with a cloth lanyard (Figure 26). This would have enabled the circuit breaker to be easier to identify and easier to pull. This aircraft had not flown since a change of ownership, and despite a few attempts to contact the previous owner, no contact could be made so the reason they decided to install the lanyard could not be established.

Lanyard found installed on the electric trim circuit breaker of a PA-23-250

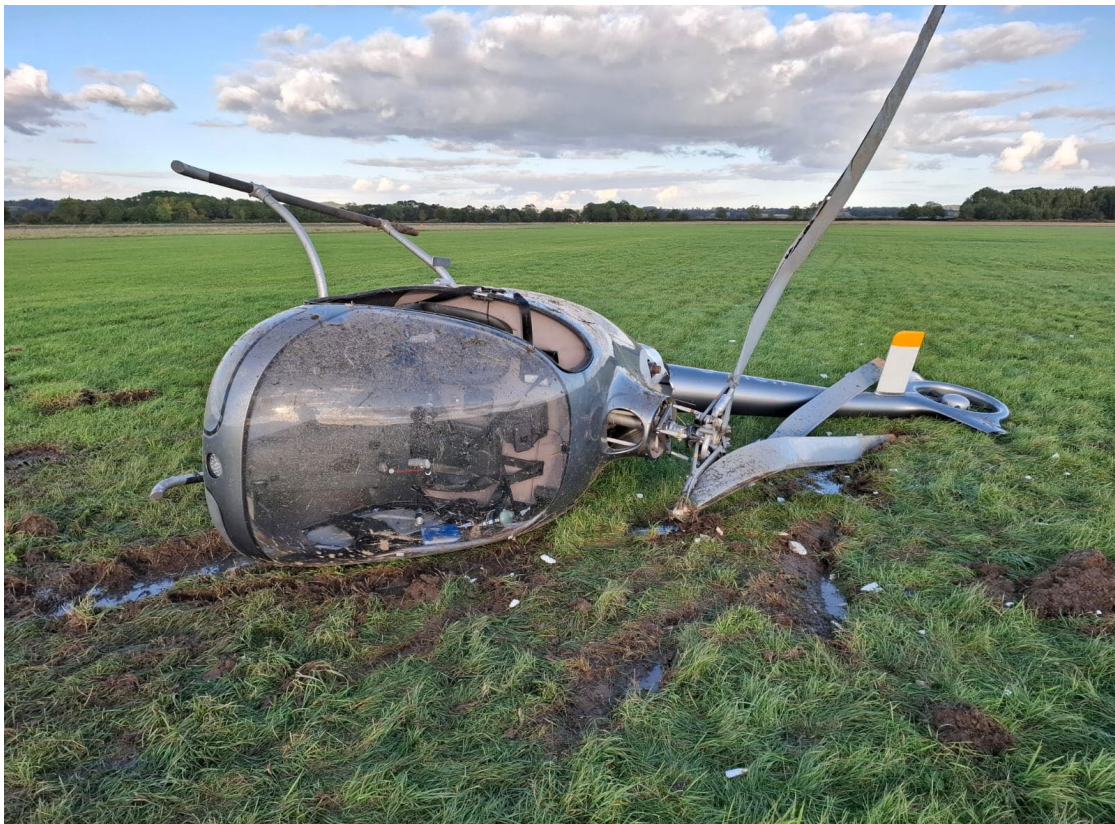
The helicopter came to rest on its left side (Figure 1) close to the location in which it had been hovering. The cabin and cockpit area had minor damage. The main rotor blades were severely damaged, the tail boom had separated, the right door had detached, and the skids had slid sideways to the right. The maintenance organisation attended the accident site and disconnected the tail rotor control rod from the tail rotor control unit, so that the tail boom could be removed to ease transportation of the helicopter back to a hangar for examination.

Figure 1
Accident site

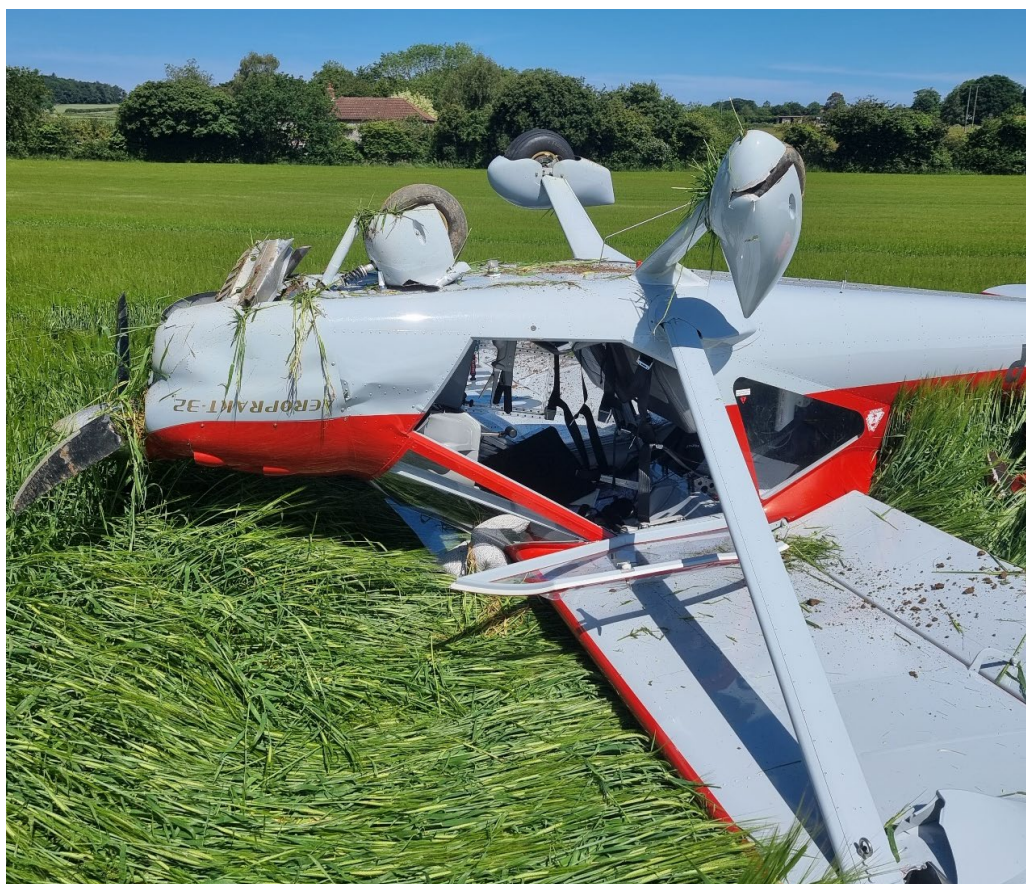
Figure 1

The pilot considered diverting to an airfield with a longer and more in-to-wind runway but was concerned that any damage to the nose leg could lead to it collapsing on touchdown, with unpredictable consequences. While the aircraft was equipped with a ballistic parachute recovery system, the pilot said he was unwilling to use it in a pre-meditated way because the outcome would be “unknown.” At this point his passenger was becoming increasingly distressed, so the pilot elected to conduct an immediate precautionary landing on the “softest soil and springiest crop” that he could find. He identified a corn field nearby and landed aligned with the furrows, using full flap for the approach. Just before touchdown he turned the fuel and battery master switches off and landed as close to the stall as he could. After touchdown the aircraft came to rest inverted (Figure 1). Both occupants were able to self-evacuate from the aircraft with only minor injuries.

G-RASP inverted after landing in crop field.

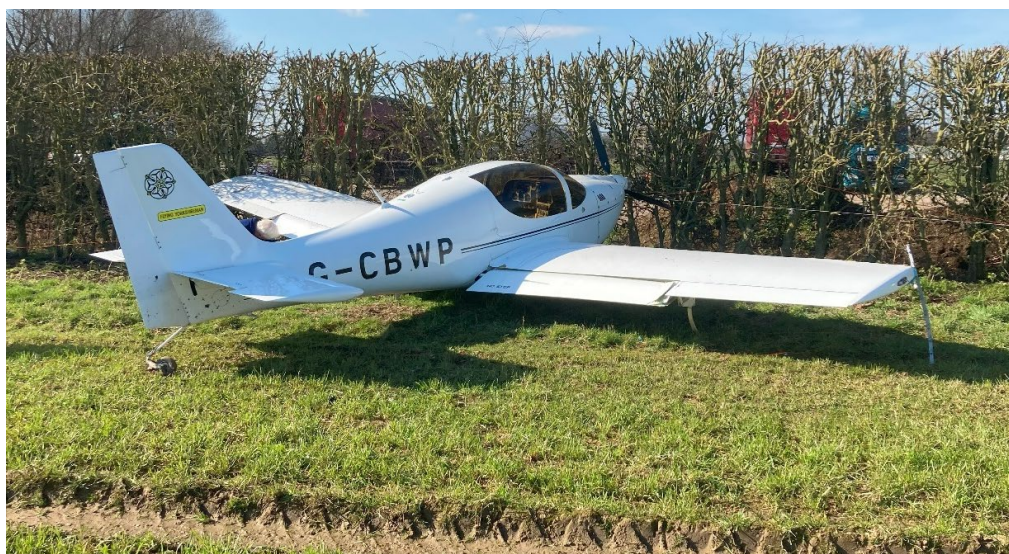
Figure 2

The aircraft was recovered from the accident site (Figure 2) but was subsequently assessed as beyond economical repair, due to extensive damage to the mounting structure of the wings.

G-CBWP after it had come to rest

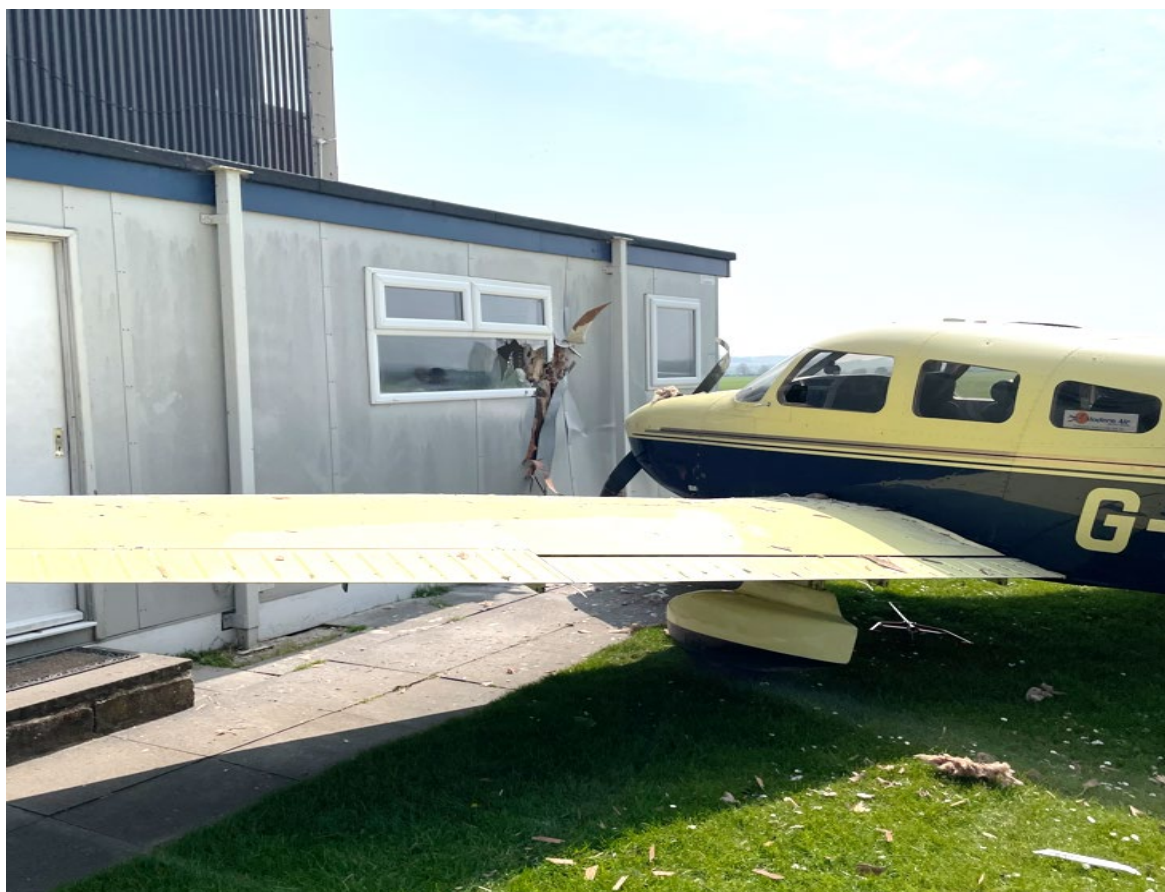
The engine started and immediately ran at high power. The pilot's attempts to apply the toe brakes and parking brake were unsuccessful and the aircraft, having completed a 180° right turn followed by a left turn, struck a building (Figure 1). The engine stopped on impact and the pilot, who was wearing the three-point harness, received minor injuries to his left elbow and forehead.

Figure 1
G-JACS after the accident

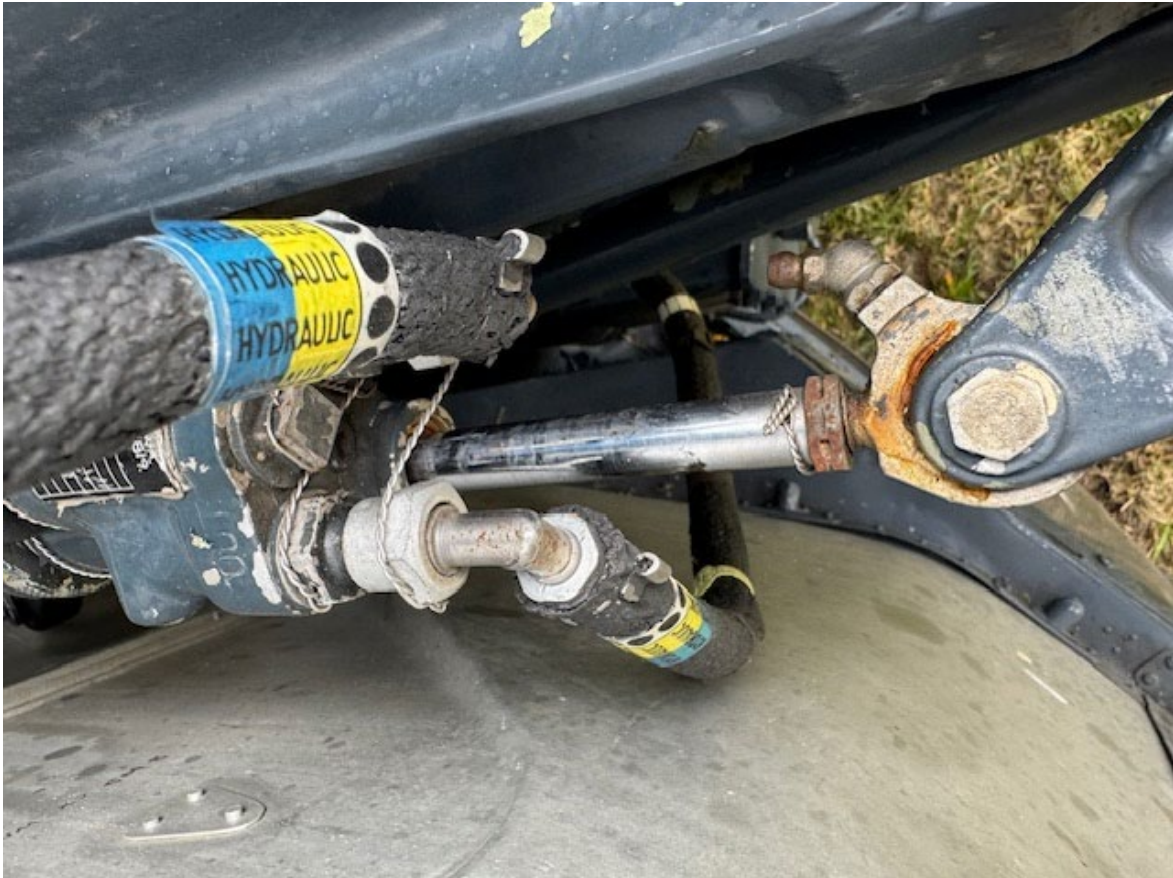
Figure 1

The instructor sought an independent technical assessment of the helicopter hydraulic system, flying controls and rotor head, which found no obvious evidence of system malfunction or component failure. However, it was found that the single piston hydraulic collective pitch servo jack was fully extended (Figure 1) after the accident. He considered that this may have been an artefact of the roll over and subsequent damage to the helicopter. This was plausible because the servo would not have been in hydraulic lock, therefore free to extend and retract, because the system had been set to OFF for the check. Nevertheless, it was unexpected.

Collective servo extension
