Report on the investigation of
a serious injury to a passenger on the sea safari rigid
inflatable boat

Lundy Explorer

at Ilfracombe, England

on 7 June 2023

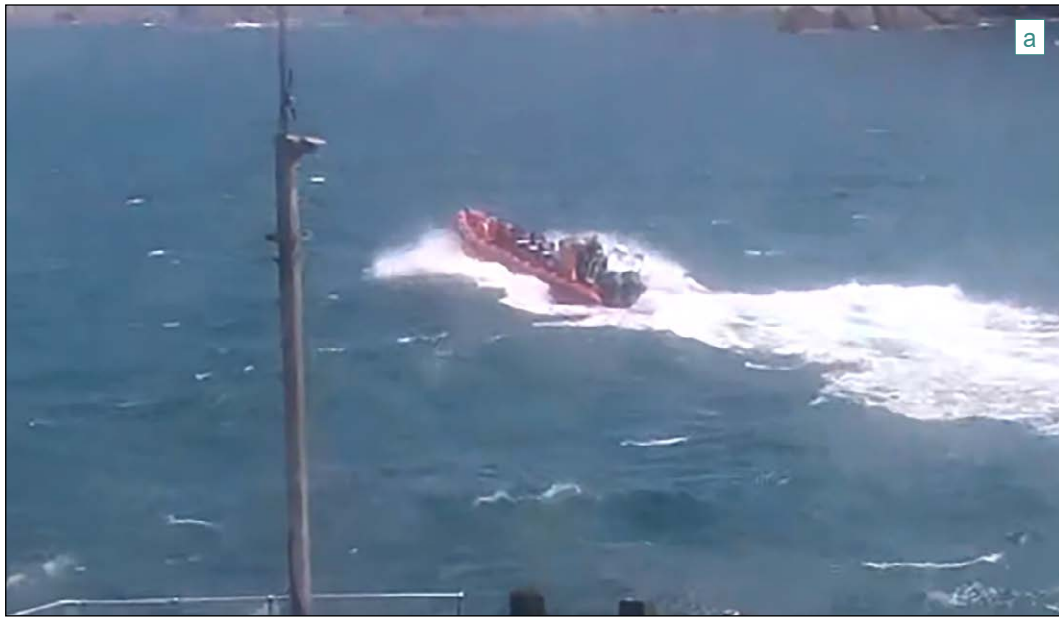
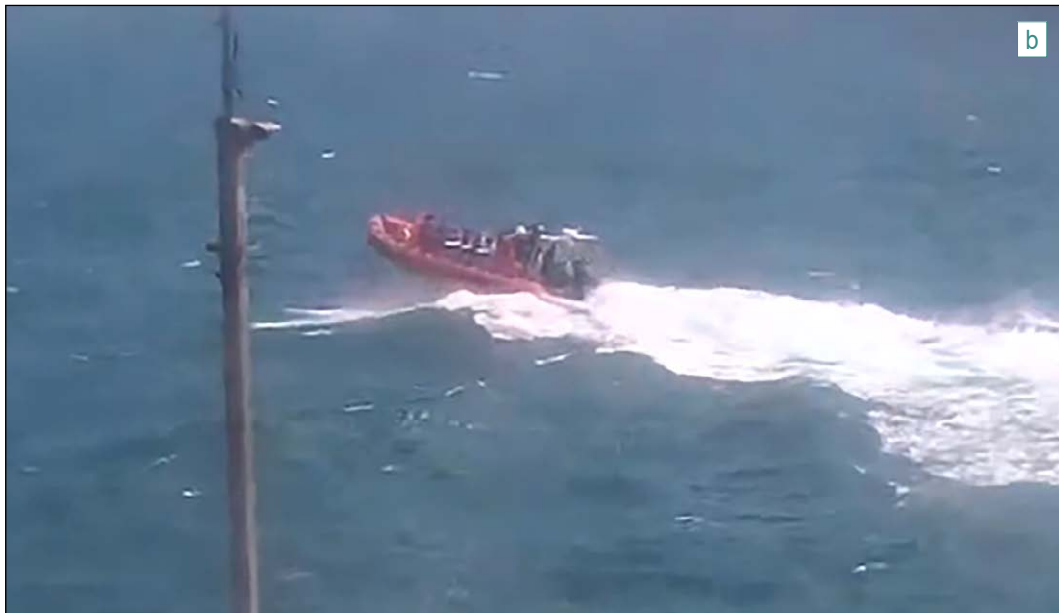
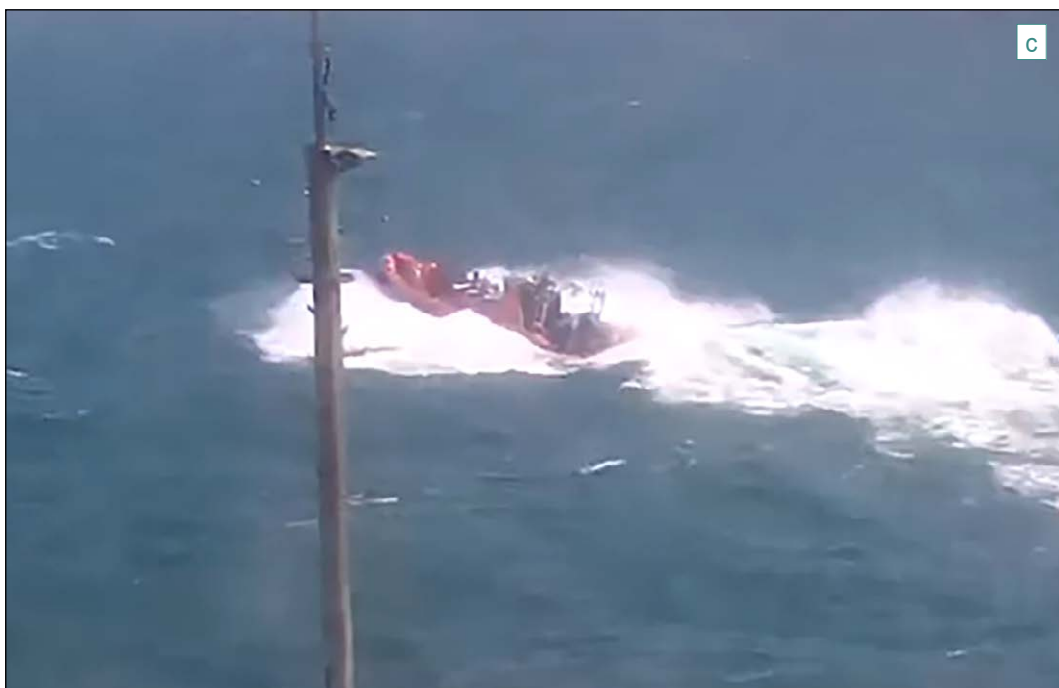
Figure 4: *Lundy Explorer* pitching as it heads out from the harbour

As *Lundy Explorer* rounded the pier to head into open water, the RIB pitched moderately (**Figure 4**); the skipper considered this to be normal and expected the RIB's movement to ease once it was clear of the harbour. The passengers, some of whom had been on previous trips, were initially unconcerned and considered the movement to be typical in the conditions.

Lundy Explorer's trip began as normal, and the skipper navigated the sea conditions after rounding the pier. The closed-circuit television images (see **Figure 4**) indicated *Lundy Explorer* was not planing and initially handled the wave heights without significant issue. However, the interaction of the easterly winds with the headland meant the conditions to the north of the harbour entrance were probably worse than

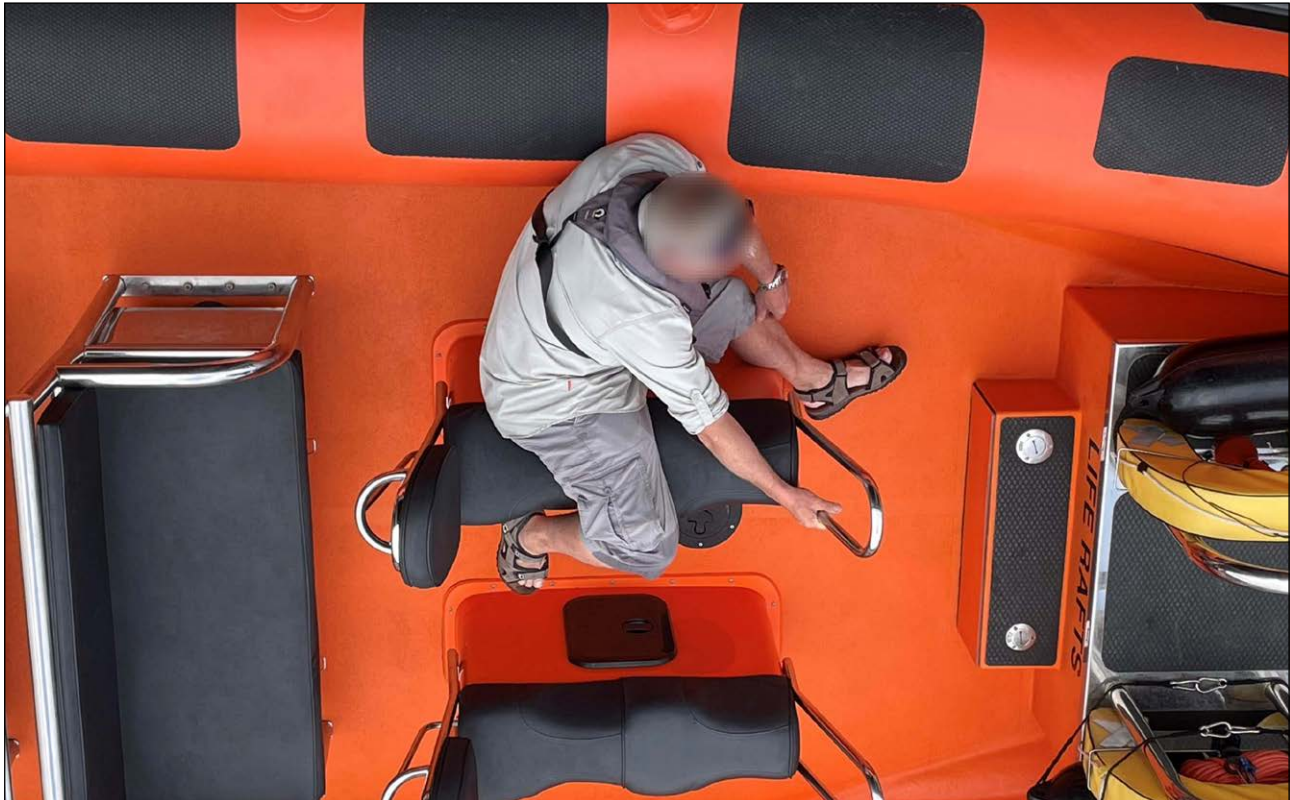
Figure 6: Reconstruction of the casualty's position after falling from the jockey seat

Two passengers immediately raised their arms to notify the skipper that there was a problem. A passenger on the aft bench seat shouted to the skipper that someone had fallen off. The dislodged passenger was wedged between the jockey seat pedestal and the RIB's sponson, in a twisted position with her right leg over the seat (**Figure 6**). The deckhand attended to the dislodged passenger, who said that she could not feel her legs. The deckhand was concerned that the casualty's position was unsafe and moved her right leg from the seat. The deckhand then attended to the two injured passengers on the bench seat.

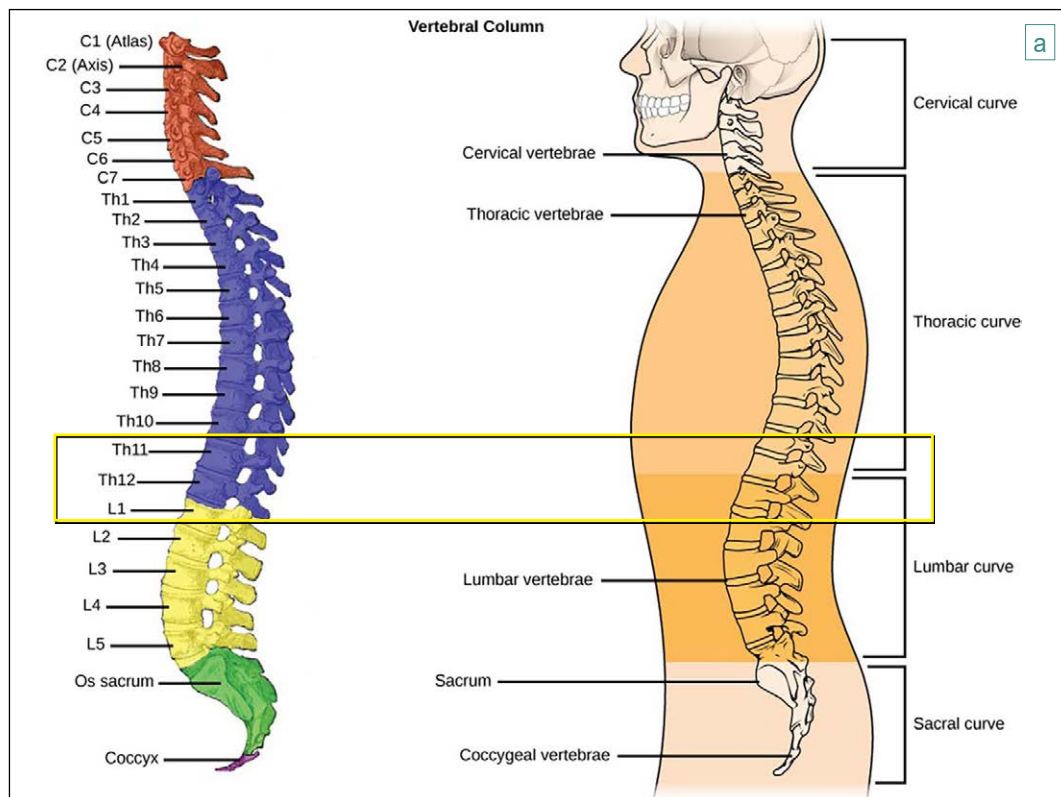
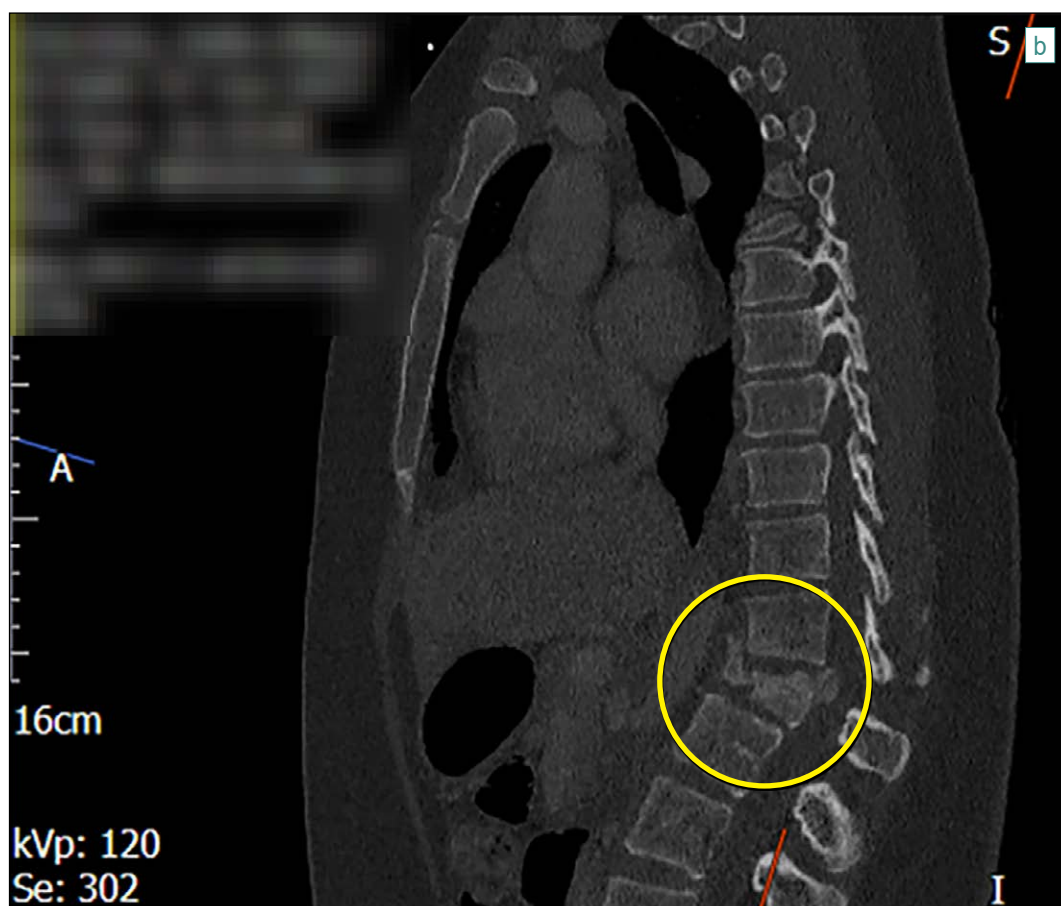
Figure 7: Location of T12 vertebra (a) and X-ray of the injury (b)

The casualty was a 28-year-old female in good health who was 1.72m tall and weighed 90kg. She sustained a wedge compression fracture to the T12 vertebra (**Figure 7**) and damage to her spinal cord, resulting in paralysis below the fracture. She had no pre-existing conditions, including osteoporosis, that would have

contributed to the injury. The injury was permanent. The hospital's consultant neurosurgeon advised that the injury was caused at the moment of impact and no additional damage due to post-accident movement was evident.

The injured passenger had no pre-existing health conditions that would have made her more vulnerable to an injury. It is likely that her displacement from the seat caused the large forces experienced to become misaligned with her spine and resulted in a shearing force, as described in the High Speed Craft Human Factors Engineering Design Guide. The shearing force resulted in a fracture of the T12 vertebra, damage to the spinal cord and permanent paralysis.

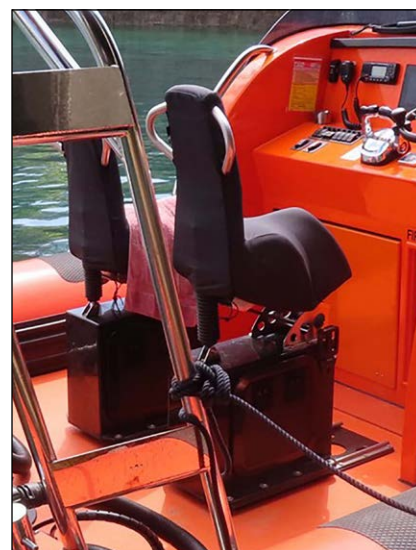
Figure 8: *Lundy Explorer's* helm position suspension seat

The RIB was operated from an aft steering console equipped with a radar, navigation plotter, and fixed very high frequency radio. The two crew positions had suspension seating⁴ (**Figure 8**), which were reportedly only used on long trips in low wave heights.

Although the crew were not using the suspension seats, their position, standing near the RIB's centre of the rotation, possibly desensitised them to the extent of the conditions. *Lundy Explorer* was not fitted with sensors that could *provide real time vibration data that enables the person driving the vessel to understand the impact of their driving*, as discussed in MGN 436 (M+F). Consequently, the skipper might not have fully realised the discomfort caused by the forces acting on the passengers at the front of the RIB and did not therefore consider returning to harbour. Given the further accidents in 2025 resulting in passenger injuries during Ilfracombe Sea Safari Limited RIB excursions, it is likely that the ability to monitor the real-time conditions experienced at the forward section of the RIB would be beneficial to the person at the helm.

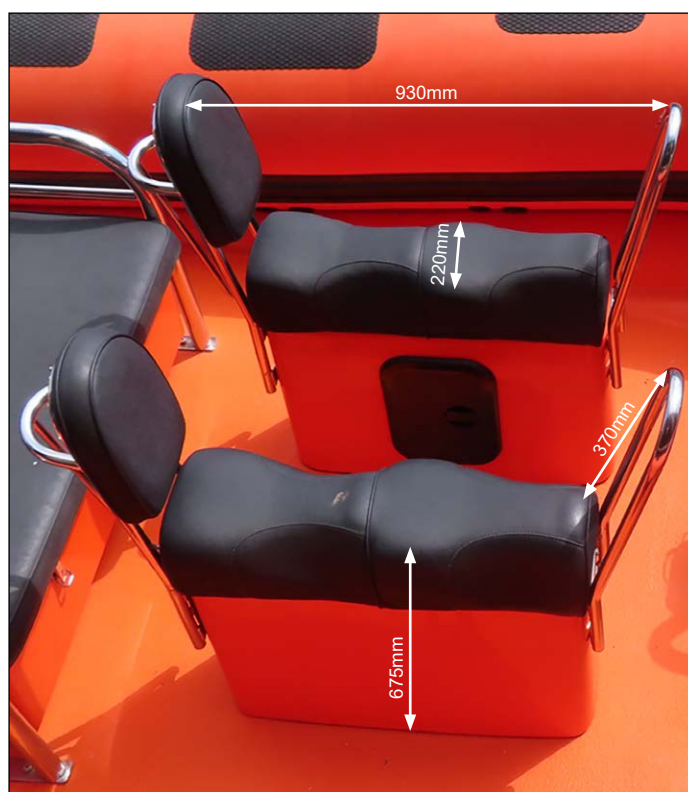
Figure 9: Jockey seat dimensions

Lundy Explorer's passenger seating arrangement comprised four rows of bench seats accommodating three passengers each and two twin occupancy jockey seats. The seats were cushioned with vinyl-covered generic foam. Not all of the 16 available seats needed to be occupied. The jockey seats had shallow moulded contours to indicate the seated positions for two people. There was a cushioned backrest for the rearmost passenger and an extended vertical handhold constructed from stainless steel tube with a round profile for the forwardmost passenger (**Figure 9**).

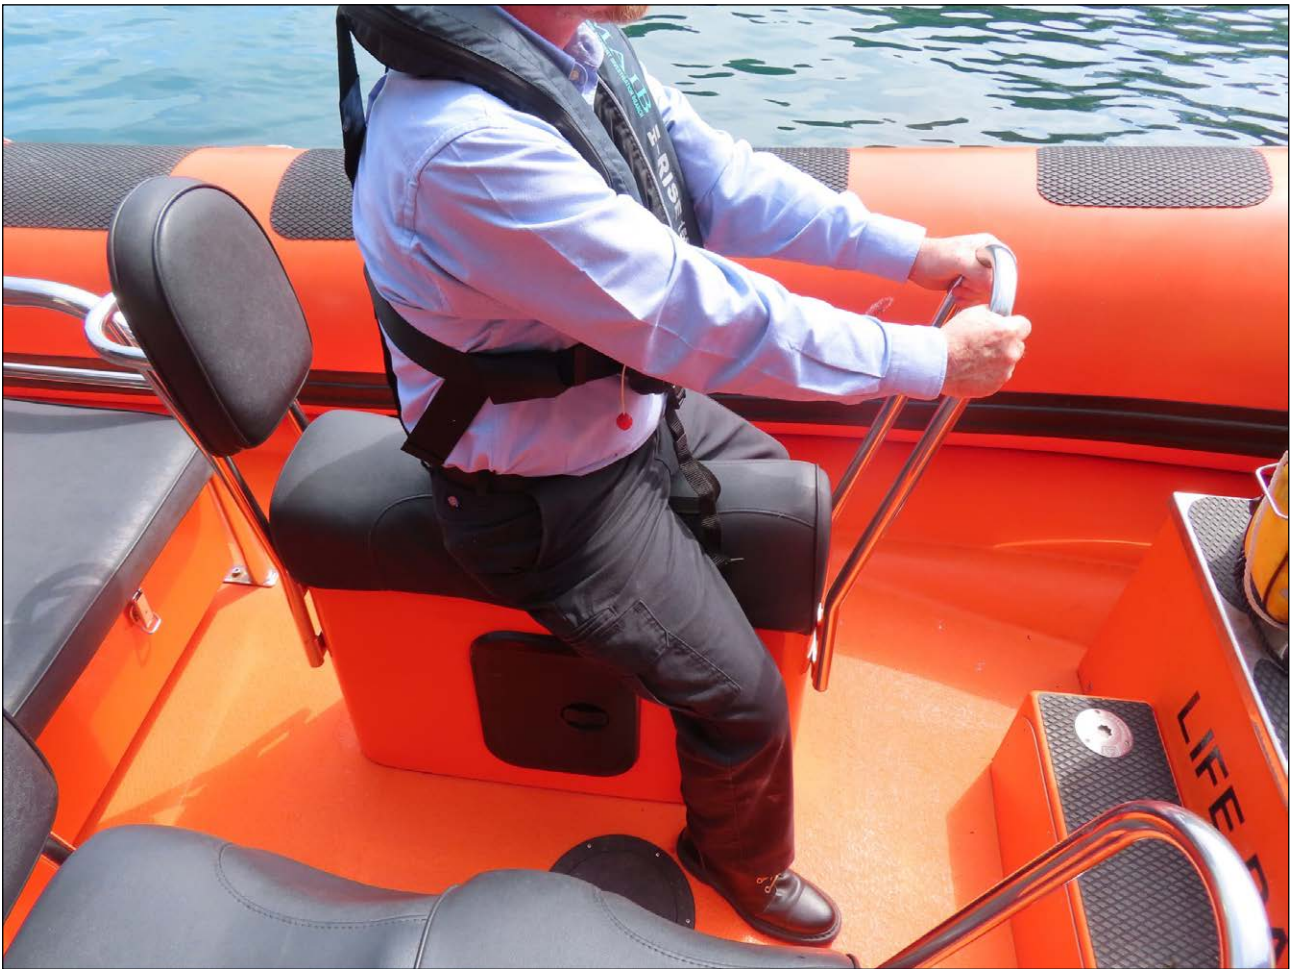
Figure 11: Reconstruction of the casualty's approximate position on the jockey seat

Lundy Explorer had capacity to seat the trip's 12 passengers on the four bench seats. When the passengers were embarked at the landing stages, two were told to move from a bench seat to the forward jockey seats as filling from the front was the usual method for seating them. The injured passenger's physiology allowed her to sit on the jockey seat with her feet on the deck and use her knees to brace against shock loads (**Figure 11**). However, the seat was not designed for single occupancy and lumbar support could not therefore be provided by the seat's back rest if using the handhold. Consequently, the chances of being displaced from the jockey seats during rough conditions were increased.

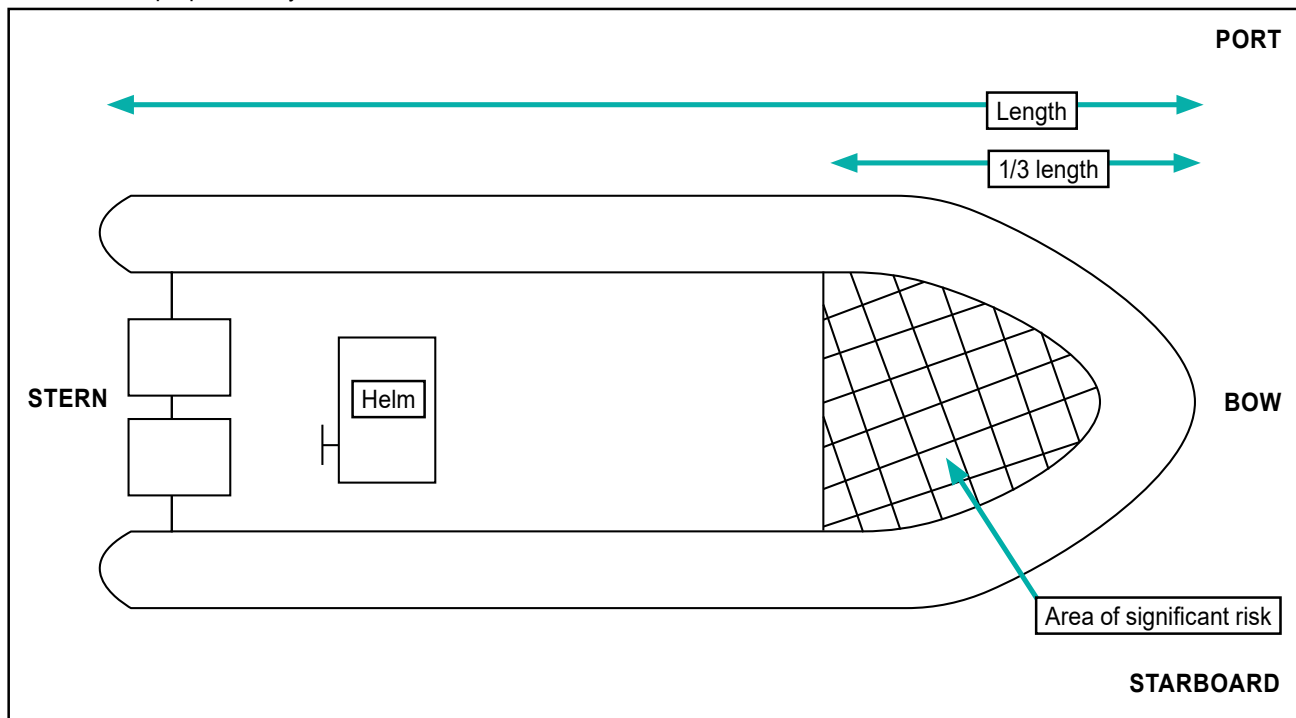
Figure 2: RIB outline highlighting the area of significant risk

Commercial passenger tours using RIBs, including sea safaris and thrill rides, have experienced a surge in popularity across the UK, with a corresponding increase in the occurrence of accidents. Since 2001, the MAIB has been notified of 54 accidents during RIB rides that have resulted in lower back injuries, 17 of which resulted in spinal fractures. Initial analysis of these previous accidents as part of this investigation indicates that passengers seated in the front third of a RIB's overall length (**Figure 2**) are exposed to a significantly higher risk of lower back injuries than those seated further back, as the vertical motions experienced are generally greater towards the bow.
