Accident

Aircraft Type and Registration:	Robinson R22 Beta, G-KKRN	
No & Type of Engines:	1 Lycoming O-320-B2C piston engine	
Year of Manufacture:	1989 (Serial no: 1201)	
Date & Time (UTC):	3 February 2025 at 1700 hrs	
Location:	Near Wokingham, Berkshire	
Type of Flight:	Training	
Persons on Board:	Crew - 2	Passengers - None
Injuries:	Crew - None	Passengers - N/A
Nature of Damage:	Empennage detached, significant damage to fuselage and rotors	
Commander's Licence:	Commercial Pilot's Licence	
Commander's Age:	54 years	
Commander's Flying Experience:	1,580 hours Last 90 days - 97 hours Last 28 days - 27 hours	
Information Source:	Aircraft Accident Report Form submitted by the pilot

Synopsis

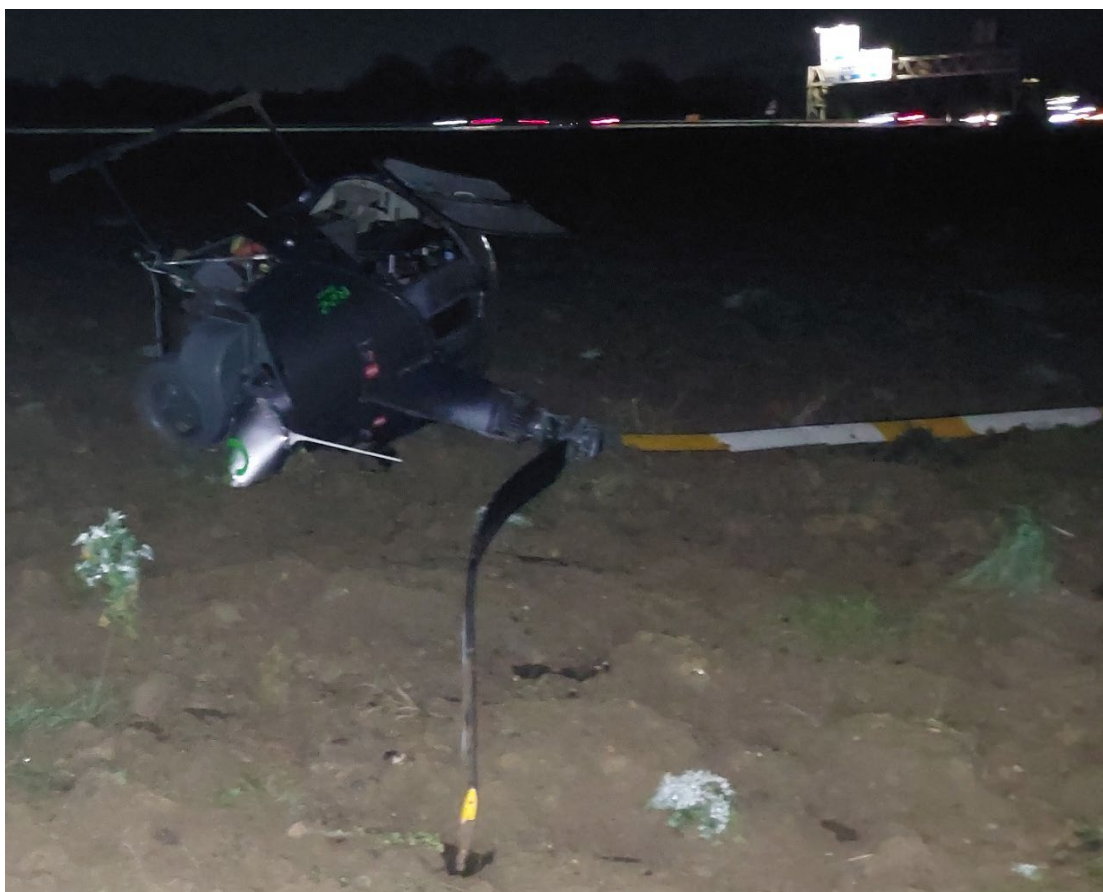
Figure 1

Once autorotation had been established the instructor asked the trainee to push the mixture control back down to the fully rich position, the intent being to try an engine restart if time allowed. Having established the autorotation as his immediate priority, the instructor then focused on field selection. With the M4 motorway to his right, and trees and powerlines to his left, the only viable option was the ploughed field ahead. At this stage there was not enough height left to consider a restart, therefore the instructor concentrated on executing an engine-off landing at the slowest possible forward airspeed. He assessed that the helicopter was travelling at less than 5 kt when he levelled the skids just prior to ground contact. As the skids touched down, they dug into the soil and the helicopter tipped forward onto its nose before “gently” rolling to the right. During the period immediately after ground contact the main rotors struck the rear empennage, which detached from the helicopter and was thrown forward of the wreckage.

Neither pilot was injured in the accident, and both were able to self-evacuate through the left door (Figure 1).

G-KKRN after the accident (image courtesy Thames Valley Police)
