AAIB Bulletin

9/2025

Published: 11 September 2025.

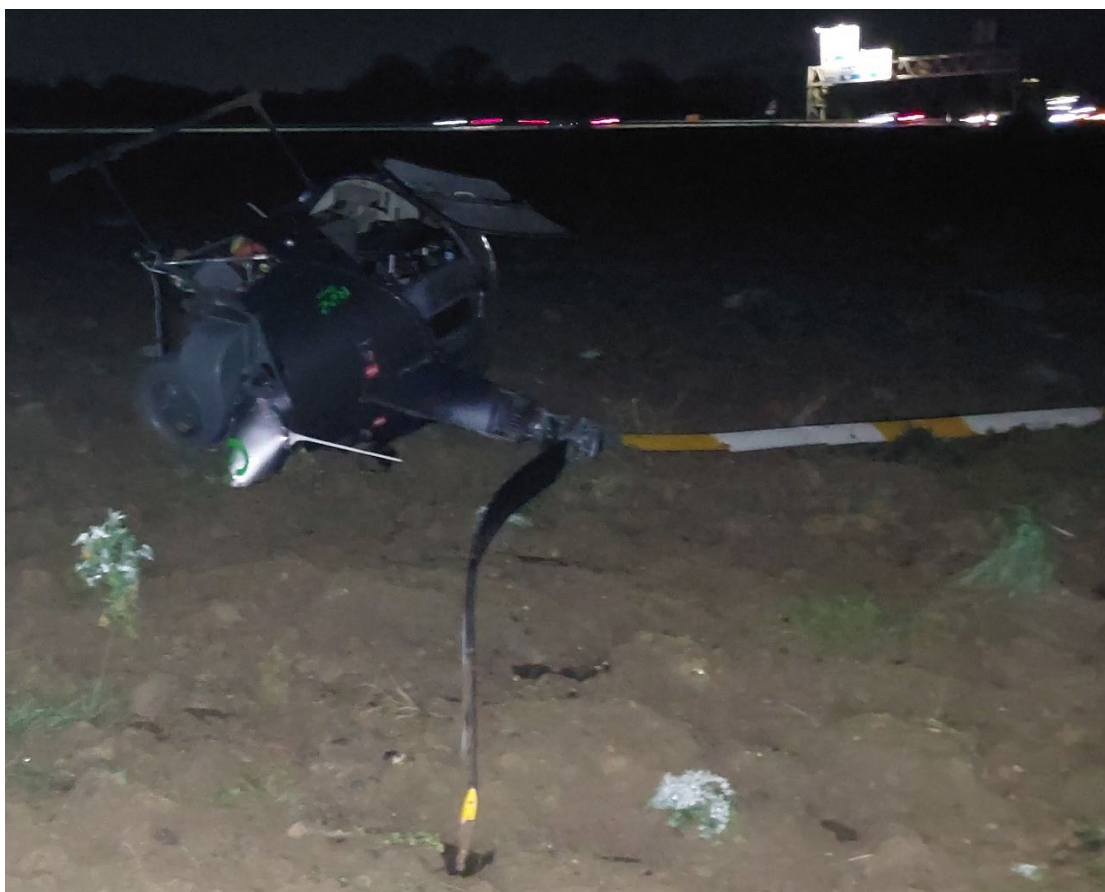
Figure 1

Once autorotation had been established the instructor asked the trainee to push the mixture control back down to the fully rich position, the intent being to try an engine restart if time allowed. Having established the autorotation as his immediate priority, the instructor then focused on field selection. With the M4 motorway to his right, and trees and powerlines to his left, the only viable option was the ploughed field ahead. At this stage there was not enough height left to consider a restart, therefore the instructor concentrated on executing an engine-off landing at the slowest possible forward airspeed. He assessed that the helicopter was travelling at less than 5 kt when he levelled the skids just prior to ground contact. As the skids touched down, they dug into the soil and the helicopter tipped forward onto its nose before “gently” rolling to the right. During the period immediately after ground contact the main rotors struck the rear empennage, which detached from the helicopter and was thrown forward of the wreckage.

Neither pilot was injured in the accident, and both were able to self-evacuate through the left door (Figure 1).

G-KKRN after the accident (image courtesy Thames Valley Police)

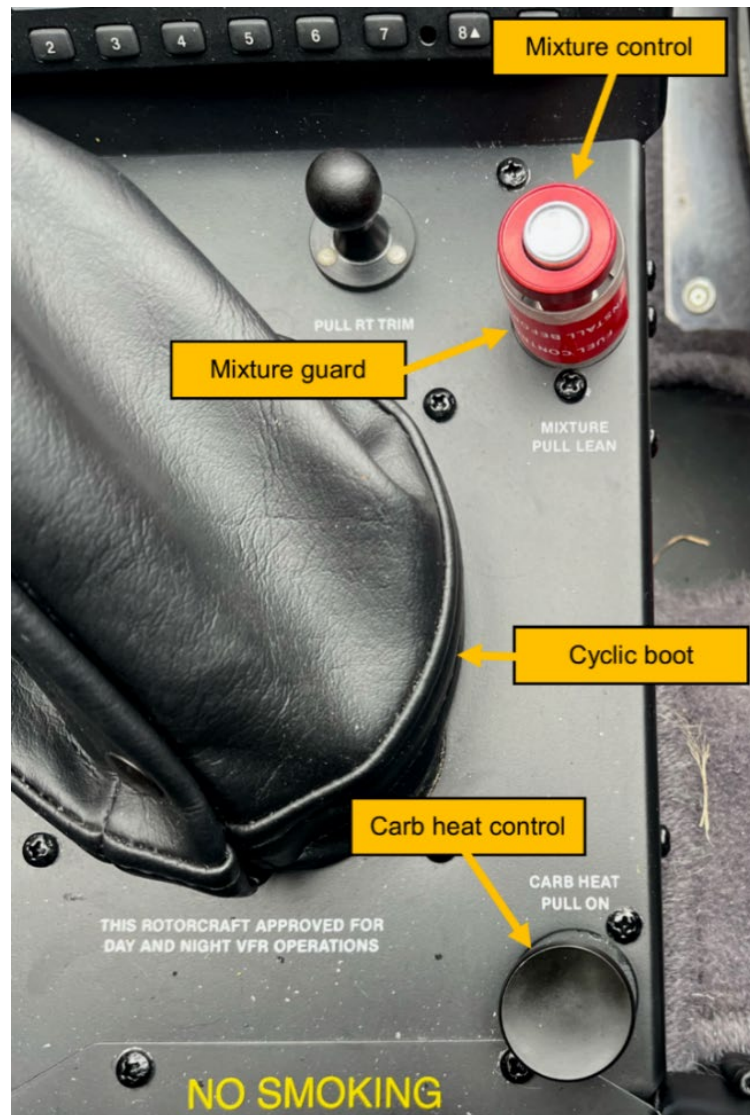
**Figure 2**

G-KKRN is an R22 Beta, powered by the Lycoming O-320, a normally aspirated engine with manually operated carburettor heating². The carburettor heating control is located on the centre console aft and right of the cyclic stick boot (Figure 2).

The mixture control is positioned directly forward of the carb heat control, close to the bottom of the lower instrument panel and to the right of the PULL RT TRIM control (Figure 2). It is coloured red rather than black and has a different physical shape to the carburettor heating control. On top of the mixture control is a friction release button which, when pressed, allows the control to be moved. During the before start checks the mixture control is set to the FULL RICH position (fully down) and a plastic tubular guard is placed around the stem of the control. In normal operation, the mixture remains at FULL RICH until the after-landing shutdown checks when it is pulled upwards to the OFF position to stop the engine.

Centre console controls

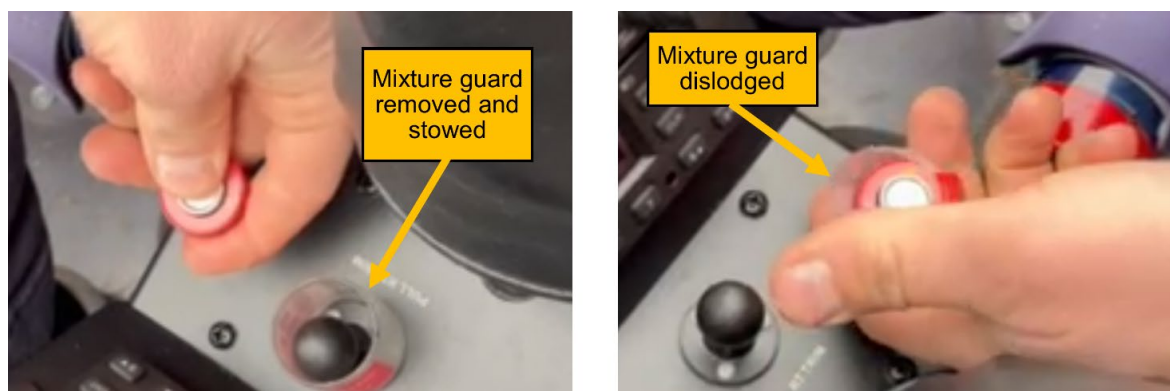
Figure 3

The mixture guard is a tactile physical barrier intended to reduce the risk of inadvertent mixture operation during flight. It is common practice for pilots to remove the guard when intentionally operating the mixture control. Some pilots temporarily stow it over the adjacent trim selector (Figure 3 (left)) before returning it to the mixture control on completion of the selection. It is possible to dislodge the guard with the control in the FULL RICH position if a pilot slides their index and middle finger under the mixture control and applies upward pressure (Figure 3 (right)).

Mixture control guard removed and stowed (left) and dislodged (right)
