Fatal man overboard from the fishing vessel *Kingfisher* (DH 110) approximately 30 nautical miles east-north-east of Wick, Scotland on 12 July 2024

SUMMARY

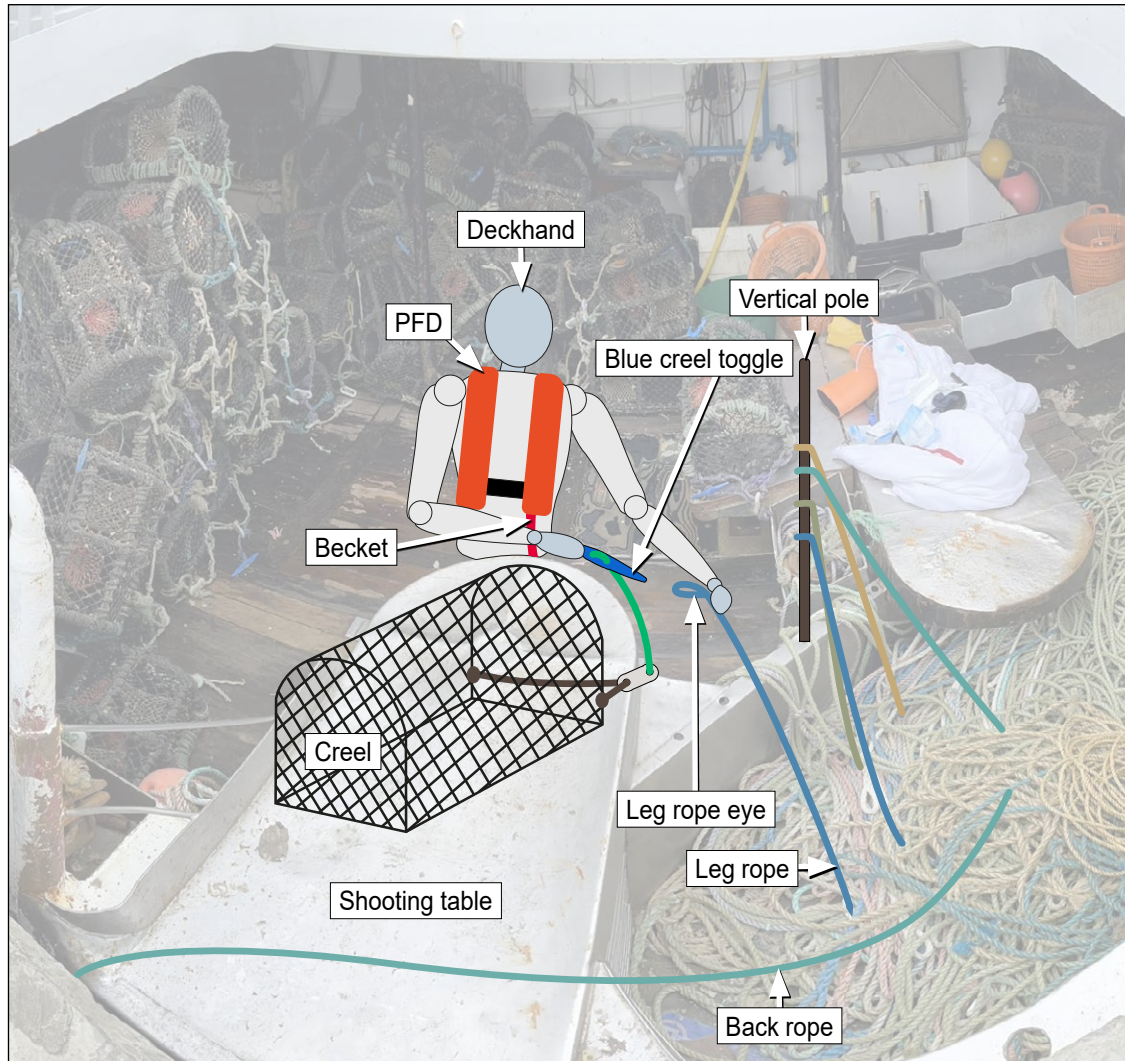
At about 0900¹ on 12 July, the crew restarted fishing in a water depth of about 50m. By 1500, they began shooting the fourth string of the day. One of the deckhands was standing at the shooting table, manually toggling the creels one at a time onto leg ropes connected to the back rope (**Figure 2a**). At 1508, the deckhand inadvertently threaded the third creel's toggle through both the eye in the leg rope and the becket that was hanging loose from his personal flotation device (PFD) (**Figure 2b**). The other crew members on deck heard a scream and saw the deckhand being rapidly dragged by the leg rope across the shooting table and over the vessel's side.

Figure 2a: Representation of the deckhand toggling creels at the shooting table

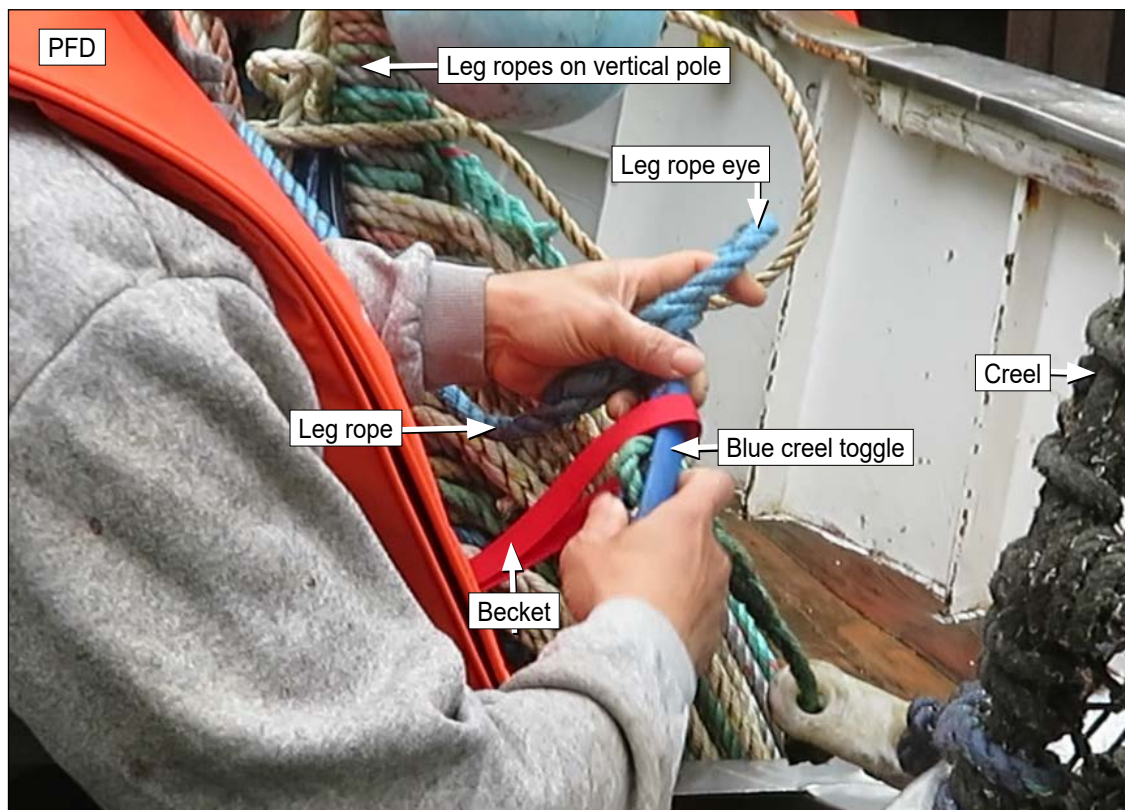
Figure 2b: Reconstruction of the deckhand inadvertently passing blue creel toggle through the lifejacket becket

The becket on the deckhand's PFD was connected to the leg rope of the third creel being shot away. The deckhand was pulled over the shooting table and overboard by the back rope, and then under the water. Although the deckhand's PFD inflated, it did not provide enough buoyancy to counteract the weight of the deployed creels pulling him underwater. While *Kingfisher's* crew responded promptly and the deckhand was recovered within 7 minutes, he could not be revived.

The blue toggle's shape made it easier to thread through the eye of a leg rope than the white toggle design and its length improved security of the creel once threaded (see **Figure 4**). It is likely the deckhand's concentration lapsed just before the accident and he inadvertently threaded the toggle through the loosely hanging becket of his PFD while connecting the third creel to the leg rope (see **Figure 2b**). Of the two types of toggles used on *Kingfisher* the blue toggle design was more likely to inadvertently snag on items such as the loose becket due to its length and slim pointed shape. There was no specific reason identified for the purchase of the blue toggles other than that of availability. The different shaped toggles, the snag hazard posed by a freely hanging PFD becket, and the possibility of threading the pointed blue toggle through a becket loop appear not to have been formally recognised as a serious hazard to life. Although the chance of making such an error could be seen as unexpected and relatively unlikely, the consequences were severe.

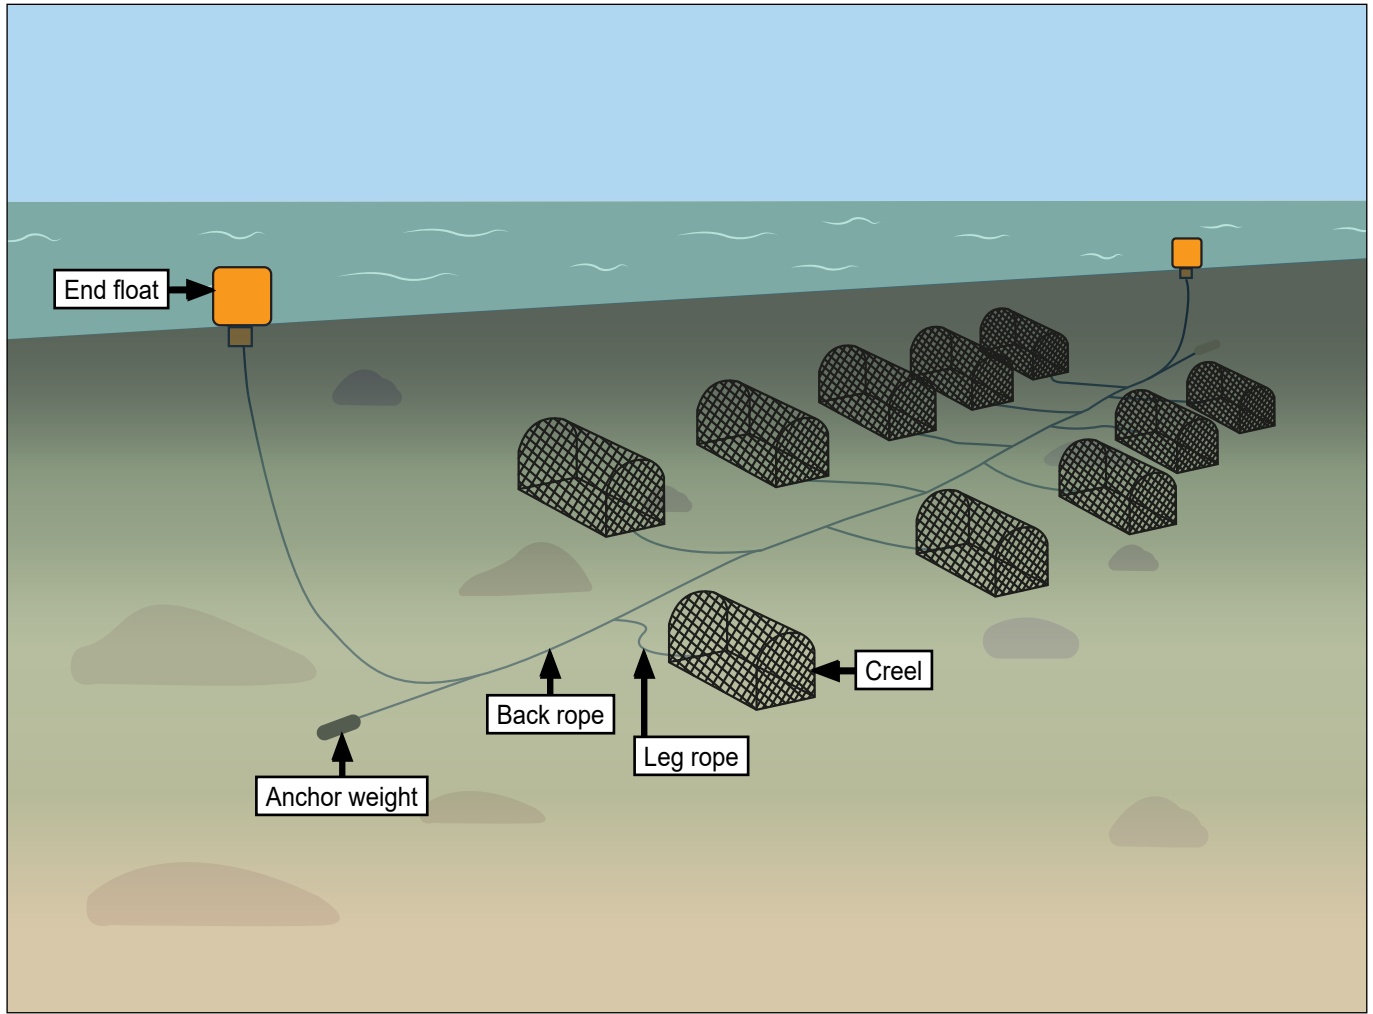
Kingfisher operated with 40 strings of 120 creels. Each creel weighed between 20kg and 25kg. The creels were individually connected to a back rope (**Figure 3**) via 2m long leg ropes, which were spaced approximately every 30m along the back rope. Each end of a string had an anchor weight attached to hold the creels in position on the seabed, and riser lines leading to end floats to identify the location of the string and to aid recovery. After recovery, each creel was stripped of catch and then stowed aft of the working area before being rebaited, connected to the leg rope and shot away from the shooting table.

Figure 3: Creel fishing arrangement

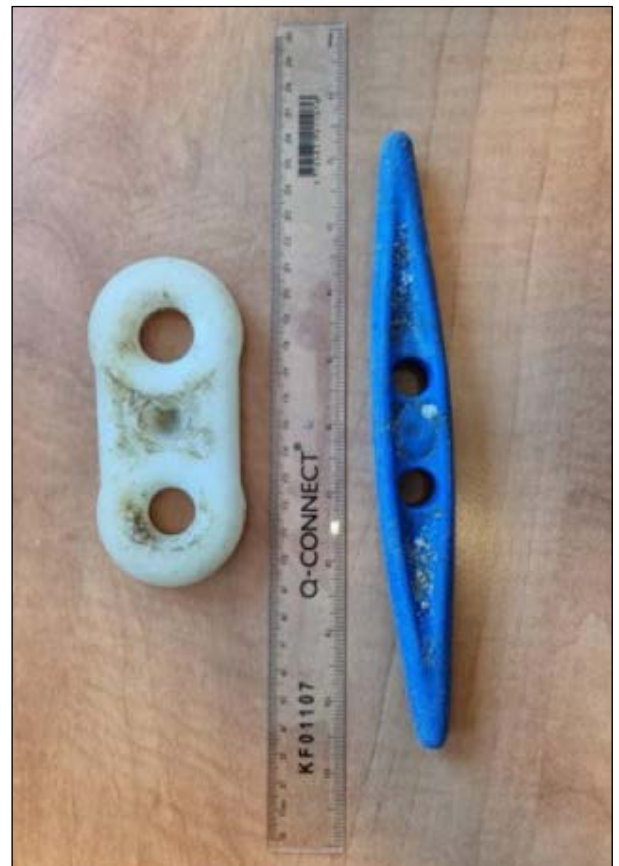
Two different types of toggles were used to connect the creels to the leg ropes: approximately 90% were of an oval white plastic design; the remainder were of a blue double-ended plastic spike design about 200mm long (**Figure 4**). The blue toggles were part of a new batch that had been purchased.

Figure 4: Blue and white creel toggles

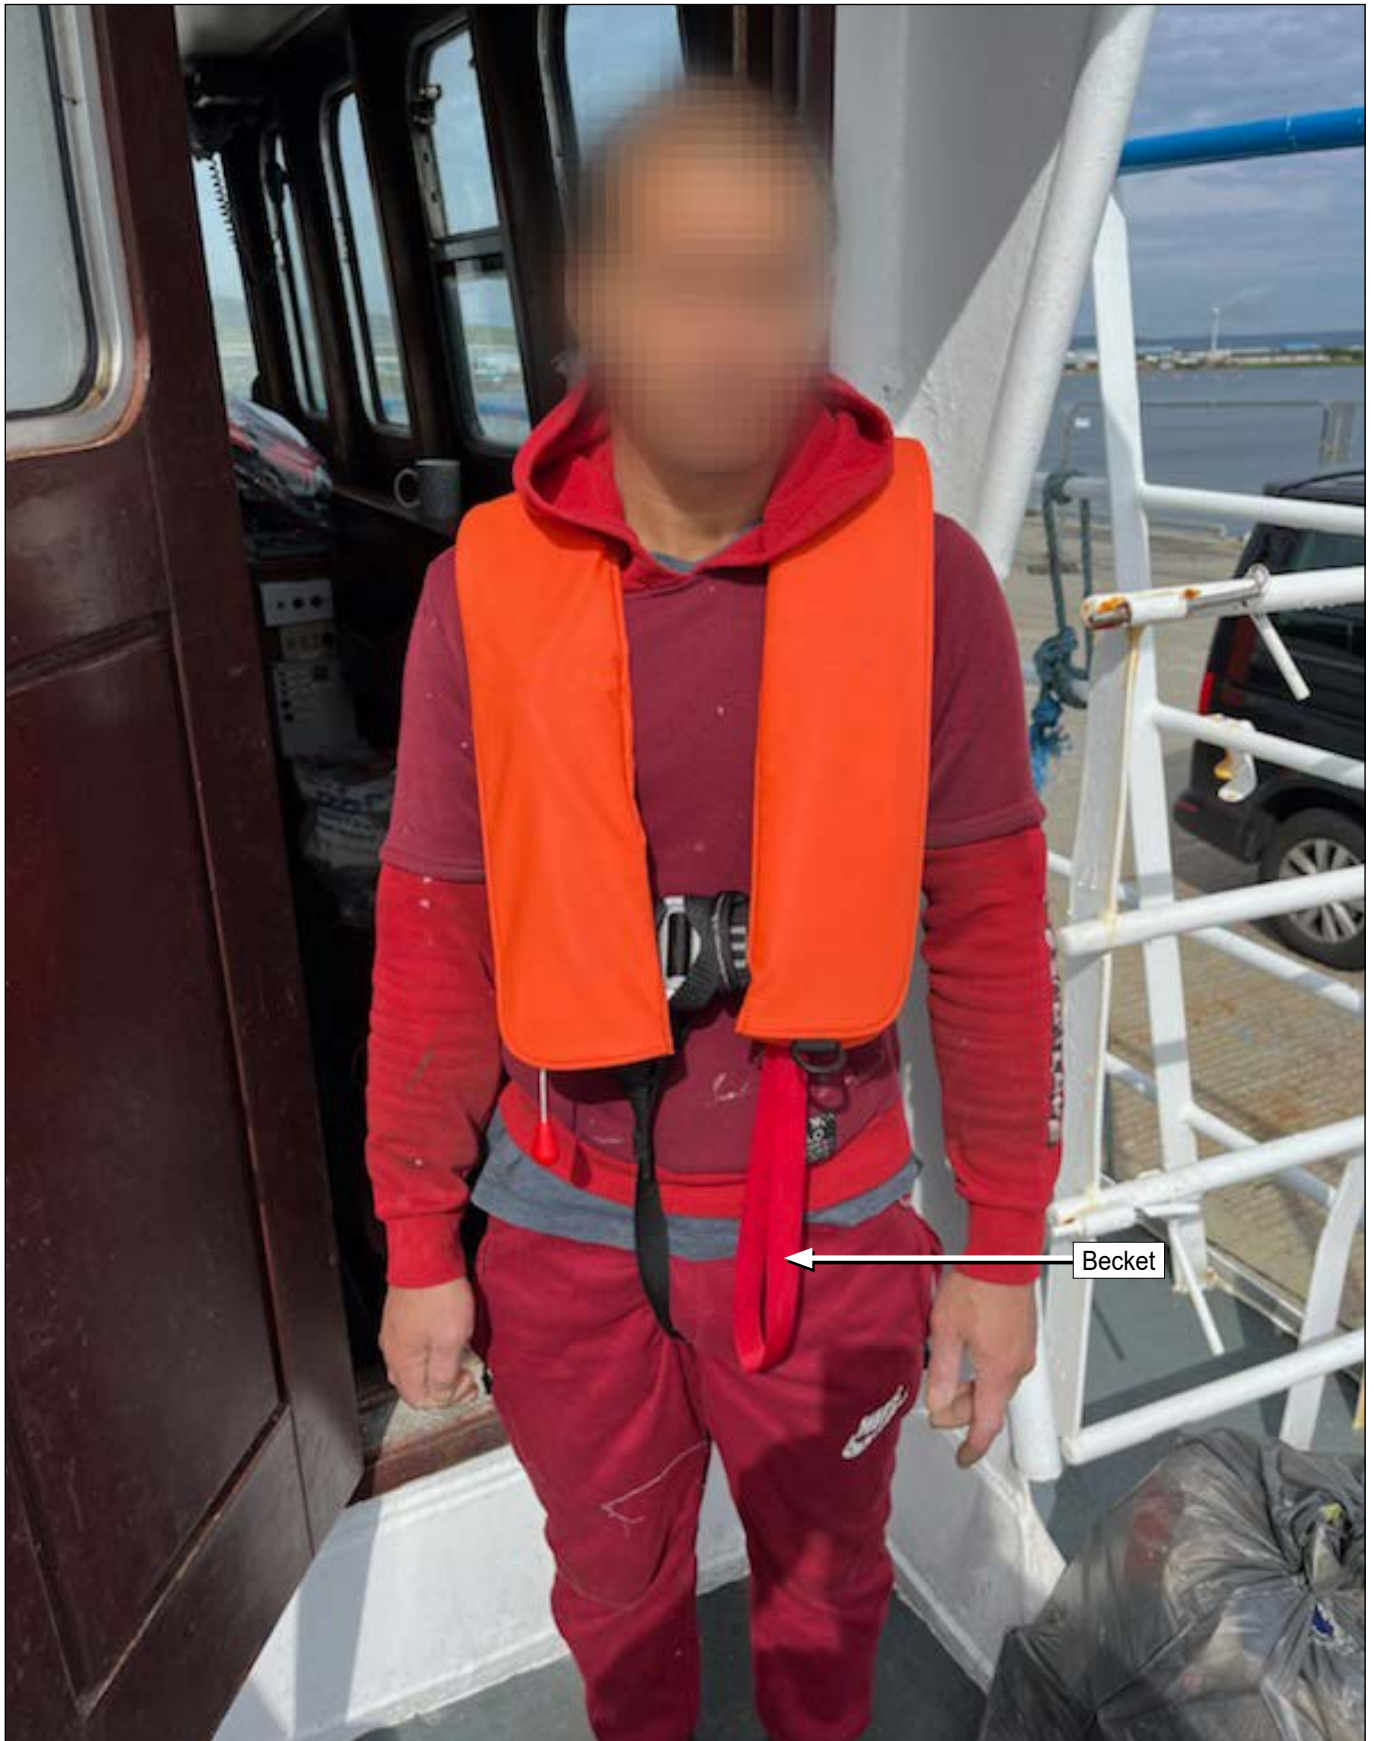
Figure 5: The red webbing becket on the PFD

The EN ISO 12402-2 (275N) standard required PFDs to be equipped with a rescue lifting becket. The becket was stored within the PFD's stole when new and was intended to deploy upon inflation. During heavy use on board *Kingfisher*, the Velcro tape securing the stole on some of the PFDs gradually degraded allowing the becket to be released and to hang down loosely from the PFD.

Some of the crew who had experienced loose PFD becketts snagging on parts of the fishing gear had cut the becketts off to prevent this. However, removal of the becketts had been done without individuals consulting between themselves or raising the snagging problem with the skipper. Had the skipper been informed about the problem with the PFD becketts, the owner or manufacturer could have been notified. Alerting the manufacturer would likely have received a rapid response to the effect that removal of the becket both invalidated the PFD's certification and reduced the wearer's rescue options.

Seago Yachting Ltd has increased the minimum length of the PFD lifting strop (becket) from 15cm to 29cm to increase the friction fit under the cover and enhance visibility when the PFD has inflated. Additionally, the latest Seaguard model incorporates a Velcro tab to secure the becket that breaks free upon inflation and allows it to hang free. This attachment can be retrofitted to any Seago lifejacket.
