SAFETY FLYER TO THE FISHING INDUSTRY

**Fatal man overboard from the fishing vessel *Kingfisher* (DH 110)
approximately 30 nautical miles east-north-east of Wick, Scotland
on 12 July 2024**

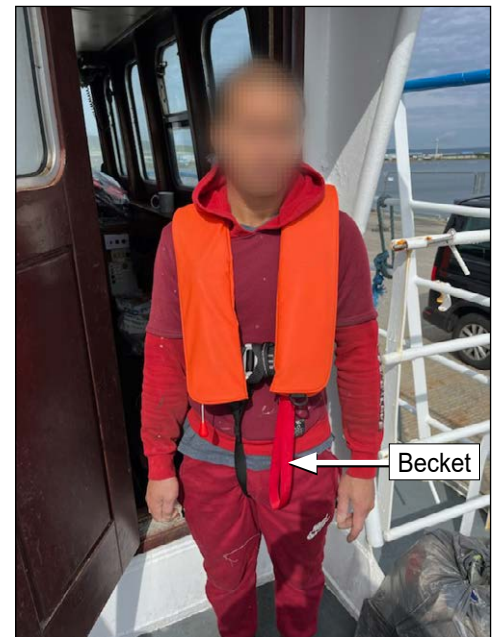
- The becket on the deckhand's PFD created a snagging hazard that enabled him to inadvertently connect himself to a creel's leg rope.
- The becket was initially stowed in the PFD's stole when new but had worked loose during use (see **figure**).
- The hazard of the becket snagging had been identified by other crew members, who had cut the becket off their PFDs, but this had not been communicated to anyone else on board.
- The vessel's risk assessment process had not identified the hazard posed by the becket.

Figure: The red webbing becket on the PFD

3. Modifying safety equipment in any way changes its designed use and may prevent it functioning correctly when needed. Remove from service and replace any safety equipment that is damaged or inappropriate for the area of operation.

4. In this instance, where a deckhand had to work close to the vessel's side, a safety tether instead of a PFD could have been considered. See Marine Guidance Note 588 (F) Amendment 2¹: Compulsory provision and wearing of personal flotation devices on fishing vessels.
