Report on the investigation of
the fire and subsequent loss of power on board the
Finland registered roll-on/roll-off cargo ship

Finnmaster

at King George Dock, Hull, England

REPORT NO 13/2025

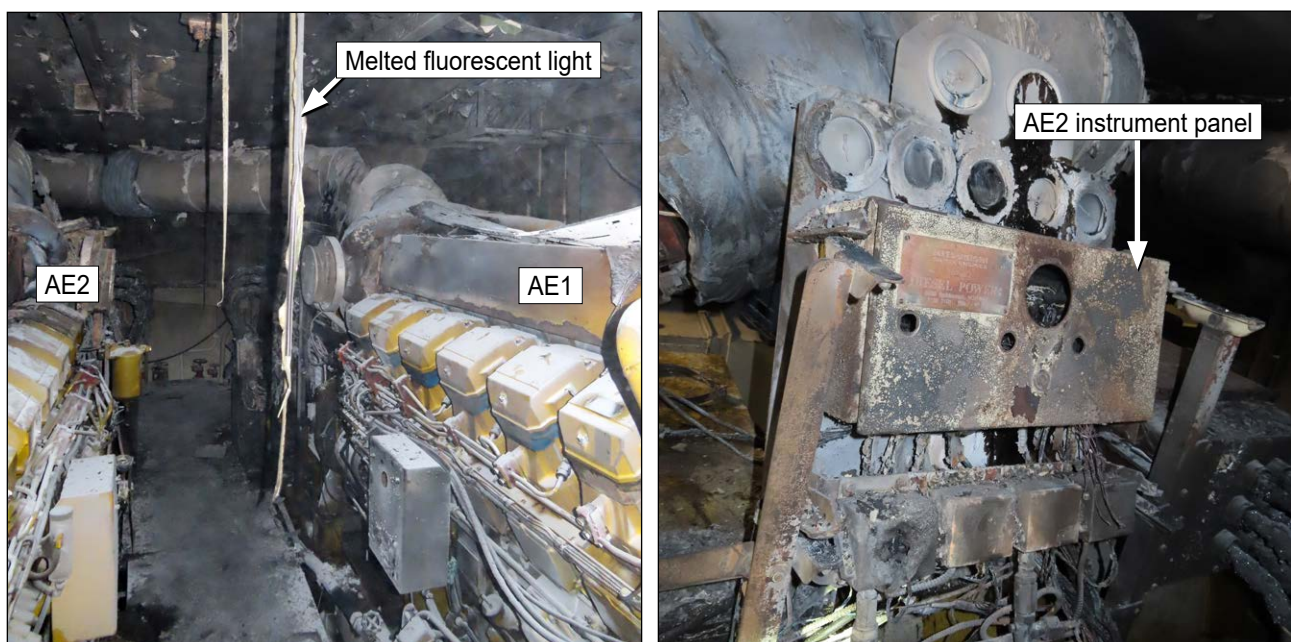
Figure 3: Damage to the auxiliary engine room

Finnmaster sustained fire damage to the equipment in the AER (**Figure 3**). The heat generated during the fire was sufficient for plastic components to melt, causing damage to electrical wiring and other susceptible equipment. Smoke damage was largely limited to the interior of the compartment.

The fire significantly affected the area of the AE instrument panels. The pressure gauge indicating the fuel supply pressure to the outboard fuel injection pump on AE2 had seized, showing 3.8 bar after the fire. The inboard fuel injection pump coupling bolts on AE2 had failed and jammed in the coupling. The fuel injection timing on the cylinders that side of the engine had changed.

The terminal box containing the wiring for the instrumentation on both AE1 and AE2 was positioned on the frame of the instrument panel for AE1. The door of the terminal box had failed, causing the internal wiring to melt due to its exposure to the heat of the fire.

The external alternator output, exciter and monitoring cables serving both AEs were heat-damaged. Both AE1 and AE2 sustained significant damage, necessitating their later removal from the ship for repair.

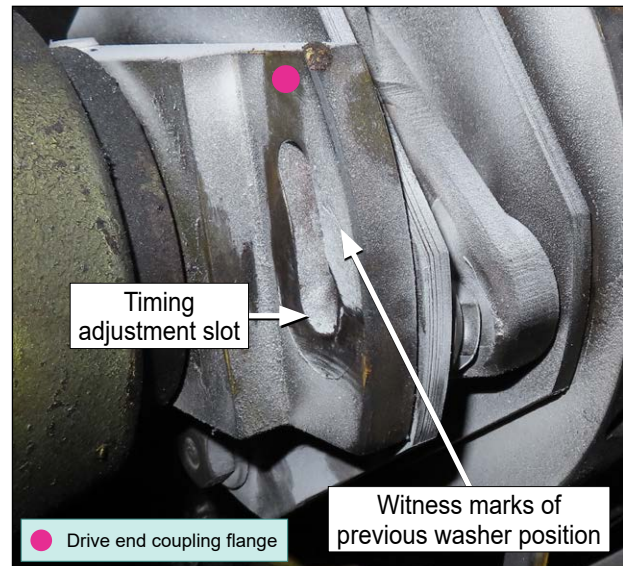
Figure 12: Witness marks on drive end coupling flange

Witness marks were visible on the surface of the drive end coupling flange where the flat washer had previously been seated (**Figure 12**). An examination of the accessory drive assembly in the gear drive for AE2's inboard fuel injection pump did not indicate any defects.

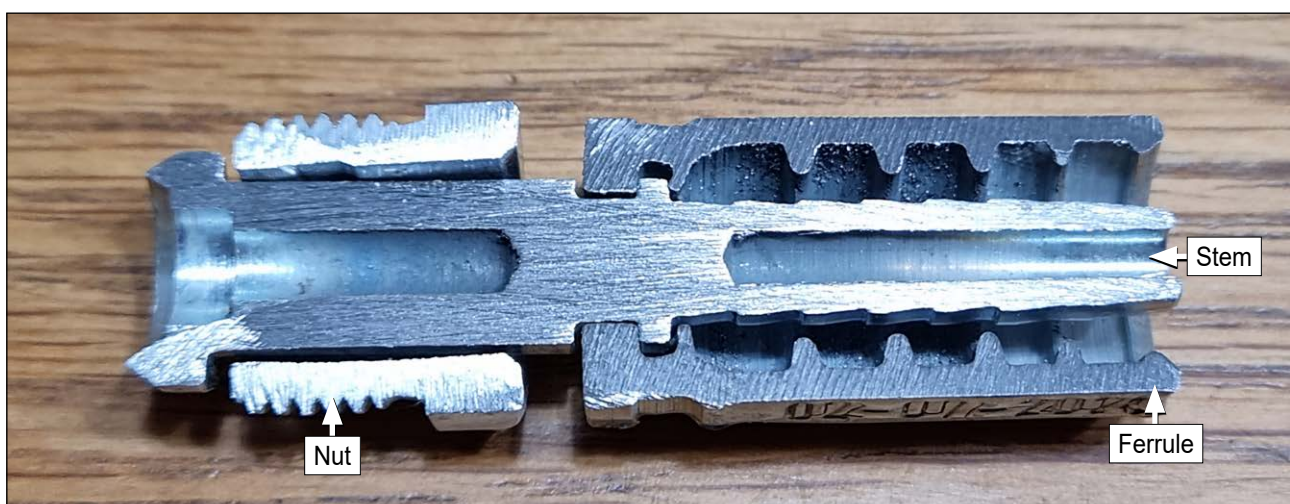
Figure 25: Section through flexible hose assembly coupling between cylinders C241 and C242

The flexible hose assembly from between cylinders C241 and C242 in the AER's pilot hose system was subsequently sectioned to fully investigate the blockage identified in the radiographs. The section revealed that the 4mm bore through the pilot hose coupling had not been fully drilled during manufacture, preventing the passage of gas through the flexible hose assembly (**Figure 25**).

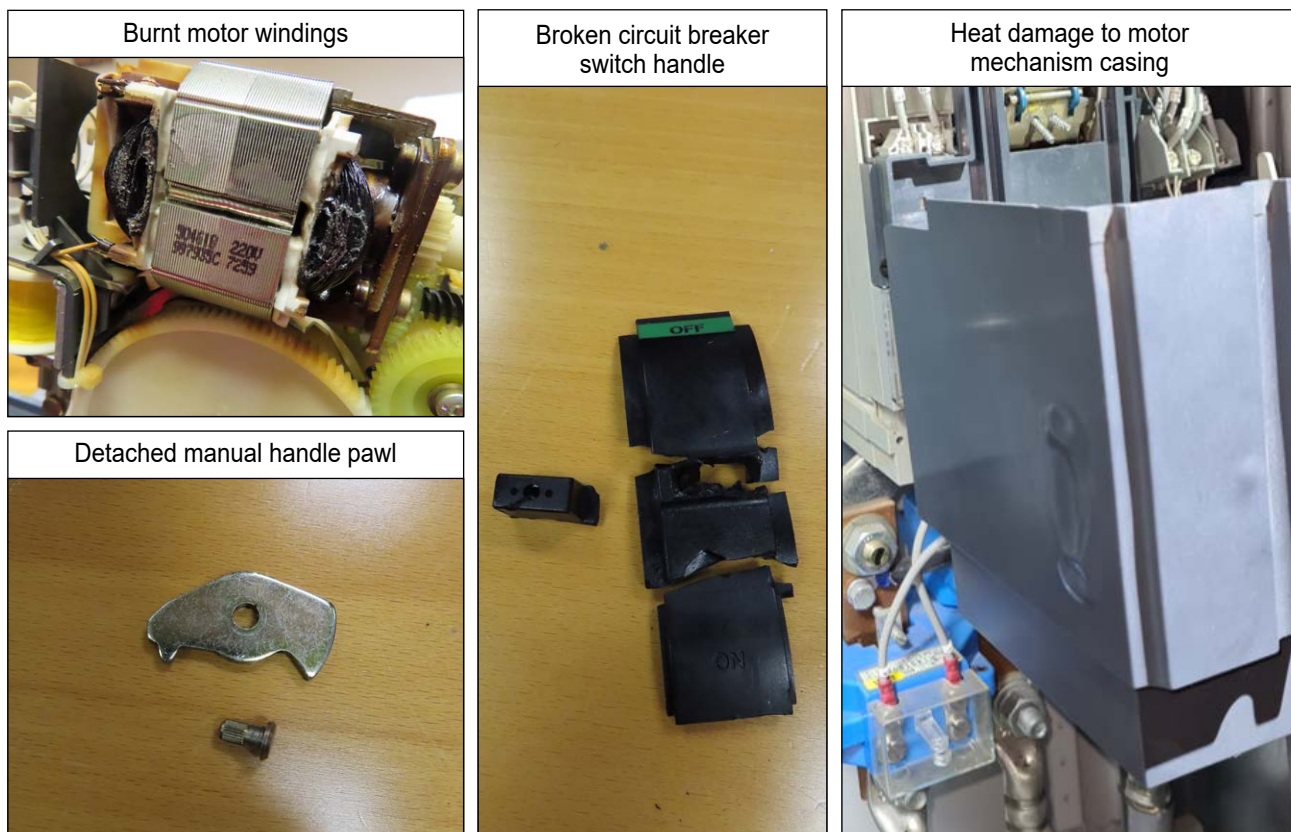
Figure 26: Damage to the EDG circuit breaker

The undervoltage relay operated correctly when tested in isolation, but operated intermittently when tested in conjunction with the UVT unit relay. Detailed examination of the of UVT unit showed that three soldered connections on the circuit board inside the unit were cracked. There was a lack of fusion in the soldered connection between the circuit board and the pins from the connector block where the input and output wires were connected.

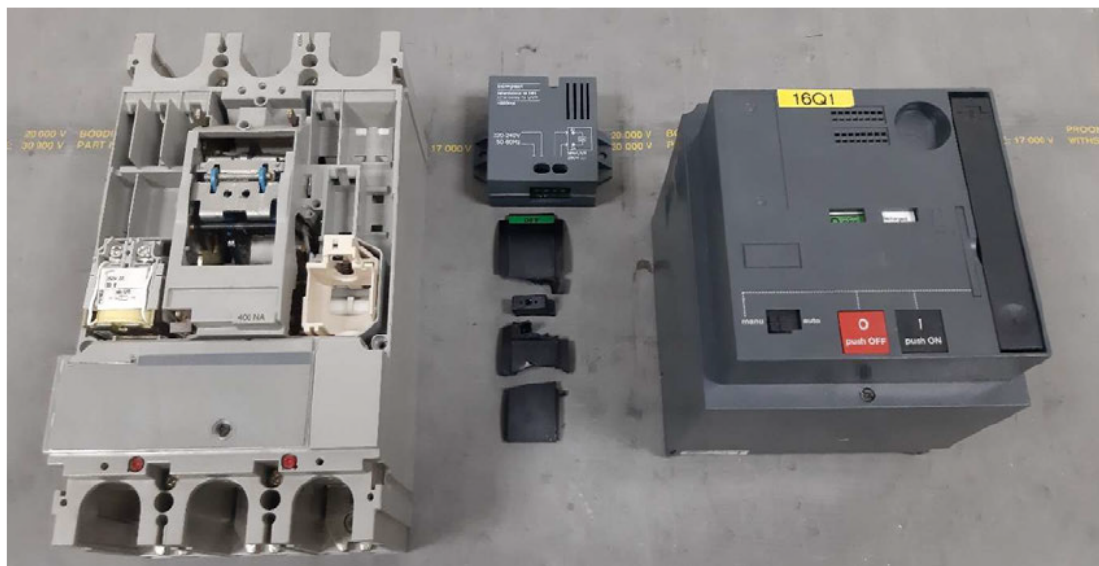
On closer inspection of the switch, we found that the fixing holes of the handle are deformed, and the handle is clearly broken.

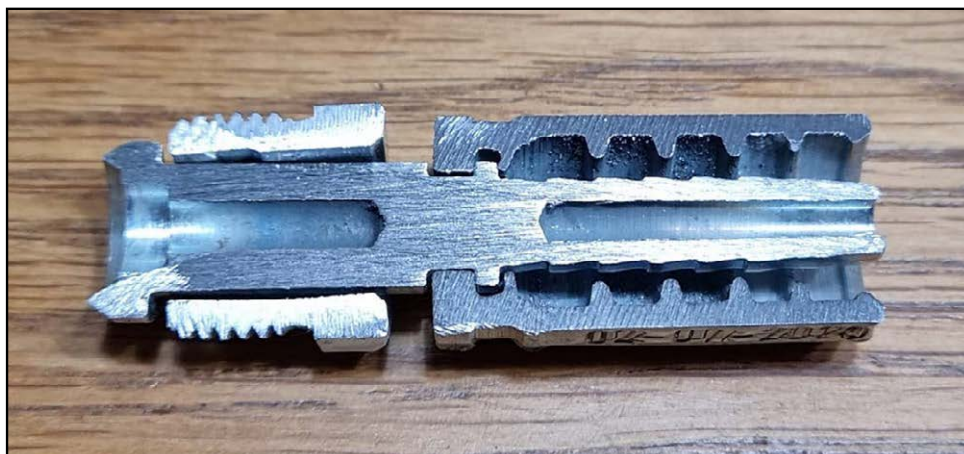
Section through blocked CO₂ pilot hose coupling showing incomplete bore through the stem

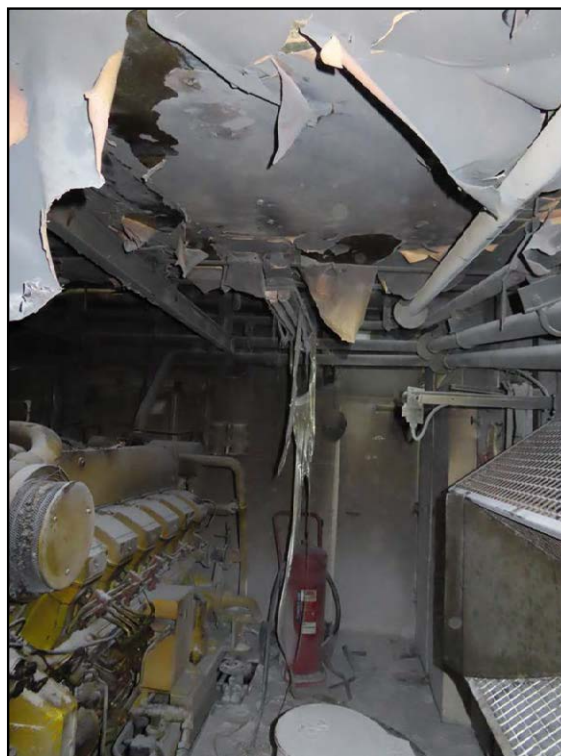
Finnmaster's fire-damaged compartment
