Accident

| Aircraft Type and Registration: | Boeing 737-8K5, G-TAWB | |
| Date & Time (UTC): | 16 December 2024 at 1628 hrs | |
| Location: | East Midlands Airport | |

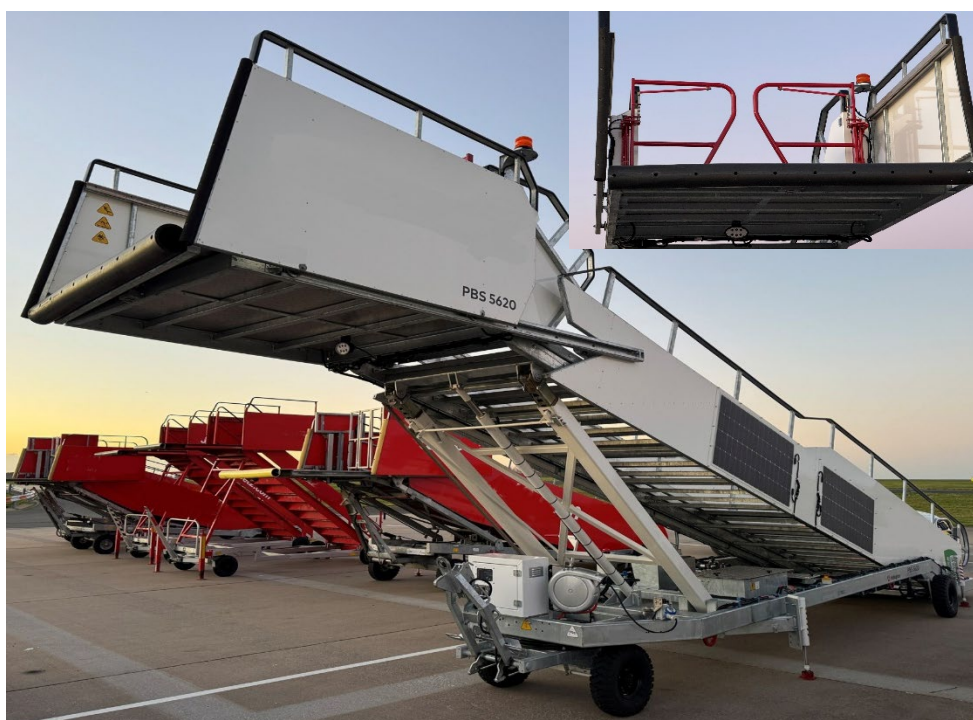
Figure 4

The ground handling company has other step types available which have features such as an electrically operated hydraulic system, electrical lighting or electrical or diesel-powered drive systems (to move the steps up to or away from the aircraft). Most of these other step types are fitted with additional safety barriers with interlocks to the drive system which prevents the steps being moved if the safety barriers are not closed. Before the accident the ground handling company had committed to replacing all the basic steps with steps fitted with interlocked safety barriers and were aiming to complete this by the end of 2025.

Steps featuring interlocking safety barriers

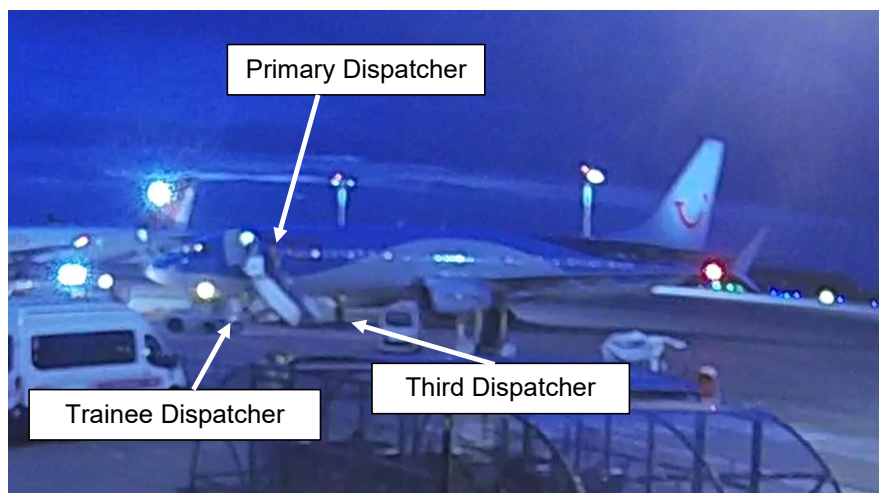
Figure 5

Having completed the aircraft loading, including the passenger boarding, both the trainee dispatcher and the primary dispatcher proceeded up the steps and into the aircraft. The primary dispatcher waited at the front of the aircraft whilst the trainee dispatcher went into the flight deck to complete the paperwork with the commander. The trainee dispatcher then left the aircraft and descended the steps before going over to the team leader to complete some paperwork. The primary dispatcher then confirmed with the cabin manager that the paperwork was complete before leaving the aircraft to wait for the cabin manager to close the door. When the accident occurred, the primary dispatcher was at the top of the steps either on the top platform or the next step down. He recalled that he saw the SCCM step her left foot on the steps, with her right foot on the aircraft with the gust lock released when the steps began to move. He shouted for the movement to stop but it did not, and the

SCCM could not position herself back into the aircraft before the gap was sufficient for her to fall between the steps and the aircraft. He saw her try to hang onto the door, but she was unable to do so. The trainee dispatcher did not see the steps move or the fall as he had his back to the aircraft.

A screenshot of the CCTV showing the position of the dispatchers when the steps were moved
