Collision between the tender to *Isabell Princess of the Sea* and the rigid inflatable boat *Vega* in Göcek, Turkey, resulting in one fatality on 27 July 2024

BACKGROUND

SUMMARY

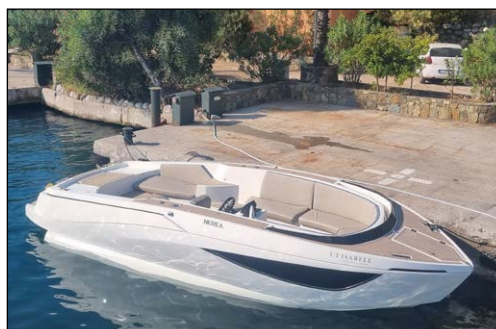
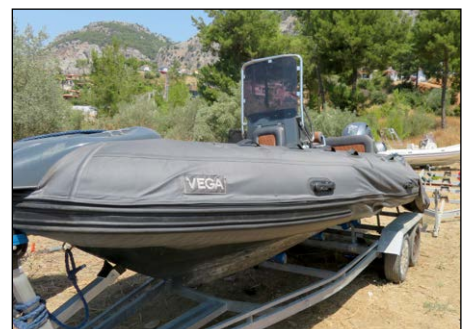
Tender to *Isabell Princess of the Sea* and RIB *Vega*

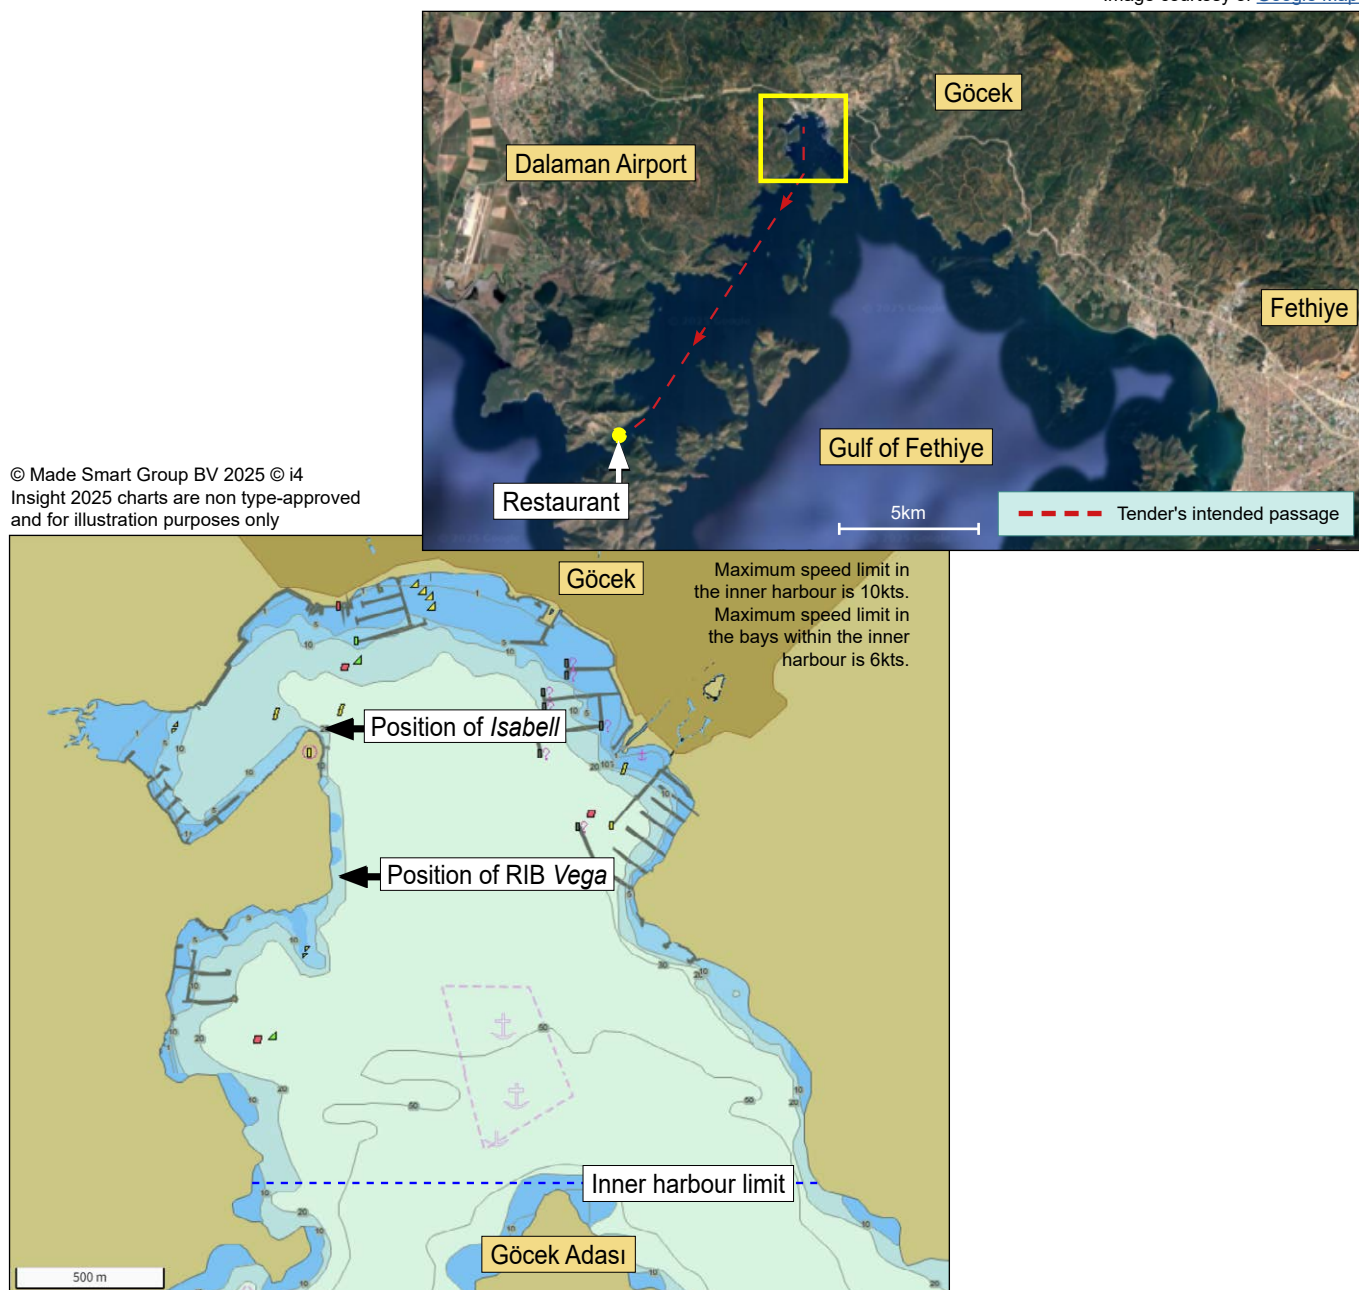
Figure 1: The port of Göcek and (inset) the tender's intended passage

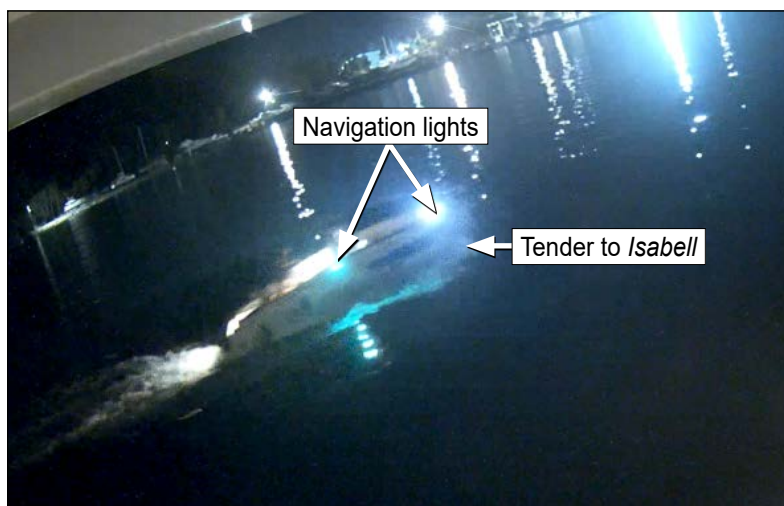
Figure 2: CCTV still, showing the tender underway

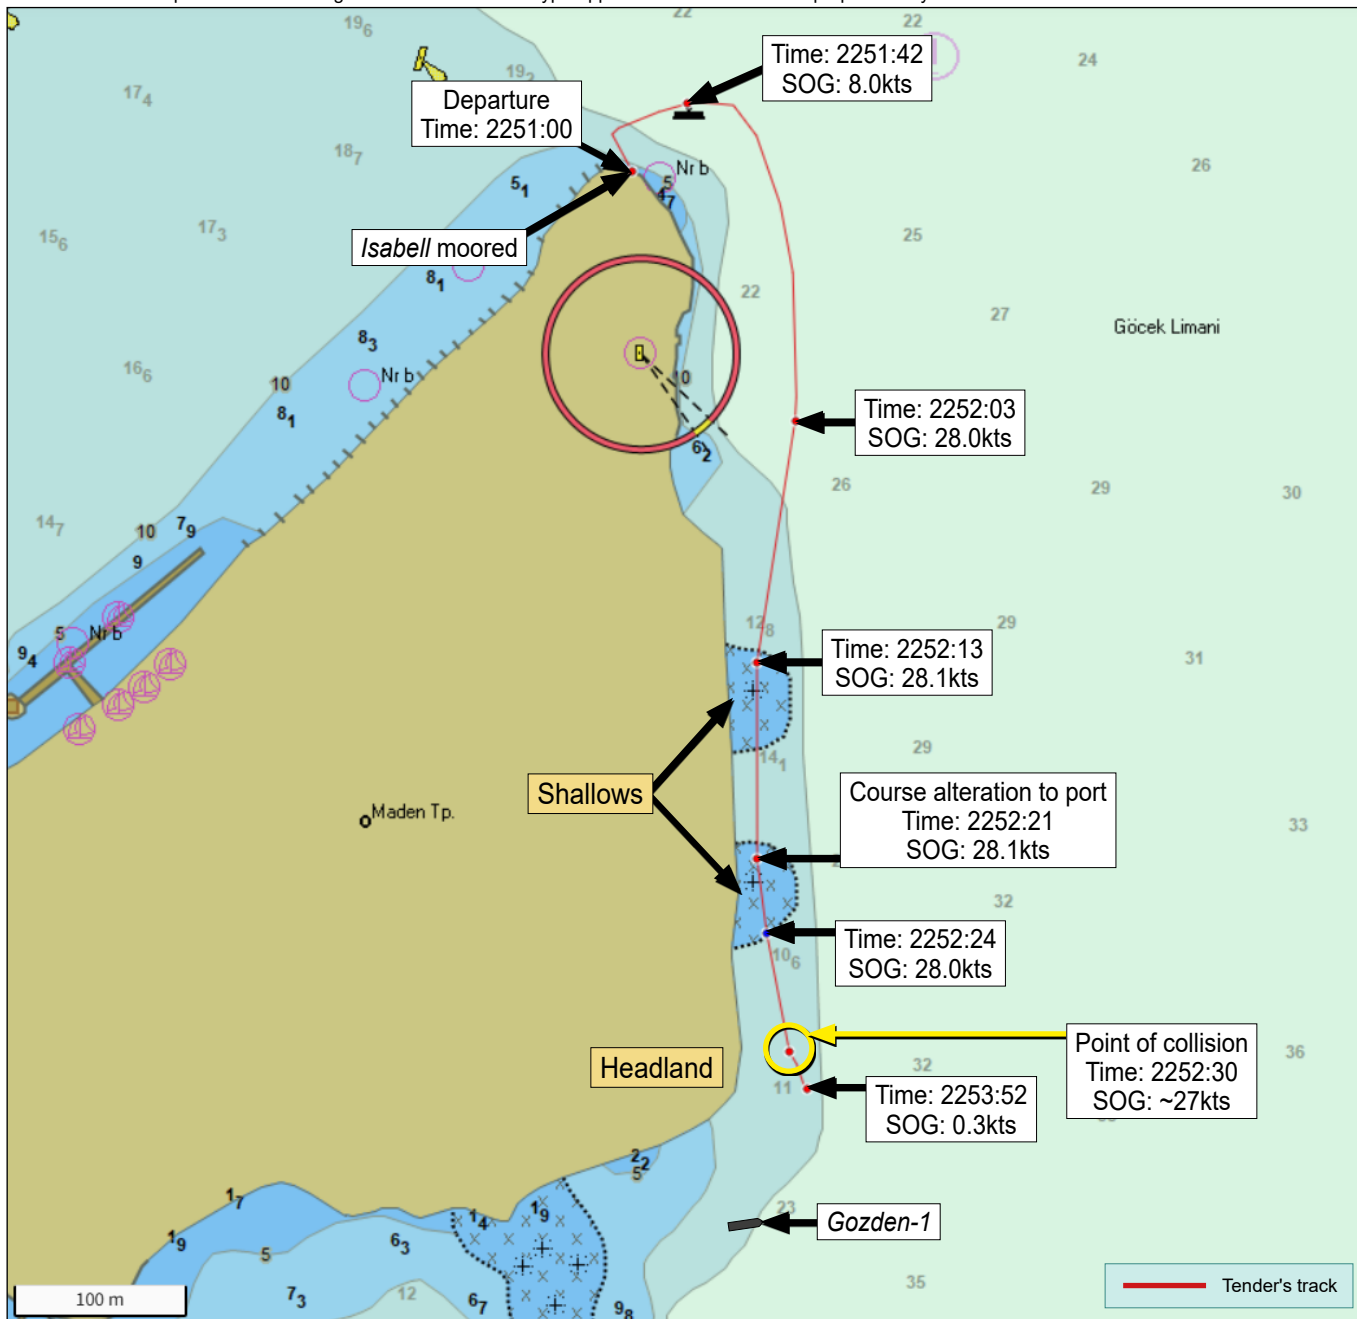
Figure 3: The tender's chart plotter track to the east of the headland

The tender collided with RIB *Vega* 1 minute 30 seconds after leaving *Isabell*. For the first minute the tender proceeded slowly, at speeds up to 8kts, and for the next 30 seconds it proceeded at about 28kts until striking *Vega*. The RIB's dark grey hull, stationary in the water and showing a single all-round light that could have been obscured by background lights from other vessels anchored to seaward, would have been difficult to see under the best of circumstances. It is therefore unsurprising that the owner's representative helming the tender, whose eyes would still have been developing their night vision, did not see *Vega* before the impact. That the helm's night vision was impaired is also evidenced by them not detecting the gulet, *Gozden-1*, whose owner had to shine a bright light directly towards the tender to draw attention to its presence.

The tender's passage from *Isabell* to the restaurant relied on the owner's representative's local knowledge of the area and no attempt had been made to use the chart plotter to avoid navigation hazards or to keep the tender on track. Navigating by eye at night using local knowledge is more challenging than during daytime, but the owner's representative did not monitor the tender's progress on the chart plotter and post-accident analysis shows that the tender crossed two shallow patches close to the shore before the collision. The lack of planning and assessment of the navigational risks associated with making the passage to the restaurant in the dark put the tender, its occupants, and other water users at risk. To attempt the passage without making best use of the navigational aids available increased the risk of an accident occurring.

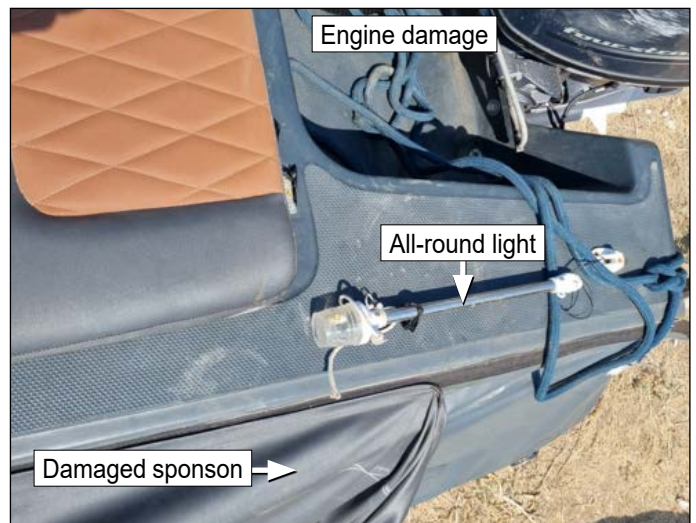
Figure 4: Damage to Vega's aft port quarter

Damage noted during the inspection included:

- impact marks on the aft port quarter section of the hull and outboard motor;
- displacement of the helm seat and aft seating area; and
- the all-round light had been torn from its bracket.
