Report on the investigation of  
the fire and subsequent loss of power on board the  
Finland registered roll-on/roll-off cargo ship

***Finnmaster***

at King George Dock, Hull, England

REPORT NO 13/2025

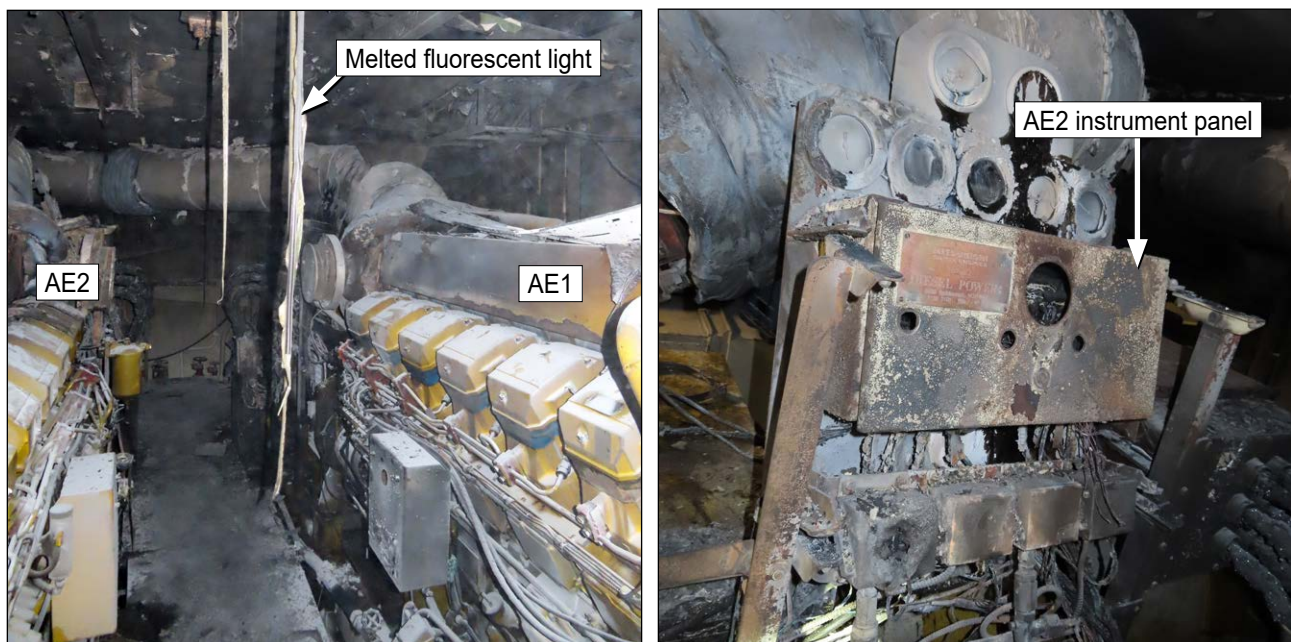
**Figure 3:** Damage to the auxiliary engine room

*Finnmaster* sustained fire damage to the equipment in the AER (**Figure 3**). The heat generated during the fire was sufficient for plastic components to melt, causing damage to electrical wiring and other susceptible equipment. Smoke damage was largely limited to the interior of the compartment.

The fire significantly affected the area of the AE instrument panels. The pressure gauge indicating the fuel supply pressure to the outboard fuel injection pump on AE2 had seized, showing 3.8 bar after the fire. The inboard fuel injection pump coupling bolts on AE2 had failed and jammed in the coupling. The fuel injection timing on the cylinders that side of the engine had changed.

The terminal box containing the wiring for the instrumentation on both AE1 and AE2 was positioned on the frame of the instrument panel for AE1. The door of the terminal box had failed, causing the internal wiring to melt due to its exposure to the heat of the fire.

The external alternator output, exciter and monitoring cables serving both AEs were heat-damaged. Both AE1 and AE2 sustained significant damage, necessitating their later removal from the ship for repair.

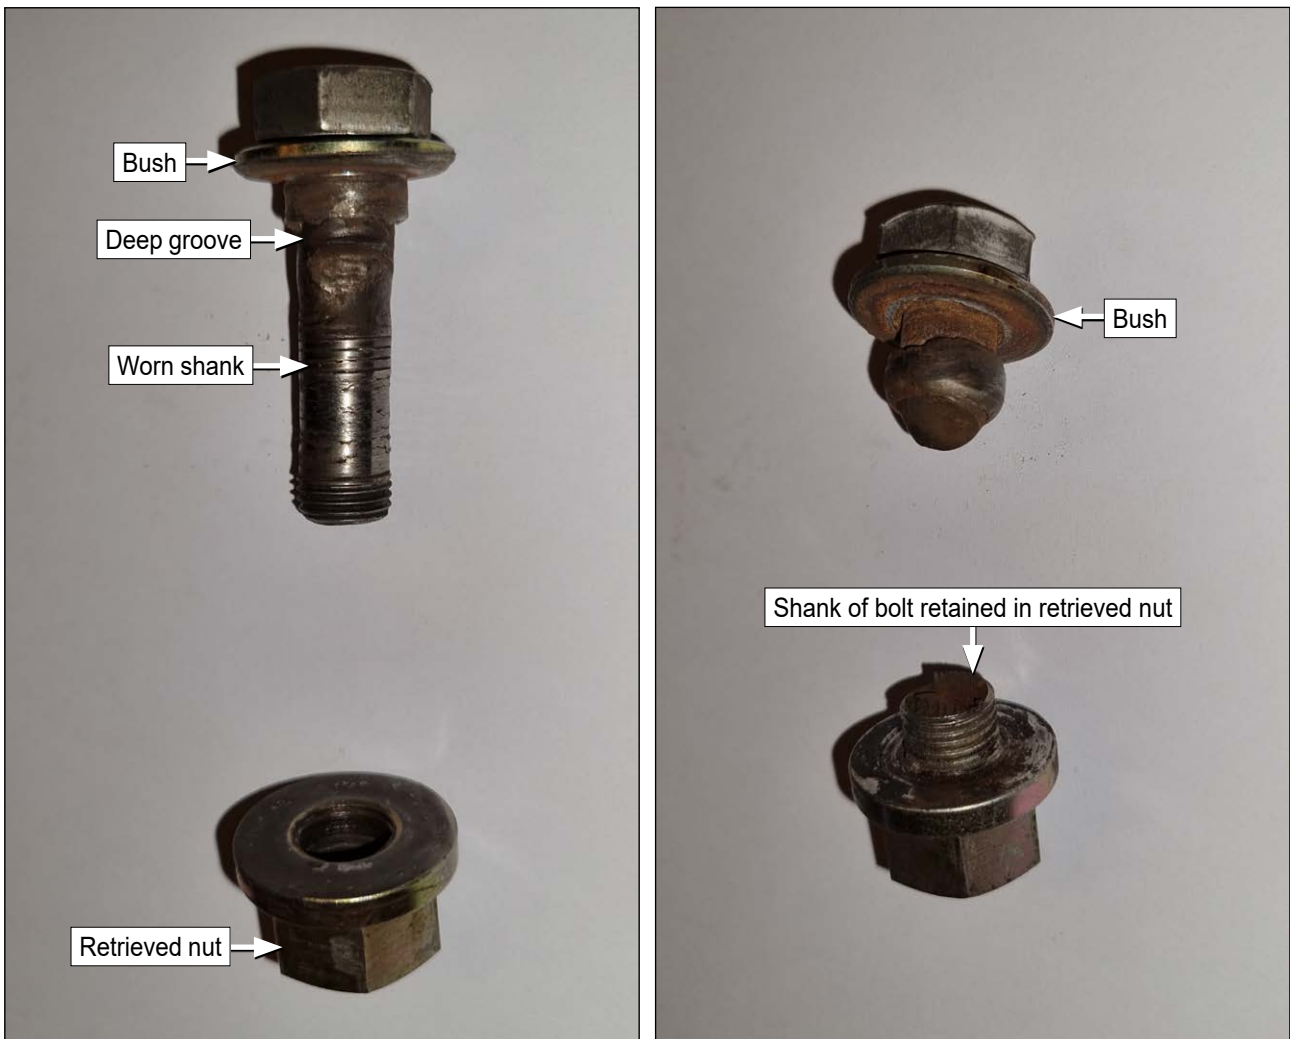
**Figure 9:** Damaged coupling drive bolts

The inboard fuel injection pump coupling on AE2 had partially failed. Both bolts connecting the drive end coupling flange to the first set of laminated plates in the coupling assembly had failed. The bolts remained lodged in their respective timing adjustment slots and laminated plate stacks. One bolt was intact, and the other had sheared part way along the length of the shank (**Figure 9**).

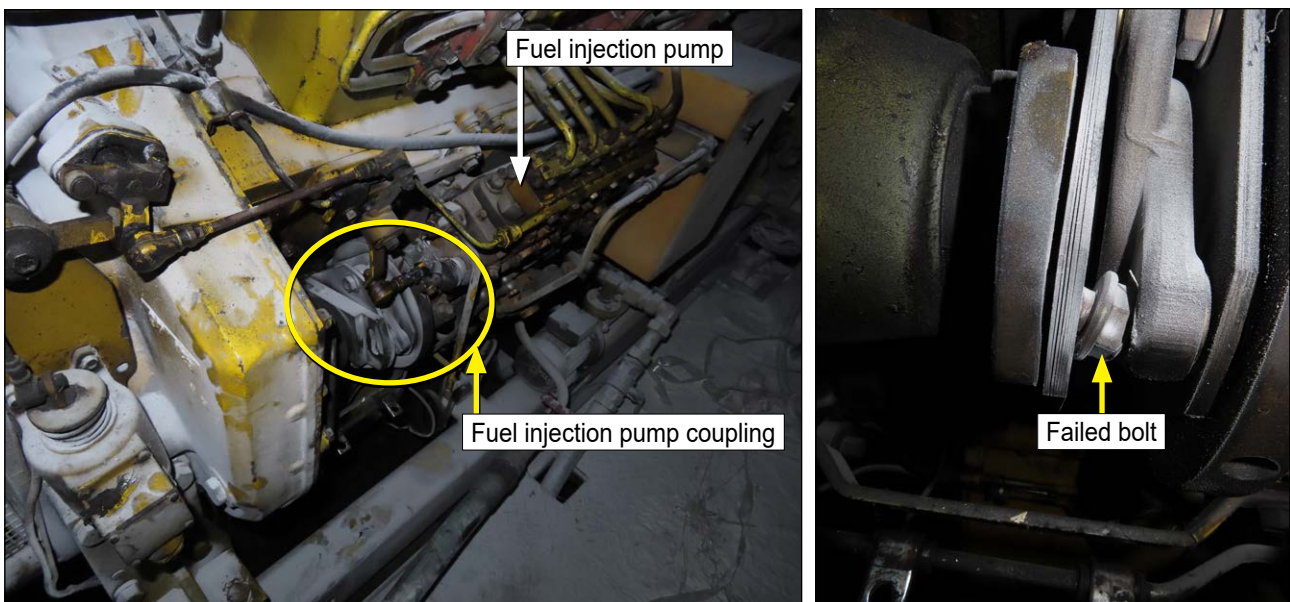
**Figure 10:** Fuel injection pump coupling with failed bolt in situ

The intact bolt was wedged in position between the cross coupling and drive end coupling flange (**Figure 10**). The bolt shank was heavily worn and the bolt head was worn on its upper surface. The nut from this bolt was retrieved from the tank top below the engine following the fire. The sheared bolt was heavily worn across the fracture of the shank and its head was worn where it had been in contact with the cross coupling. The end of the bolt and nut were retrieved from the tank top below the engine following the fire.

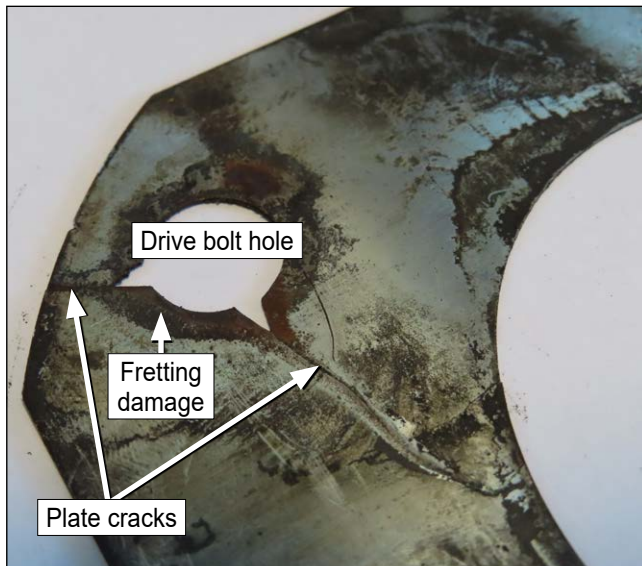
**Figure 11:** Drive end laminated plate damage

The laminated plates on the drive end of the inboard fuel injection pump coupling were damaged and cracks ran from the coupling bolt holes (**Figure 11**). This damage extended through the full thickness of the laminated plate stack with substantially more damage on one side than the other. The face of the drive end plates adjacent to the drive bolt holes showed evidence of fretting damage.

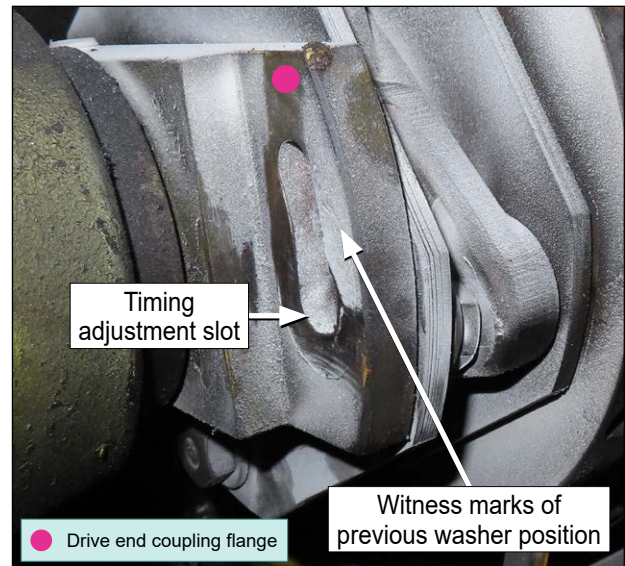
**Figure 12:** Witness marks on drive end coupling flange

Witness marks were visible on the surface of the drive end coupling flange where the flat washer had previously been seated (**Figure 12**). An examination of the accessory drive assembly in the gear drive for AE2's inboard fuel injection pump did not indicate any defects.

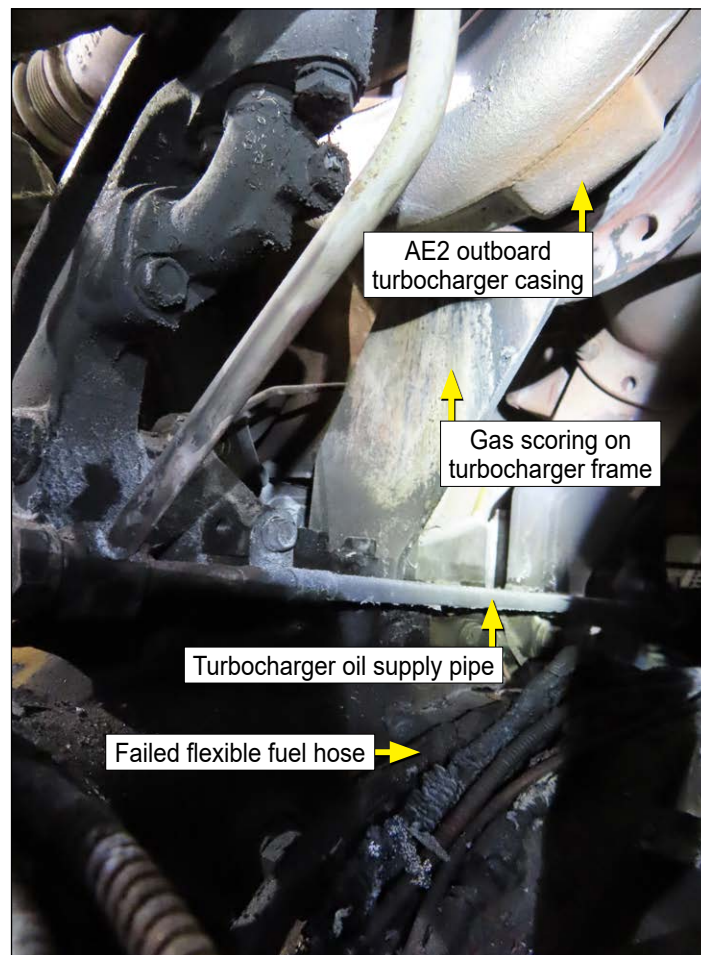
**Figure 15:** Gas scoring marks on turbocharger frame surface

The surfaces of the insulation blankets over the turbochargers of AE2 were found to be heat damaged following the fire. Beneath the insulated box structure, witness marks on the support frames for the outboard turbocharger showed evidence of gas emitting from the junction of the turbocharger outlet transition ring. The marks extended over an arc of approximately 120°, angled down towards the top of the engine block (**Figure 15**).

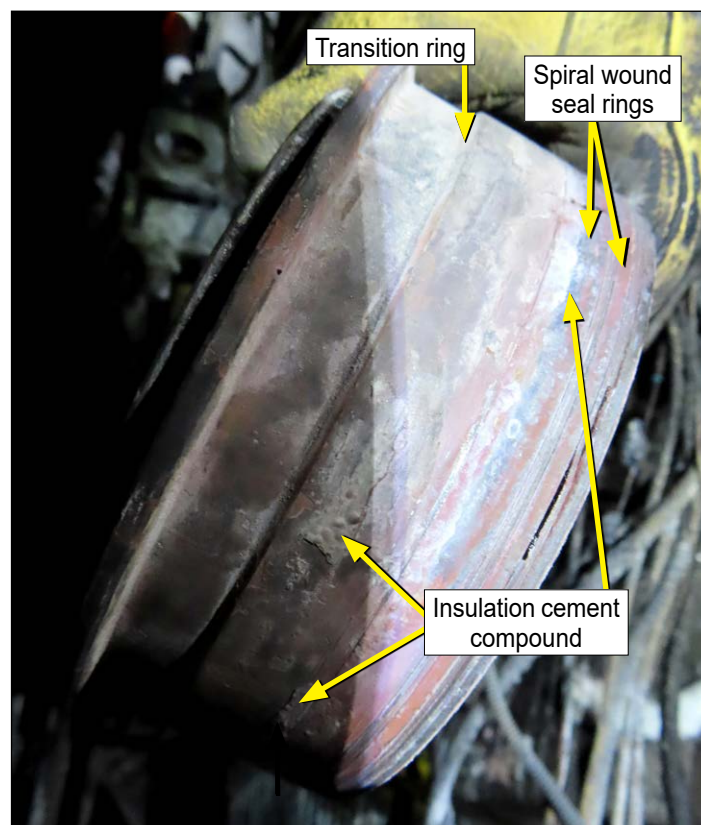
**Figure 16:** Turbocharger exhaust gas outlet transition ring

Disassembly of the outboard turbocharger allowed the removal of the exhaust transition ring. A layer of hardened insulation cement compound was partially in place at the junction of the transition ring and the exhaust pipe. When the transition ring was removed, the cement compound was found to extend the length of the ring past the seal arrangement. The spiral wound seal rings were seized in their grooves, and there was evident clearance between the transition ring and the exhaust pipe (**Figure 16**).

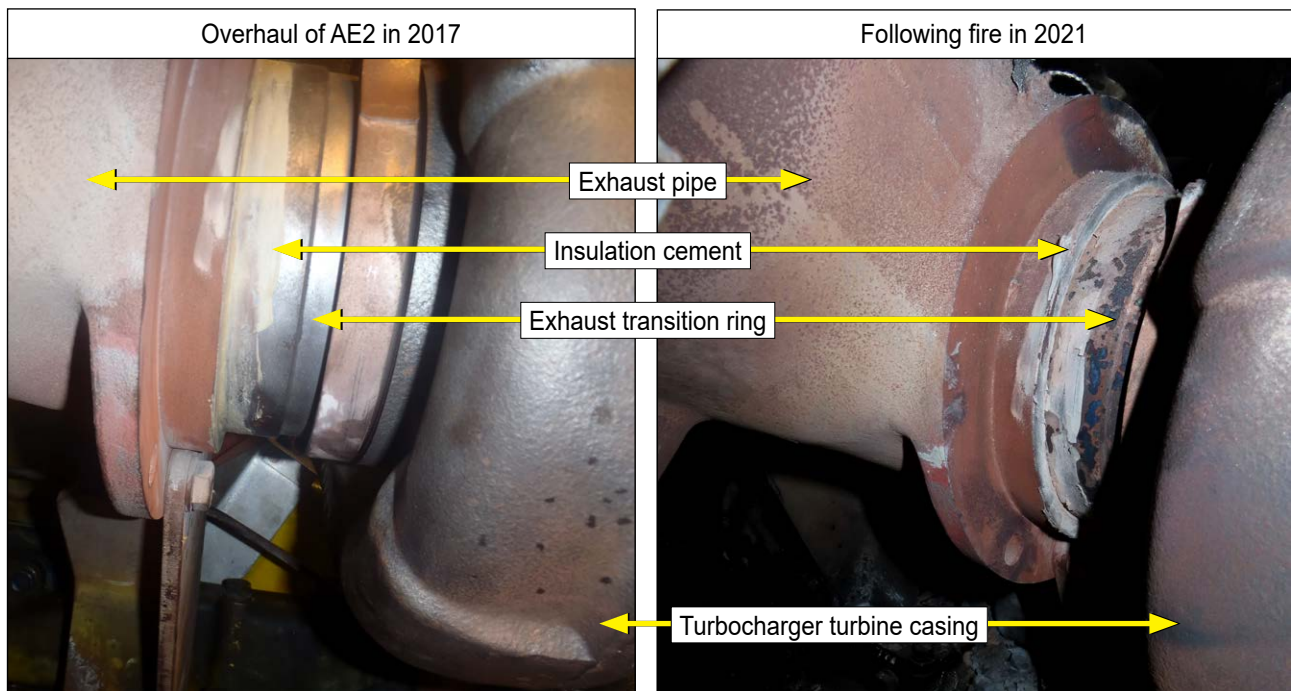
**Figure 18:** Use of insulation cement on the inboard turbocharger transition ring seal

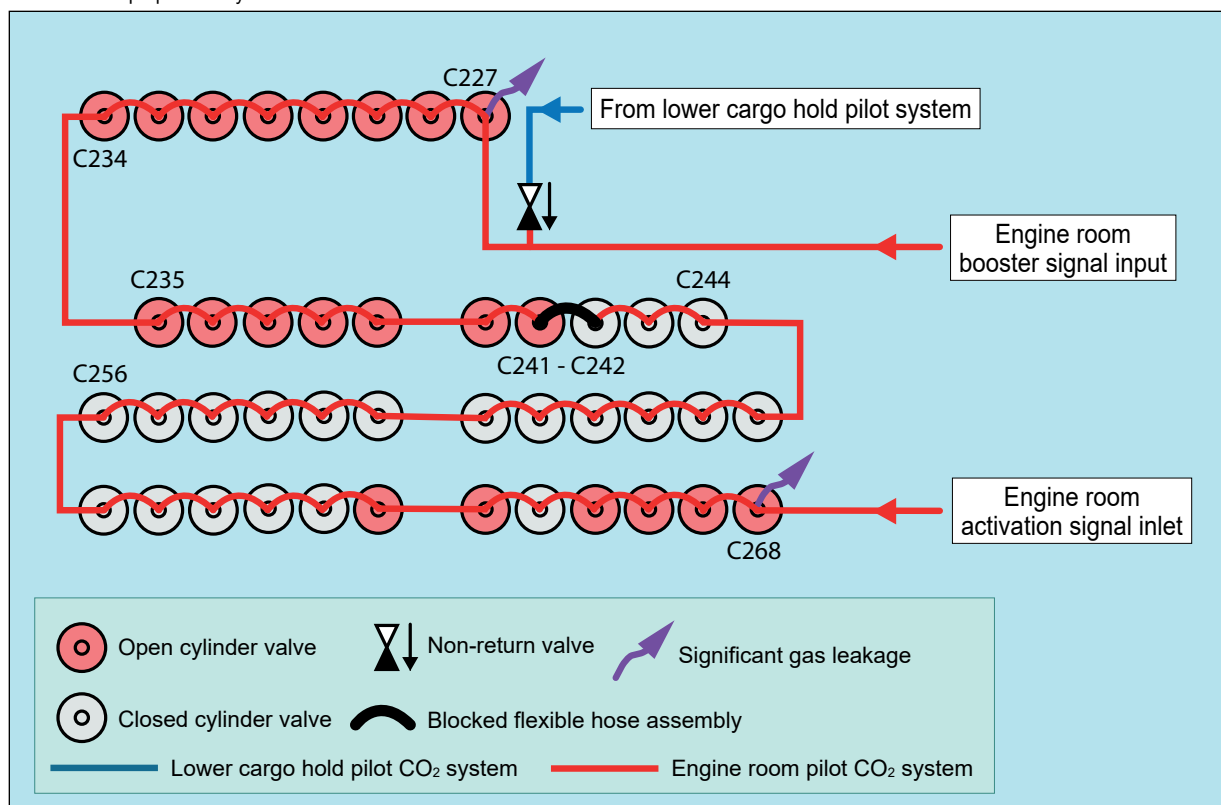
**Figure 22:** Identified faults in CO<sub>2</sub> pilot system serving *Finnmaster's* engine room

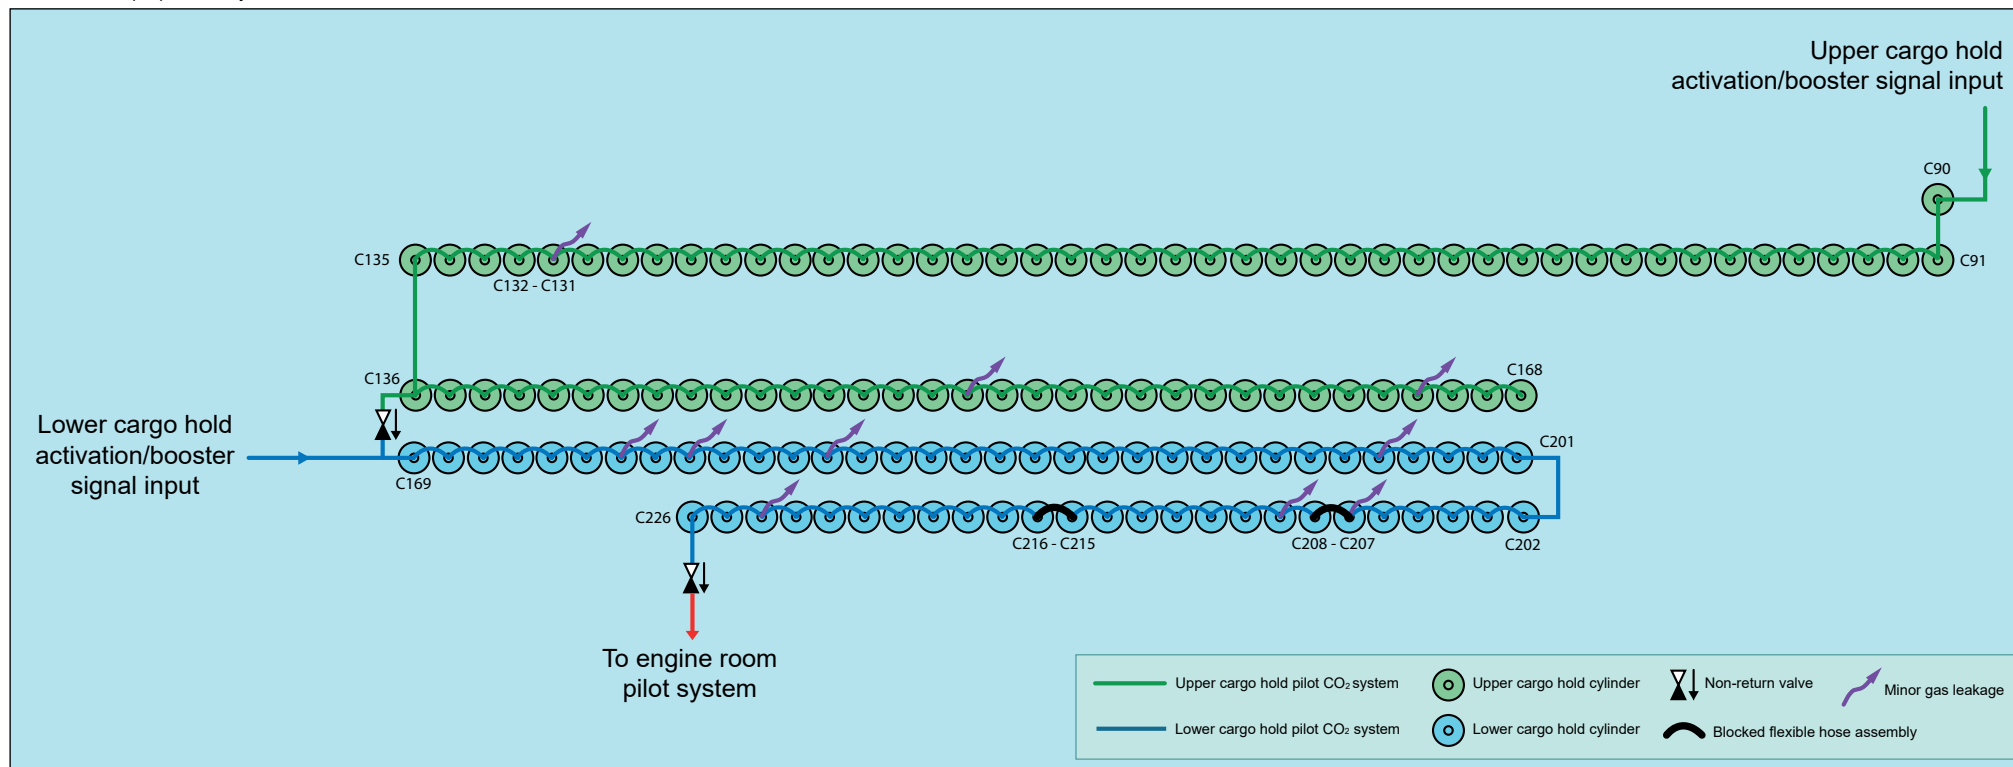
**Figure 23:** Identified faults in CO<sub>2</sub> pilot system serving *Finnmaster's* cargo holds

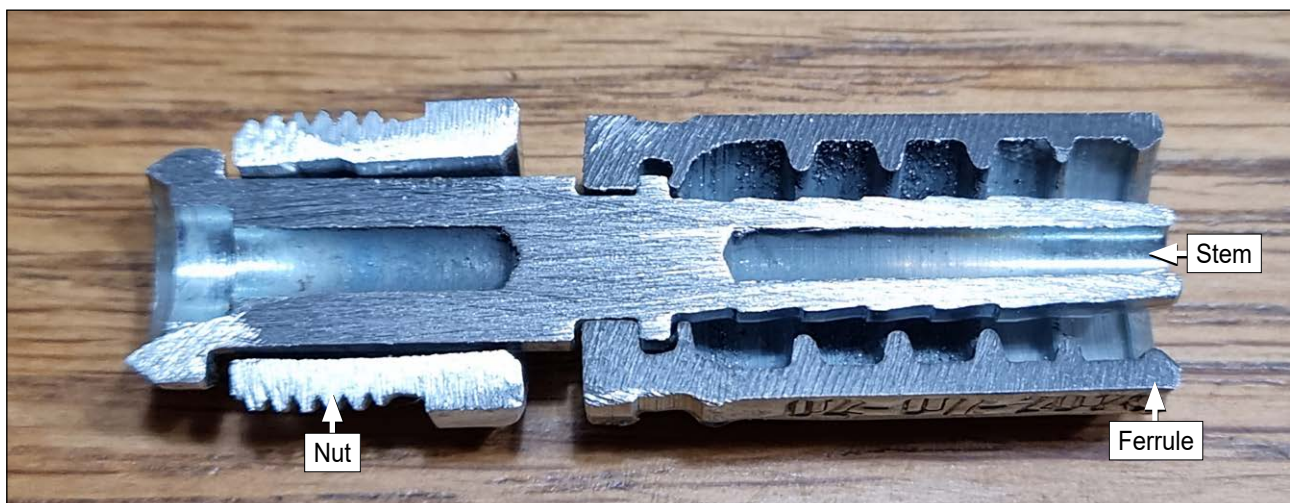
**Figure 25:** Section through flexible hose assembly coupling between cylinders C241 and C242

The flexible hose assembly from between cylinders C241 and C242 in the AER's pilot hose system was subsequently sectioned to fully investigate the blockage identified in the radiographs. The section revealed that the 4mm bore through the pilot hose coupling had not been fully drilled during manufacture, preventing the passage of gas through the flexible hose assembly (**Figure 25**).

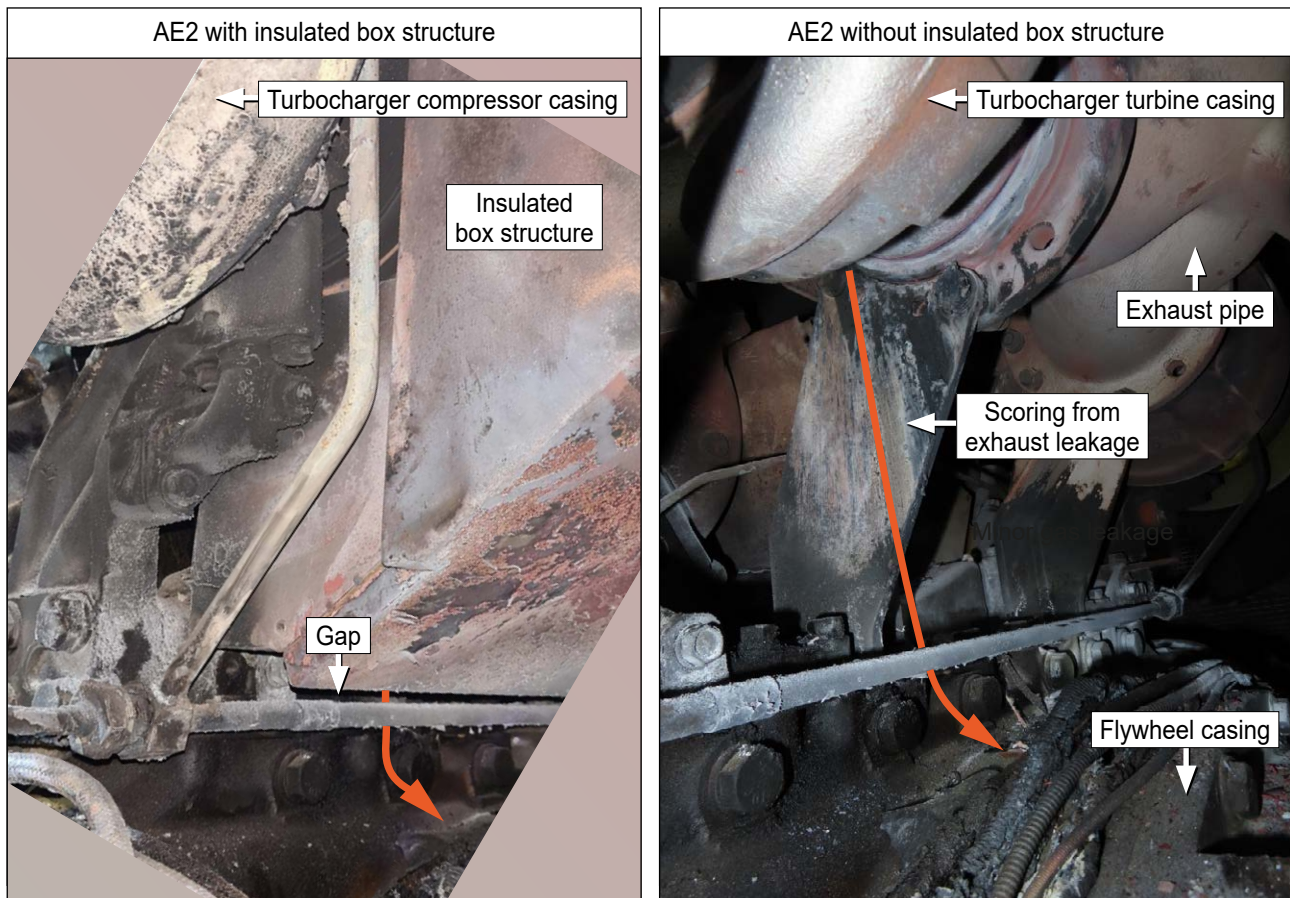
**Figure 28: AE2 exhaust gas leakage path**

The volume and temperature of the exhaust gas produced by the engine rose significantly when the inboard fuel injection pump coupling partially failed. The incorrect maintenance procedure on AE2's exhaust allowed high temperature exhaust gas to leak into the insulated box structure, below which the flexible hose containing fuel under pressure was positioned (**Figure 28**).

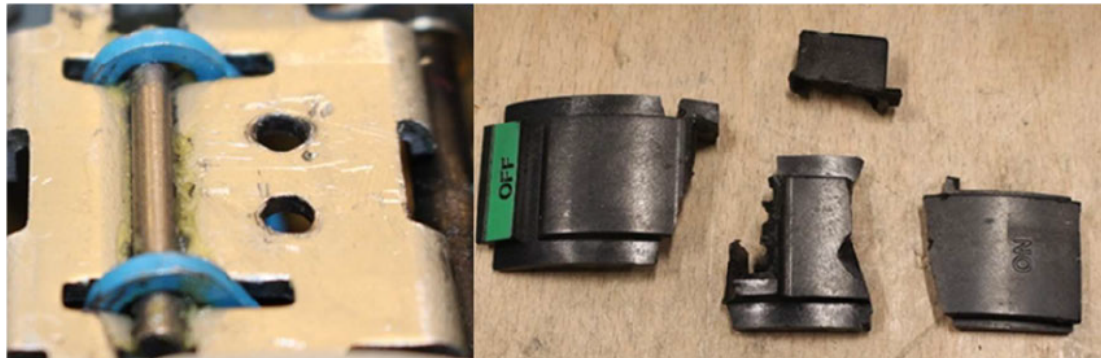
On closer inspection of the switch, we found that the fixing holes of the handle are deformed, and the handle is clearly broken.

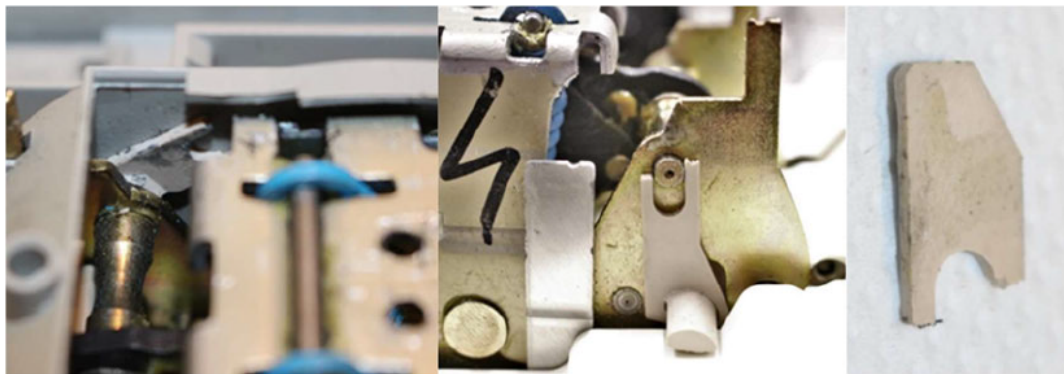
We also found parts of the SD lever broken.

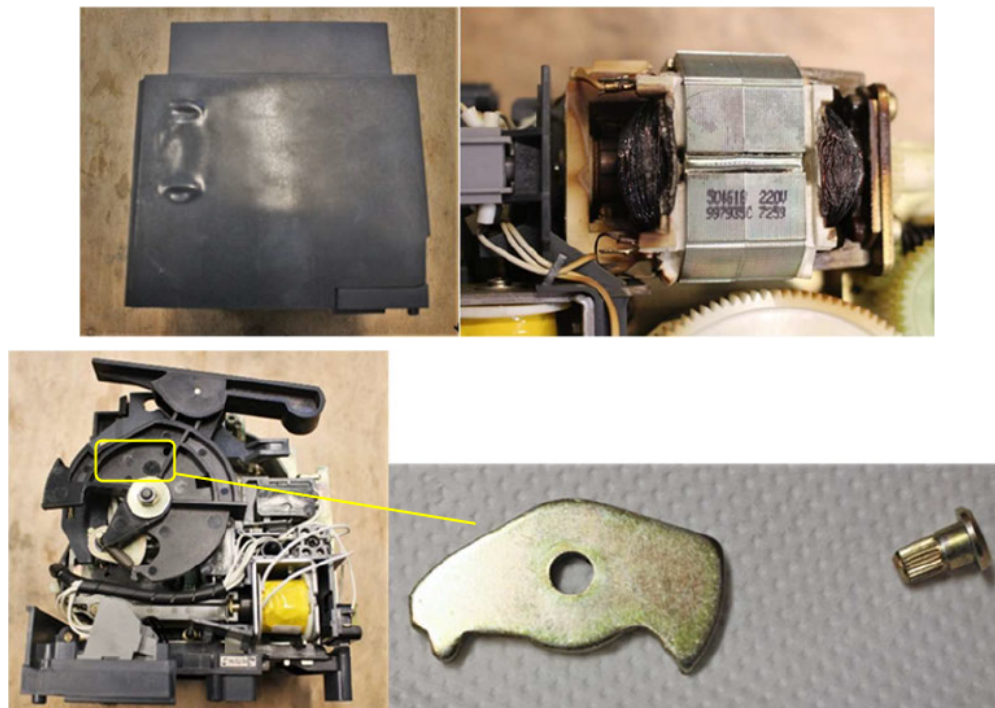
The motor mechanism casing showed signs of heat damage. With the cover removed we can see the motor is burnt out, and the charging handle ratchet arm and axle had become detached.

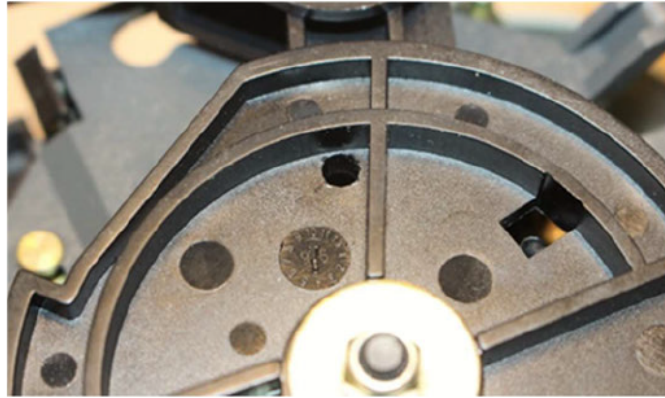
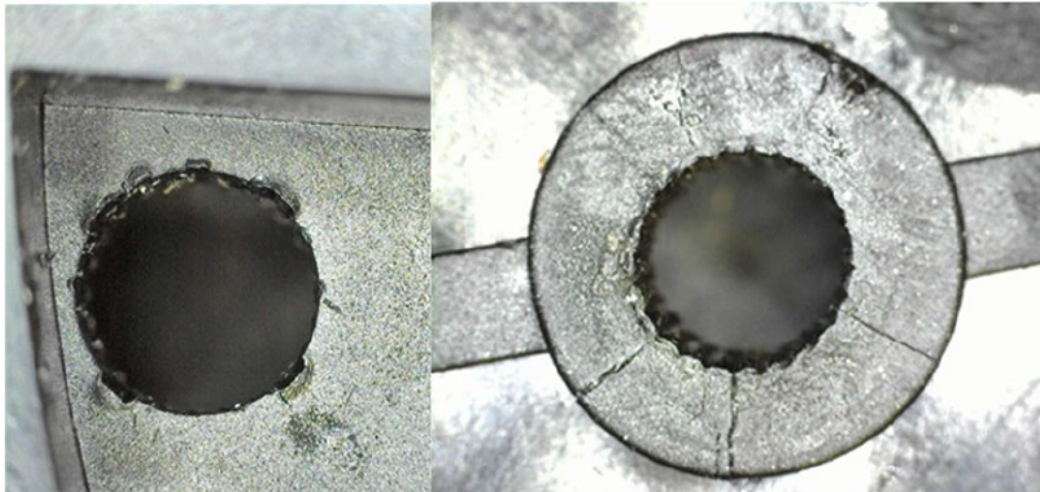
A closer view of the ratchet axle position on the motor mechanism handle, shows cracking and deformation of the plastic.

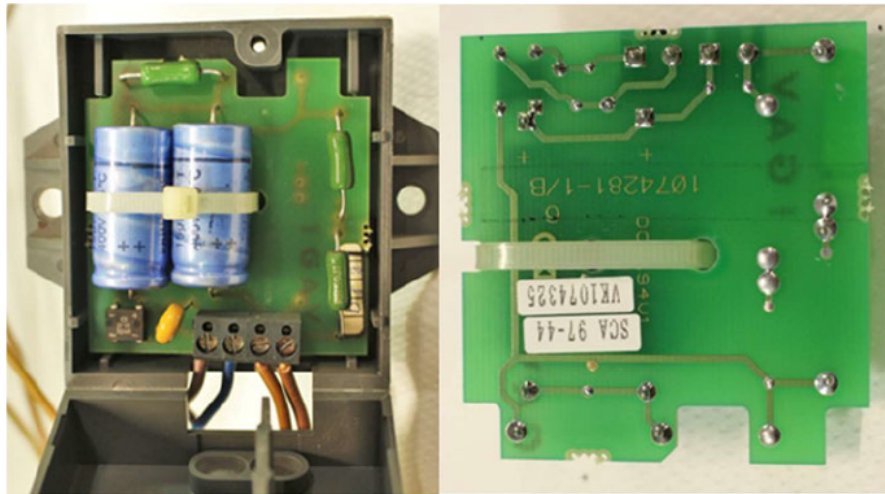
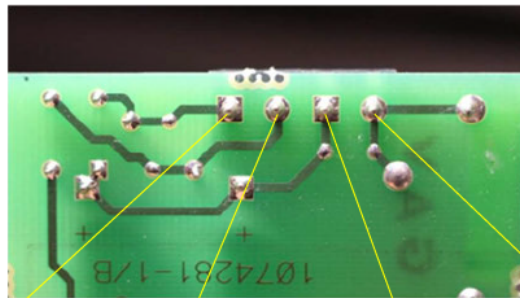
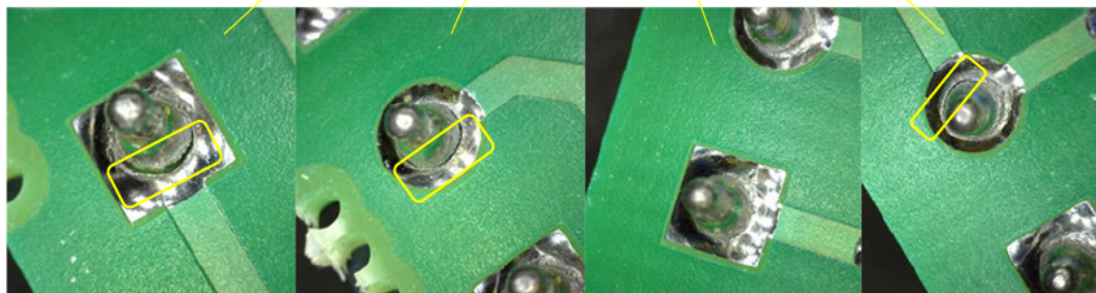
When viewing the UVR time delay unit we found internal soldering had cracked on three of the four terminal pins.

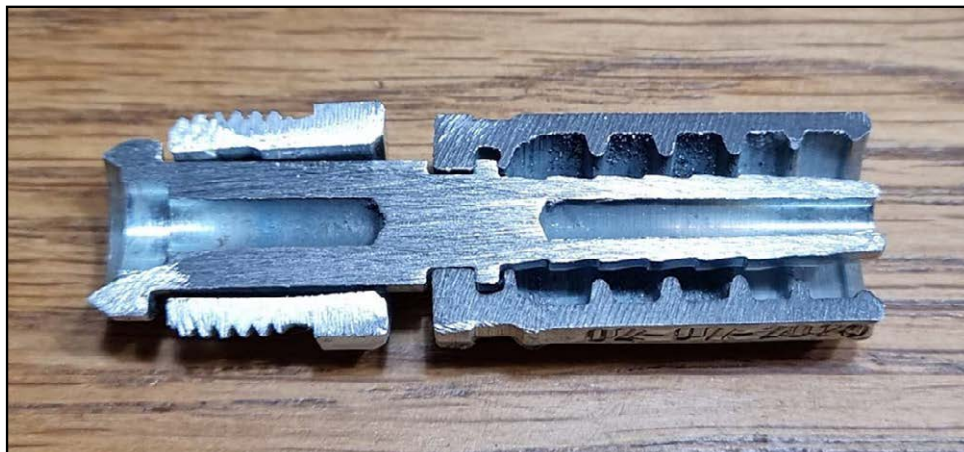
Section through blocked CO<sub>2</sub> pilot hose coupling showing incomplete bore through the stem

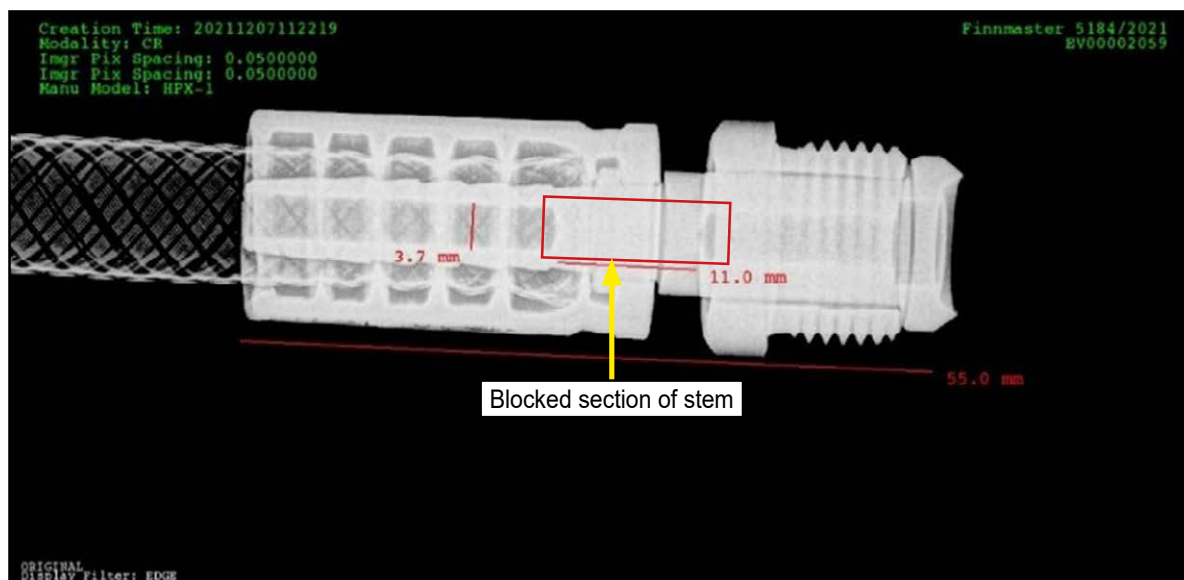
**Figure 3:** CO<sub>2</sub> pilot hose coupling, showing incomplete bore through the stem

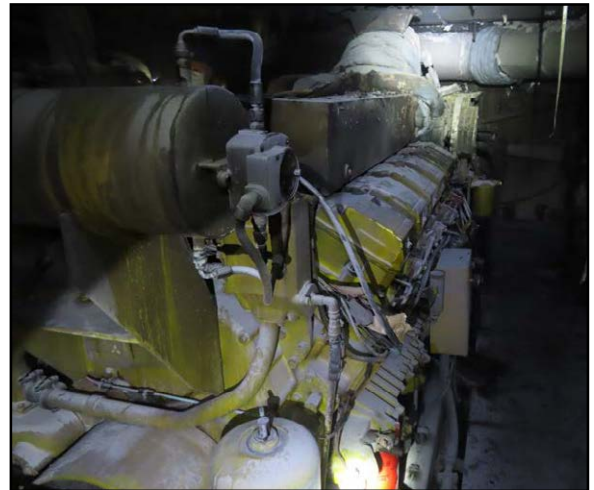
**Figure 1:** Damage sustained to auxiliary engine room
