# Rail Accident Report

## **Collision between passenger trains at Salisbury Tunnel Junction, Wiltshire 31 October 2021**

Report 12/2023  
October 2023

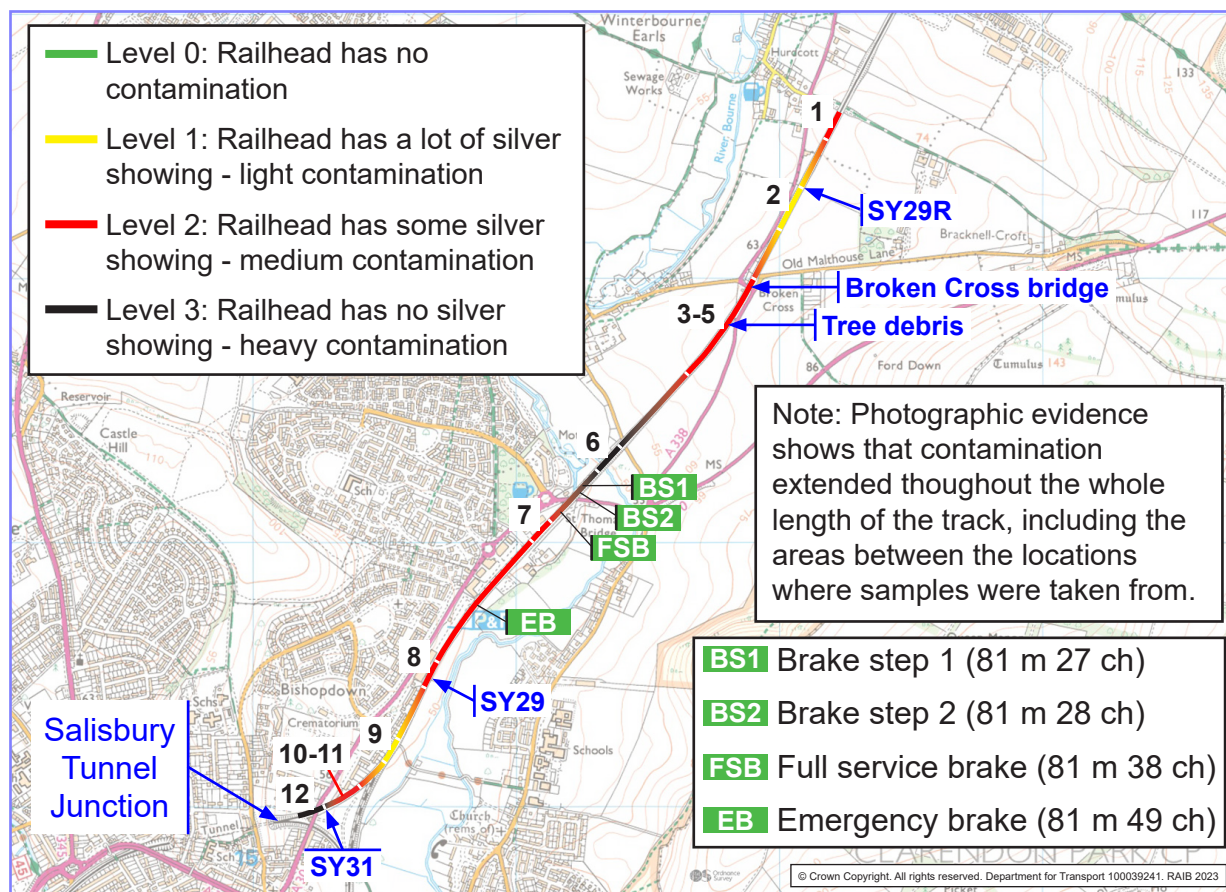
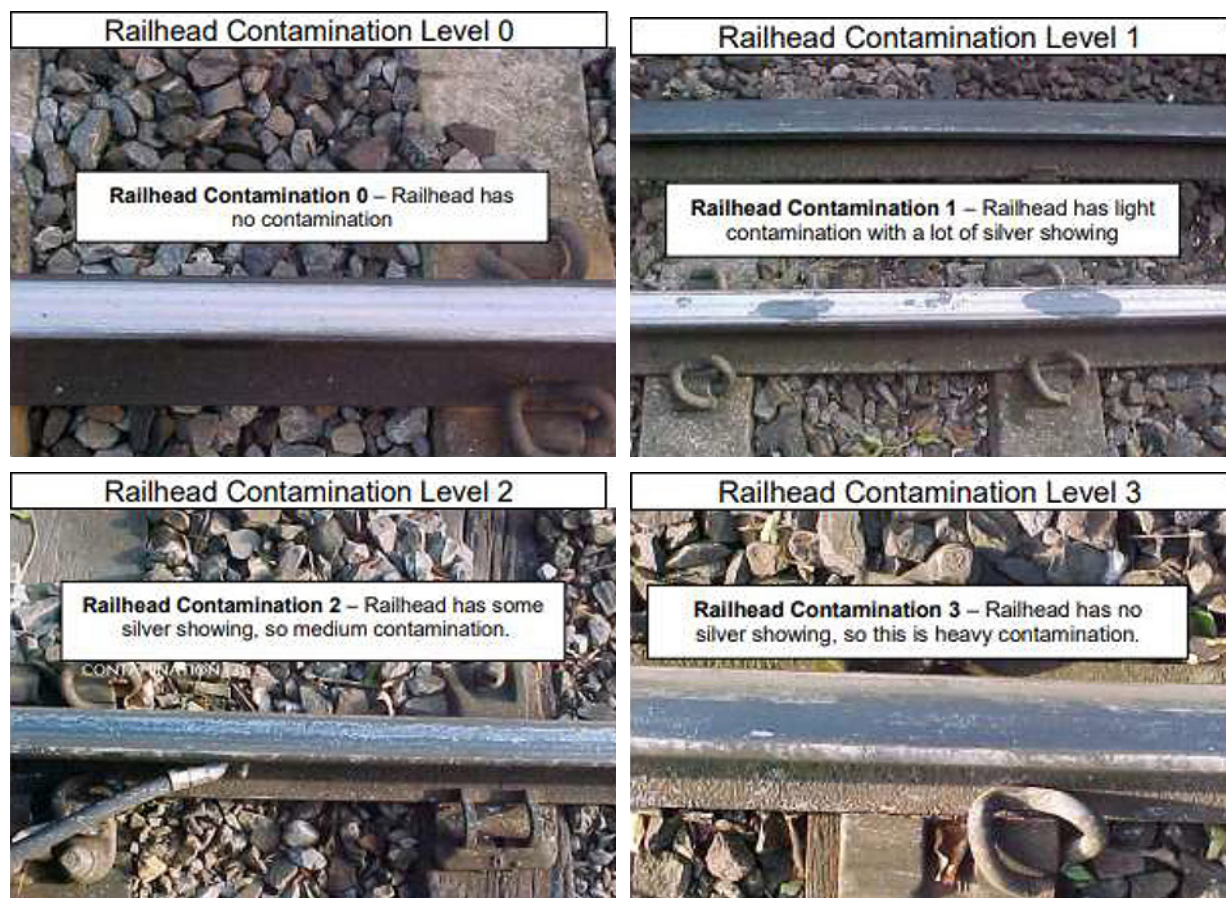
133 In addition to the leaf fall density provided by MetDesk (figure 18), Met Office data going back to 2016 showed that, around the time the accident occurred, the trees in the area were approximately two weeks behind the normal leaf fall schedule, having around 65 to 70% of their leaves remaining. The wind and rain on the day of the accident (paragraph 43) almost certainly resulted in increased leaf fall and this is likely to have contributed to the high levels of contamination observed on the section of line approaching Salisbury and the approach to the junction.

Figure 24: Post-accident sample locations and (below) Network Rail classification of contamination levels (NR/L3/OPS/045/4.07).

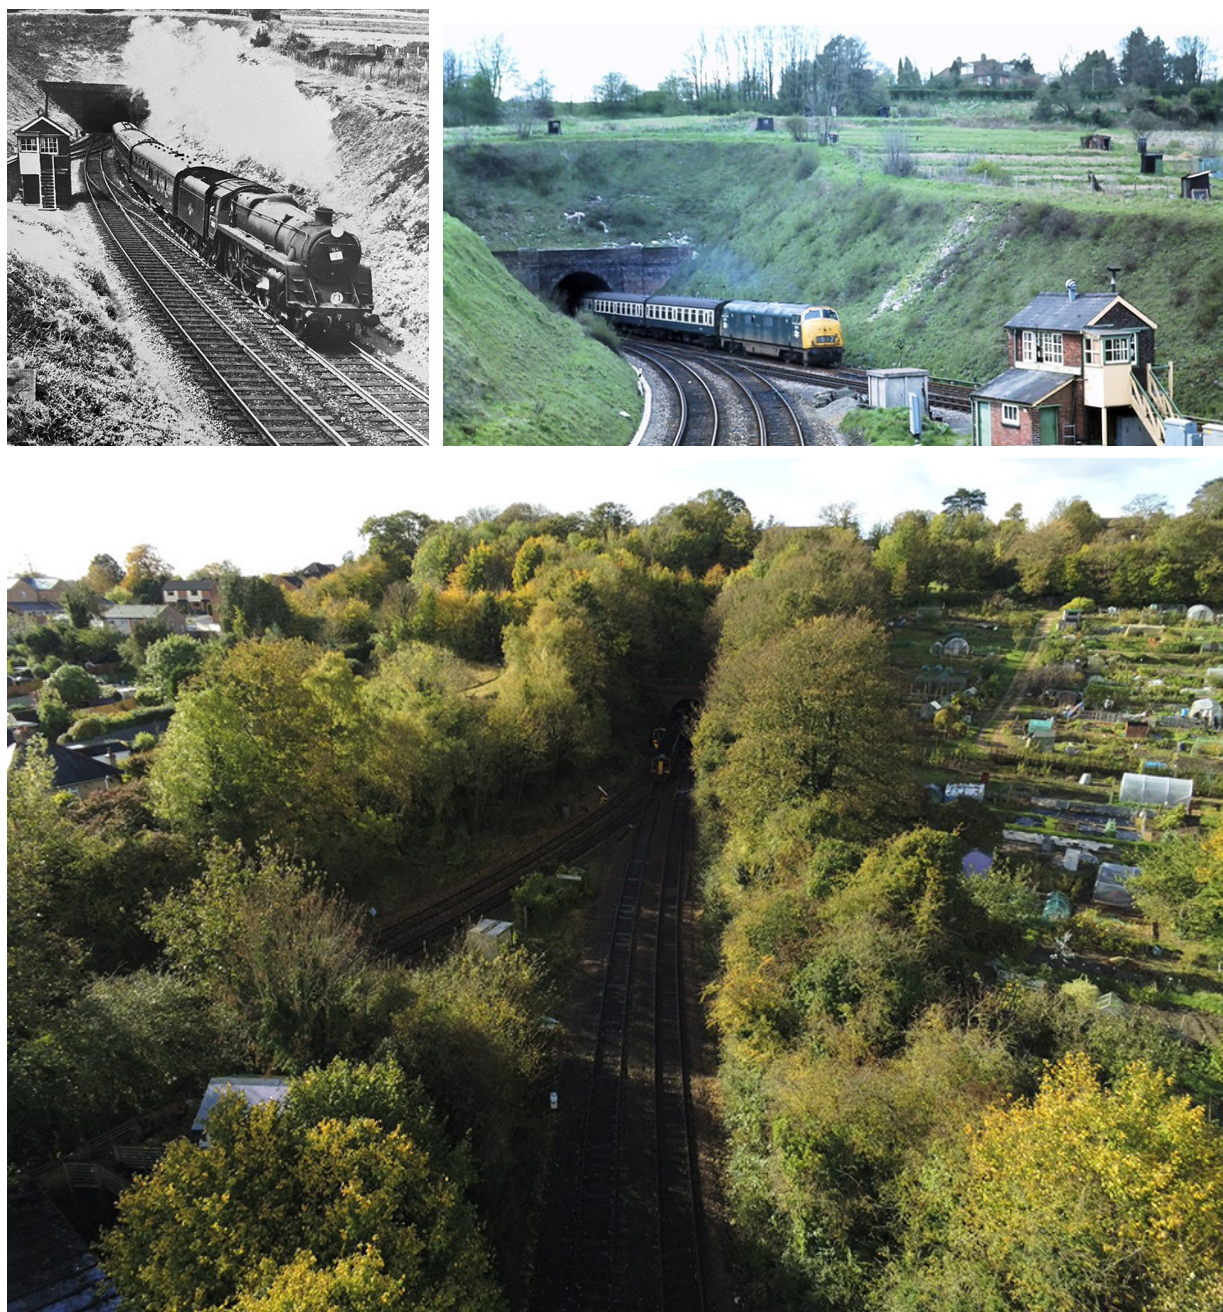
- 147 No action to manage the vegetation had been taken between 2018 and 2021 and video footage shows that vegetation continued to grow on the main lines approaching Salisbury Tunnel Junction between 2019 and 2021. A comparison between the 2021 scores and those from earlier inspections therefore brings into question the robustness of the process. It is also unclear whether classification of sites with an assessment score of between 21 and 26 as *'high risk during peak leaf fall period and wet conditions'* in NR/L2/OTK/5201/F3076 may have affected the contractors' scoring. As explained in paragraph 139, operational standard NR/L2/OPS/095 did not require any action to be taken for such sites, but the contractors were unlikely to have been aware of this. Figure 32 shows the change in the management of vegetation at Salisbury Tunnel Junction over the previous decades.

Figure 32: The Up and Down Dean and Main lines looking towards Fisherton Tunnel in 1963 (top left, courtesy of Crecy publishing), in the 1970s (top right, courtesy of Crecy publishing), and on 1 November 2021 (main image).
