Accident

Aircraft Type and Registration:	Sportstar SLM, G-CMGB	
No & Type of Engines:	1 Rotax 912iS piston engine	
Year of Manufacture:	2022 (Serial no: 2022-2205)	
Date & Time (UTC):	1 September 2024 at 0804 hrs	
Location:	Chesterfield, Derbyshire	
Type of Flight:	Private	
Persons on Board:	Crew - 1	Passengers - None
Injuries:	Crew - 1 (Fatal)	Passengers - N/A
Nature of Damage:	Destroyed	
Commander's Licence:	UK National Private Pilot's Licence	
Commander's Age:	71 years	
Commander's Flying Experience:	390 hours (of which 181 were on type) Last 90 days - 46 hours Last 28 days - 26 hours	
Information Source:	AAIB Field Investigation

Synopsis

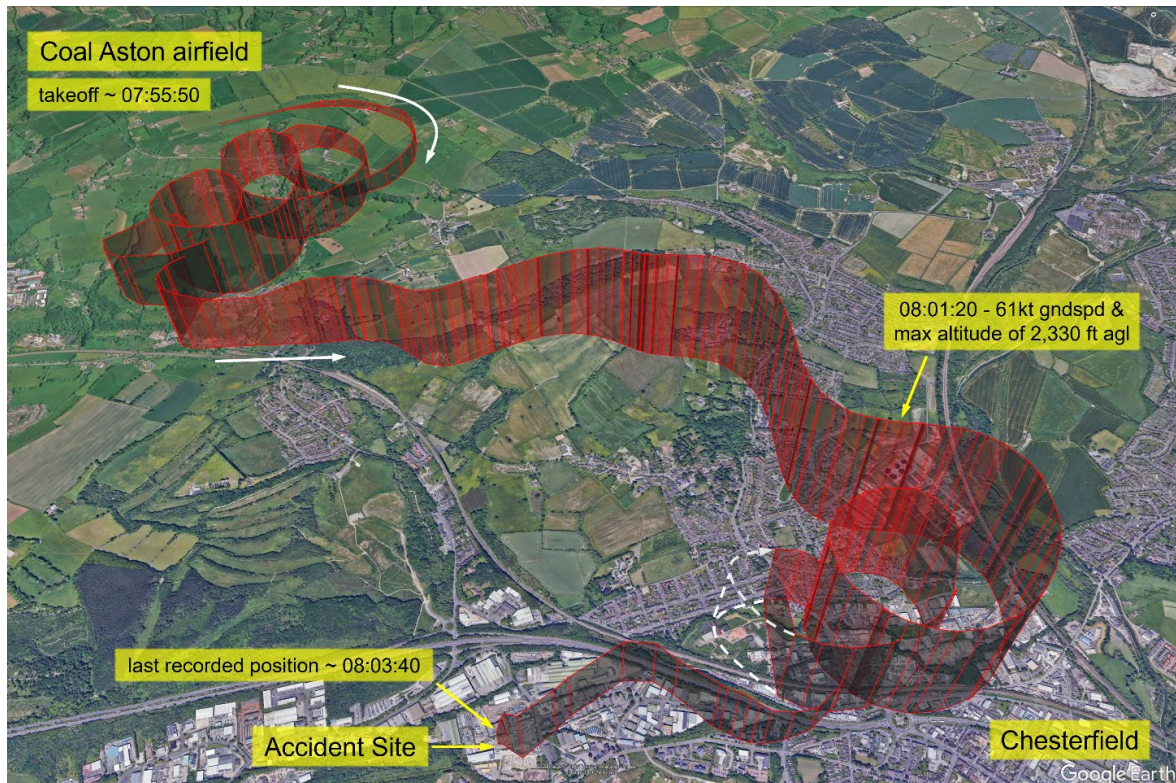
Figure 1
GPS track of the flight

After takeoff, the aircraft entered a climbing turn to the right, followed by four right-hand orbits to the south of the airfield (Figure 1). Altitude varied during the turns but trended upward toward 2,000 ft amsl. An eyewitness in Unstone, 1.8 km south-west of Coal Aston, reported hearing and seeing a light aircraft circling several times before losing sight of it as it entered cloud.

G-CMGB then climbed on a meandering southerly track towards Chesterfield, reaching 2,500 ft amsl (2,330 ft agl). At Chesterfield, it flew two more right-hand orbits, descending to a minimum of 700 ft agl before climbing back up to 1,200 ft agl (Figure 1).

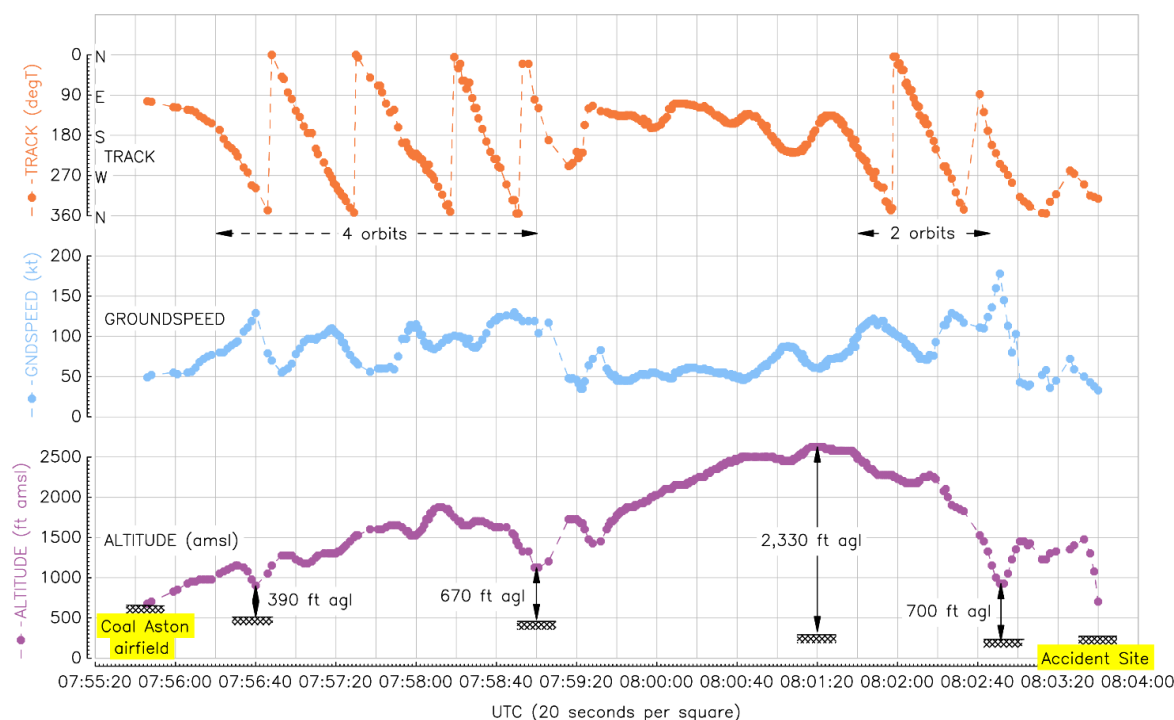
Figure 2 plots altitude and data derived from the GPS positions. Both figures show the aircraft initially climbing and descending in a series of right orbits to the south of the airfield. During the first orbit the aircraft descended to about 390 ft agl and then climbed away at over 3,000 ft/min. On the fourth orbit the aircraft descended to about 670 ft agl at a similar rate. Groundspeed varied between 50 and 130 kt. The aircraft then headed towards Chesterfield, on lower ground to the south, in a series of turns and climbing to a maximum altitude for the flight of 2,330 ft agl.

GPS derived data for accident flight with some ground elevations illustrated

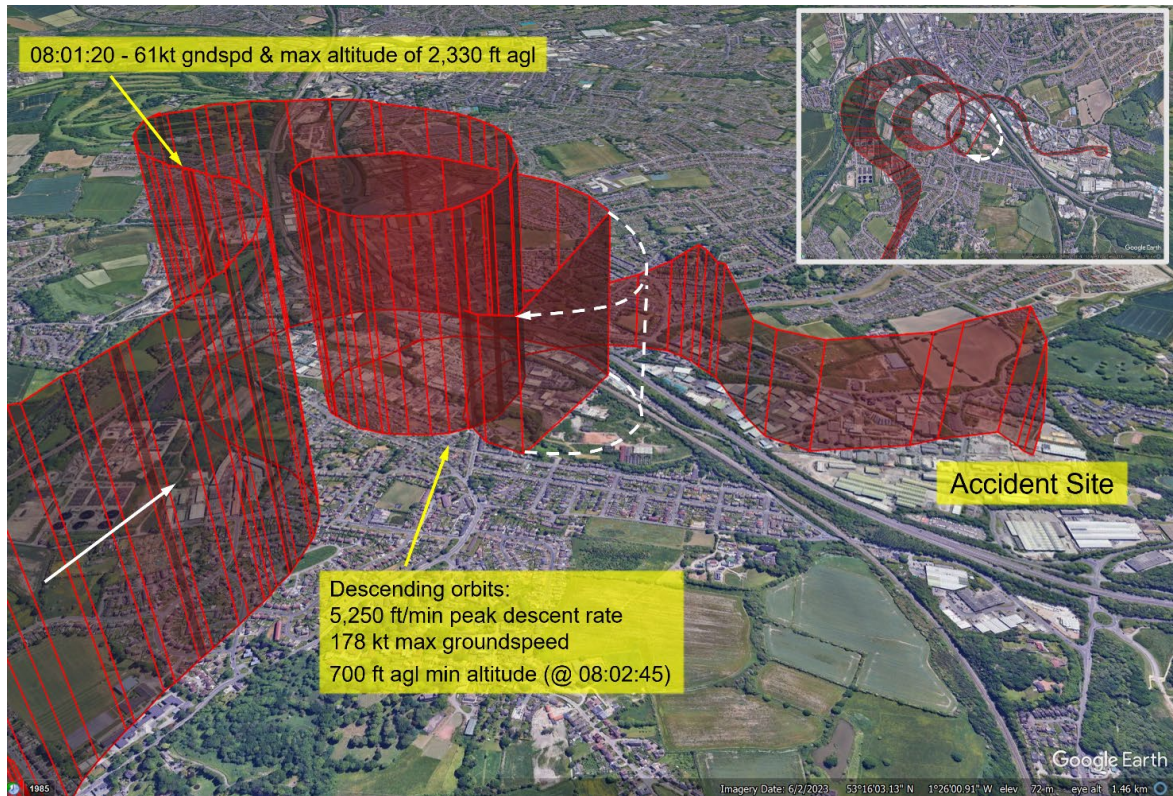
**Figure 3**

Above Chesterfield the aircraft made two descending right orbits over a period of about 90 seconds, during which the aircraft accelerated to a groundspeed of 178 kt (Figure 3). The descent rate peaked at 5,250 ft/min. The minimum altitude in the descent was 700 ft agl before the aircraft climbed a little over 500 ft at a similar rate.

GPS track of aircraft over Chesterfield with descending orbits highlighted

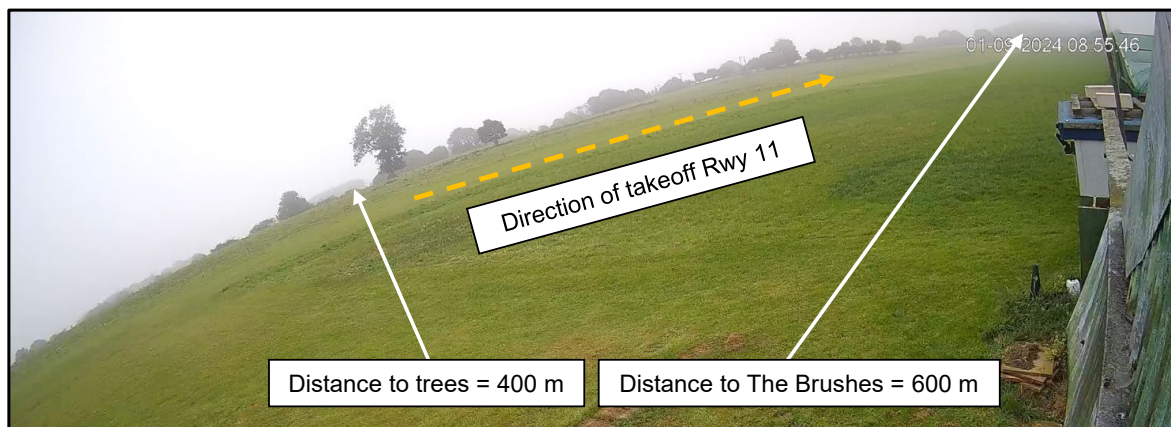
Figure 9

CCTV showed the following conditions at Coal Aston at the time of takeoff (Figure 9):

Coal Aston Airfield conditions at time of takeoff

CCTV footage showed that at the time of takeoff from Coal Aston, visibility was between 400 and 600 m. The tops of the trees beyond the threshold of Runway 29 (The Brushes) appeared to be obscured by cloud. While it was not possible to determine the extent of cloud cover in the surrounding area from the footage, it is likely that, in the direction of takeoff, the cloud base was only 100 ft above the runway.

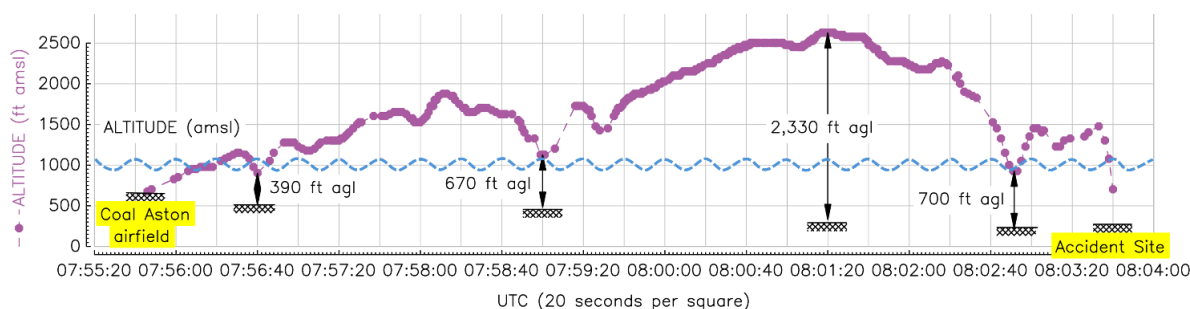
Figure 10

Witness observations of the aircraft appearing below cloud near Coal Aston and Chesterfield are consistent with recorded data and a cloud base of approximately 1,000 ft amsl as detailed by the Met Office aftercast (Figure 10).

Aircraft altitude (extract from Figure 2) against a 1,000 ft amsl cloud base
