Grounding and subsequent loss of the dive support vessel *Jean Elaine* in Saint Peter's Pool, Orkney Islands, Scotland on 22 July 2024

SUMMARY

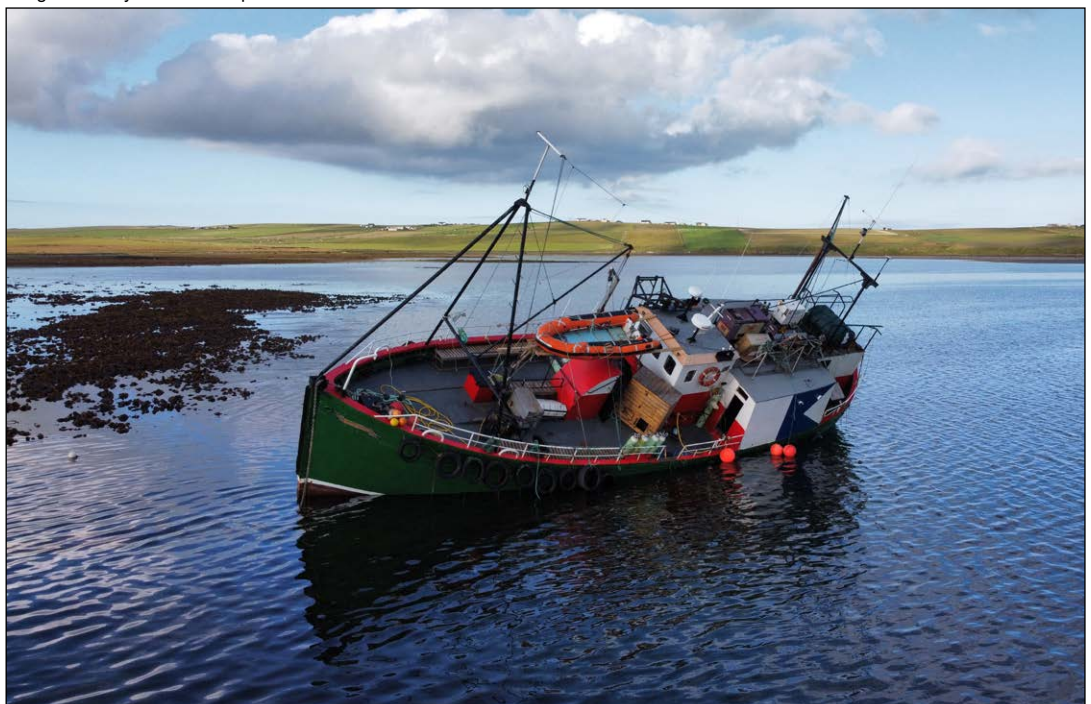
On the afternoon of 22 July 2024, the 21.88m dive support vessel *Jean Elaine* (**Figure 1**) grounded on a falling tide while attempting to manoeuvre out of Saint Peter's Pool in Deer Sound, Orkney Islands, Scotland. The vessel developed a severe port list and suffered water ingress. Despite efforts to save the vessel, it was ultimately abandoned.

Figure 1: *Jean Elaine* grounded in Saint Peter's Pool

As the tide continued to fall, *Jean Elaine's* list worsened (see **Figure 1**). The skipper shifted four large air bottles from the port side of the wheelhouse to the starboard gunwale to try to counter the list, but this had no effect.

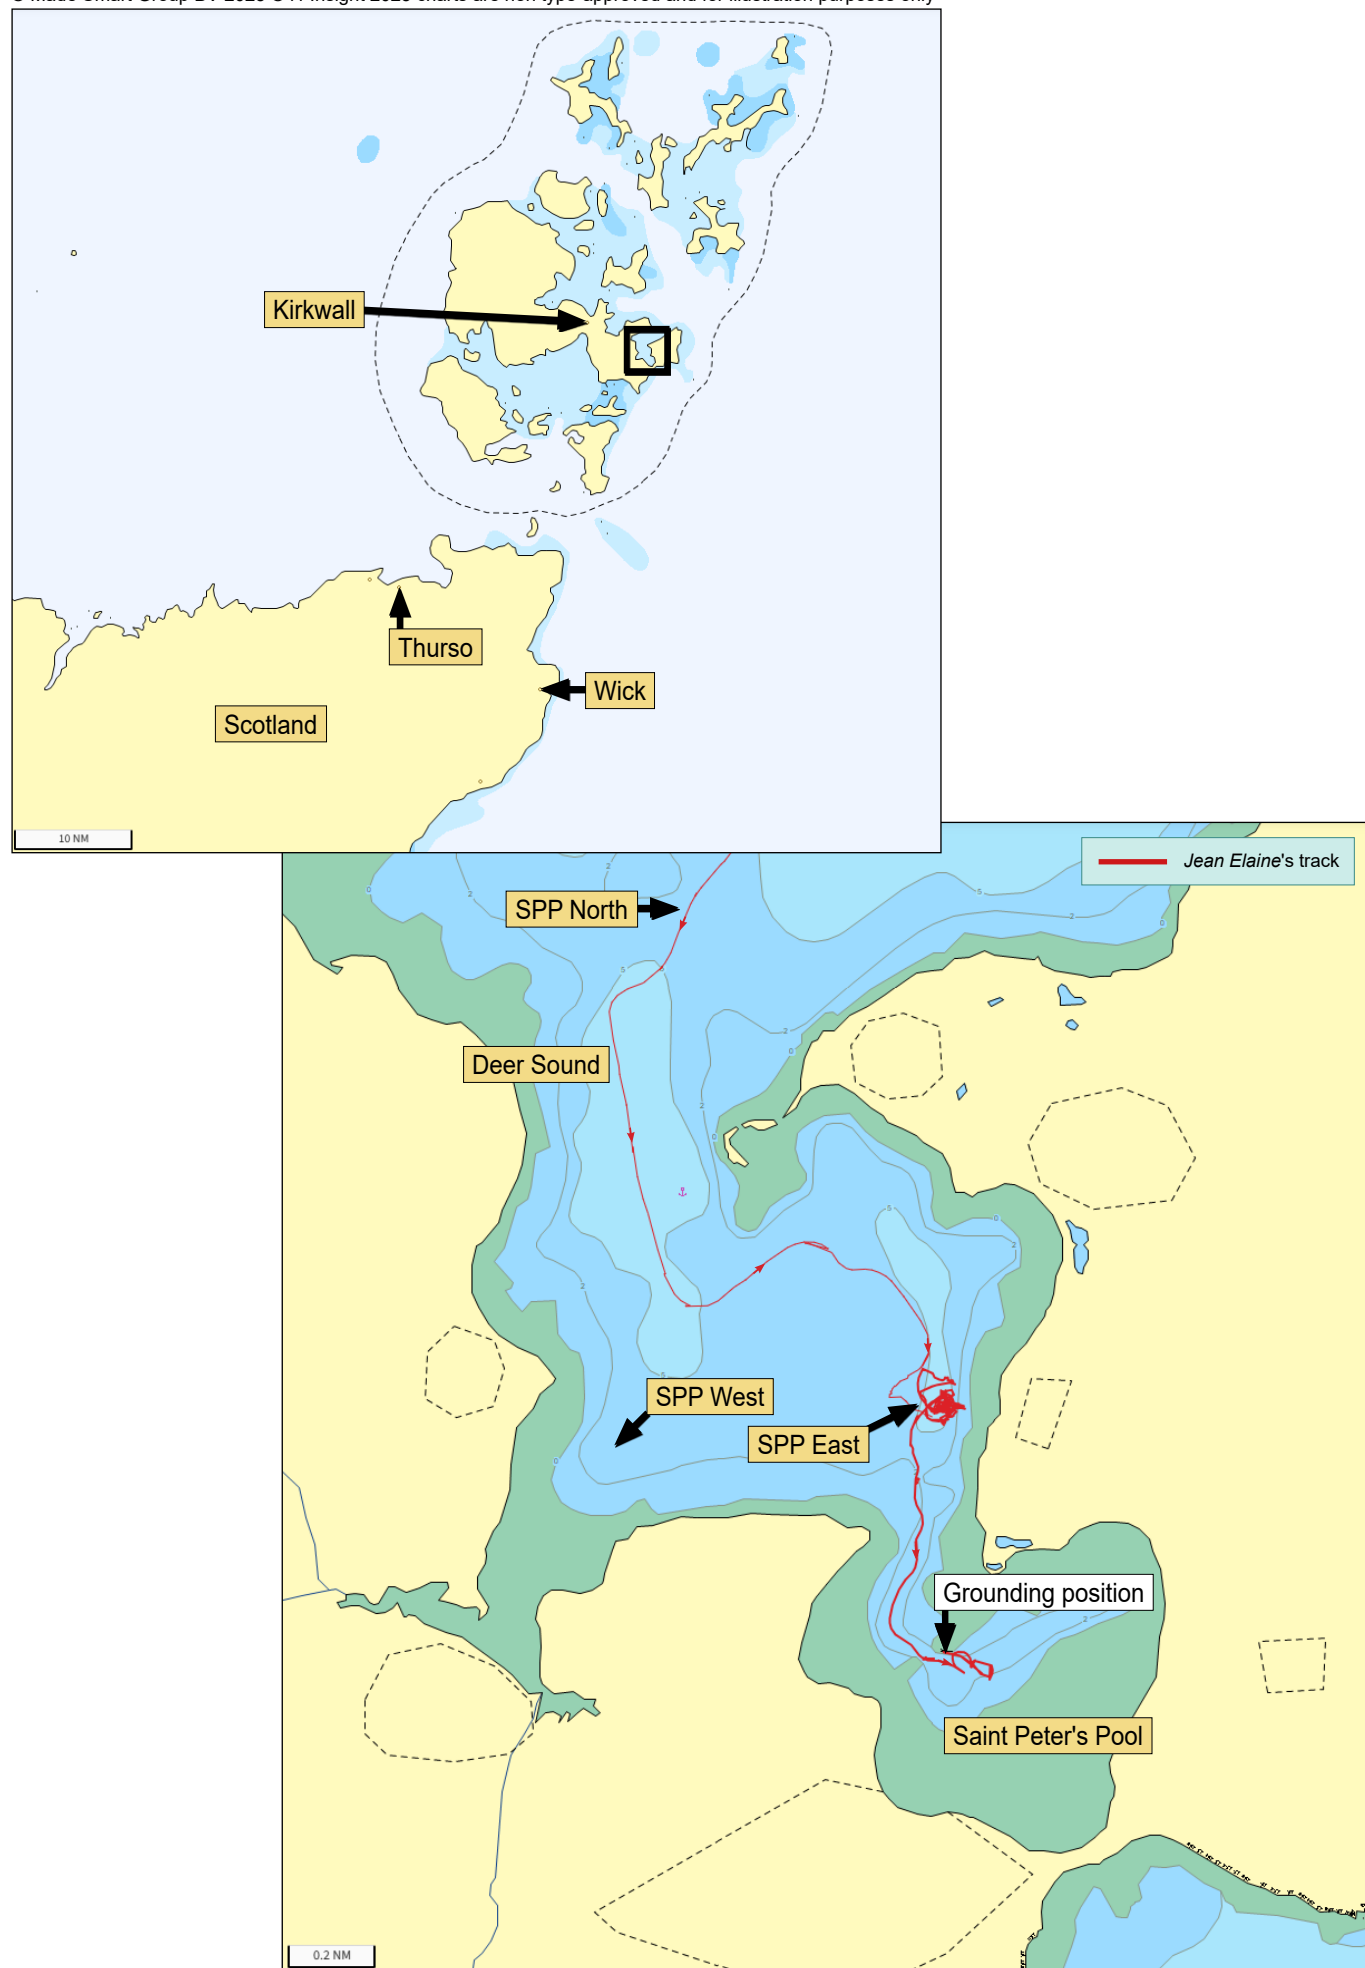
Figure 2: Jean Elaine's track, grounding position and the three pre-identified dive sites in the (inset) Orkney Islands

Once the mate and Project Seagrass diver were back on board, the skipper turned *Jean Elaine* to exit Saint Peter's Pool. At 1500, during this manoeuvre, *Jean Elaine* grounded (**Figure 2**).

The project plan identified three survey locations within Deer Sound, labelled SPP North, SPP East and SPP West (see **Figure 2**). Though the project plan named Saint Peter's Pool within it, none of the survey locations were within the pool and the plan did not contain any contingency to expand the scope of survey should the nominated sites prove unsuitable.

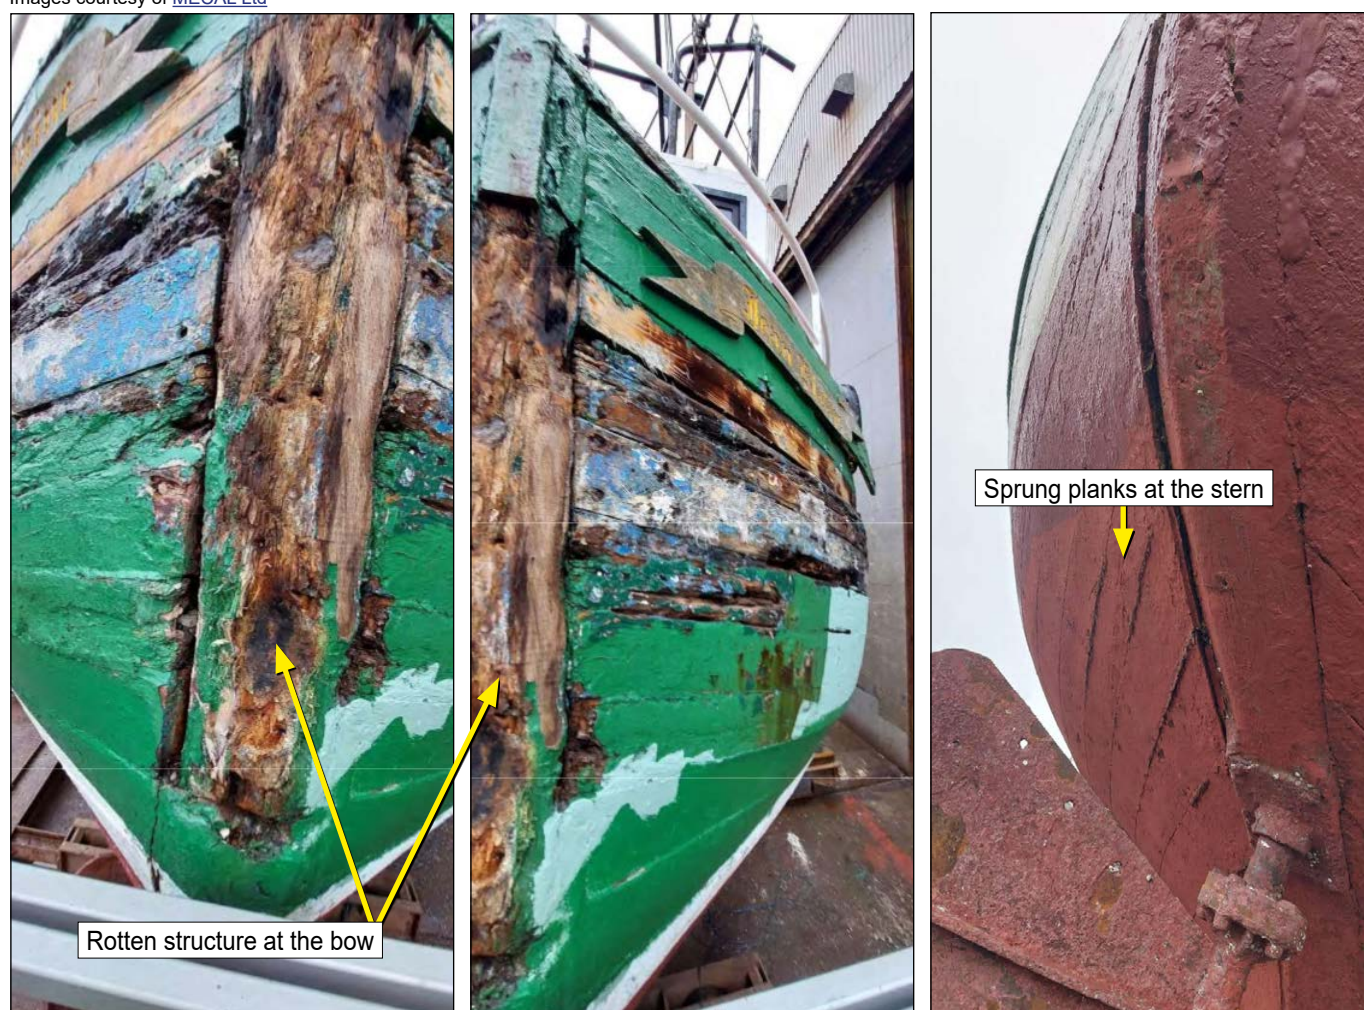
On 29 April 2024, *Jean Elaine* was examined out of the water for the renewal of its certificate. The examination was carried out by MECAL Ltd, a certifying authority authorised by the MCA to survey and certify vessels under MGN 280 (M). The survey identified sprung and rotten hull planking (**Figure 3**) and the certificate held by *Jean Elaine* was not renewed. The suspension of certificate notice issued by MECAL Ltd to the skipper of *Jean Elaine* stated that, *While this suspension notice is in force, the vessel must not operate commercially*.

Figure 3: *Jean Elaine*'s hull defects in April 2024

Jean Elaine was not certified for commercial operation at the time of the accident as the vessel's certification had not been renewed following the survey in April 2024, which identified significant structural issues with the hull. Its insurance was invalid due to the lack of certification. The poor condition of the hull planking likely reduced its ability to resist the localised loading it experienced as *Jean Elaine* listed onto the seabed as the tide fell. Additionally, the skipper had not revalidated their certificate of competence. Given the requirements for revalidation of the skipper's Yachtmaster Offshore qualification, it was unlikely that this omission contributed to the accident.
