PHASE 1 SITE INVESTIGATION

96-8, Emery Road, Brislington

Project No. 001MYTRP1

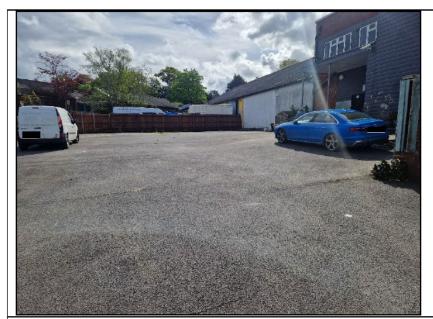
A walkover survey was carried out on 29th April 2024. The external area had hardstanding present throughout. In the case of the area fronting the nursery, this comprised tarmac which was observed to be in good condition. This was separated by a fence from the remainder of the site which had concrete present which was in reasonable condition with some cracking present.

Figure 2. Tarmac area adjacent to nursery

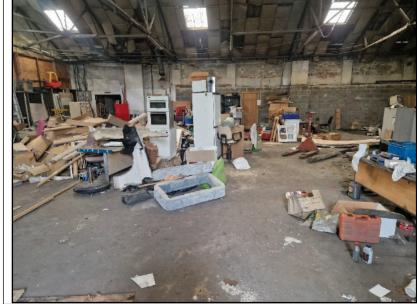
Figure 4. Interior of storage area.

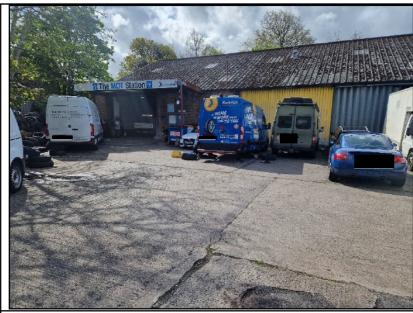
Figure 3. MOT garage eastern part of site.

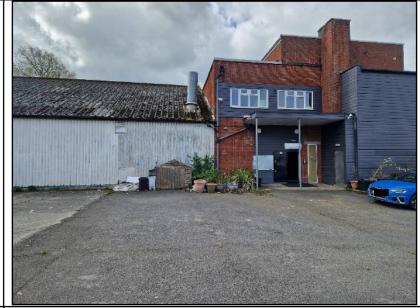
The interior of the western part of the site comprised the former nursery which had wooden flooring, playrooms toilets etc. The area to the east of this had been used as a warehouse with a concrete floor and was observed to have been used for the storage of items such as furniture. An inspection pit was present which was covered. No staining was observed to be present. An MOT station formed the easterly extent of the building. No tanks were present. Cement bonded asbestos roofing was present on part of the building.

Figure 5. Cement bonded asbestos roofing.
