**Serious Incident**

<b>Aircraft Type and Registration:</b>	Short Bros SD3-60, N915GD	
<b>No &amp; Type of Engines:</b>	2 PT6A SER turboprop engines	
<b>Year of Manufacture:</b>	1989 (Serial no: SH3755)	
<b>Date &amp; Time (UTC):</b>	6 November 2024 at 1500 hrs	
<b>Location:</b>	Terrance B. Lettsome International Airport, British Virgin Islands (TUPJ)	
<b>Type of Flight:</b>	Commercial Air Transport (Cargo)	
<b>Persons on Board:</b>	Crew - 2	Passengers - None
<b>Injuries:</b>	Crew - None	Passengers - N/A
<b>Nature of Damage:</b>	Left mainwheel tyre carcass damaged	
<b>Commander's Licence:</b>	No information provided	
<b>Commander's Age:</b>	No information provided	
<b>Commander's Flying Experience:</b>	No information provided	
<b>Information Source:</b>	Aircraft Accident Report Form submitted by the pilot

**Synopsis**

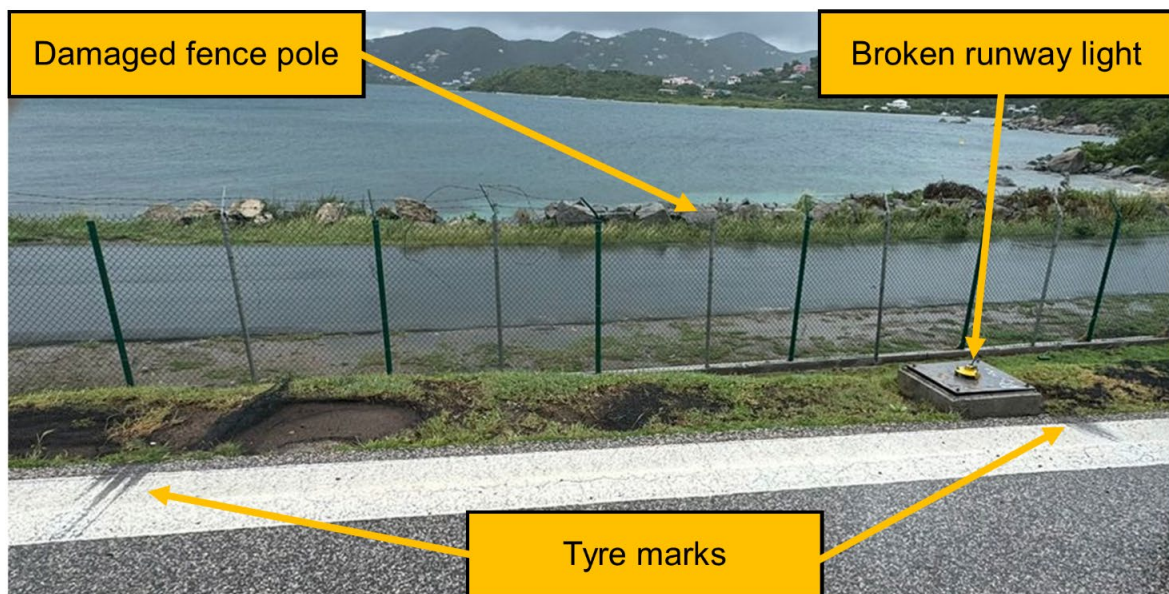
**Figure 1**

During an airfield inspection at TUPJ, which began at 1900 hrs Z on 6 November, it was found that a frangible light at the western edge of the Rwy 07 undershoot was missing. Tyre marks were also discovered on the extreme end of the runway. Based on the nature of the marks, their orientation and location, as well as the track between them, it was determined they were made by an aircraft rather than a ground vehicle (Figure 1). The airfield boundary fence in the Rwy 07 undershoot had also sustained damage. The barbed wire support arm on one fence pole was missing and the wire had been severed in that location (Figures 1 & 2).

Observations from the inspection of Rwy 07 undershoot

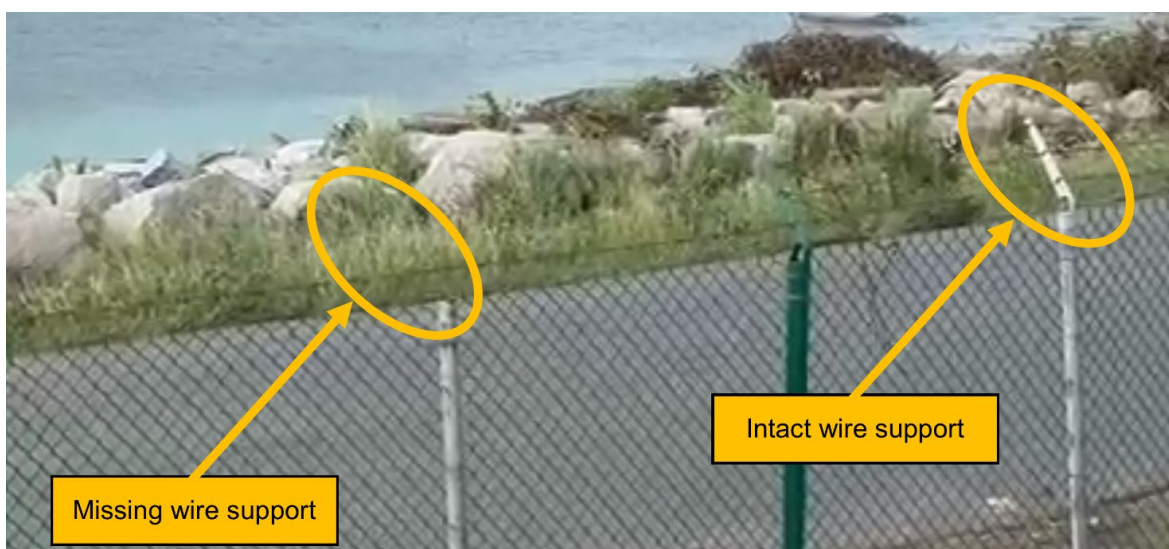
**Figure 2**

Broken fence pole with barbed wire support arm missing

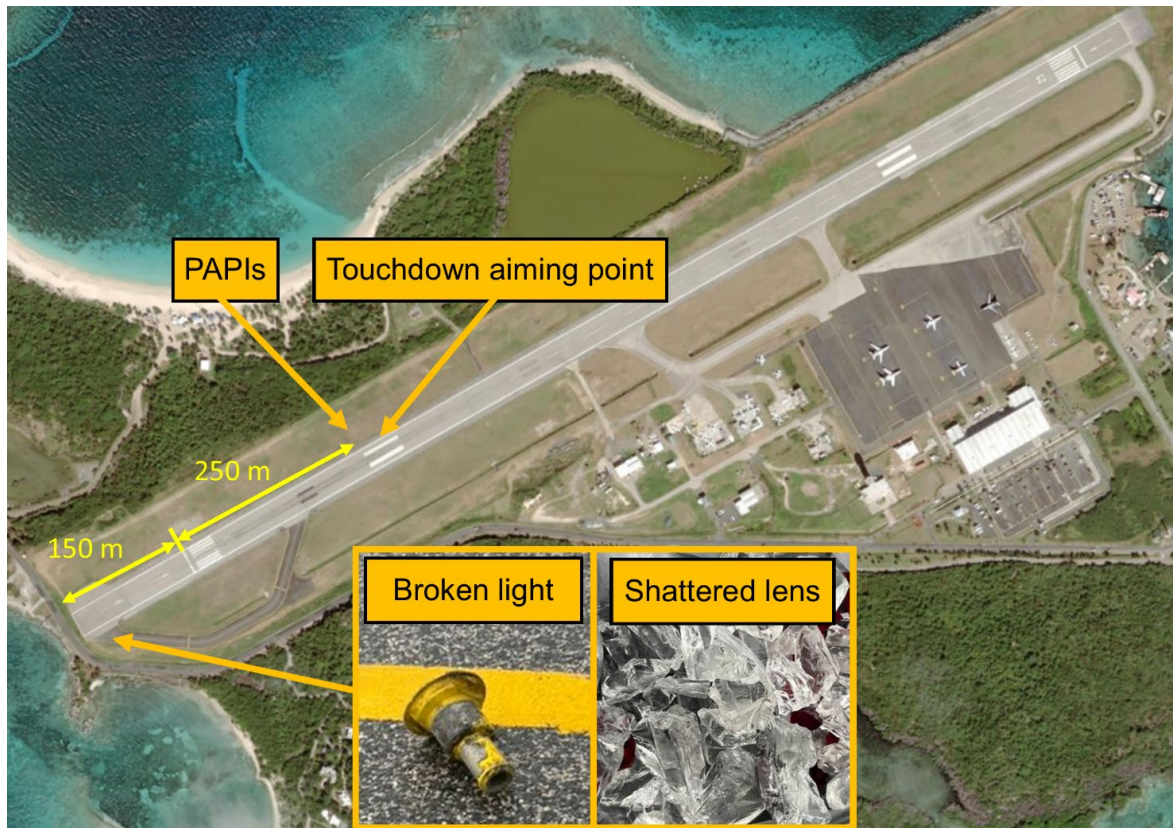
**Figure 3**

The body and shattered lens from the missing runway light were found at the edge of taxiway Alpha (Figure 3).

Airfield overview showing location of damage light (satellite image ©2025 Maxar)

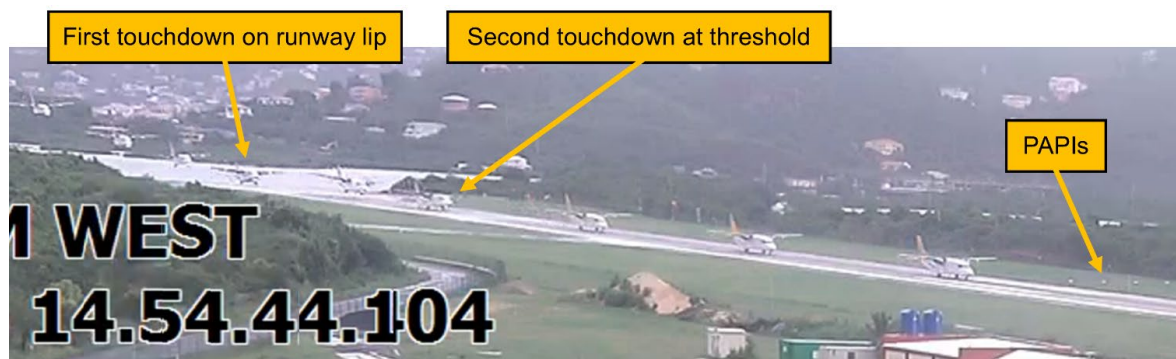
**Figure 4**

To determine how the damage might have occurred, the airfield authorities reviewed CCTV footage from 6 November. They found that when N915GD made its approach to Rwy 07 at 1854 hrs Z it initially touched down in the undershoot at the edge of the runway pavement, bounced once and then landed off its second touchdown (Figure 4).

Composite CCTV imagery of N915GD's approach (local time recorded on CCTV footage)

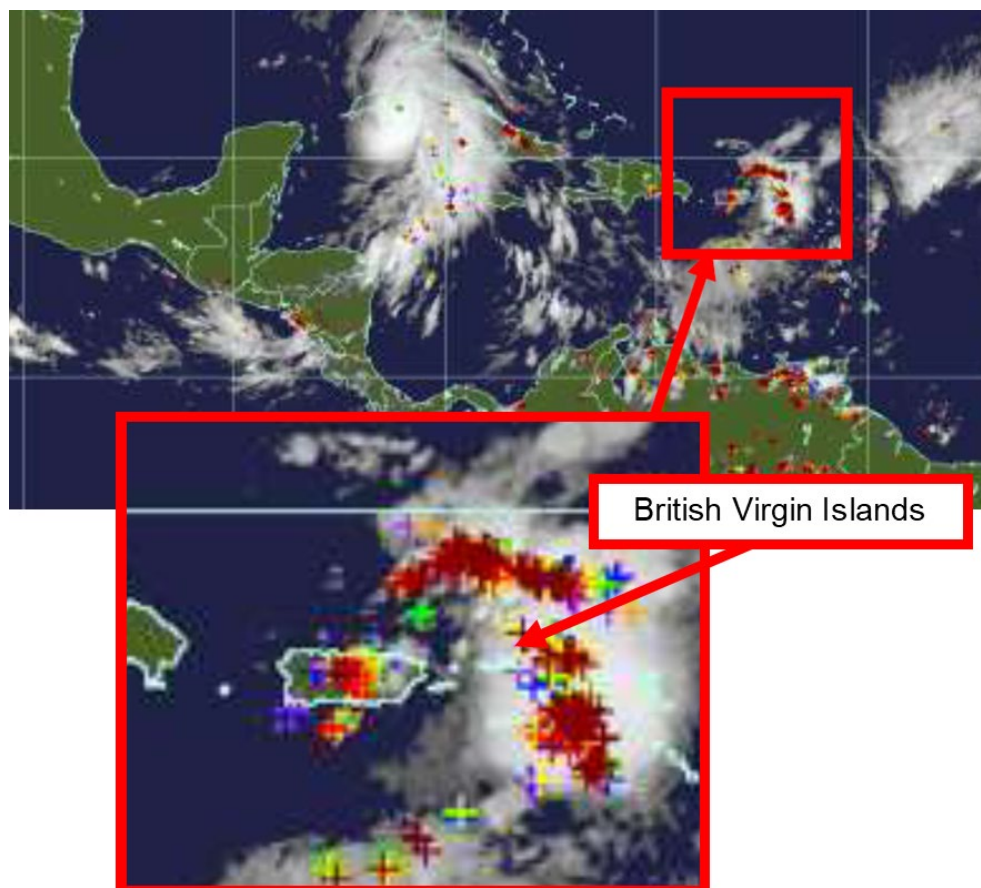
**Figure 5**

- The TUPJ TAF included a risk of thunderstorms from 1800 hrs UTC, with an associated forecast reduction in visibility and cloud bases.
- The reported intensity of the rainfall at the airfield along with the number of lightning strikes recorded on the weather radar imagery at Figure 5 indicated an active CB cell was over or close to the territory at the time of the serious incident.
- There was no indication of any significant wind shear in association with the thunderstorms, but the Met Office did not have access to the full record of wind speed or direction.

Weather radar image at 1900 hrs Z on 6 November 2024 (crosses indicate lightning strikes)

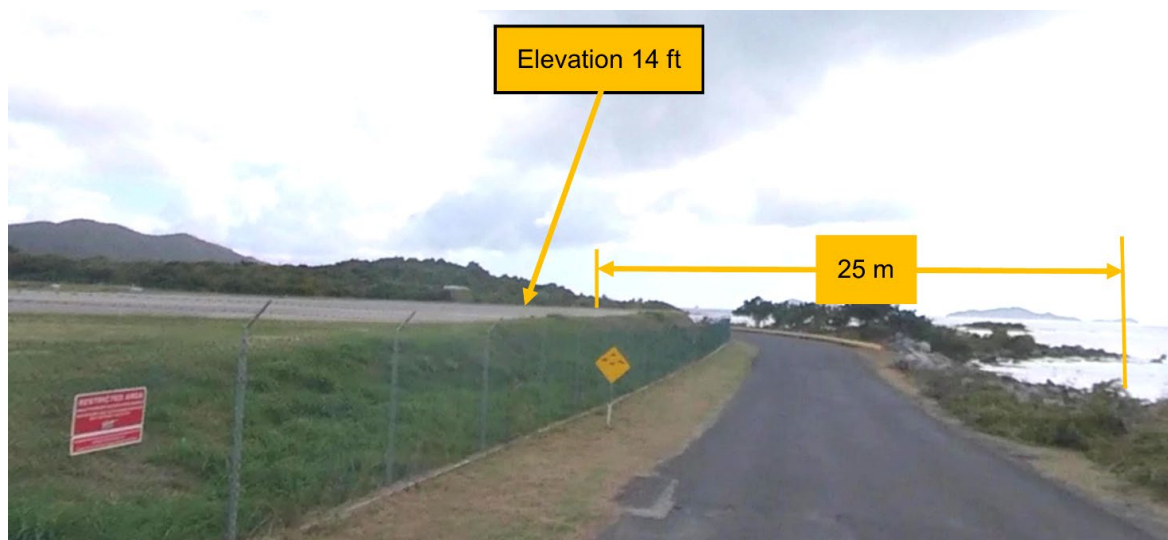
**Figure 6**

TUPJ has a single runway with displaced thresholds at either end. The paved undershoot for Rwy 07 is approximately 150 m long, after which the ground falls away across a public road and rocky shoreline to the sea. The distance between the paved surface and the sea is approximately 25 m and the reported touchdown elevation is 14 ft (Figure 6). As it passes through the undershoot, the top of the airfield perimeter fence is below the level of the paved runway surface.

Rwy 07 undershoot looking in south-easterly direction (image ©Google Earth)

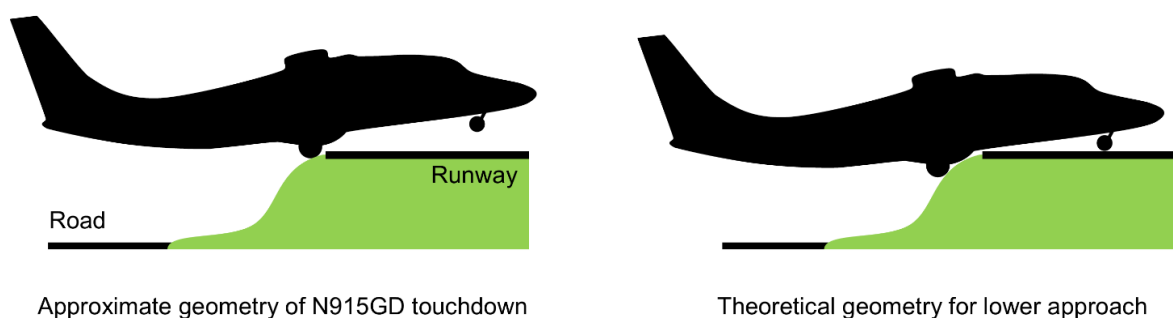
**Figure 7**  
Illustrative touchdown geometries

Based on the visual 3.5° angle described by the airfield’s PAPIs, the aircraft was approximately 80 ft below the expected approach path when it first touched down. Given the profile of the undershoot short of the paved runway surface, the aircraft would not have needed to be much lower on the approach for hull loss to have been a credible outcome (Figure 7).
